# **Structural Condition Survey For Existing Rear Retaining Wall at Nos 85, 87 and 89 Roehampton Rise Barnsley**

Prepared on behalf of  
**Barnsley Metropolitan Borough Council**  
Date of Survey –15<sup>th</sup> March 2017

07-17-17-3-1208

Issued 28.03.2017

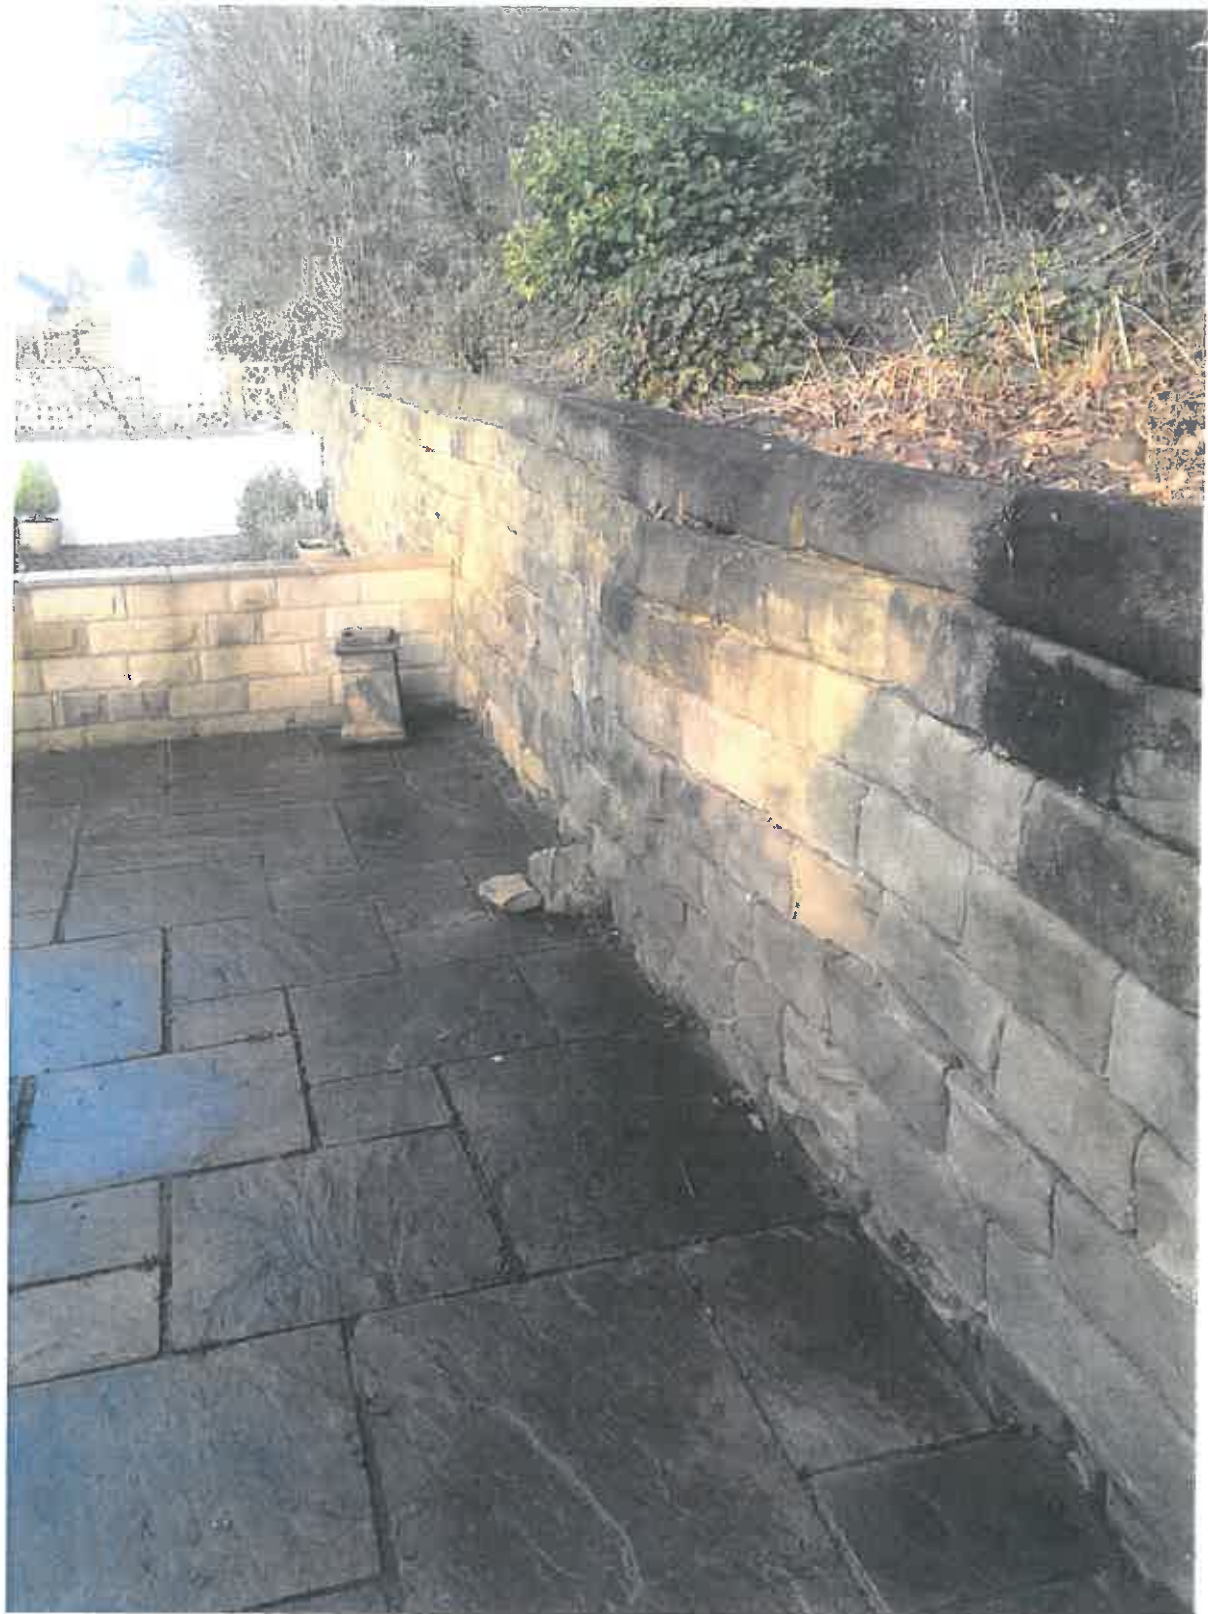
The top of the wall is meandering in and out of horizontal and vertical alignment. There is significant bulging to the face of the wall. It was noted that the bulging is worse in the proximity of the trees. This is also evident in the locations where some trees have been cut down.

*Photo 1 – Left Hand Side View towards No 85 from No 87 Showing Bulging and Misalignment to wall*

- I. The bulging is worst in the locations of the existing large tress or former positions of the trees cut down. The close proximity of the trees to the retaining wall is causing significant thrust onto the walls most likely from roots pushing against the wall. This thrust will continue to increase as the trees and the roots continue to grow bigger. At some point this increasing force will eventually cause the wall to fail and collapse.
- II. There is also the influence of the overburden pressure (surcharge) caused by vegetation growth in the woodland. There is lack of maintenance and care.
- III. We recommend that the wall be taken down carefully and rebuilt to the original alignment using the existing stones. We also recommend that the joints to the exposed face should have mortar to increase the strength of the wall.

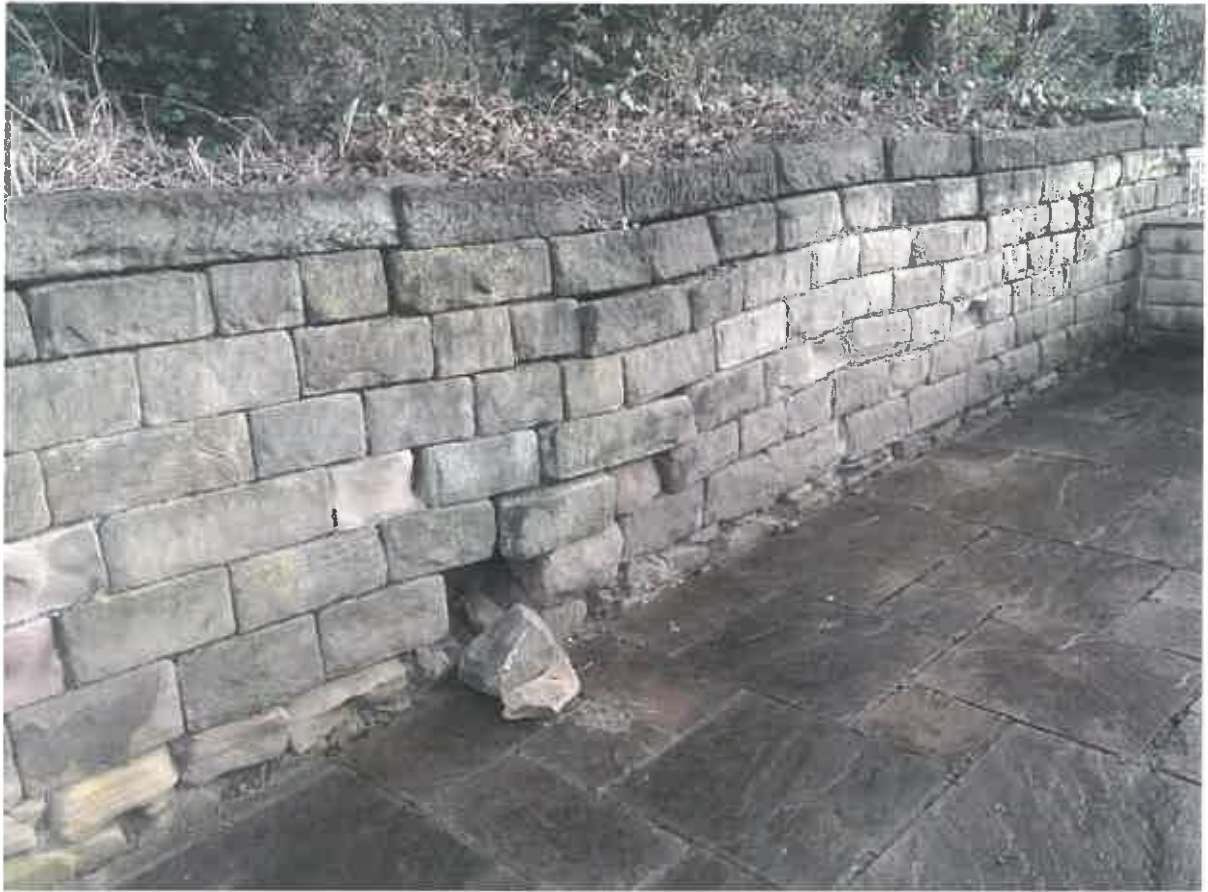
There is no movement to the ground in front of the wall. However there is a depression in the ground at the top of the wall on the retained side. Some of the joints to the wall have opened up with some stone blocks dislodging from the wall at some locations.

*Photo 2 – View from No 87 Showing Bulging, Misalignment to wall and Masonry Dislodging from Wall*

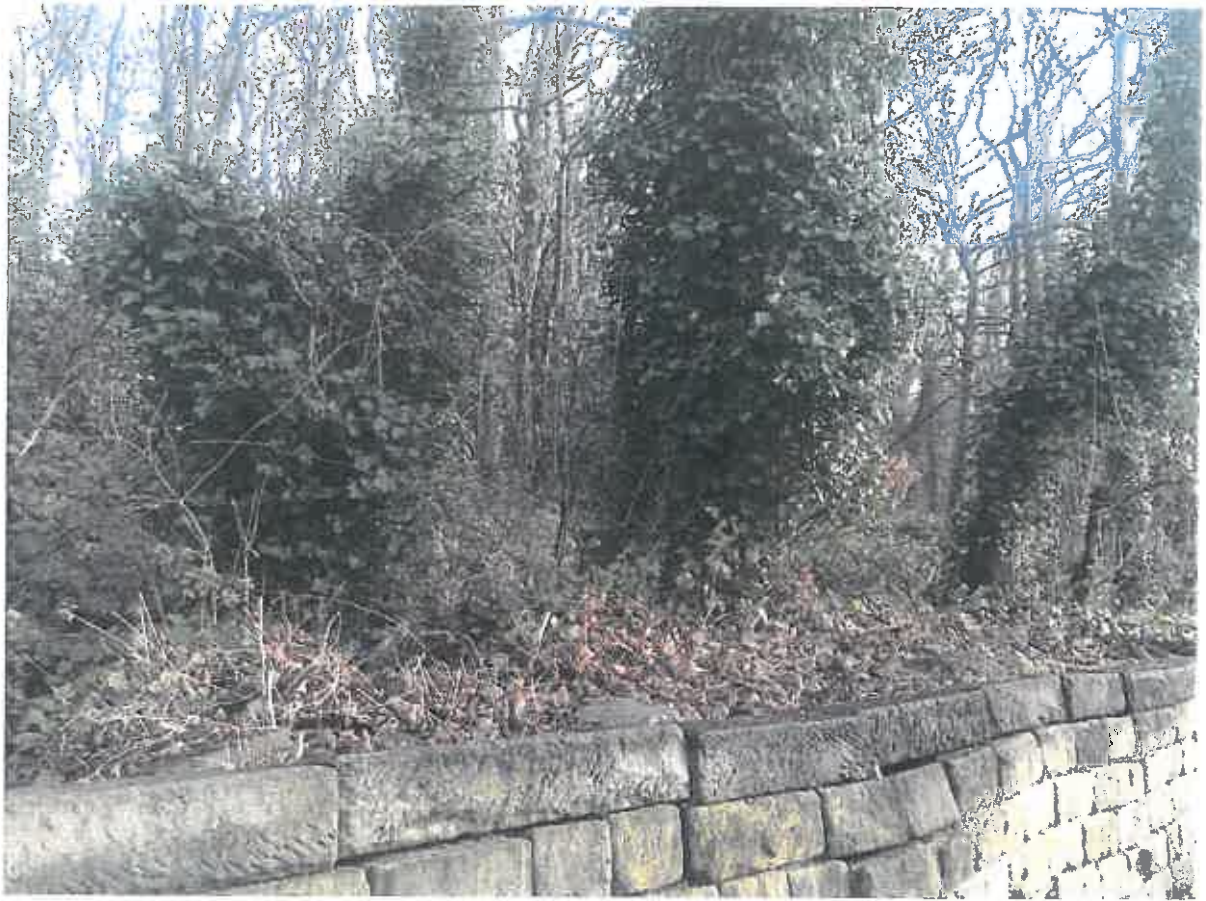
There is a lot of vegetation growth at the top of the retaining wall as well as fully grown trees as close as 1.5m from the face of the wall. In some places the trees have been cut down.

*Photo 3 – View from No 87 Showing Bulging, Misalignment to wall, and close Proximity of Trees to the Wall*

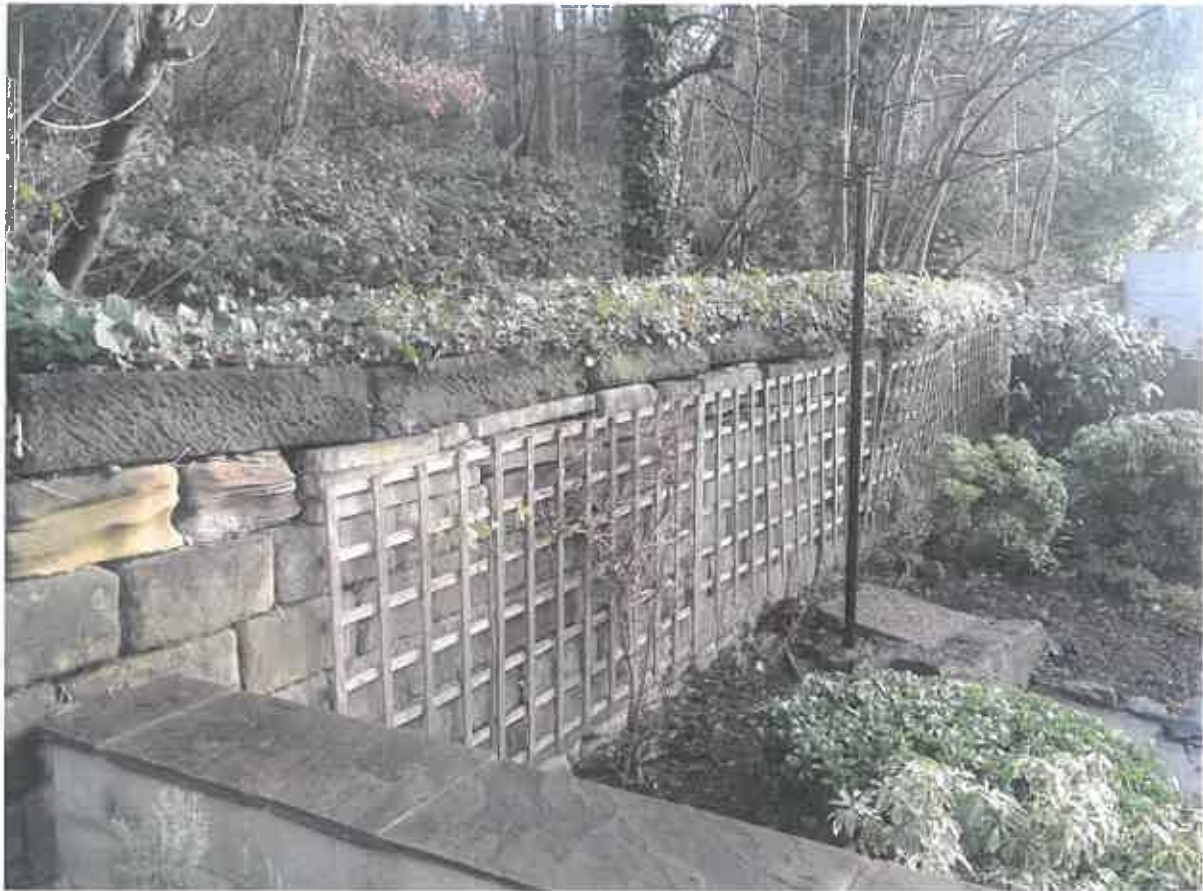
*Photo 4 – Right Hand Side View from No 87 towards No 89 Showing Bulging, Misalignment to wall, and close Proximity of Trees to the Wall*
