# Engineer's Report

| Our Reference | <b>IFS-RBS-SUB-11-0031530</b> |

| Address | <b>The Gables, Carlton Road, Carlton, Barnsley,<br/>S71 3JD</b> |

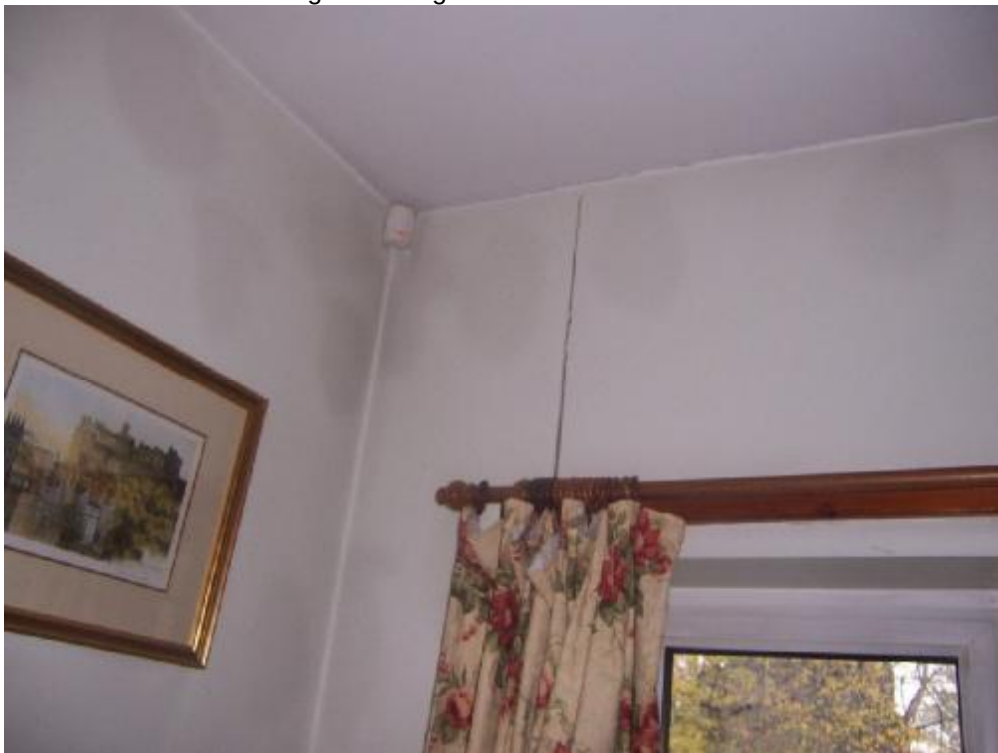
Up to approximately 10mm wide cracking was noted above and below the window openings on the front and side walls, with some minor vertical cracking also evident at the rear left corner of the room.

The damage was generally orientated towards the right hand side of the cottage.

FIGURE 4 Internal damage to lounge

Generally cracks 1mm wide or less will be filled (internal) or re-pointed (external). Internally, where the cracks are wider than 1mm, but less than 5mm the underlying brickwork/stonework will be exposed and prior to making good the plaster finishes the cracking will be covered with expanded metal lathe. Where cracks are 5mm across or wider, some form of bed joint reinforcement may be introduced, where practicable.
