# Annual Tree Health & Woodland Inspection.

4U2 View

1825  
March 2022

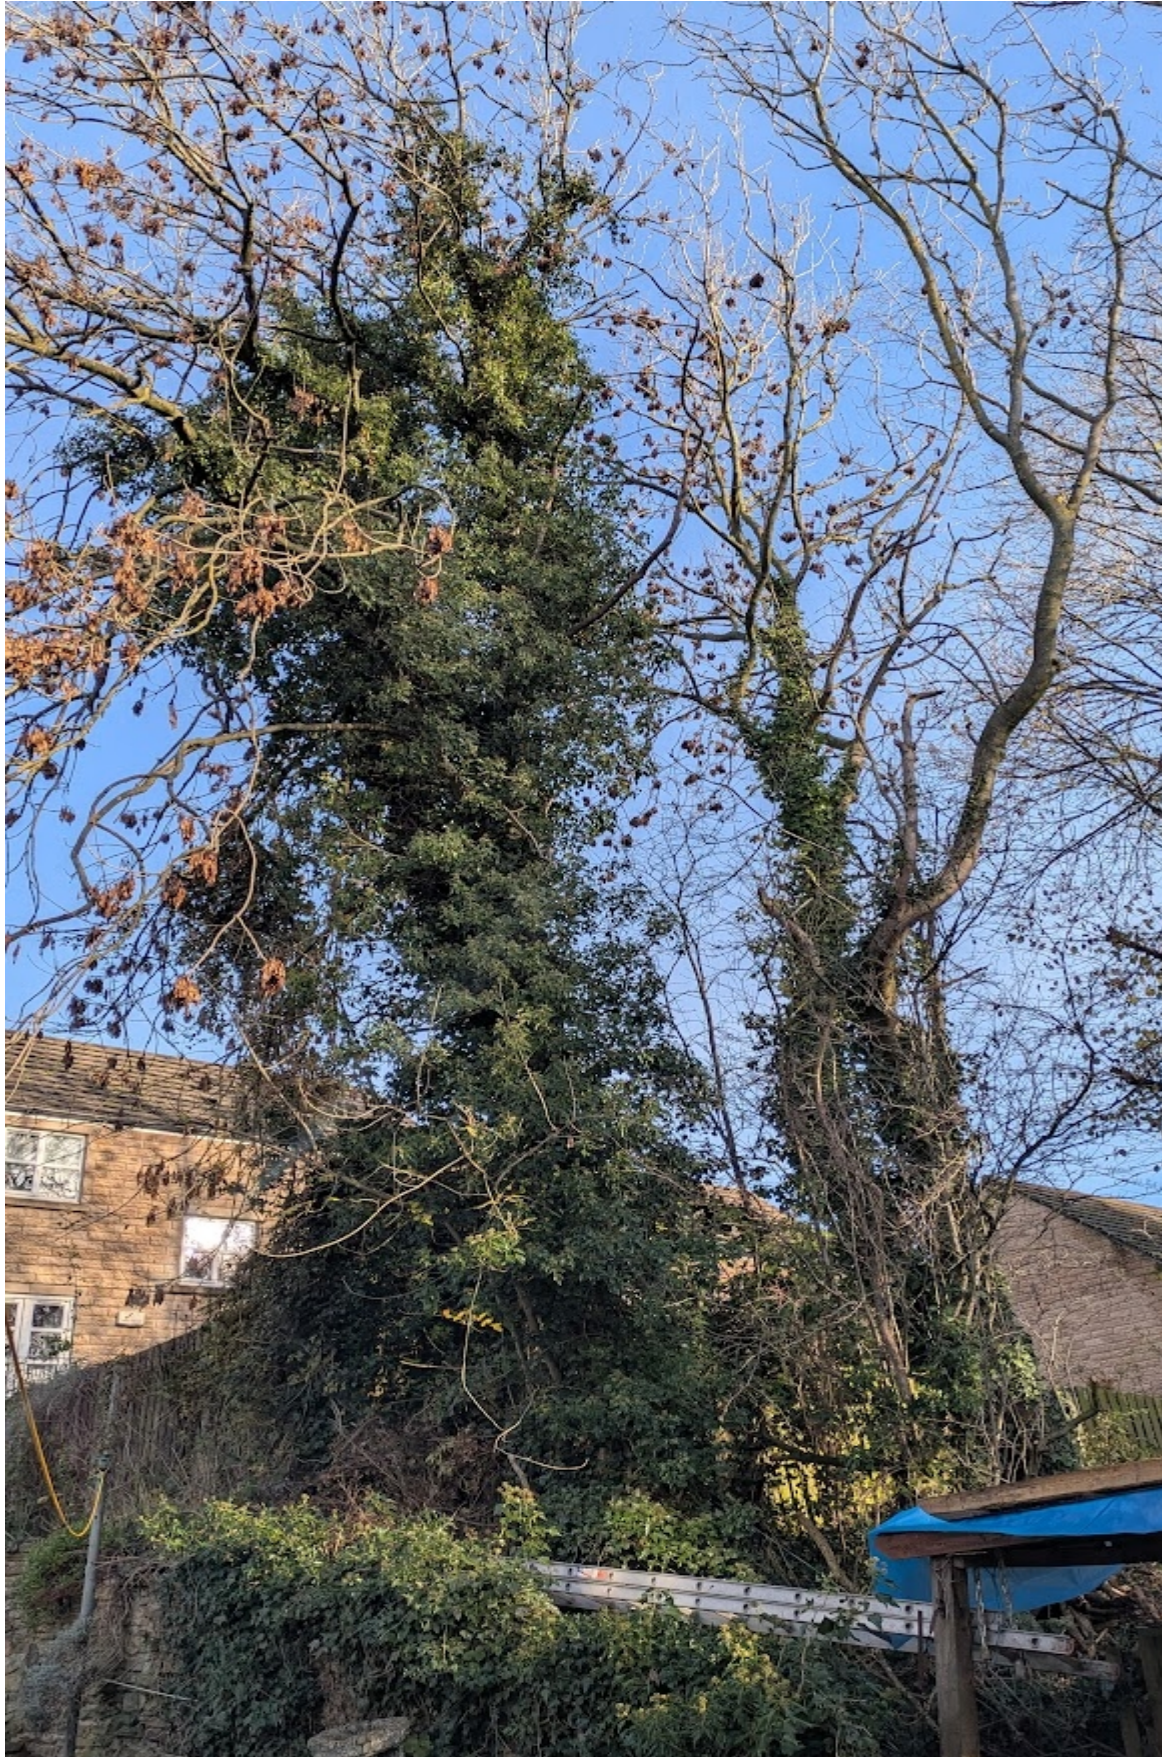
Some trees clad in ivy, minor storm damage, acer tar spot on sycamore, not a health issue, tree in the photo required a 30% canopy reduction to balance the tree and remove overhang of the garden, cut ivy at the base of the tree, six months' timescale. Cutting of the ivy will allow a detailed inspection of the stem of the tree.

Ash tree, 30% height reduction, cut ivy at base on the trees in this area.

Ash tree, reduce by 30% to reduce lean over the garden, see photo, cut ivy at base of the tree, six month timescale.
