Tree Related Structural Concerns at Residential Property

RSC24111501

Friday 15 November 2024

45 Rectory Lane, Thurnscoe, Rotherham S63 0RS

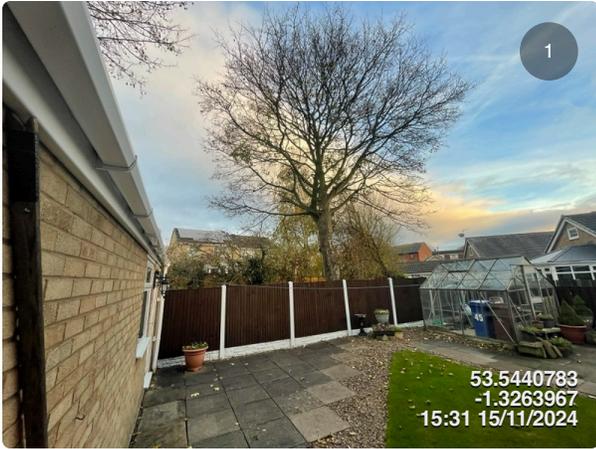
Photo 1 showing the Sycamore Tree in question.

a) The removal of the primary factor that has caused structural movement and is likely to continue to do so. That is, that consideration be given to allowing the tree to be felled. Should the tree remain and continue to flourish, then the likelihood of further settlement to the premises cannot be discounted.

b) Should the above not be permitted, then a reduction to the crown of the tree to reduce its impact on the environs. It should be noted, however, that such pruning might stimulate new growth that could potentially lead to exacerbation of any settlement.

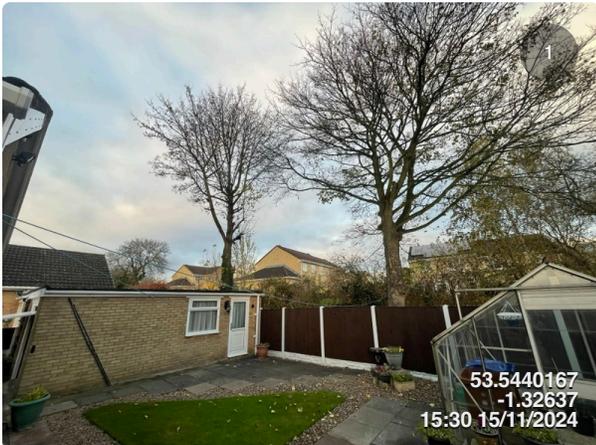
Photo 2

The Sycamore Tree own by my client is in the foreground. Located behind the fence on the bank of a watercourse. The tree's relative position to the garage can be seen. A 2nd tree own by a neighbour can be seen behind the garage.

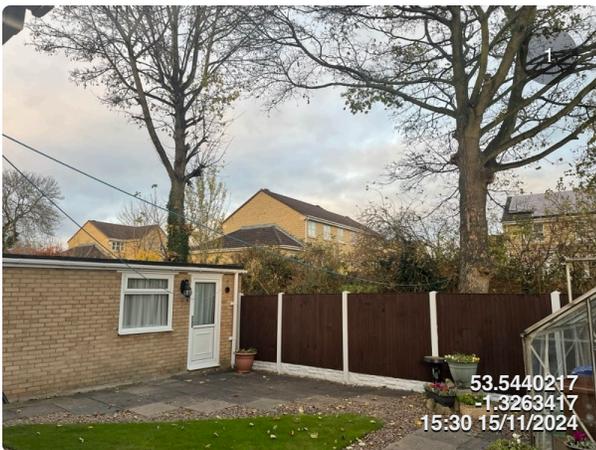
Photo 3

As commentary to Photo 2 above.

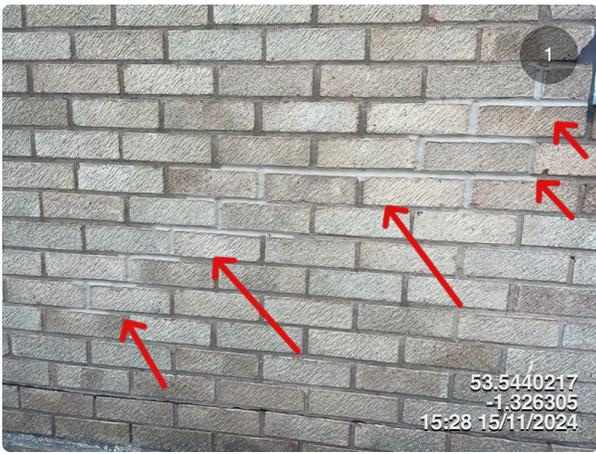
Photo 4

The garage wall from outside. Settlement cracking has occurred to the brickwork jointing of the single skin (1/2 brick thick) garage wall and this has been recently pointed on the outside of the garage wall. The distance from the tree at this point was measured at 6.9m.

A) There is evidence of movement having occurred to the garage resulting in settlement cracking to the jointing of the brickwork structure and shearing of some masonry. This is type of cracking is typical to settlement caused by heave and shrinkage of clay subsoils, as are generally present in this locality. The location of a tree within close proximity to a structure, as in this instance, is often a significant contributory factor; the roots can cause a desiccation of the subsoil in times of drought.

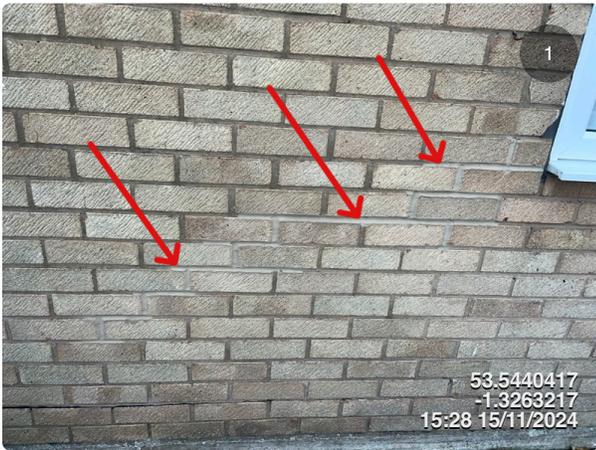
Photo 5

Commentary as Photo 4.

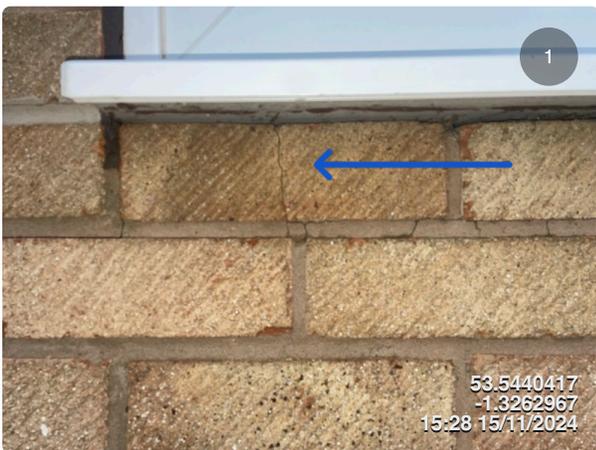
Photo 6

The garage wall from outside. The movement has also resulted in bricks shearing (blue arrow).

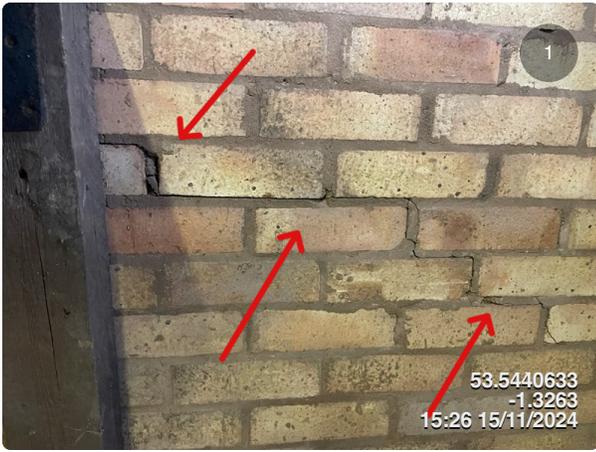
Photo 7

The garage wall from inside. The settlement cracking to the wall can be clearly seen.

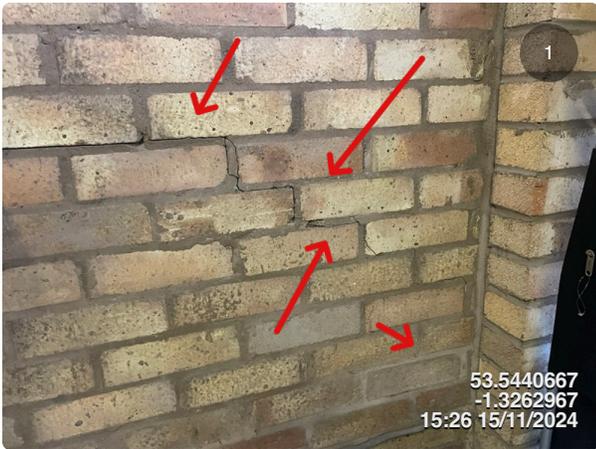
Photo 8

Commentary as Photo 7.

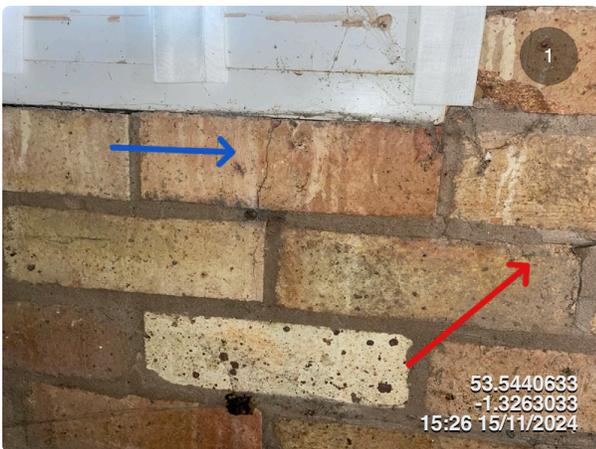
Photo 9

Settlement movement cracking of brickwork joints and shear crack to brick (blue arrow).

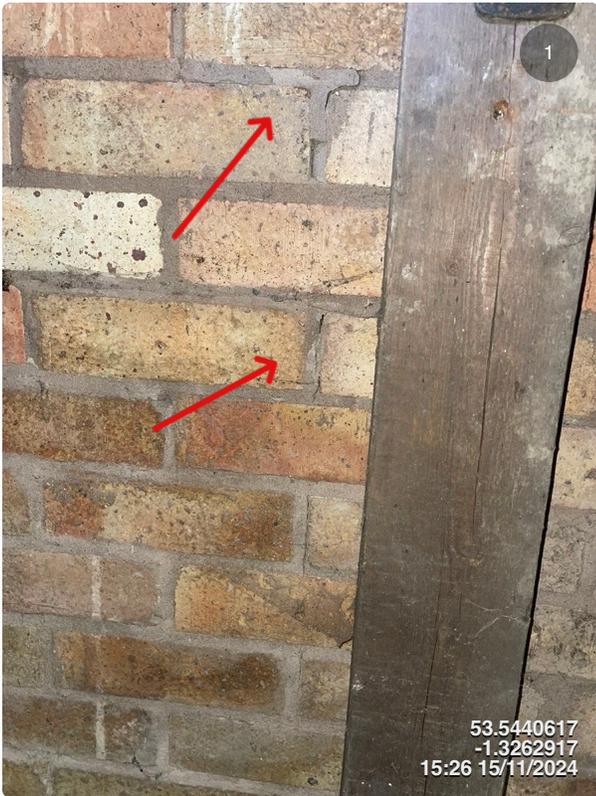
Photo 10

Commentary as Photo 7.

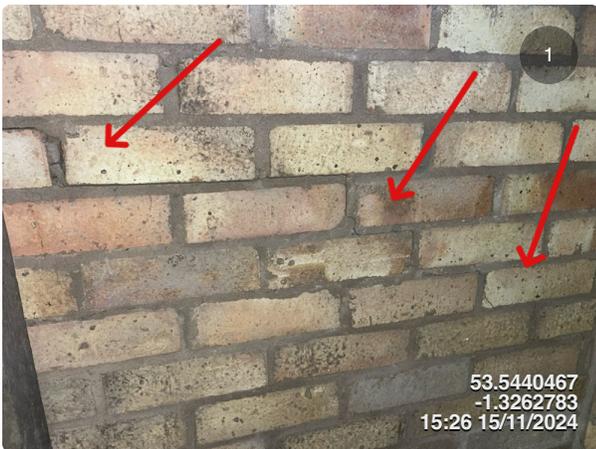
Photo 11

Commentary as Photo 7.

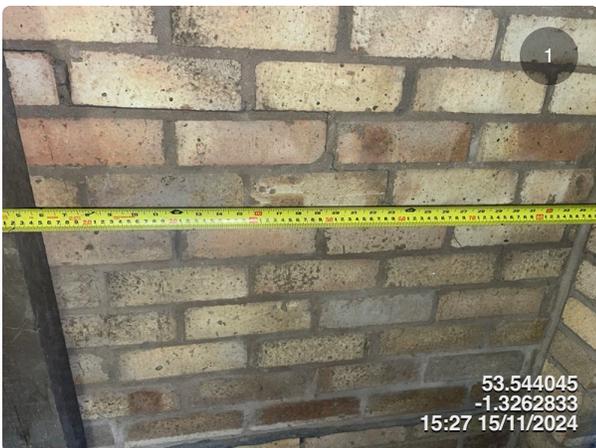
Photo 12

The cracking extends over an horizontal distance of around 900mm.

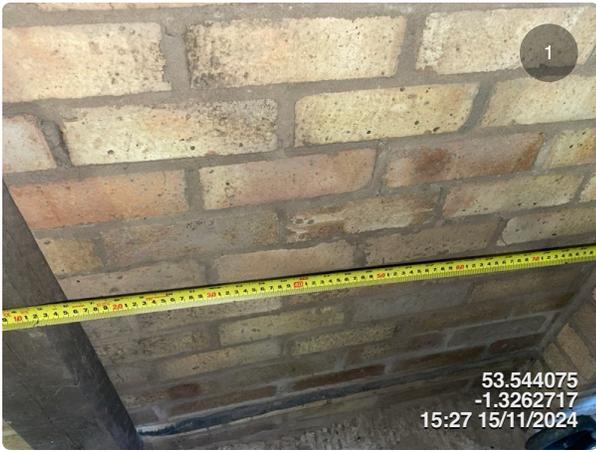
Photo 13

Commentary as Photo 12.

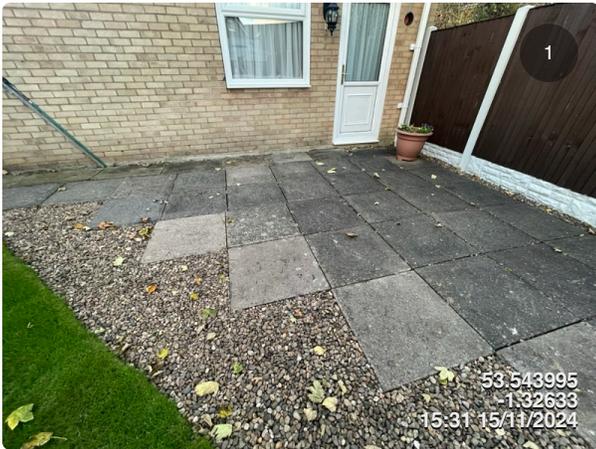
Photo 14

The roots from the tree are causing paved patio area to be raised upwards causing potential trip hazards. My elderly client is concerned for her wellbeing when in this area of her garden.

B) A tree root at surface level was observed within the rear lawn area. There are signs of vertical movement to the paved patio area which might be attributed to some extent to the tree roots. My inspection was non-intrusive, however, so no paving was taken up to verify this. My client's concerns over tripping and taking a fall do seem well founded.

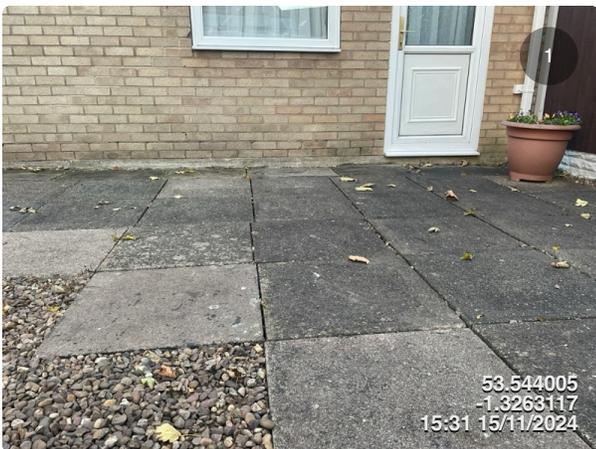
Photo 15

Commentary as Photo 14.

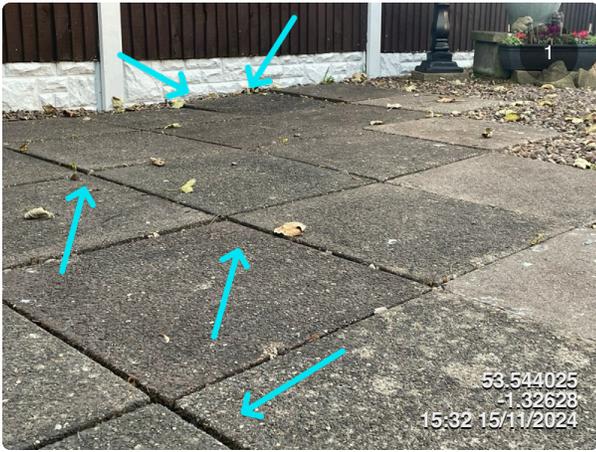
Photo 16

Commentary as Photo 14.

The tree roots have caused the patio to become very uneven.
