*BS5837:2012 Trees in relation to  
design, demolition and construction*

## Belle Vue College, Cockerham Lane, Barnsley S75 1AT

20<sup>th</sup> June 2014

| <b>Title</b> | Belle Vue BS5837:2012 Tree Survey Report | | |

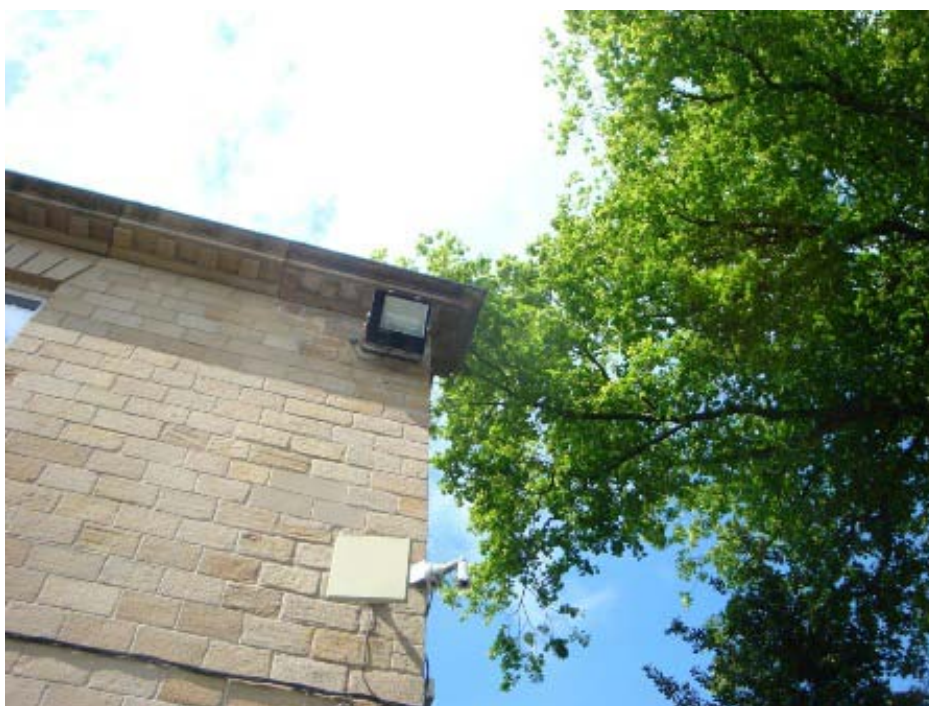
- 3.1.3 Ivy was found across many trees on the site and it is recommended that this be removed to permit future inspections. T5 was found to be touching the building and this should be crown raised to clear the roof and prevent damage.

*T5 touching the roof of Belle Vue*

| Tree / Group No | Recommended works | Work Priority |
|---|---|---|
| T5 | Reduce from building / Sever ivy | 3 |

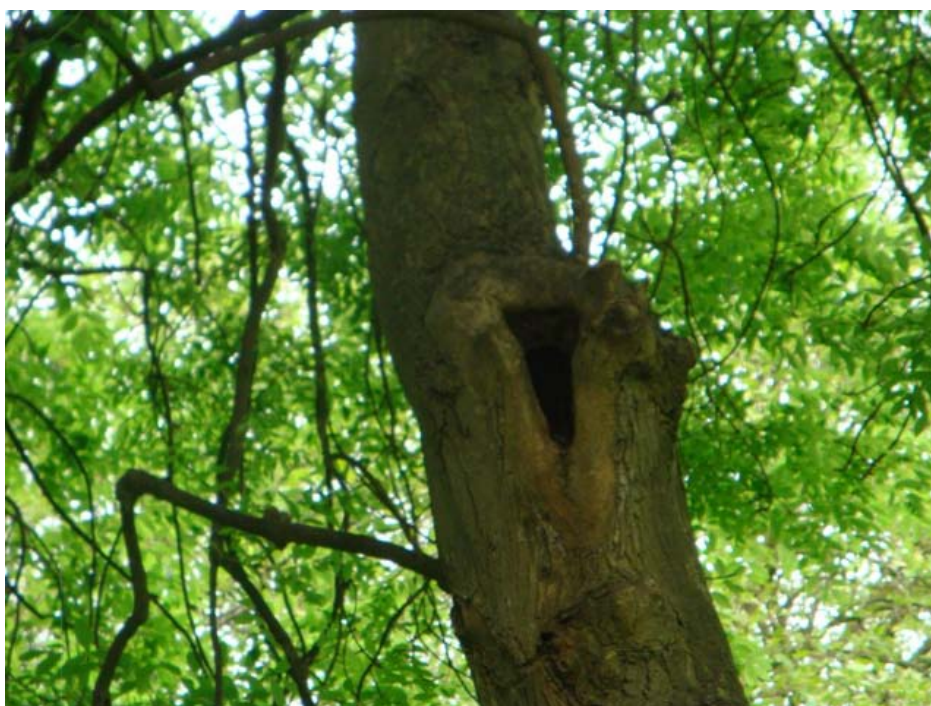
- 3.1.4 T40 was found to have 3 cavities, all on the main structural limbs. There is potential for these cavities to be bat roost sites. The cavity represent a structural compromise in the limbs of the trees however they also represent an ecological benefit. As a compromise, the end weight of the branches should be reduced to relieve stress on the limbs and reduce the risk to site users from failure whilst retaining the cavities.

*Cavity on T40 (potential for bat roost)*

| Tree / Group No. | Species | Height | Dia @ 1.5m | Crown Spread | | | | First Branch Height/Direction | Crown Clearance | Age Class | Physiological Condition | Structural Condition | Management Recommendations | Remaining Contribution | Retention Category |
|---|---|---|---|---|---|---|---|---|---|---|---|---|---|---|---|
| T40 | Ash | 16 | 720 | 6 | 10 | 7 | 5 | 4:W | 3 | Mature | Good | Fair - cavities noted on 3 scaffold limbs in upper crown - POTENTIAL BAT ROOST | Reduce branch end weight / Monitor | 10-20 | C1 |

- 4.5.1 This mini pitch is located close to T38 cat C1, G39 cat B2 and T40 cat C1.
- 4.5.2 The construction of this pitch requires the removal of T38 and T40. T40 has potential for bat roosting which will need to be confirmed by an ecology survey.
- 4.5.3 A no-dig construction methodology will be required to avoid root damage to G39.

| Tree / Group No | Recommended works | Work Priority |
|---|---|---|
| T40 | Reduce branch end weight / Monitor | 4 |
