Descriptive Report with Remarks and Observation Images

Site: Gawber Road , Barnsley

Client: Mott Macdonald	Location (Street Name): Gawber Road	City/Town/Village Barnsley	Cust Job Ref.	Surveyors Name: Jordan Beckett	Date: 28/01/2019
---------------------------	--	-------------------------------	---------------	-----------------------------------	---------------------

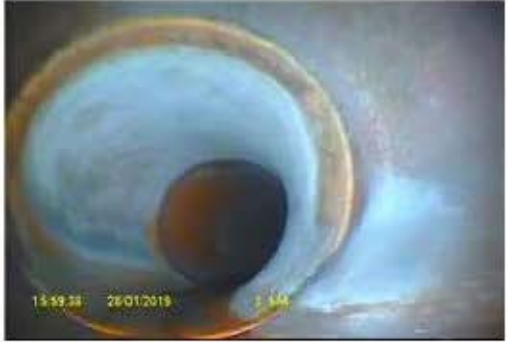
Pos	Video Ref	Code	Description	Image
00.00m		MH	Start node type, manhole MH04	
00.00m	0:00:00	WL	Water level: 0% Height/Diameter	
03.60m	0:00:17	LRQ	Line of drain/sewer deviates right [quarter]	Image Provided - Ref: 13_2

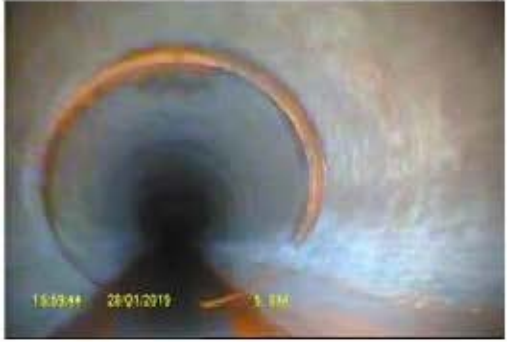
05.80m	0:00:23	JDM	Joint displaced medium - Severity 3	Image Provided - Ref: 13_3

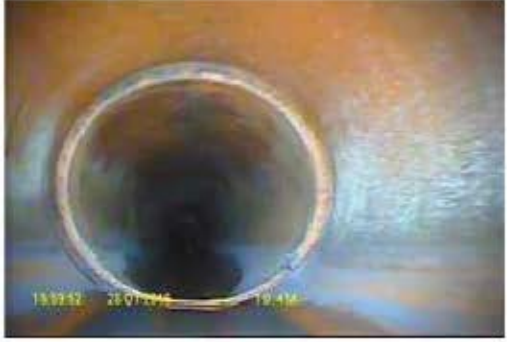
10.40m	0:00:31	JDM	Joint displaced medium - Severity 3	Image Provided - Ref: 13_4

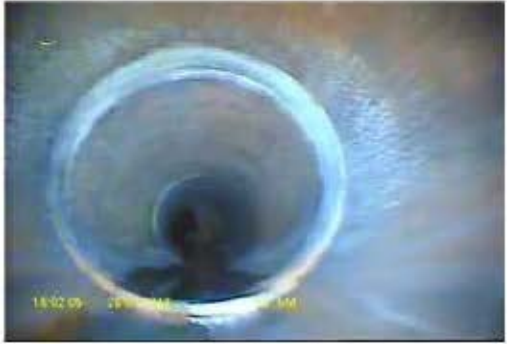
Pos	Video Ref	Code	Description	Image
12.60m	0:02:45	JDM	Joint displaced medium - Severity 3	Image Provided - Ref: 13_5

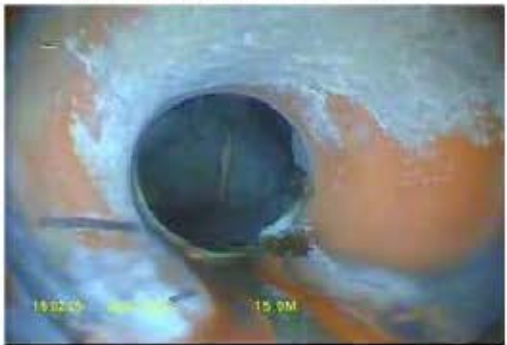
15.00m	0:03:04	LLQ	Line of drain/sewer deviates left [quarter]	Image Provided - Ref: 13_6

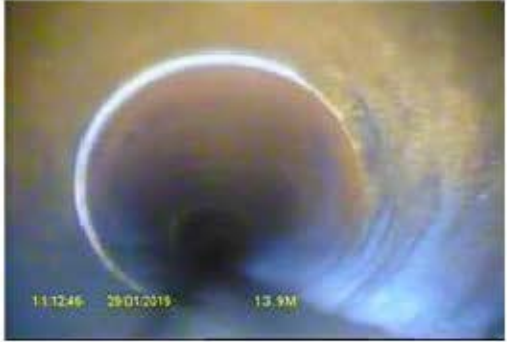
Pos	Video Ref	Code	Description	Image
00.00m		MH	Start node type, manhole MH06	
00.00m	0:00:00	WL	Water level: 0% Height/Diameter	
13.90m	0:00:43	JDM	Joint displaced medium - Severity 3	Image Provided - Ref: 15_2

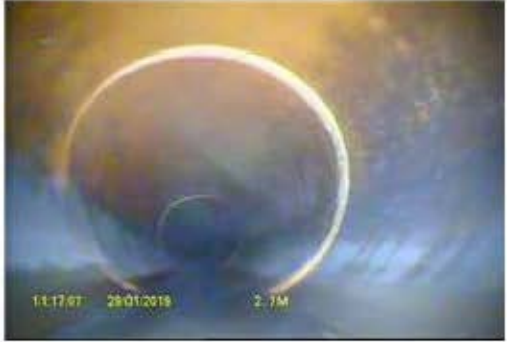
Pos	Video Ref	Code	Description	Image
00.00m		MH	Start node type, manhole MH06	
00.00m	0:00:00	WL	Water level: 0% Height/Diameter	
02.70m	0:00:27	JDM	Joint displaced medium - Severity 3	<p>Image Provided - Ref: 16_2</p>

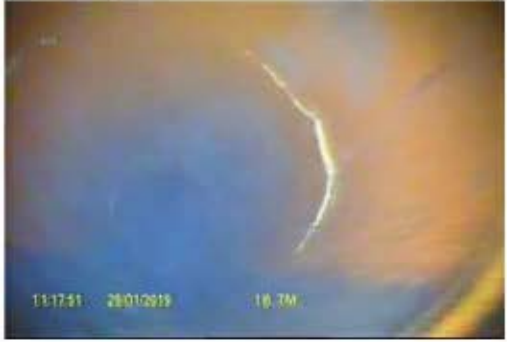
16.70m	0:01:11	CC	Crack, circumferential from 12 o'clock to 06 o'clock - Severity 1	<p>Image Provided - Ref: 16_3</p>

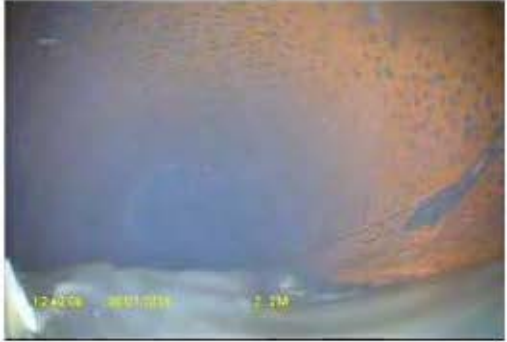
Pos	Video Ref	Code	Description	Image
00.00m		MH	Start node type, manhole MH07	
00.00m	0:00:00	S1 WL	Water level 0m - 62.2m: 20% Height/Diameter	
02.20m	0:00:17	CL	Crack, longitudinal at 03 o'clock - Severity 1	<p>Image Provided - Ref: 17_2</p>

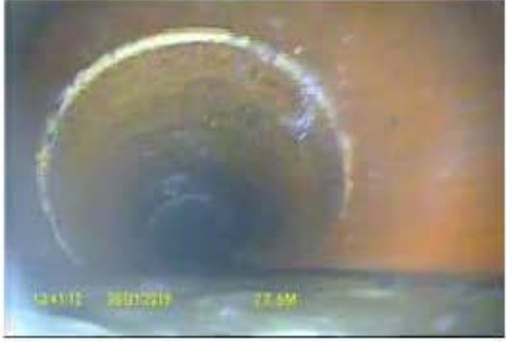
27.60m	0:01:21	JDM	Joint displaced medium - Severity 3	<p>Image Provided - Ref: 17_4</p>

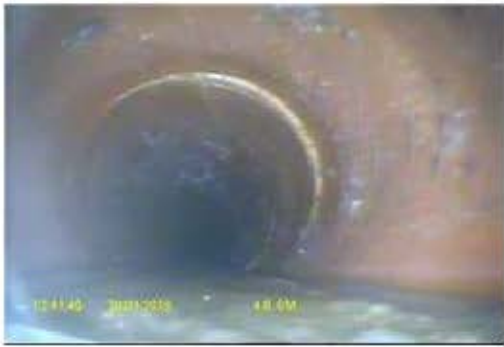
Pos	Video Ref	Code	Description	Image
48.00m	0:01:49	JDM	Joint displaced medium - Severity 3	Image Provided - Ref: 17_5

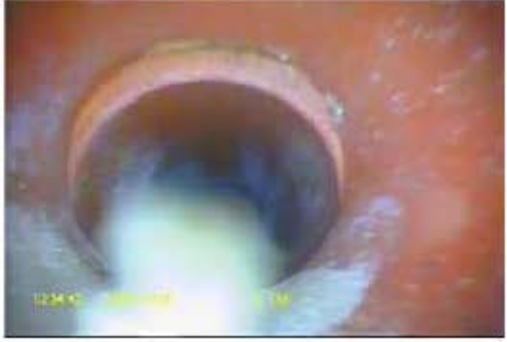
02.10m	0:00:14	JDL	Joint displaced large - Severity 4	Image Provided - Ref: 18_4

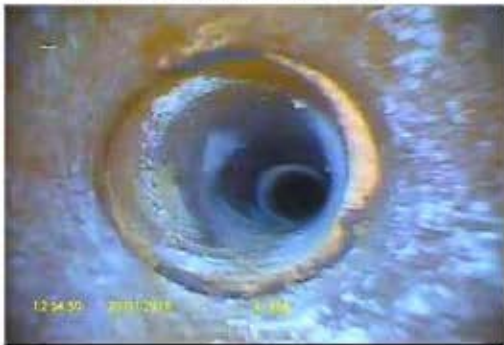
04.80m	0:00:22	JDM	Joint displaced medium - Severity 3	Image Provided - Ref: 18_6

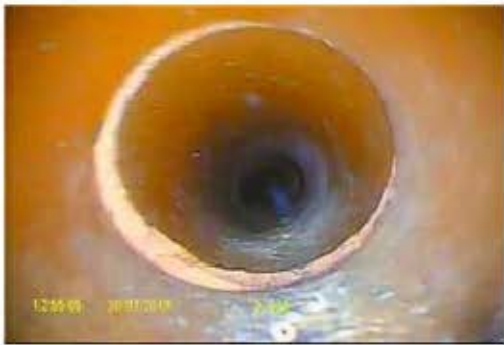
09.00m	0:00:37	JDM	Joint displaced medium - Severity 3	Image Provided - Ref: 18_7

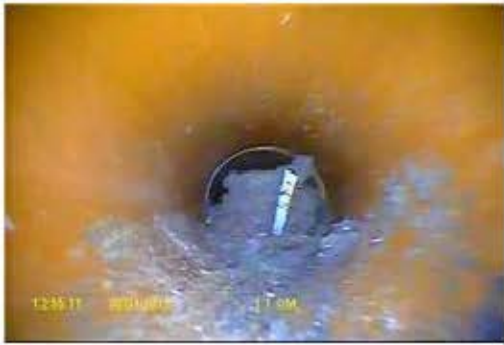
11.00m	0:00:47	DES	Settled deposits fine: 90% Cross sectional area loss - Severity 3	Image Provided - Ref: 18_8

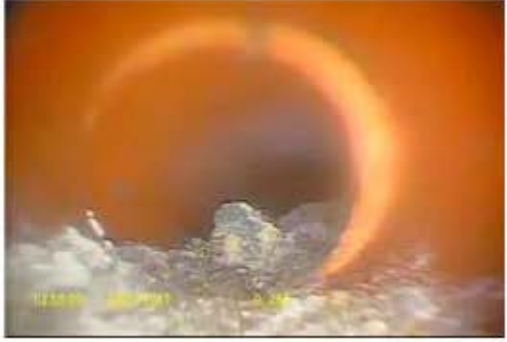
00.20m	0:00:23	JDL	Joint displaced large - Severity 4	Image Provided - Ref: 19_4

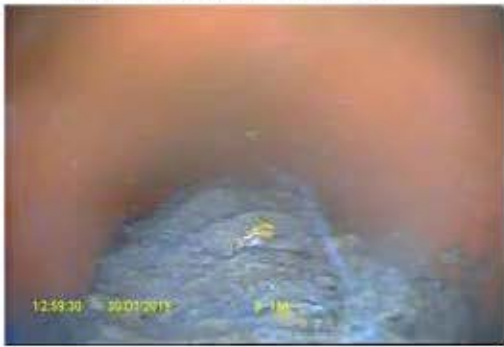
09.10m	0:00:52	DES	Settled deposits fine: 100% Cross sectional area loss - Severity 3	Image Provided - Ref: 19_6

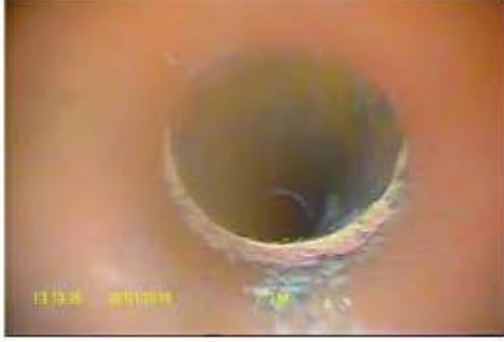
07.70m	0:00:22	JDL	Joint displaced large - Severity 4	Image Provided - Ref: 20_4

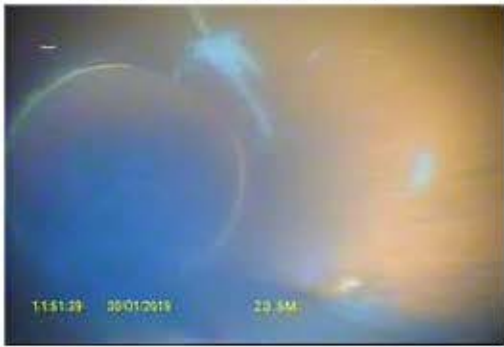
Pos	Video Ref	Code	Description	Image
00.00m		MH	Start node type, manhole MH08	
00.00m	0:00:00	WL	Water level: 0% Height/Diameter	
23.50m	0:00:44	CL	Crack, longitudinal at 12 o'clock - Severity 1	Image Provided - Ref: 21_2

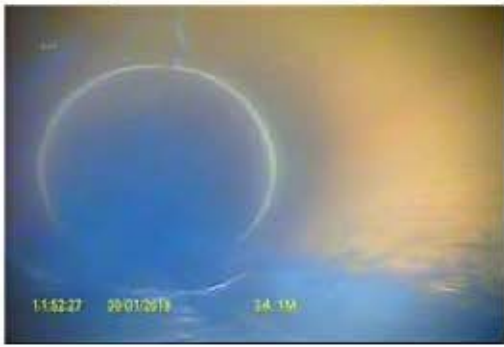
34.10m	0:01:31	CM	Cracks, multiple from 12 o'clock to 06 o'clock - Severity 2	Image Provided - Ref: 21_3

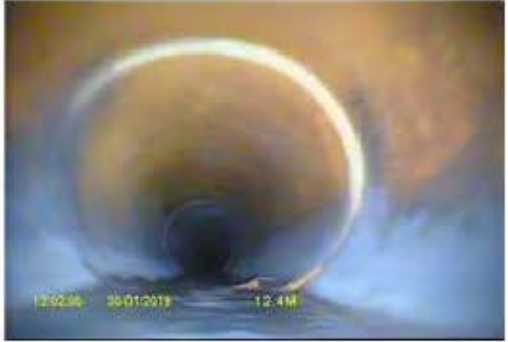
Pos	Video Ref	Code	Description	Image
00.00m		MH	Start node type, manhole MH08	
00.00m	0:00:00	S1 WL	Water level 0m - 44.8m: 10% Height/Diameter	
12.40m	0:00:29	JDM	Joint displaced medium - Severity 3	Image Provided - Ref: 22_2

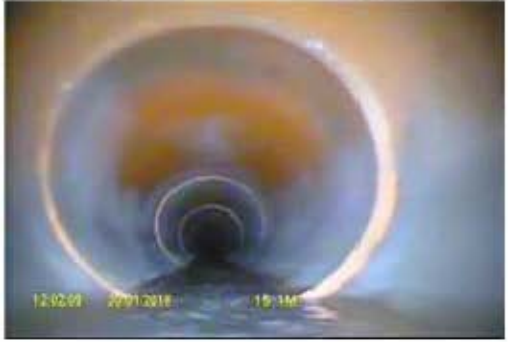
15.10m	0:00:33	JDM	Joint displaced medium - Severity 3	Image Provided - Ref: 22_3

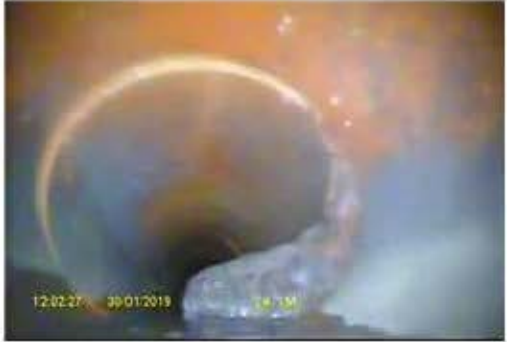
Pos	Video Ref	Code	Description	Image
24.10m	0:00:51	OB	Other obstacles: 30% Cross sectional area loss - Severity 3	Image Provided - Ref: 22_5

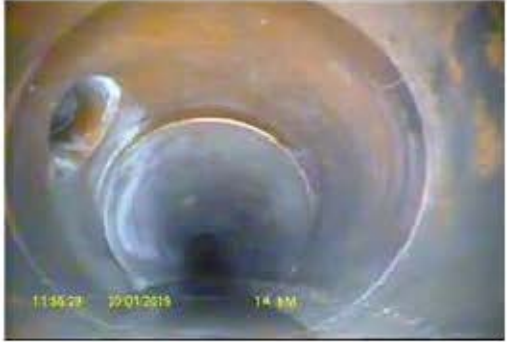
Pos	Video Ref	Code	Description	Image
00.00m		MH	Start node type, manhole MH08	
00.00m	0:00:00	WL	Water level: 0% Height/Diameter	
14.60m	0:00:36	JN	Junction at 10 o'clock: 100mm Diameter	Image Provided - Ref: 23_2

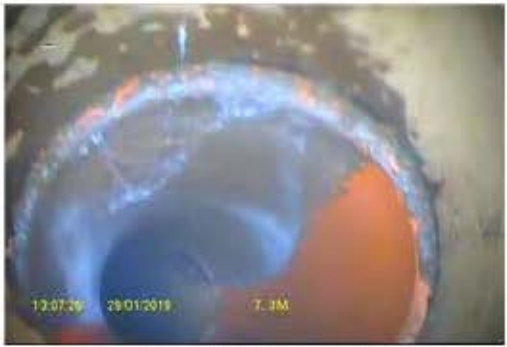
Pos	Video Ref	Code	Description	Image
07.30m	0:00:48	LLQ	Line of drain/sewer deviates left [quarter]	Image Provided - Ref: 27_5

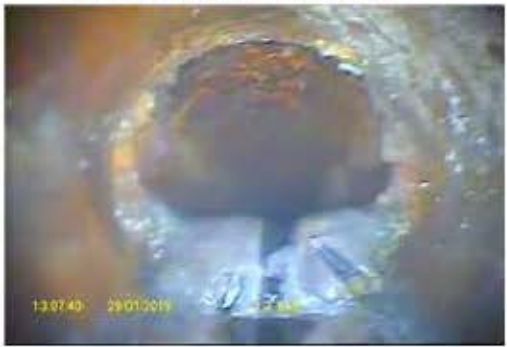
13.60m	0:01:03	JDL	Joint displaced large - Severity 4	Image Provided - Ref: 27_6

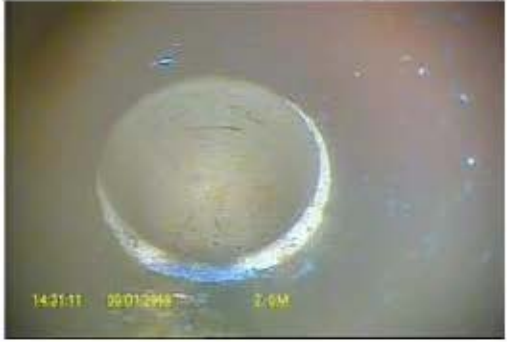
02.00m	0:00:24	LDF	Line of drain/sewer deviates down [full]	Image Provided - Ref: 28_3

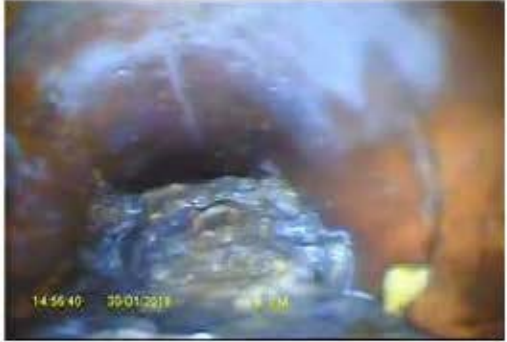
Pos	Video Ref	Code	Description	Image
00.00m		MH	Start node type, manhole MH12	
00.00m	0:00:00	WL	Water level: 0% Height/Diameter	
00.20m	0:00:08	DEG	Attached deposits, grease from 03 o'clock to 09 o'clock: 70% Cross sectional area loss - Severity 3	Image Provided - Ref: 33_2

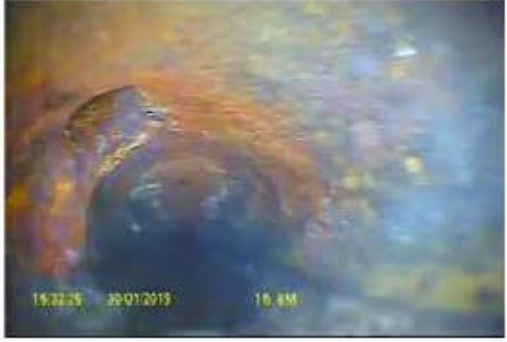
16.80m	0:00:51	JN	Junction at 11 o'clock: 11mm Diameter	Image Provided - Ref: 34_4

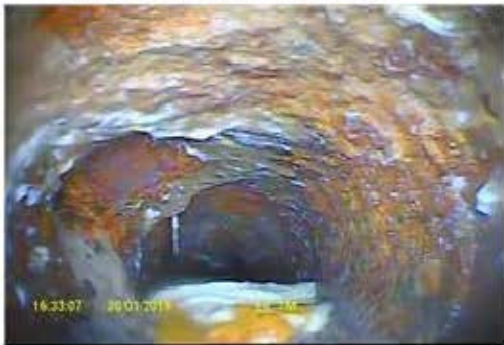
27.70m	0:00:00	JN	Junction at 09 o'clock: 100mm Diameter	Image Provided - Ref: 34_6

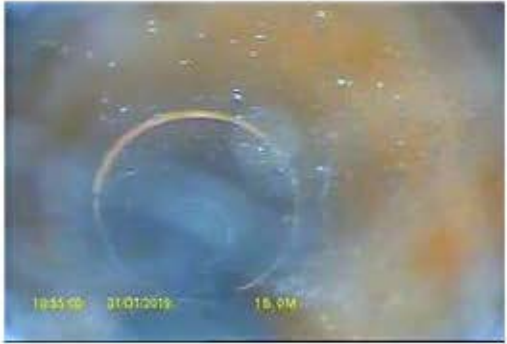
Pos	Video Ref	Code	Description	Image
00.00m		MH	Start node type, manhole MH17	
00.00m	0:00:00	WL	Water level: 0% Height/Diameter	
15.00m	0:00:49	JDM	Joint displaced medium - Severity 3	Image Provided - Ref: 37_2

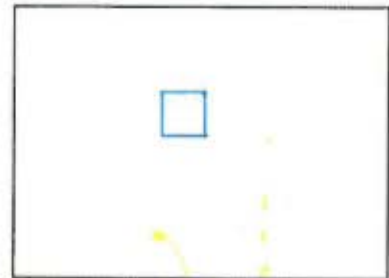
MH No	10							
COVER SHAPE	Square		Rectangle	/	Triangle		Circle	Other
COVER DUTY	Light		Medium		Heavy	/		
CONSTRUCTION	Concrete		Brick		Plastic			
FUNCTION AT OUTFALL	Surface		Foul	/	Combined

Unable to lift, Risk of Damage.

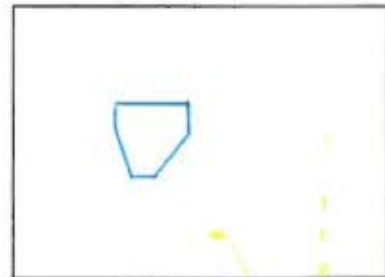
MH No	13						
COVER SHAPE	Square	Rectangle	Triangle	<input checked="" type="checkbox"/>	Circle	Other	
COVER DUTY	Light	Medium	Heavy	<input checked="" type="checkbox"/>			
CONSTRUCTION	Concrete	Brick	Plastic				
FUNCTION AT OUTFALL	Surface	Foul	Combined

Unable to lift due to risk of damage

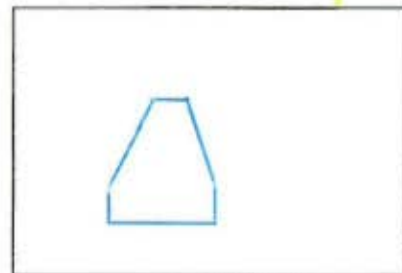
MH No	14						
COVER SHAPE	Square	Rectangle	Triangle	<input checked="" type="checkbox"/>	Circle	Other	
COVER DUTY	Light	Medium	Heavy	<input checked="" type="checkbox"/>			
CONSTRUCTION	Concrete	Brick	Plastic				
FUNCTION AT OUTFALL	Surface	Foul	Combined	<input checked="" type="checkbox"/>

Unable to lift due to risk of damage

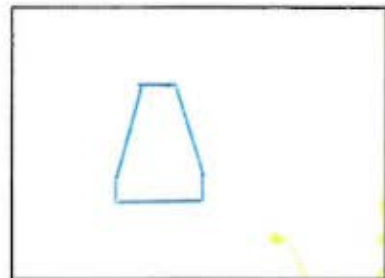
NOTES  
Unable to lift due to risk of damage.

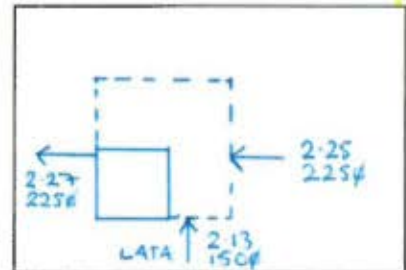
NOTES  
Depth of cover = 0.4m
