Alfa Homes

| PROJECT | Cote Lane, Thurgoland |
| TITLE | Delapidation Survey – Sheet 1 |

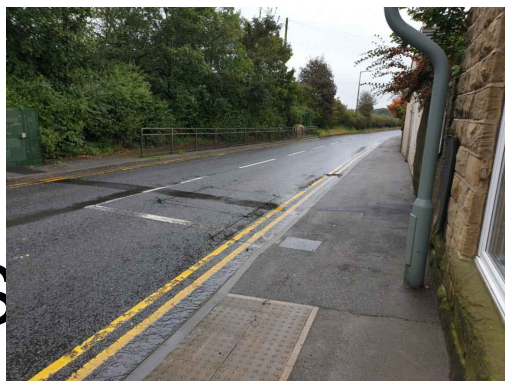
1 - Scarring on highway and footway, kerb damage.

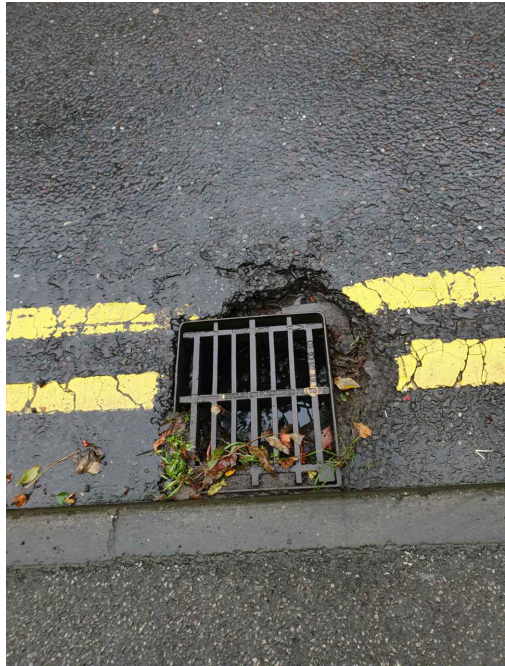
2 - Tarmac damaged around gully

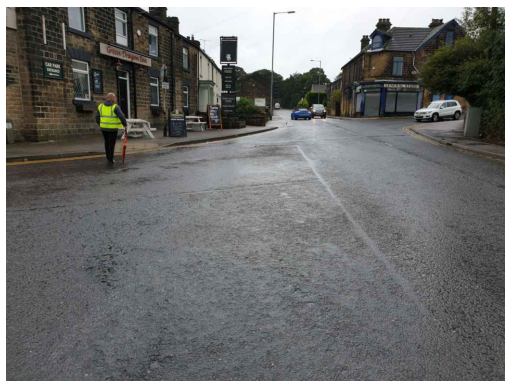
3 - Scarring on tarmac and footway. YW vales and manhole sunk

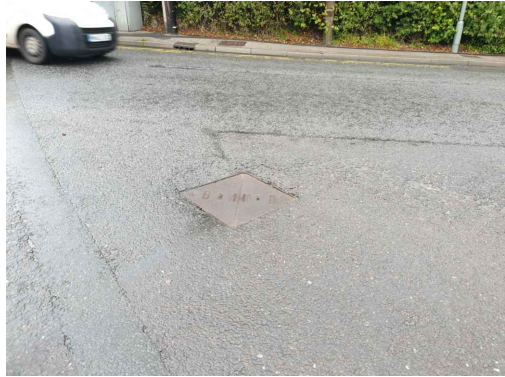
4 - Scarring on tarmac and footway. Manhole sunk. Kerb and gully misaligned

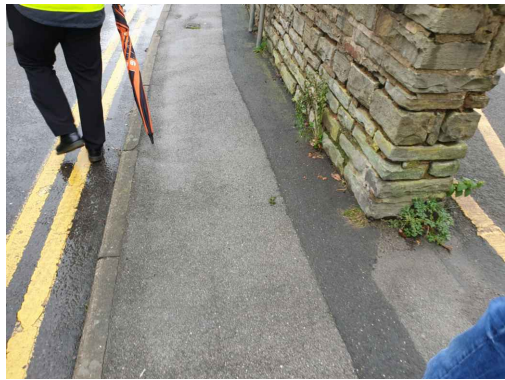
5 - Scarring on footway. Kerbs damaged and misaligned

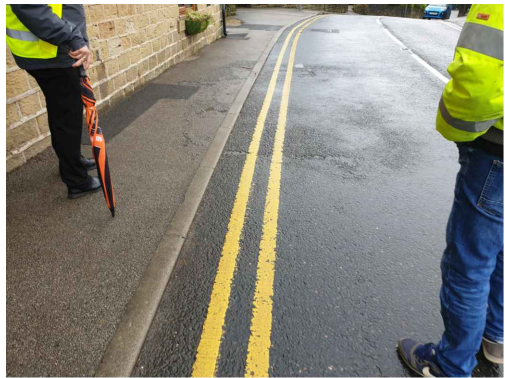
6 - Scarring and fretting on footway and highway. Kerbs damaged and misaligned

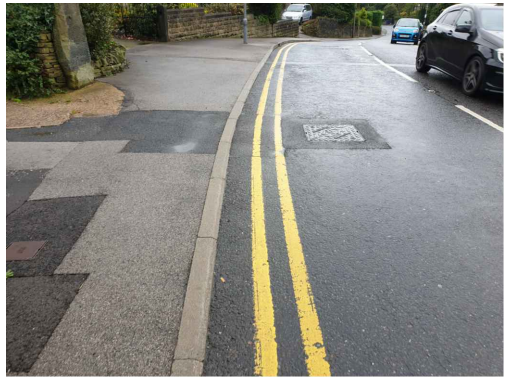
7 - Scarring and fretting on footway and highway. Kerbs damaged and misaligned. Footway damaged by driveways to the left

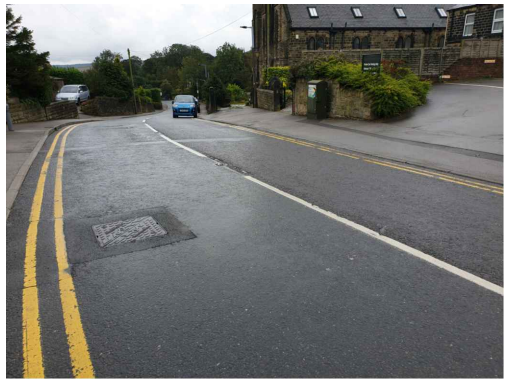
8 - Scarring and fretting on footway and highway. Kerbs damaged and misaligned. Fretting around manhole patch

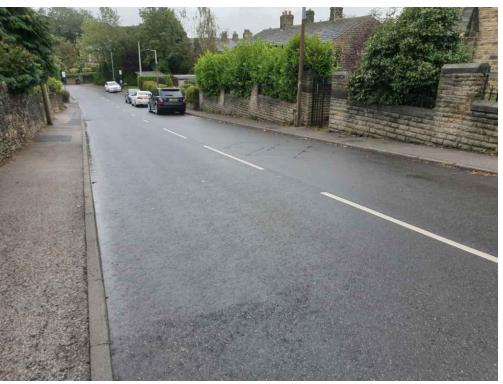
9 - Scarring and fretting on footway and highway. Kerbs damaged and misaligned.

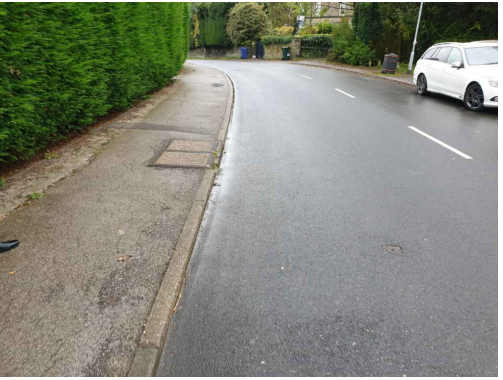
10 - Scarring and fretting on footway and highway. Kerbs damaged and misaligned. Footway tarmac cracking and damaged

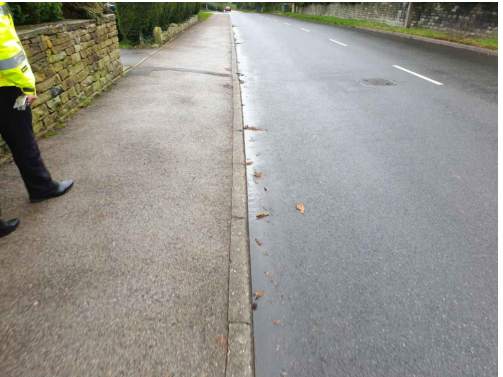
11 - Scarring and fretting on footway. Kerbs damaged and misaligned.

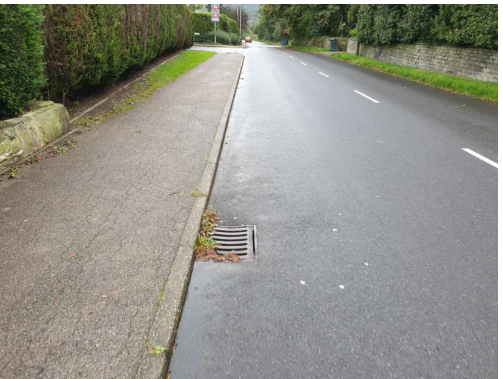
12 - Scarring and fretting on footway. Kerbs damaged and misaligned. Footway tarmac cracking and damaged

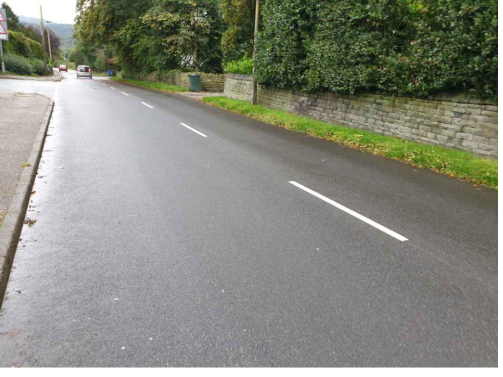
13 - Verge in tact with no damage

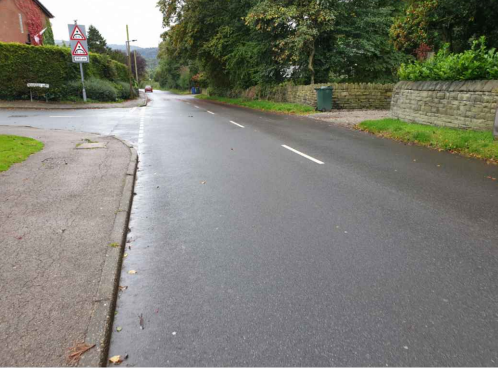
14 - Scarring and fretting on footway. Kerbs damaged and misaligned. Footway tarmac cracking and damaged

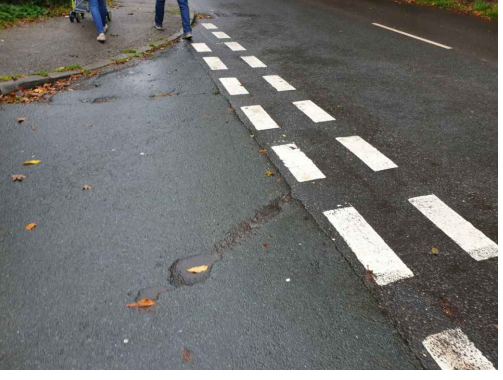
15 - Tarmac on highway damaged. Joint on junction is fretting. Kerbs damaged and misaligned. Footway tarmac cracking and damaged

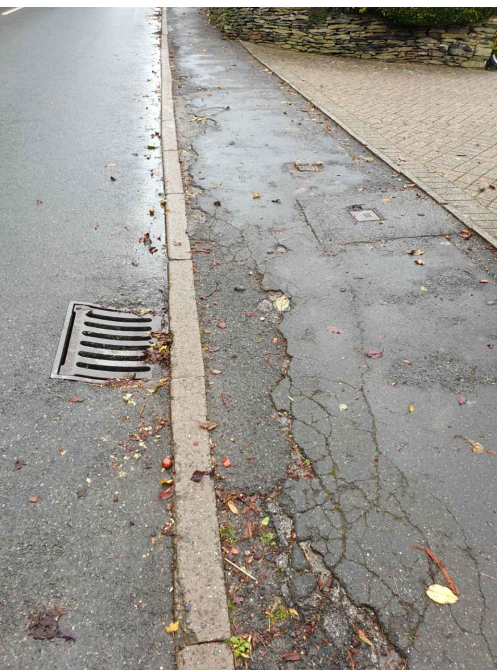
16 - Footway badly damaged with wearing course coming away. Kerbs damaged and misaligned.
