**Tree Survey: 70 Church Street,  
Brierley, Barnsley, S72 9JG.**

**Client: Anita Barry**

**Date of Survey: January 9<sup>th</sup> 2023.**

**File reference: Brierley 70 Church Street 01**

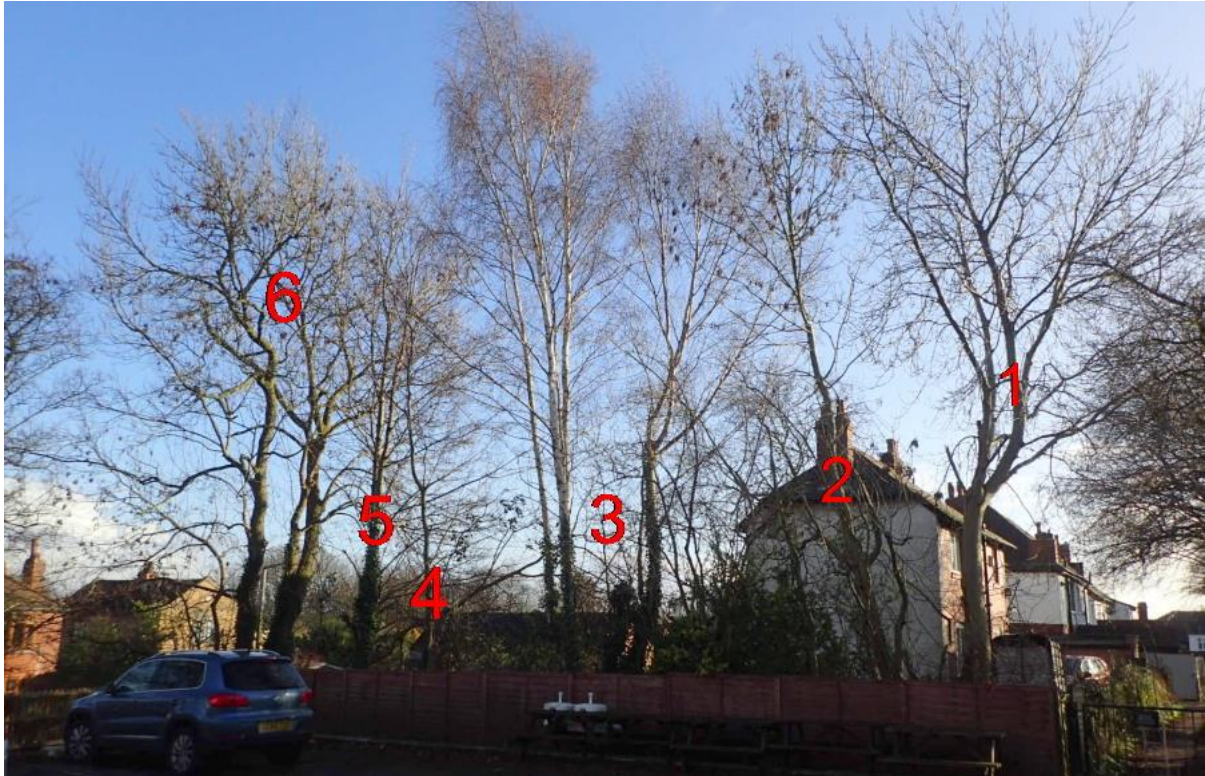
Photograph 1.

Photograph 1 is a view of the site's trees as seen from the village hall car park. Tree 6 is possible the most well-established tree, the others all seem to be more slender than tree 6, which might be because they managed to grow from what was once a boundary hedge.

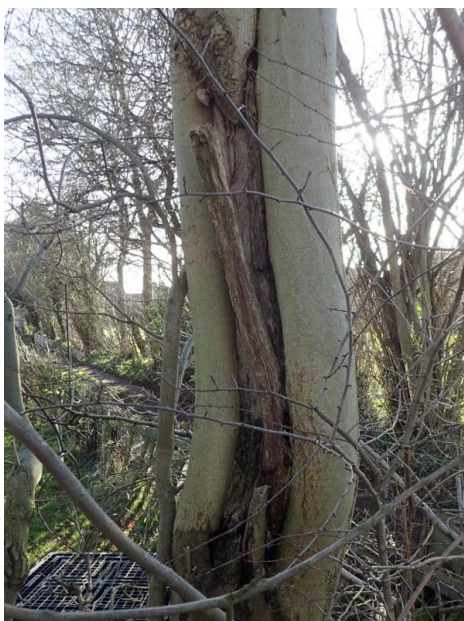
Photograph 3.

| Tree No. | Species. | Ht | TD | Age class | Category | Comments. | RPA |
|---|---|---|---|---|---|---|---|
| 1. | Ash | 9 | 350 | M | C1 | Has suffered some fairly major damage to the trunk in the past. Possibly from a bonfire on the neighbouring site. Crown rather one-sided, possibly due to some ill-considered past-pruning. Compost heap at the base. | 55 |

Photograph 2 shows the compost tipped at the base of trees 1 & 2, while photo 3 shows the bonfire damage to tree 1's trunk.

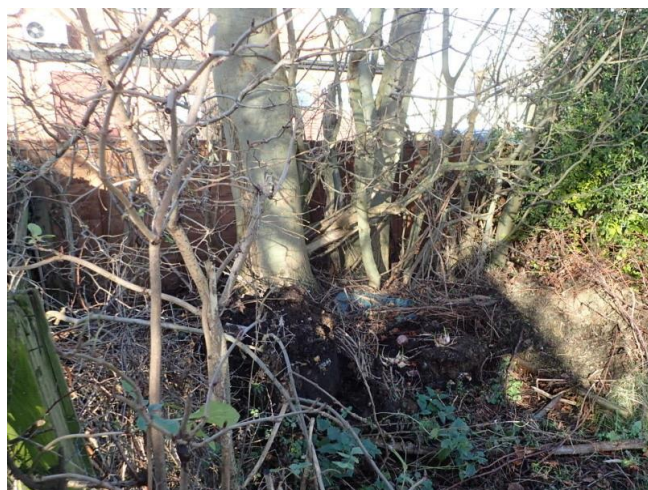
Photograph 2.

| Tree No. | Species. | Ht | TD | Age class | Category | Comments. | RPA |
|---|---|---|---|---|---|---|---|
| 2. | Ash | 9 | 300E | M | C1 | Rather slender, and also with a damaged trunk, probably from the same bonfire. Compost heap at the base. | 41 |

Compost heaps are not always benign; piles of grass clippings can get warm and damage the growing environment, or even a tree's bark, and the liquor that piles of grass clippings often generate can lead to anaerobic conditions, which can in turn lead to root death. Ideally compost heaps should be kept away from trees and bonfires should be kept well-away.

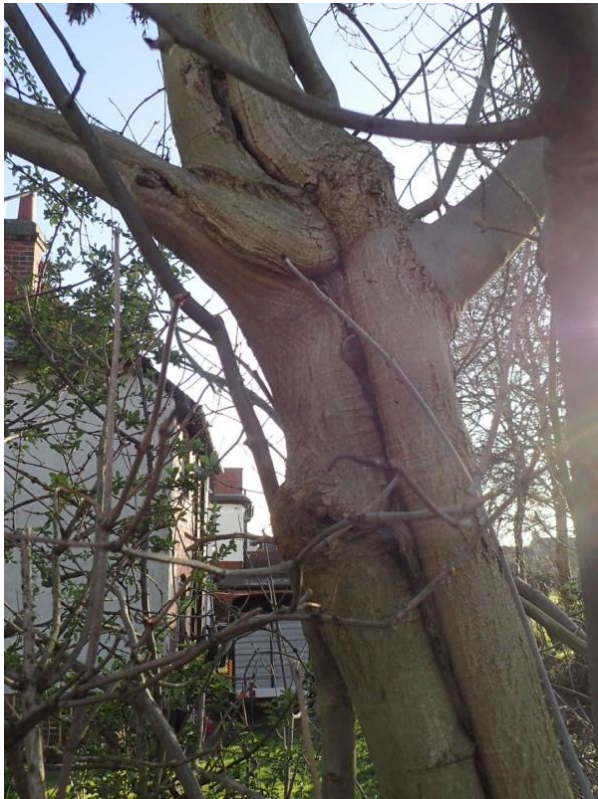
Photograph 4.

Photograph 4 shows the trunk of tree 2. As with tree 1, the damage is on the north side and suggests that both trees were scorched by a bonfire at some time in the past. Unfortunately trees scorched by bonfires are a fairly common sight as it's easy to assume that a tree will tolerate what might not seem like very much heat at all. Some tree species (from fire climax landscapes) have of course evolved to tolerate periodic fires, unfortunately native British trees are not amongst them.

I don't think this damage to these trees is terminal but such damage is invariably worrying as decay fungi can colonise a tree's heartwood when bark is lost. I found only a small jelly (ear) fungus on tree 2's heartwood, which is not a concern.

I also note that the plans suggest that trees 1 & 2 are pruned to reduce their height and spread. However I would suggest that as they are Ash, in not particularly good condition, and because they're at risk of infection from the Chalara<sup>1</sup> pandemic, it might be best to remove them and replant with a different species. This course of action could be looked upon as a positive outcome; an improvement to the neighbourhood tree population and biodiversity.

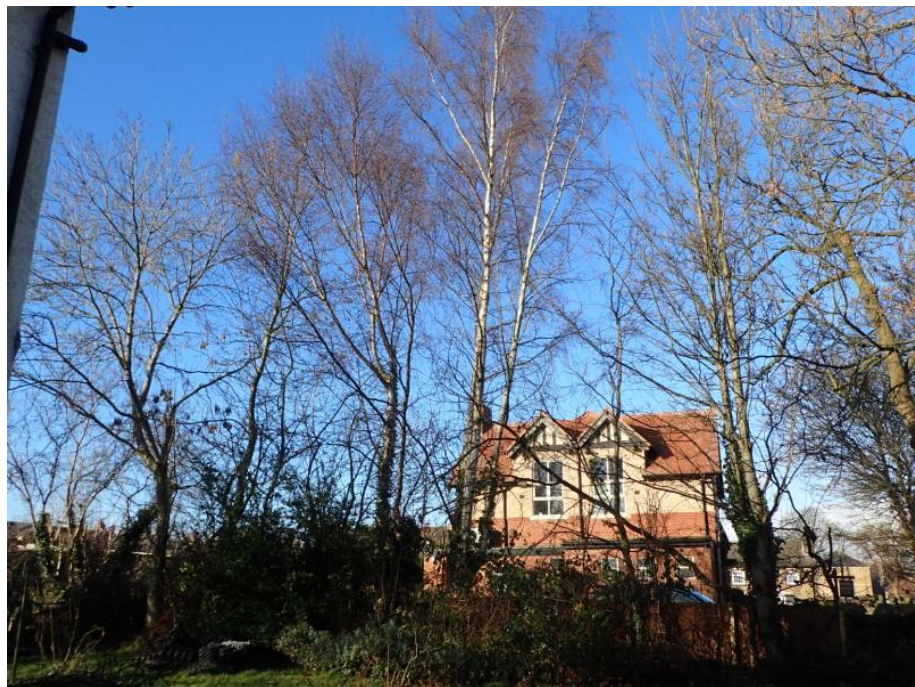
Photograph 5.

Photograph 5 is a view of trees 1 to 5 taken from the front of the house looking roughly north. That's the village hall in the background.

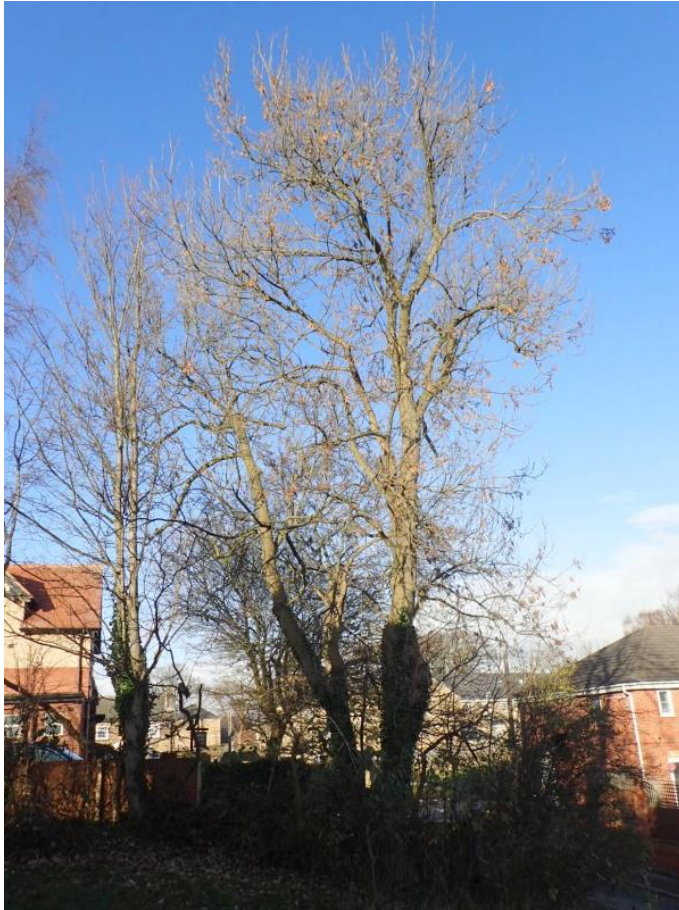
Photograph 6.

| Tree No. | Species. | Ht | TD | Age class | Category | Comments. | RPA |
|---|---|---|---|---|---|---|---|
| 6. | Ash | 12 | 600E | M | C1 | Three stems, could be coppice growth. Some epicormic growths have been infected with Chalara. Some ill-advised pruning seems to have been undertaken in the past and one stem appears to be hollow in some places. Crown rather one-sided | 163 |

Photograph 6 is a view of Ash tree 6, taken from the same position as photo 5.

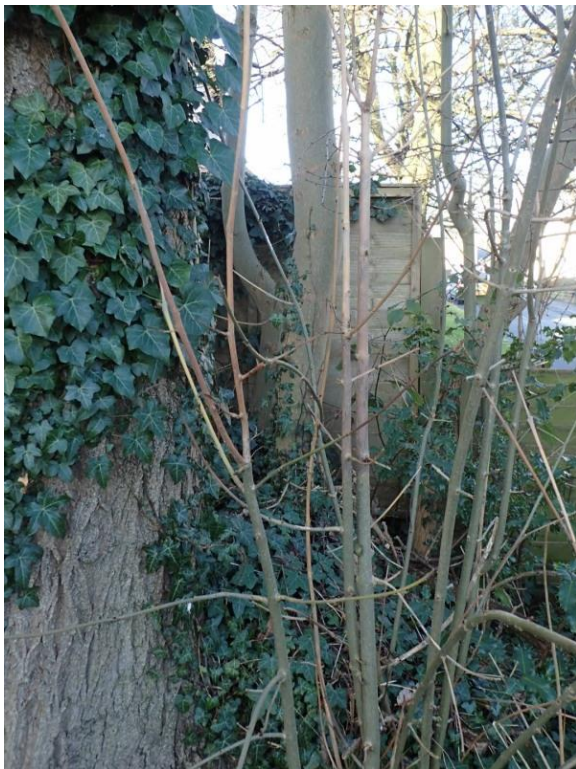
Photograph 7.

Photograph 7 shows some epicormic growths at the base of Ash tree 6. These have died back which is almost certainly due to infection with Chalara Ash Dieback, the fungal disease

which is unfortunately spreading rapidly through the area. Photograph 8 shows one of the holes on the main trunk of Ash 6. I don't know how extensive this cavity is but this is not the only hole in that trunk.

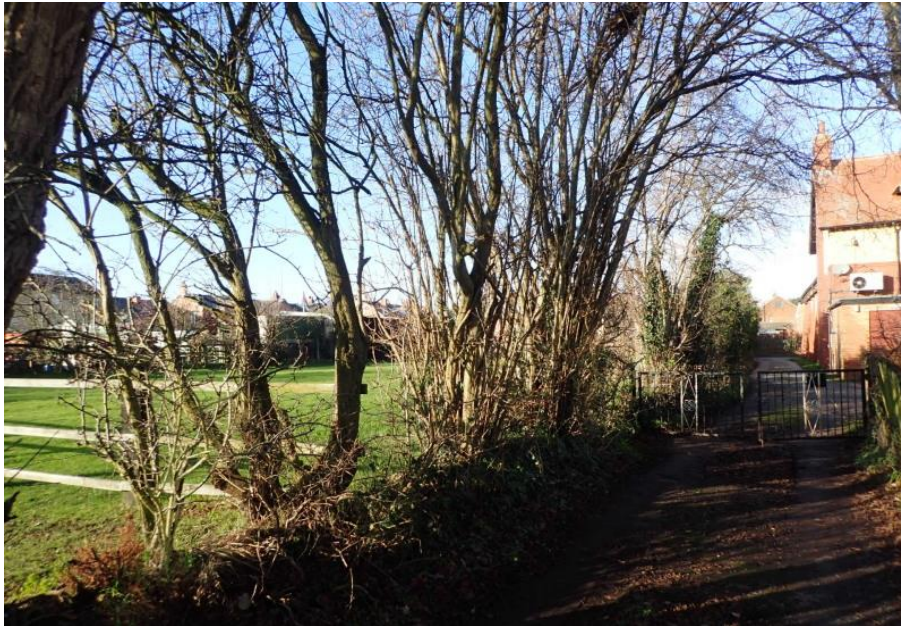
Photograph 9.

| Tree No. | Species. | Ht | TD | Age class | Category | Comments. | RPA |
|---|---|---|---|---|---|---|---|
| 7. | Group | 8 max | 250E max | M | C2 | This is the overgrown hedgerow at the opposite side of the property's "back lane." There are Hazel, Hawthorn, Elderberry and Ash growing there. It is unkempt and damaged by livestock and poor management. Its management could be improved. | 28 |

Photograph 9 shows group 7, which is another decrepit hedgerow, at the side of the paddock to the west of the back lane. Unfortunately it's fairly commonplace for such hedges to be browsed by the livestock in a paddock, which leaves them ineffective as a barrier.

In an ideal world hedgerows like this would be restored but as this probably doesn't belong to this house it's hard to see how this might be brought about.

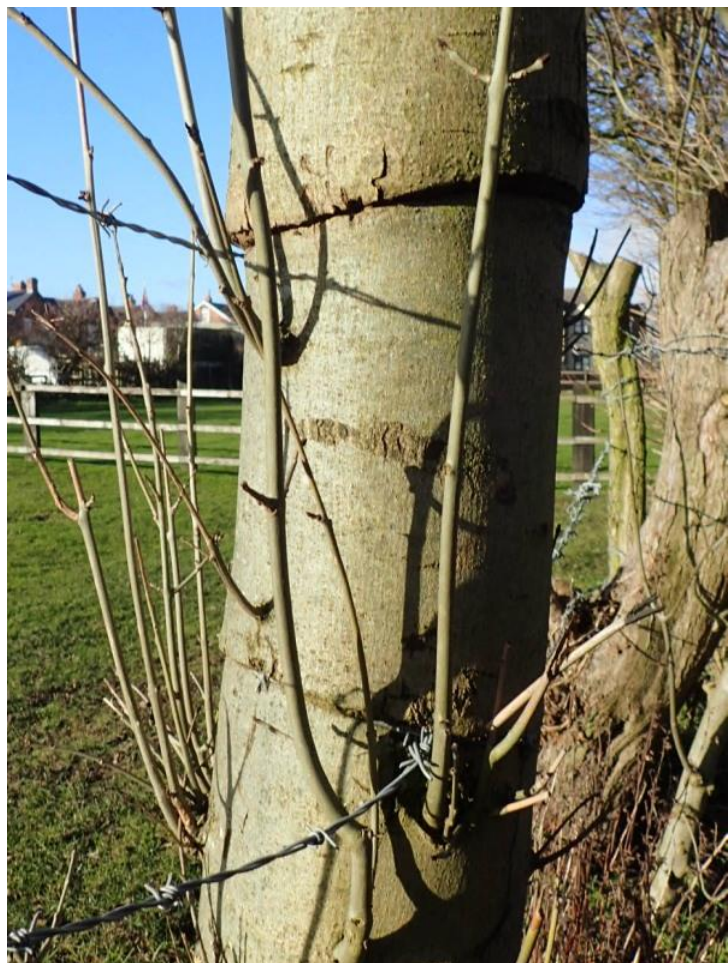
Photograph 10

It's also fairly commonplace for trees in hedgerows like group 7 to be strangled by fencing wire, as can be seen in photo 10.

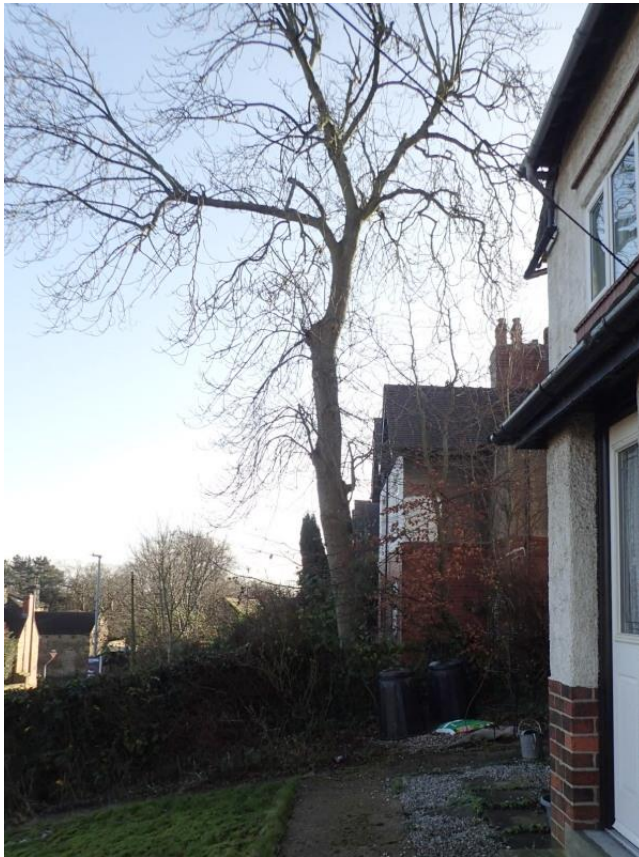
Photograph 11.

| Tree No. | Species. | Ht | TD | Age class | Category | Comments. | RPA |
|---|---|---|---|---|---|---|---|
| 8. | Ash | 13 | 450E | M | C1 | In the neighbouring garden at 72 Church Street. OK. | 102 |

Photograph 11 is a view looking south along the house's front elevation. The tree is tree 8, another Ash, but in the front garden of the next door property. There's nothing much wrong with the tree other than it's quite large and not far from the neighbouring house. It seems to have had some lower branches removed in a manner that would not meet current best-practice.
