DESIGN AND ACCESS STATEMENT
AND HERITAGE IMPACT ASSESSMENT
PROPOSED REPAIRS TO PLUNGE POOL , GARDEN WALL REBUILDING
AND WATER CASCADE REPAIRS
AT
CANNON HALL, CAWTHORNE, BARNSELY

3.0 Investigations, Observations & Scope of Works

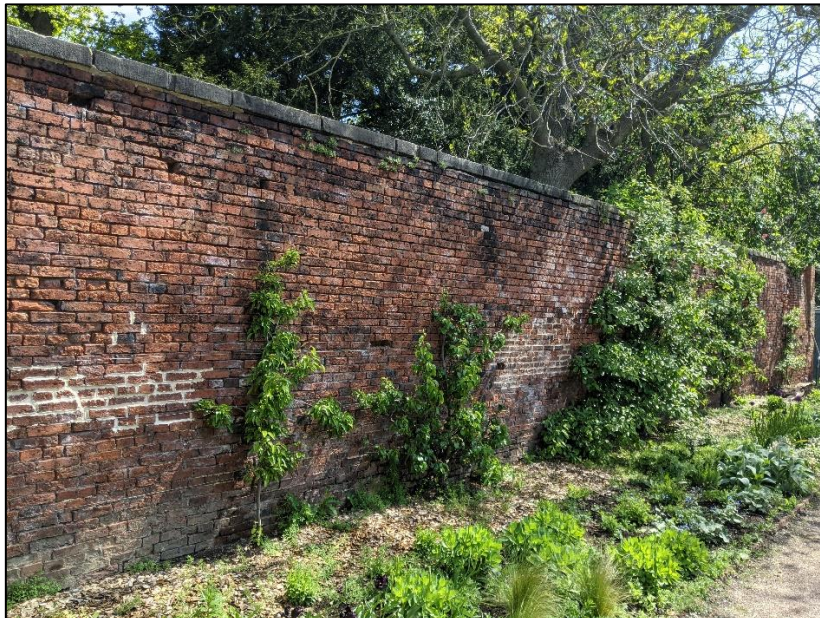
3.1. Garden wall

Photo of garden wall

3.1.1 Trial holes were dug to the front and rear of the masonry wall and the following were noted.

1. The wall is approximately 500-700mm (tapered at top), standing 3400mm tall above ground on the front, 1800mm at the rear. 1½ bricks with dry stone walling at rear. The two leaves are not considered tied, and simply abut.

2. Large ash tree approx. 2m from rear
3. Wall has inward uniform lean creating 450mm max overhang, placing the centre of the copings outside the footprint of the bottom of the wall. Wall additionally retains material behind to around half its height, plus likely pressures from tree roots.

4. Foundations exposed on front face, 750mm deep, the last 100mm being into very stiff and highly plastic clay. Rear foundations could not be (safely) found, at least 850mm deep, possibly as deep as the inner face.

5. Defects appear roughly uniform, 20m in length, with large tears to adjoining (plumb) masonry.
6. Without prior knowledge of previous rates of movement, wall appears precarious at its current angle. The stonework behind does little in way of preventing distortion to the wall, wall can be considered effectively thinner than first appears.

7. Noting a tree must have mostly grown since the wall was built due to deep depth of stone walling subsequent movement is likely attributed to the tree. For close proximity in highly plastic clay, a recommended foundation depth of 2.25m for ash trees is normal. The wall effectively has around this depth of footing relative to the tree, since the tree is located up on the raised bank behind. However, the retaining wall may simply be causing higher levels of water draw from the under the wall.

8. Movement likely due to combination of tree water demand, direct pressure from the tree itself, and lateral forces from the retained bank behind.

3.1.2 A possible range of remedial measures further to the above are:

- a. Piers to be fitted to the front face of the wall, to buttress and restrain the masonry. Approximately 4no. will be needed across the 20m affected stretch, to around 2/3 the height of the wall.
- b. Alternative repairs include piles installed to the rear bank, to which stiff piers are built and the leaning wall hung off. This would be hidden from the garden (save for some patress

plates) but far costlier and invasive in terms of installing steel and concrete in the ground behind the wall.

- c. Similar to b. but with inclined steel rods anchored into the ground behind the wall, and also invasive.
- d. Take down and rebuild the stretch of damaged wall so that it is vertical and designed to resist lateral pressures from retained bank. This is, we believe, the best way to ensure stability.

- 4.3 While the proposed partial rebuilding of the garden wall may appear a little disproportionate to the nature of the problems, the stability of the wall is in question and mere buttressing with new brick piers would be a short term measure and may not, in the medium to long term, impart sufficient stability to the wall.

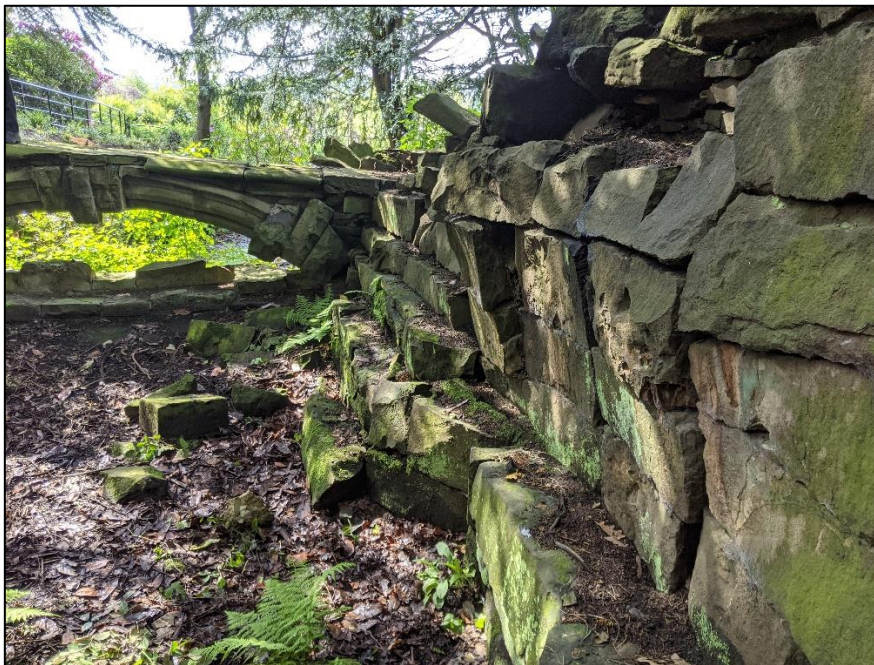
3.2 Plunge pool

Photo of part of the plunge pool with loose stones in foreground and the crossing bridge in background

- 3.2.1 Observations below were made from surface level without disturbing any ground or stones.
 1. Water flow was very visibly disappearing into a void on the LHS when looking up the spring. It also emerges into the stream through a hole in the ground on this side. It is likely passing through the bank, taking a route not originally intended!
 2. This inevitably will lead to wash out of materials as well as a general softening of the ground. The bank is made of manmade masonry and will not just naturally hang on. Cavitation at the base will potentially cause the material above to drop, and if more

loose material is present at the top than at the bottom, the outer wall will be forced outwards with a bursting action.

3. There was some very slight indication of a drop in level at the top. In any case, a loosening of the material behind will make water ingress from above more prevalent, adding to the flow/washout of fines through the masonry generally.
4. Wall retains 3-4m of fairly large masonry units, has moved out by 0.5m – significant displacement. Max 2m extent appears potential for movement.
5. Opposite bank (stable) – 4.5m width.

3.2.3 Recommendations further to the above are:

- a. Divert/repair water flow from within spring down into the plunge pool. This may be done by excavation from above and setting in hydraulic setting mortar to block the leak. Unfortunately it seems unlikely this can be reliably achieved by simply going 'up the spring' headwall.

- b. In the temporary case, prop across the entire plunge pool (4.5m width, with say 2.5m of waling boards and suitably braced horizontal struts (e.g. scaffold tubes). Rainfall may make the displacement worse otherwise, even if the spring flow can be stopped.

- c. Dismantle the upper masonry of the bank which is displaced. The wall could be repaired in situ with the either tie rods or (lots of) injected grout, but both would appear disproportionate to this historic structure, especially given that the true scope of the problem cannot be ascertained without some level of taking the bank apart. The rebuilt wall face can be rebuilt strong enough to withstand any lateral pressure should the material behind continue to sink downwards in the short term.

- 4.1 It is believed all of the proposed works are essential to conserve the historic assets and preserve them for the future.
- 4.2 The proposals for repair of the plunge pool are considered to be minimalist and are intended to be the least invasive methods of repair and stabilisation. Initial consideration was given to in-situ lime mortar grouting of the loose and tumbling stones around the plunge pool, but this method was discounted because, in all likelihood, it only serve to slow down the rate of deterioration and would not provide the longer term solution needed to save this structure. The other potential solutions, involving piling behind the plunge pool walls, would be invasive and an “over engineered” way of stabilising the walls.

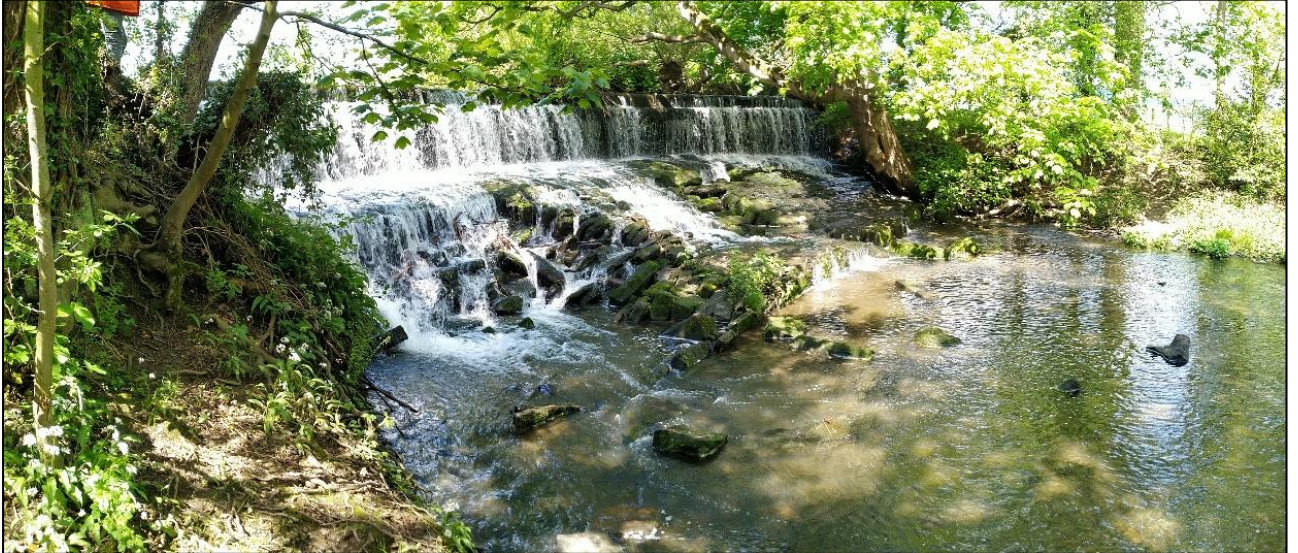
3.3 Cascade

Photo of the cascade

3.3.1 Nothing could be seen as water levels were still high. Interim observations and recommendations are as below

1. Displaced masonry to one side of cascade, in area of significantly higher flow compared to rest of river width.
2. No visible sign of deflection or missing stones to either weir wall – so far, only apron of masonry at bottom the fall has evidently been washed away (area in bottom left of the photo above).
3. Around 50% of river flow above weir is blocked by debris. This is evidently focussing flow to the disturbed area.

3.3.2 Recommendations:

- a. Remove broken tree/debris from river above weir
- b. Create short dam (does not need to be fully waterproof) for approx. 3m out from bank over affected masonry. Inspect the masonry again.
- c. Allow for nominal repairs to weir steps and reinstate apron of cobbles with hydraulic setting mortar.

- d. We anticipate that the above would be viewed as repairs and would not require Listed Building Consent, subject to discovering further information when water levels are low enough for a better inspection to be made.

- 4.4 The work to the cascade will be very simple in nature, involving just clearance of debris above the cascade to allow water to pass more evenly over the cascade, and replacing the washed out stones along the bottom of the cascade.
