# ARBORICULTURAL REPORT

to BS 5837:2012 at:

*Former Foulstone School Site  
Nanny Marr Road, Darfield,  
Barnsley,  
South Yorkshire,  
S73 9AB.*

October 2013

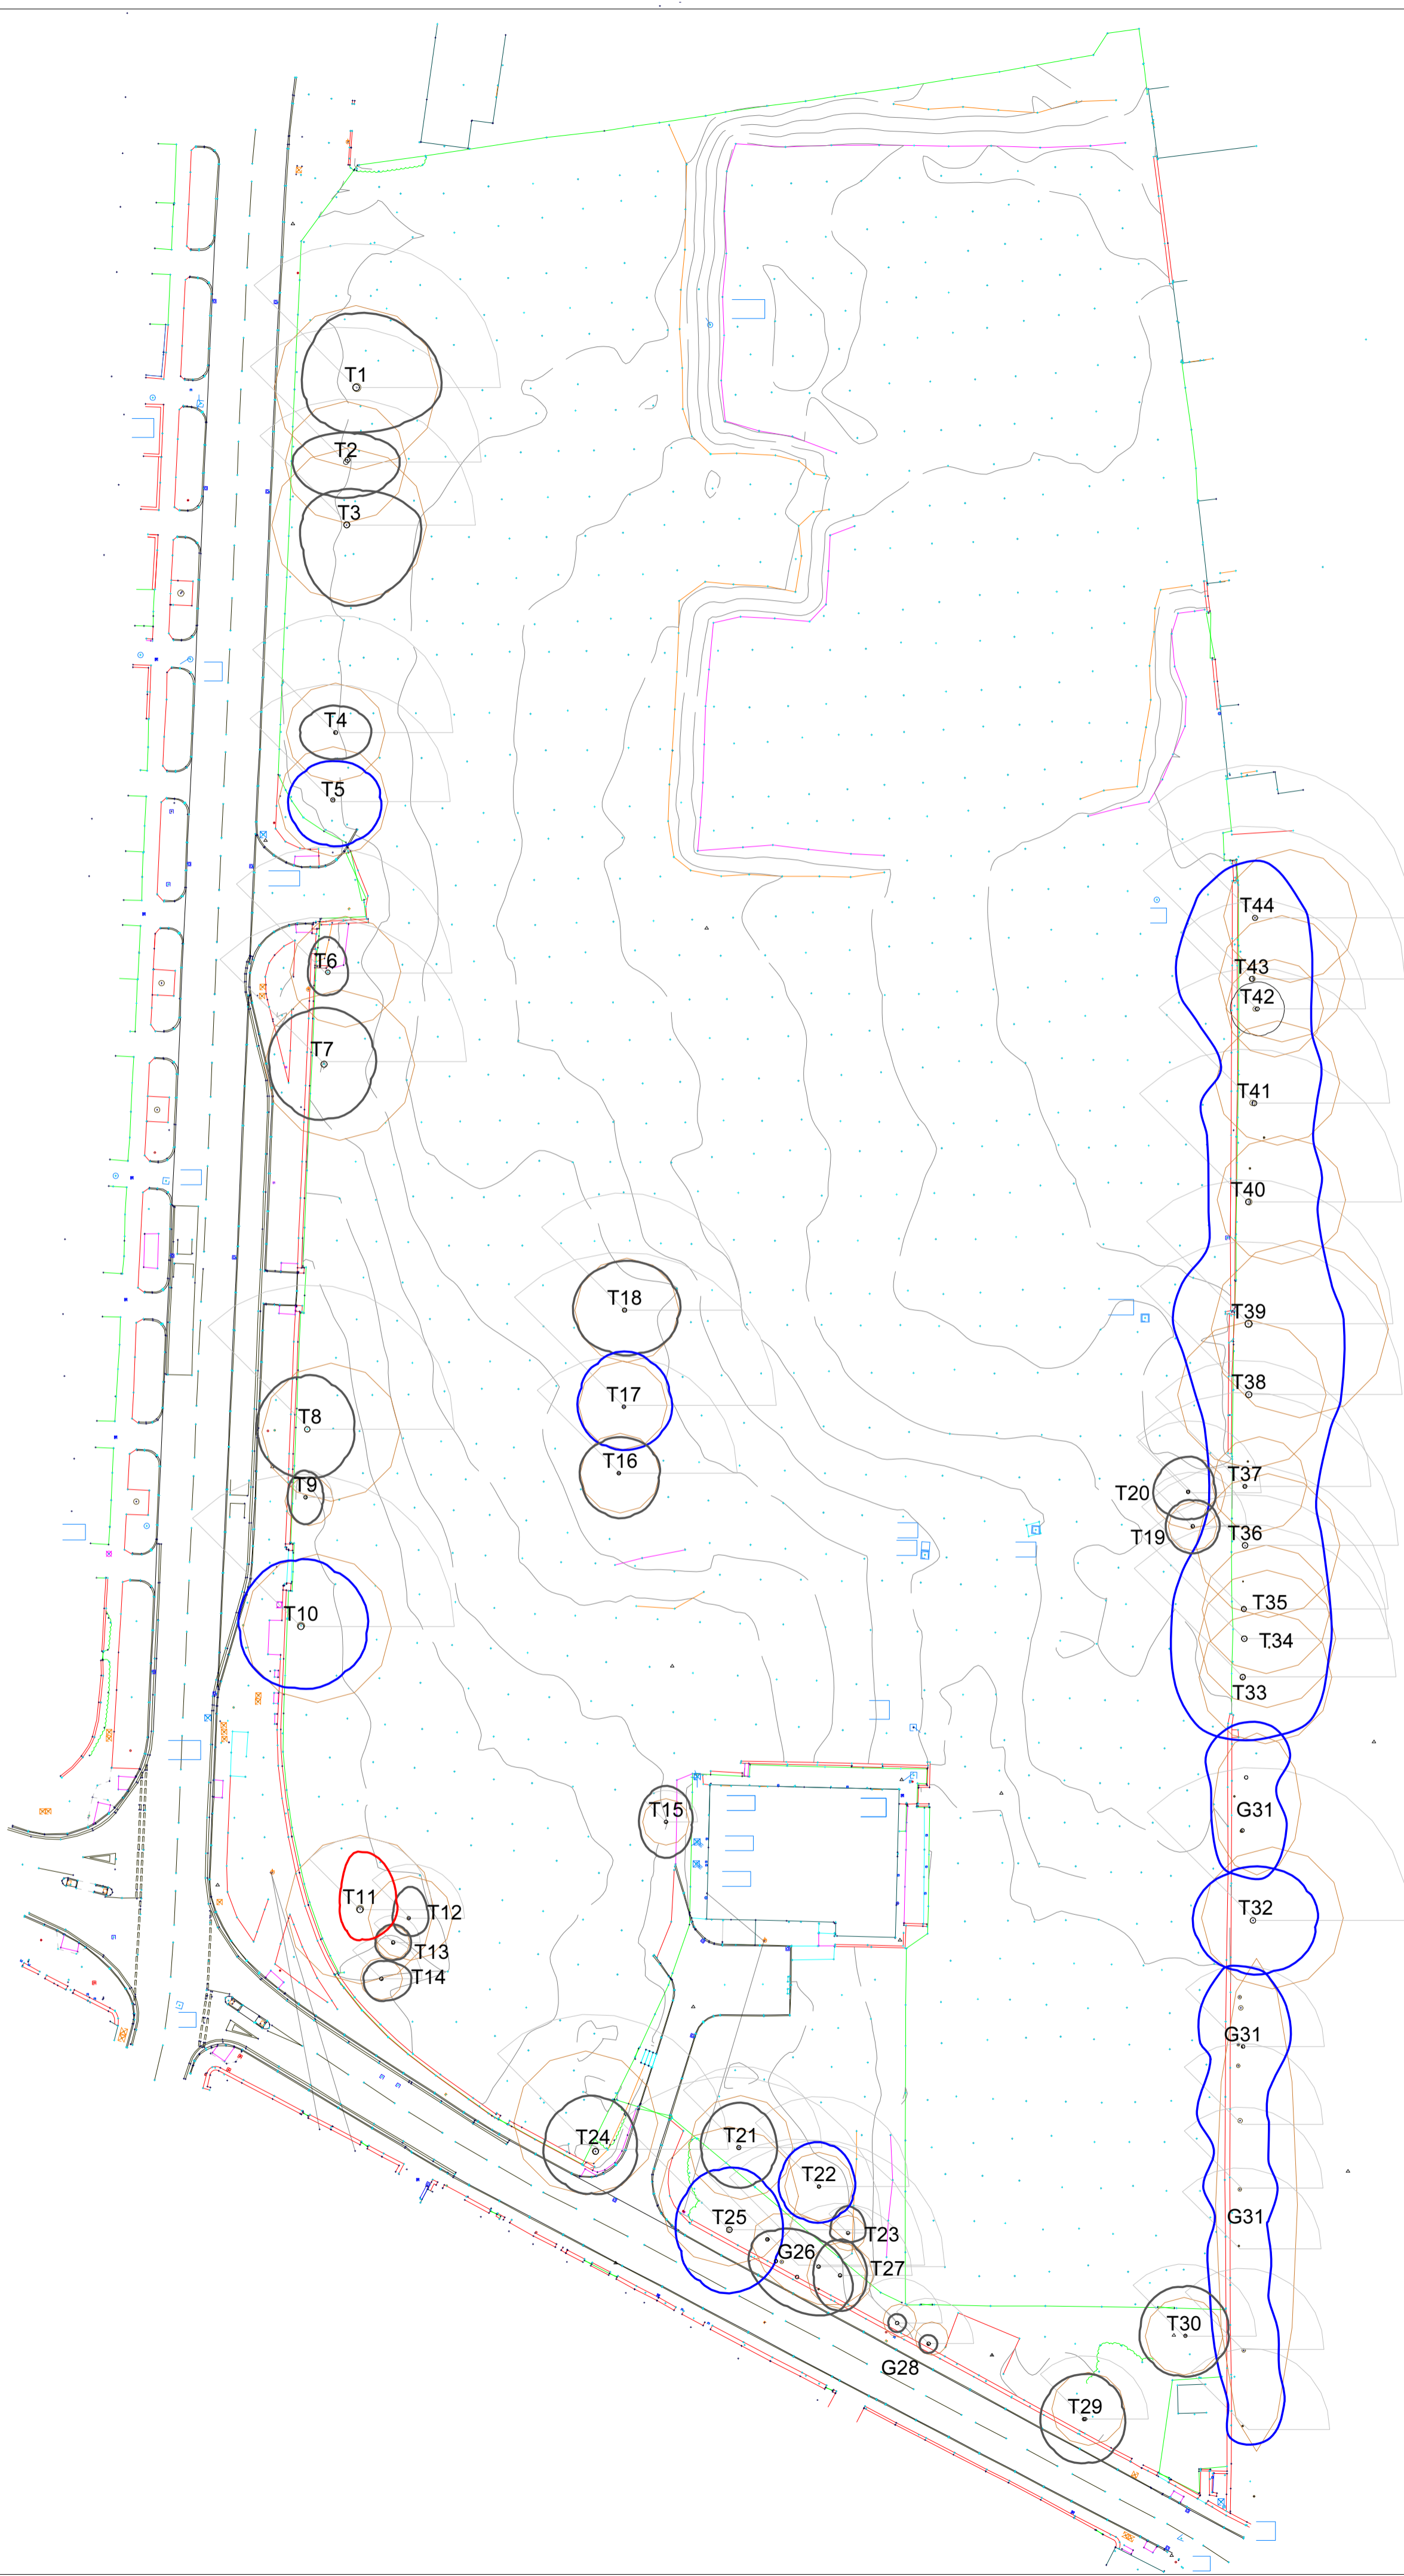
### Appendix 5: Tree Constraints Plan Nanny Marr Road - Darfield Ref1122

- 3.3.6 The line of trees situated in the adjacent park, to the east of the site, collectively forms a high value landscape feature. The crowns of the adjacent trees have been detailed as a single group on the Tree Constraints Plan at Appendix 5; however, individual stem measurements have been taken to allow for a more detailed Root Protection (RPA) calculation.

- 3.3.7 Due to the recently demolished hard surfaces and other site features that surrounded many of the sites trees, the BS: 5837 (2012) RPA calculation, as shown on the attached plan, is a likely to be a somewhat crude representation of the actual rooting area; however, it would be fruitless to try and represent any more accurate RPA than as shown.
