#### **A1.4 – Tractor Shed and Annex Photographs**

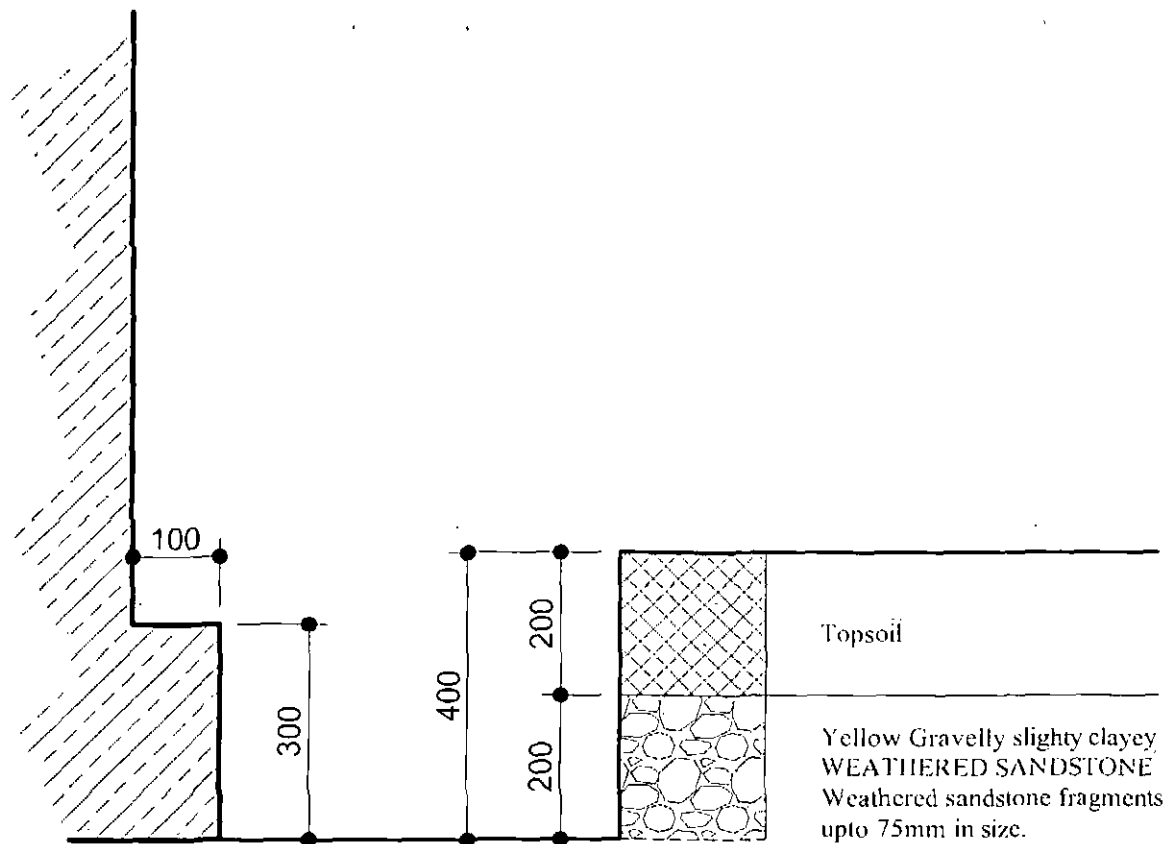
SECTION THROUGH TRIAL PIT  
ON  
EAST ELEVATION OF TRACTOR SHED

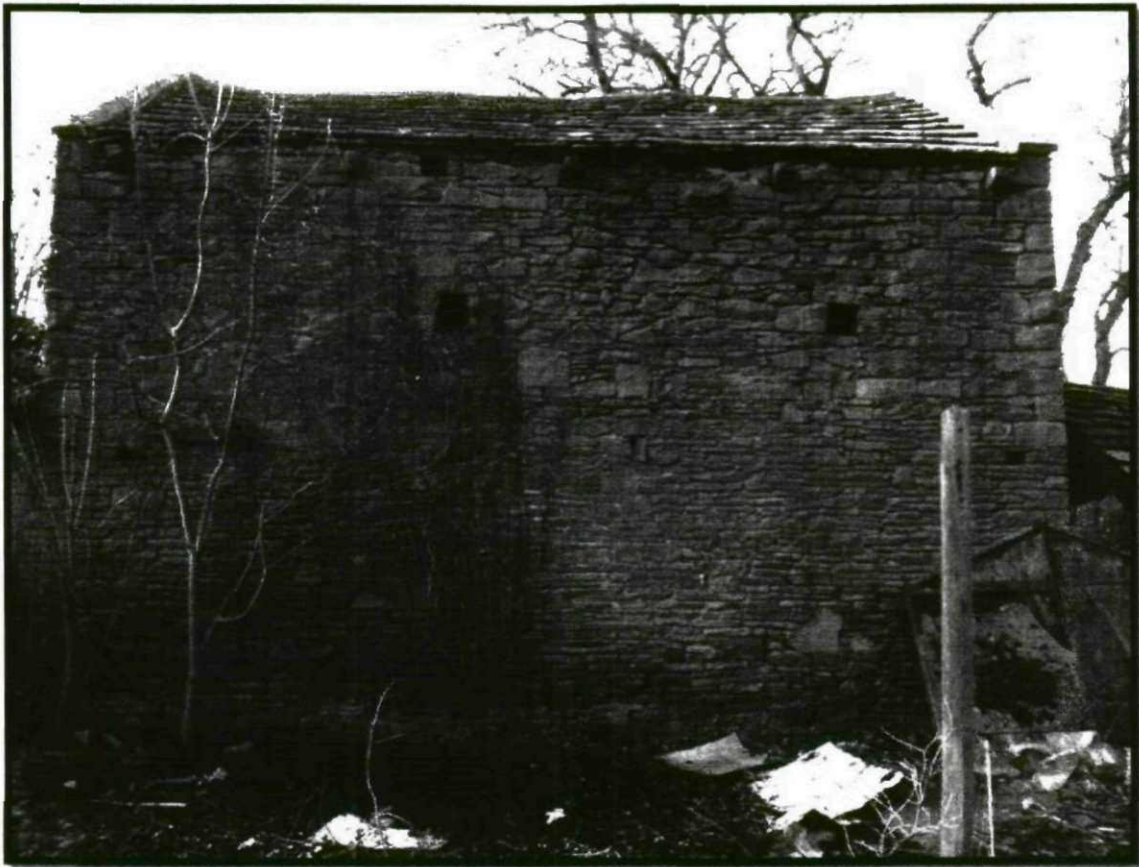
Photograph 49 – View of East Elevation

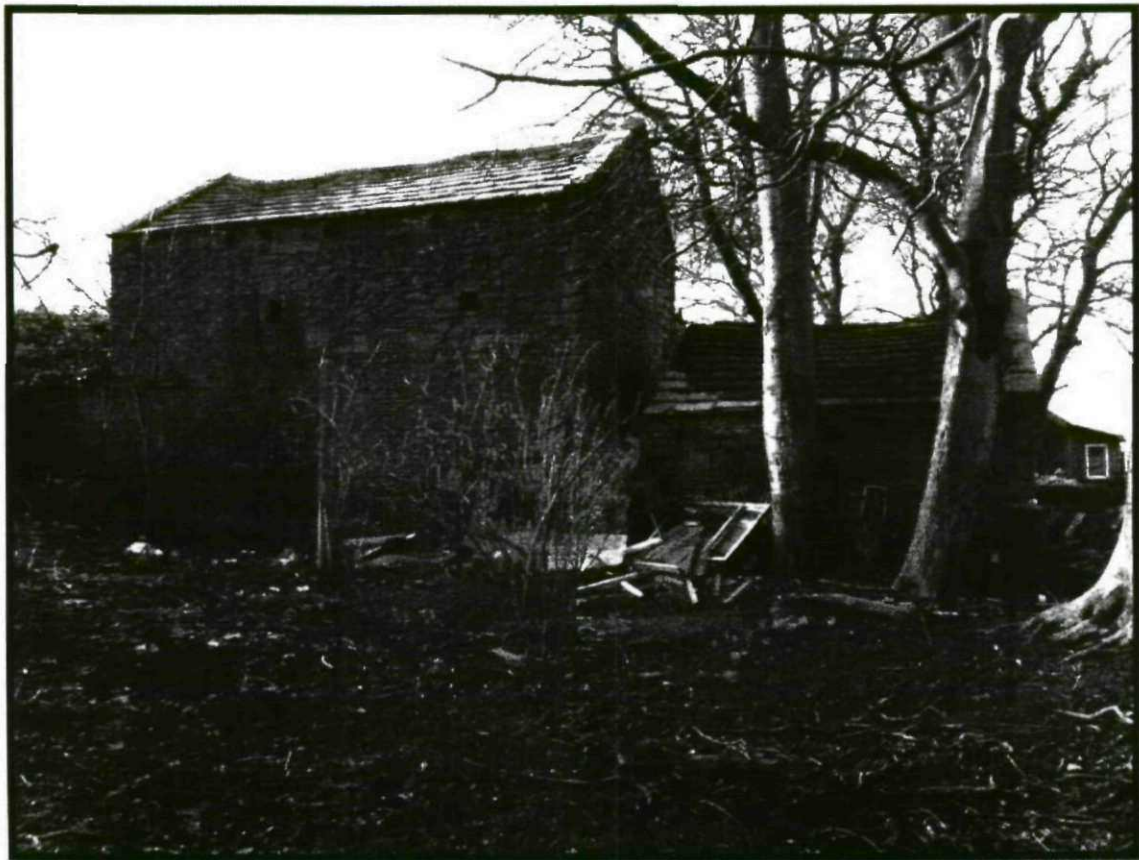
Photograph 50 – View of East Elevation showing trees

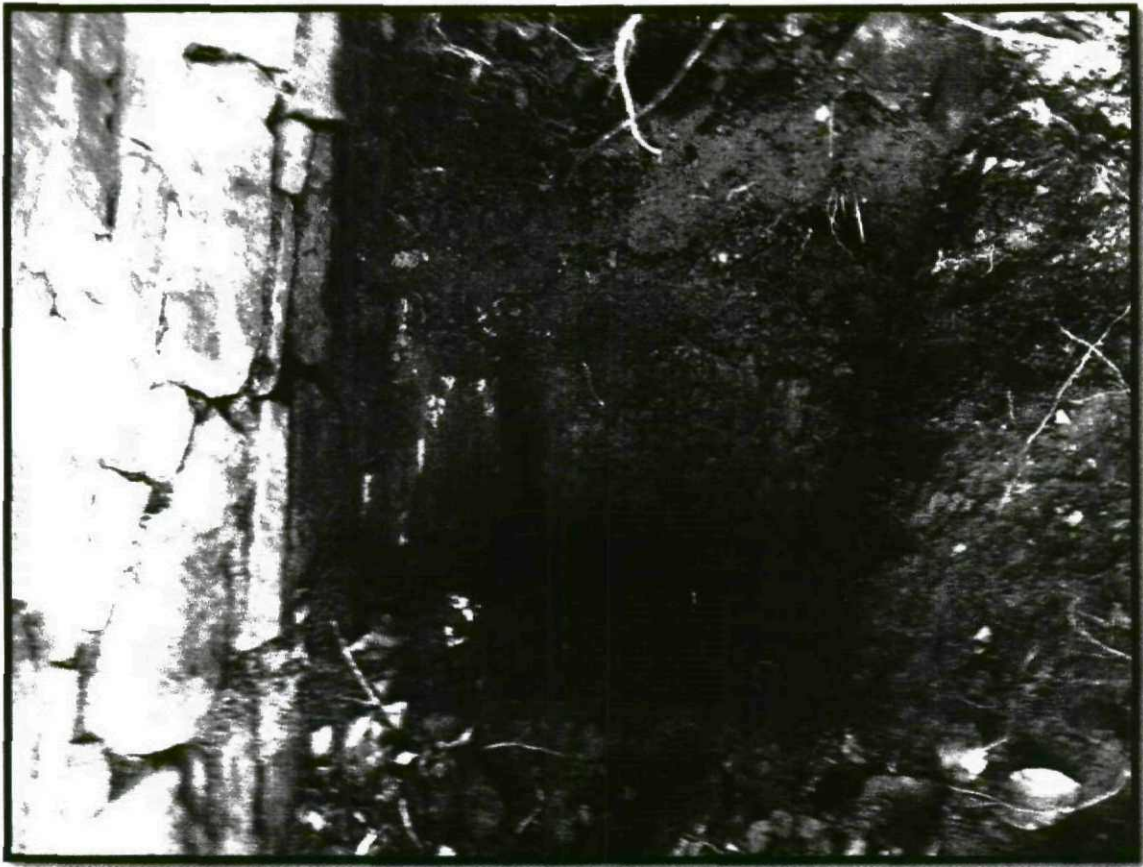
Photograph 51 – View of trial pit on East Elevation

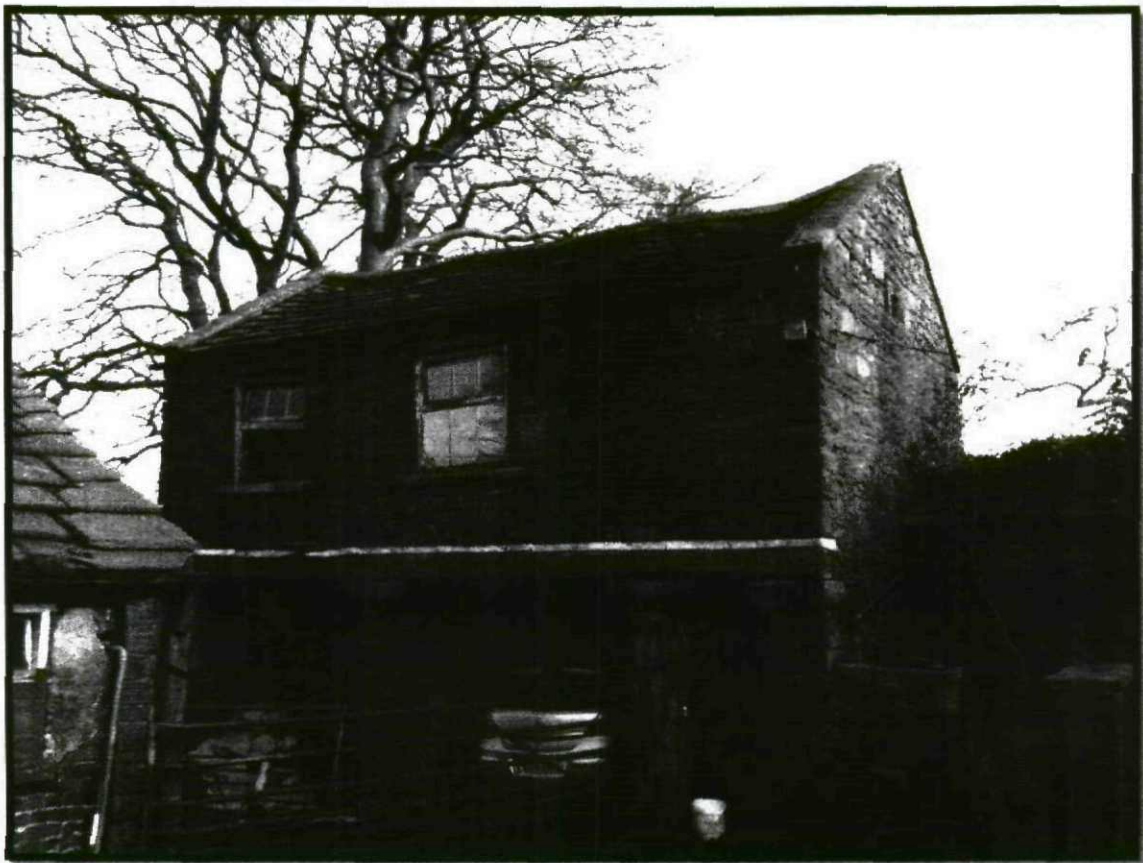
Photograph 52 – View of West Elevation

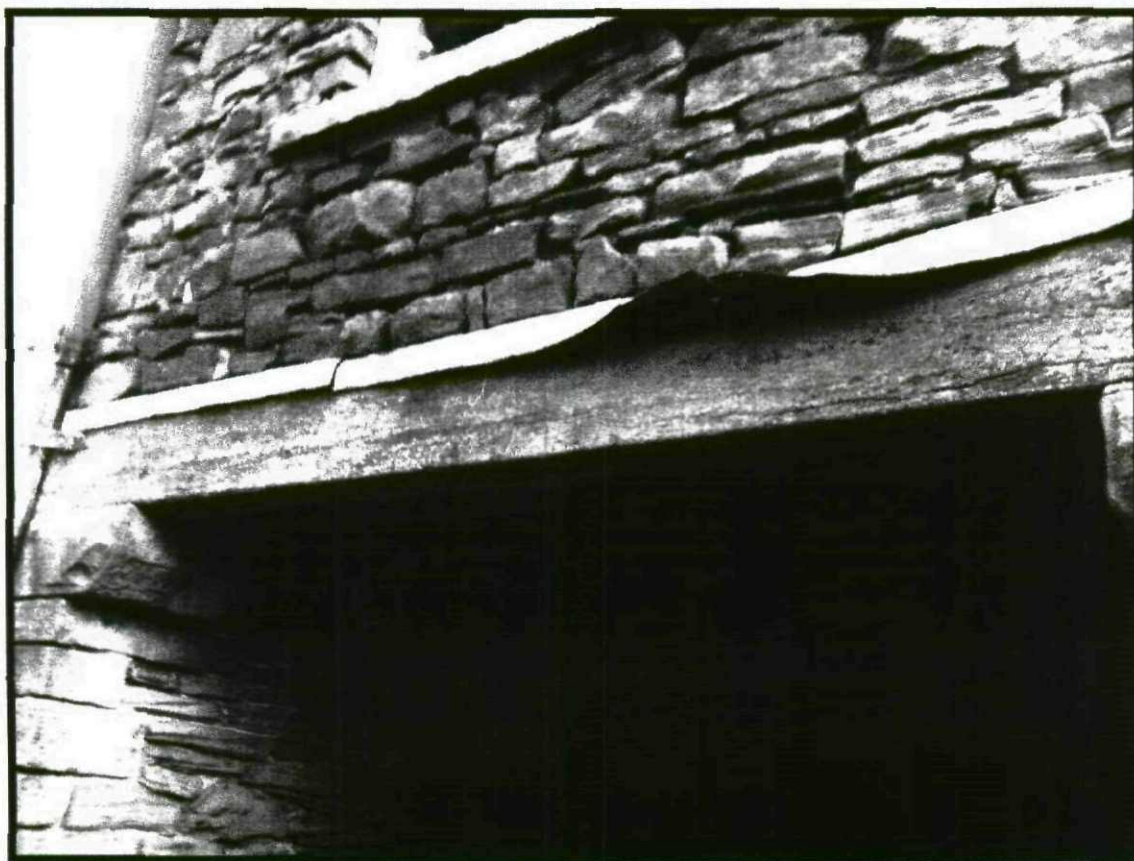
Photograph 54 – View of timber beam tom West Elevation

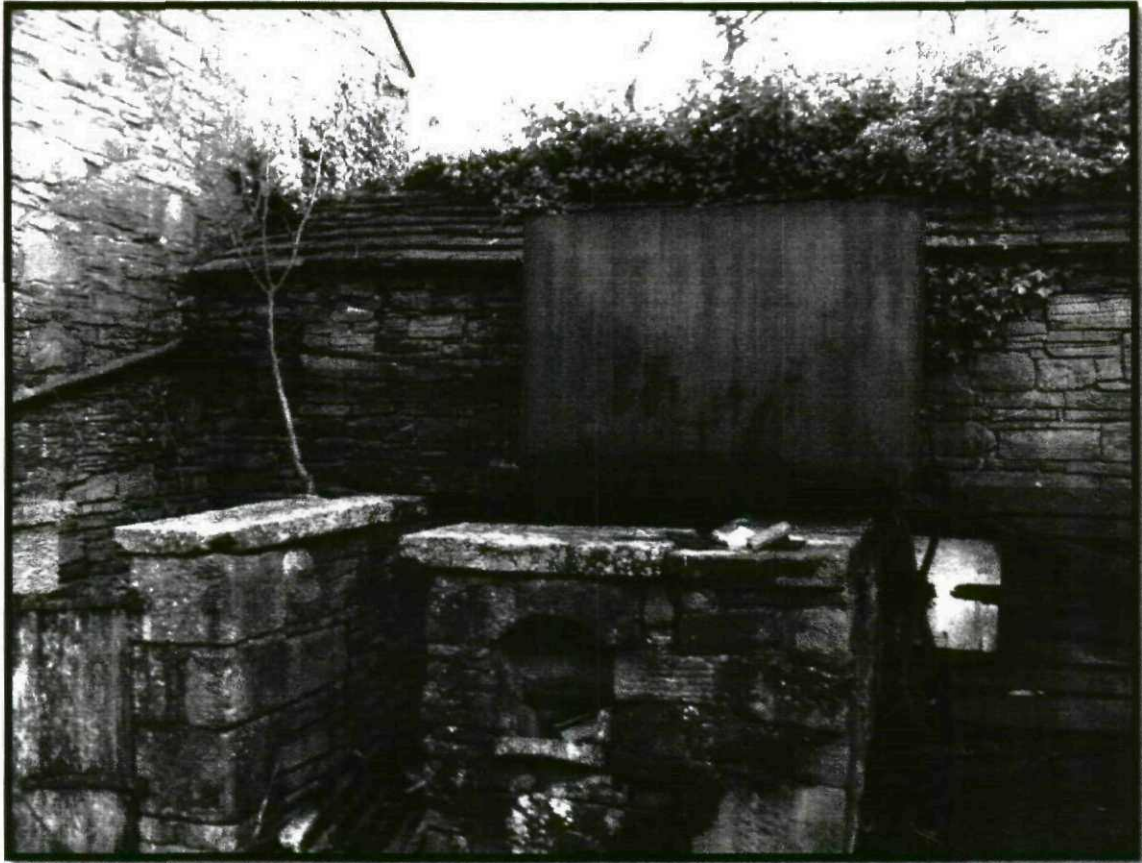
Photograph 55 – View of structure adjacent to the Tractor Shed

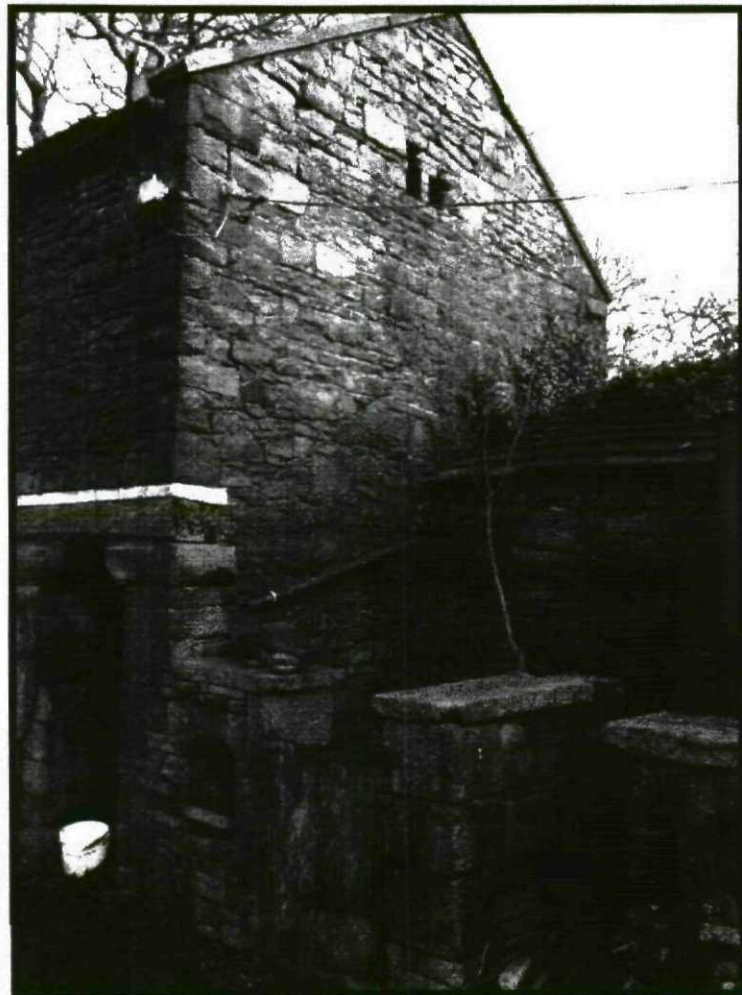
Photograph 56 – View of South Elevation

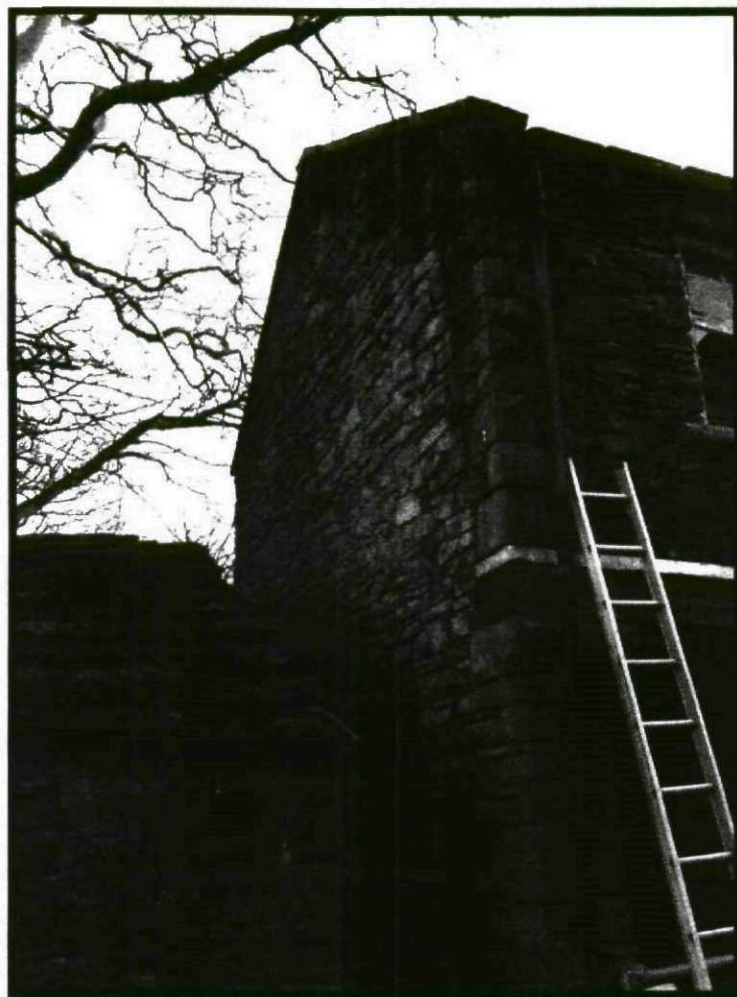
Photograph 57 – View of North Elevation

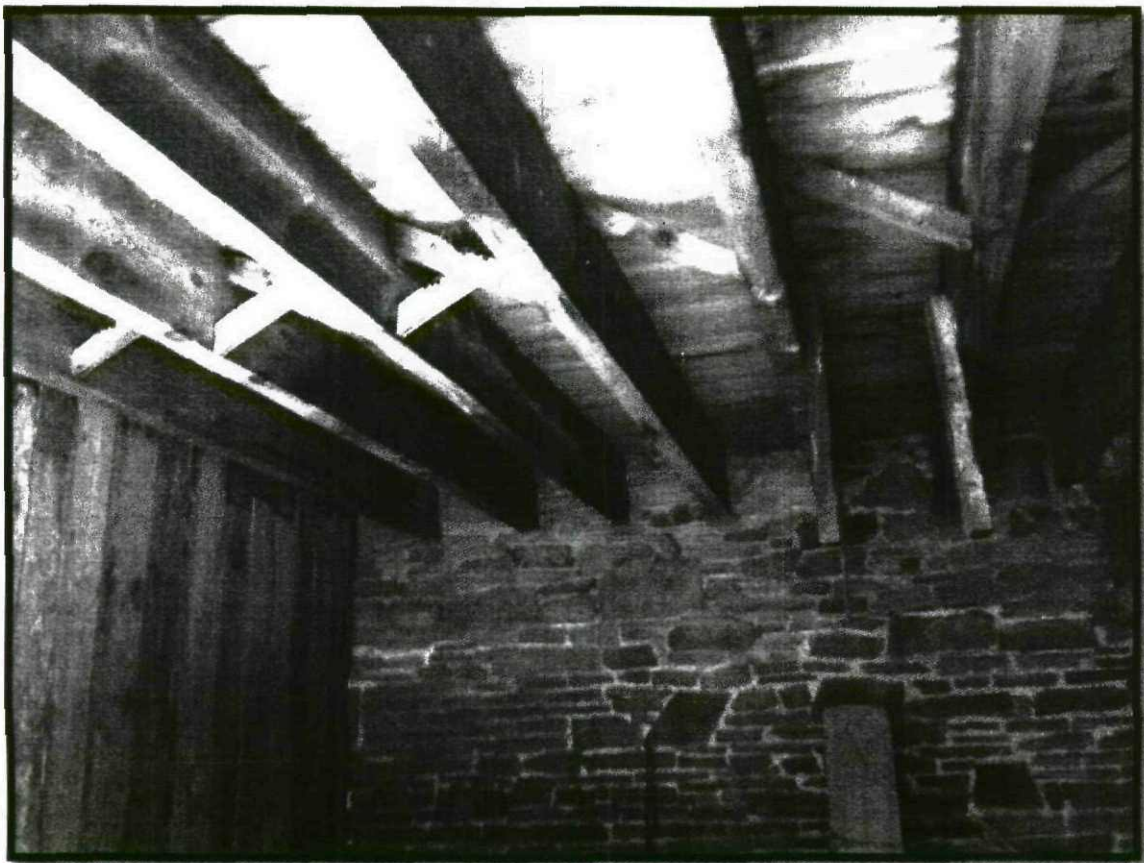
Photograph 60 – View Internal wall construction

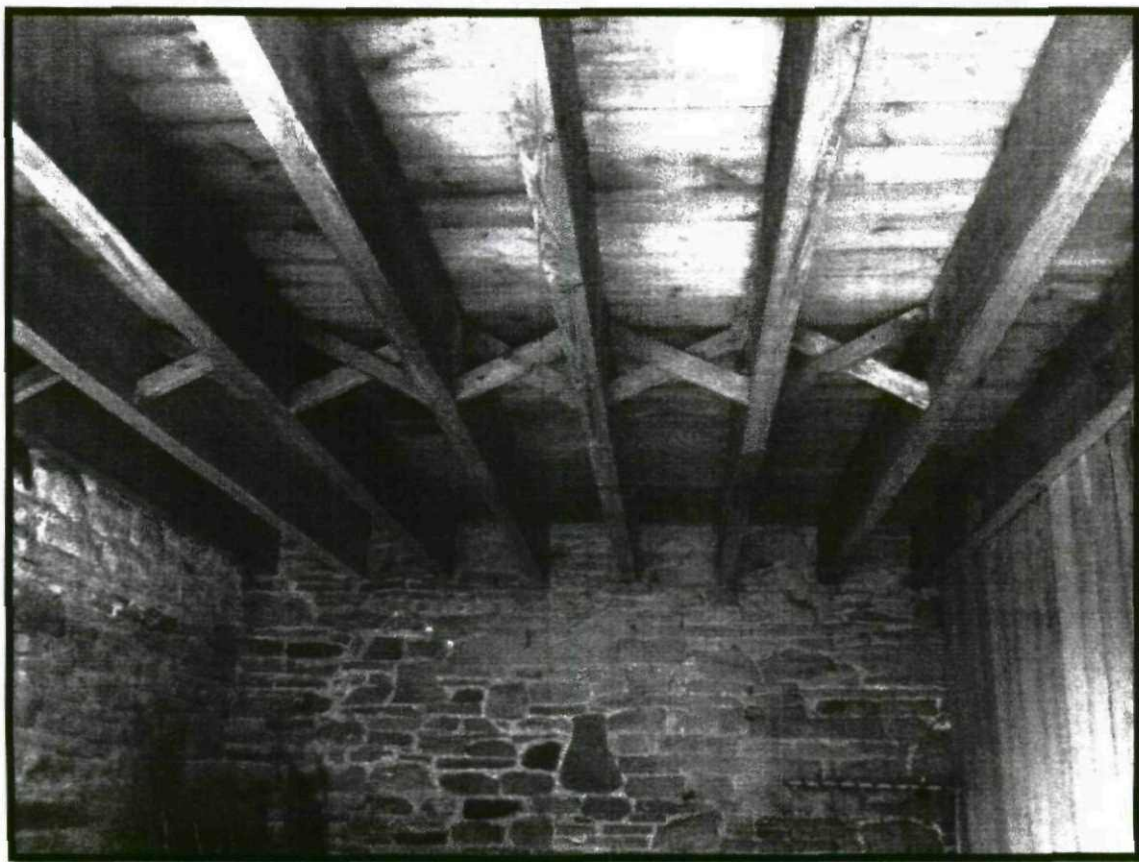
Photograph 62 – View of first floor construction

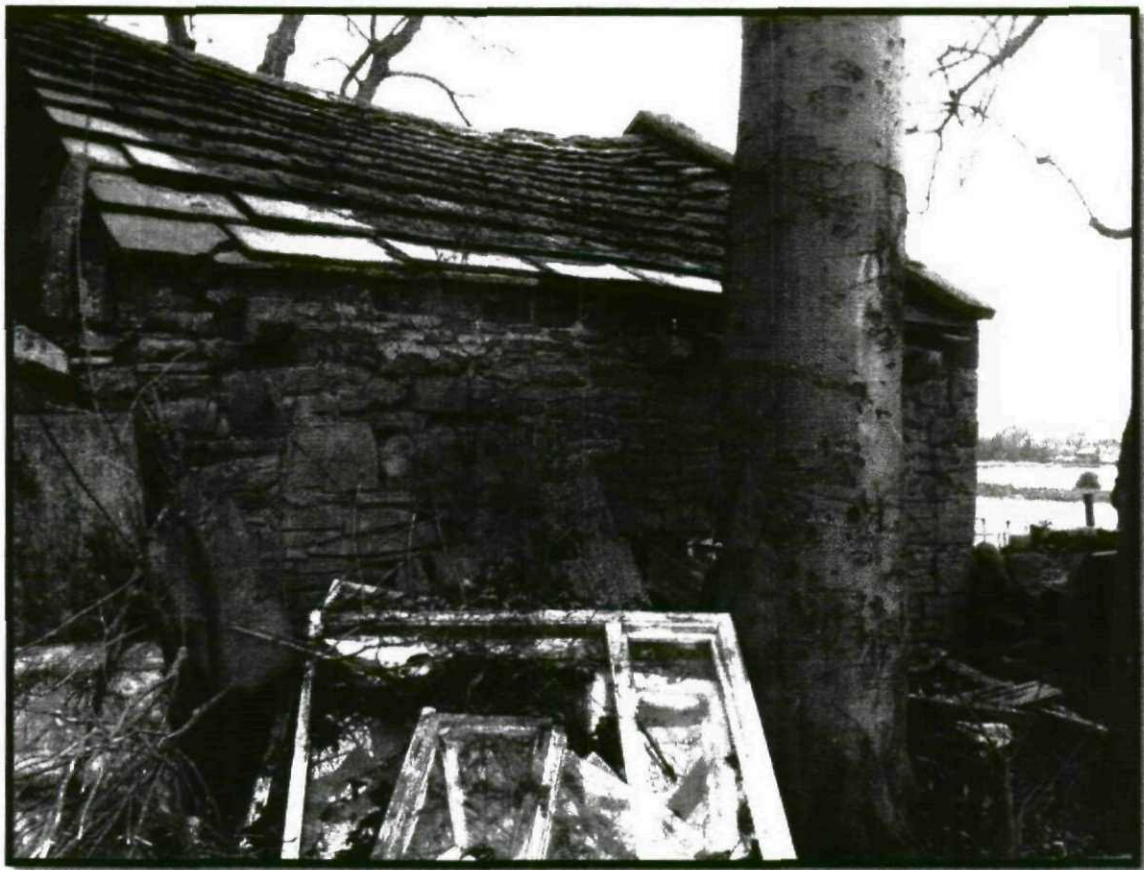
Photograph 63 – View of Annex East Elevation

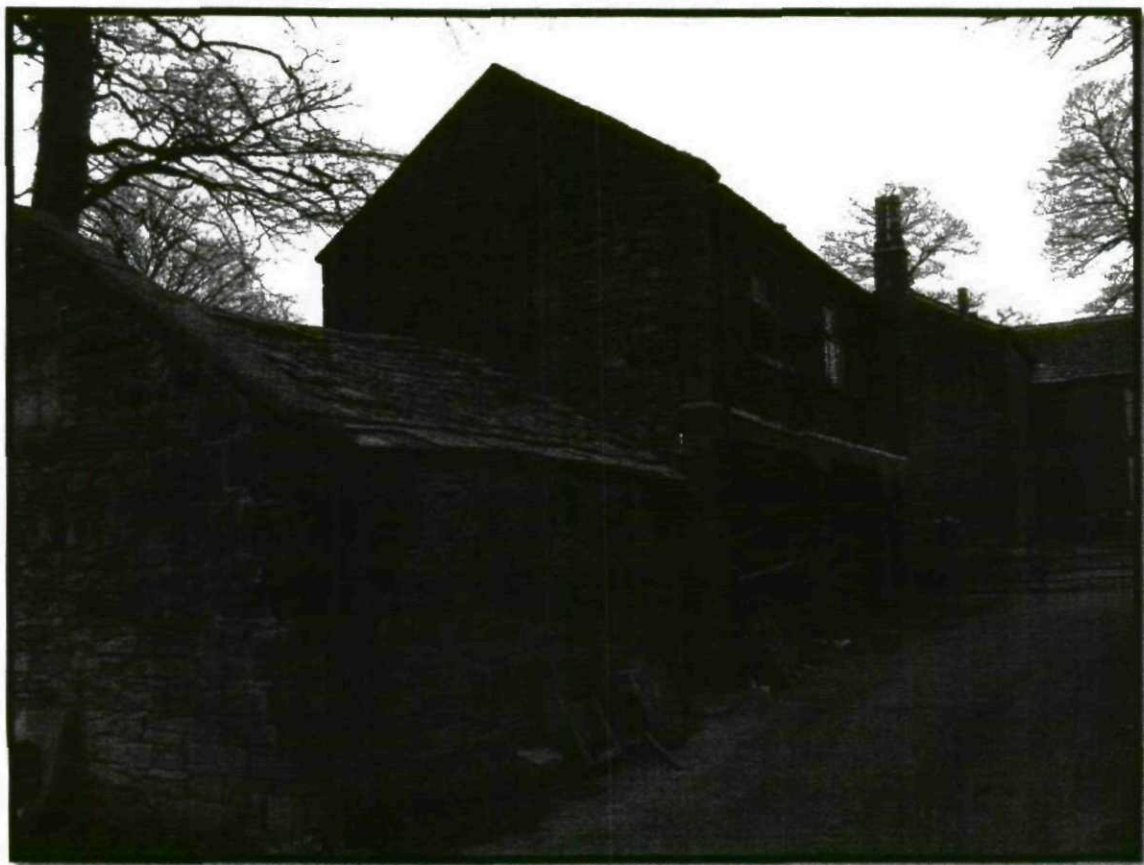
Photograph 64 – View of Annex West Elevation

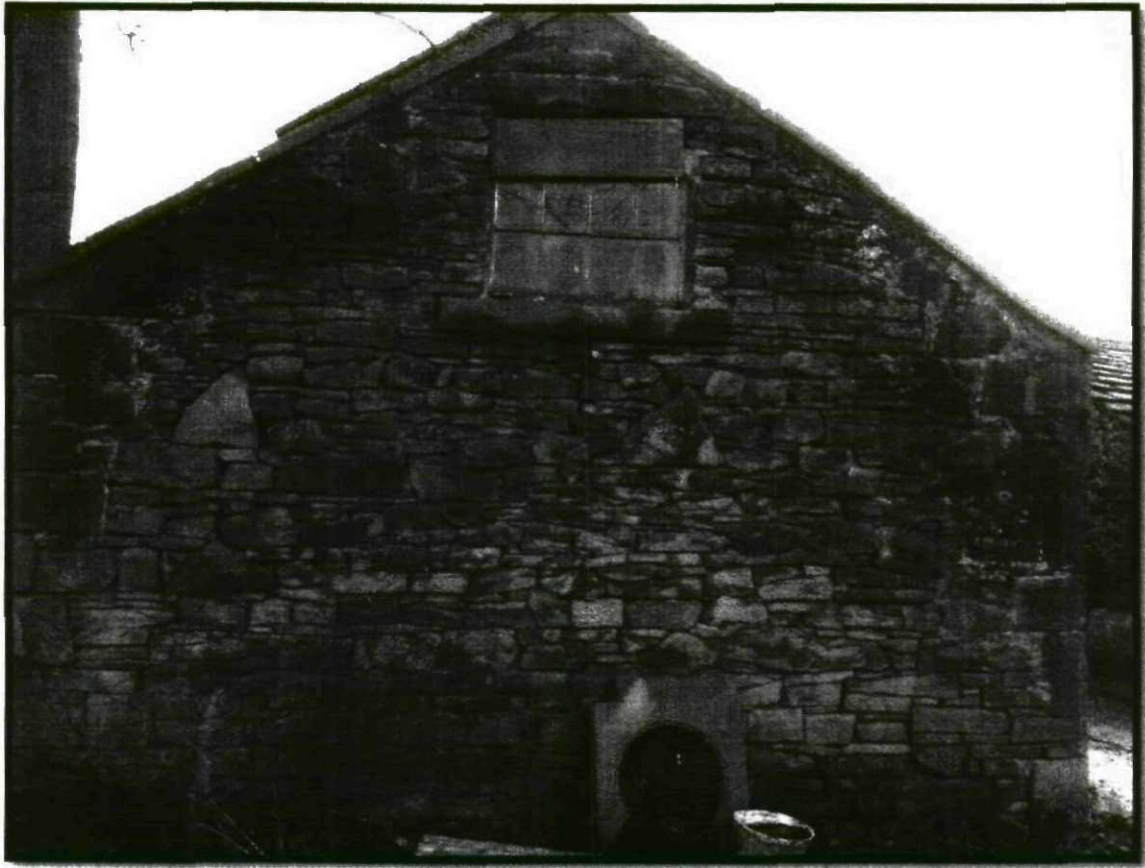
Photograph 65 – View of Annex North Elevation

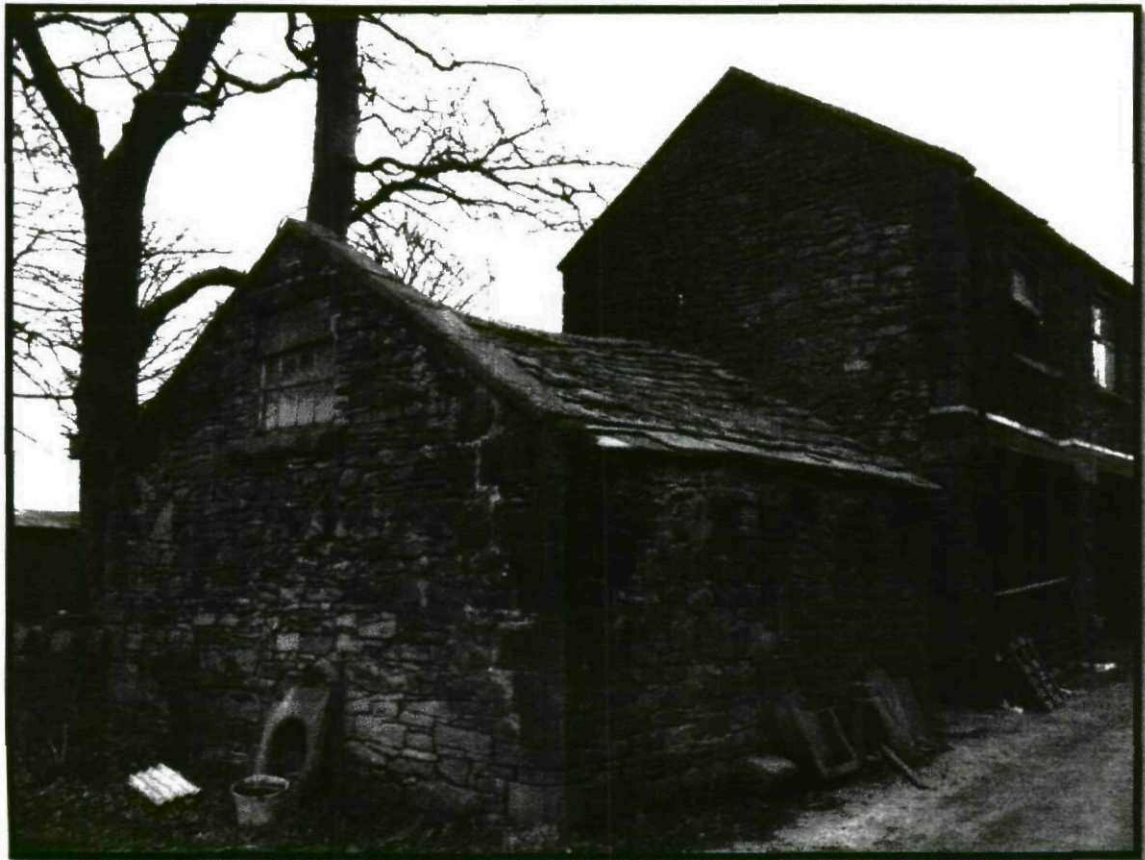
Photograph 66 – View of Annex North Elevation

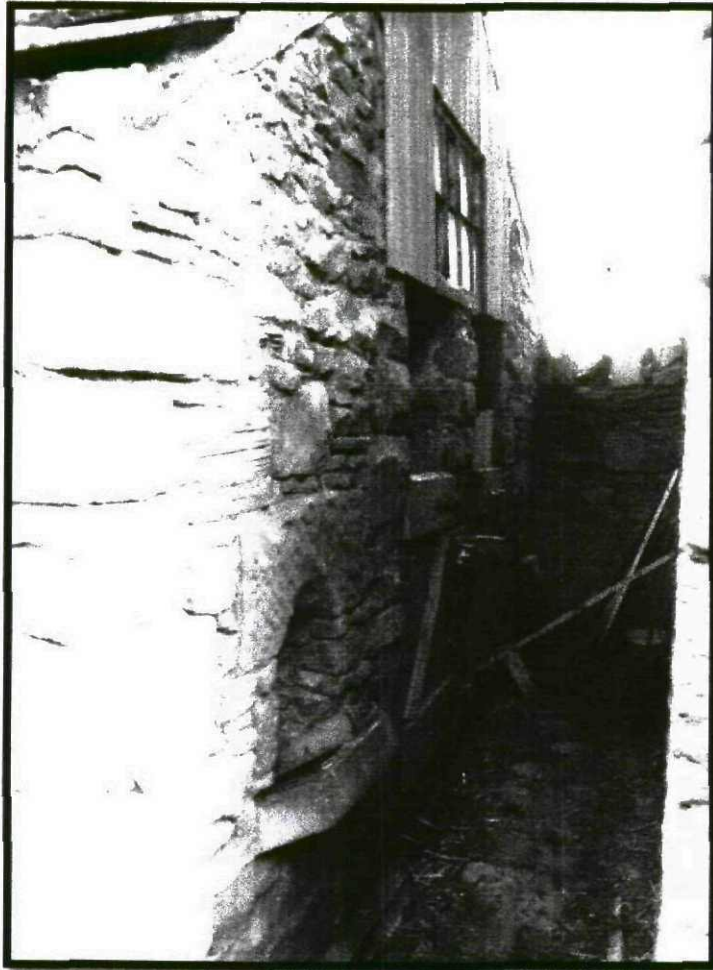
Photograph 67 – View of Annex South Elevation

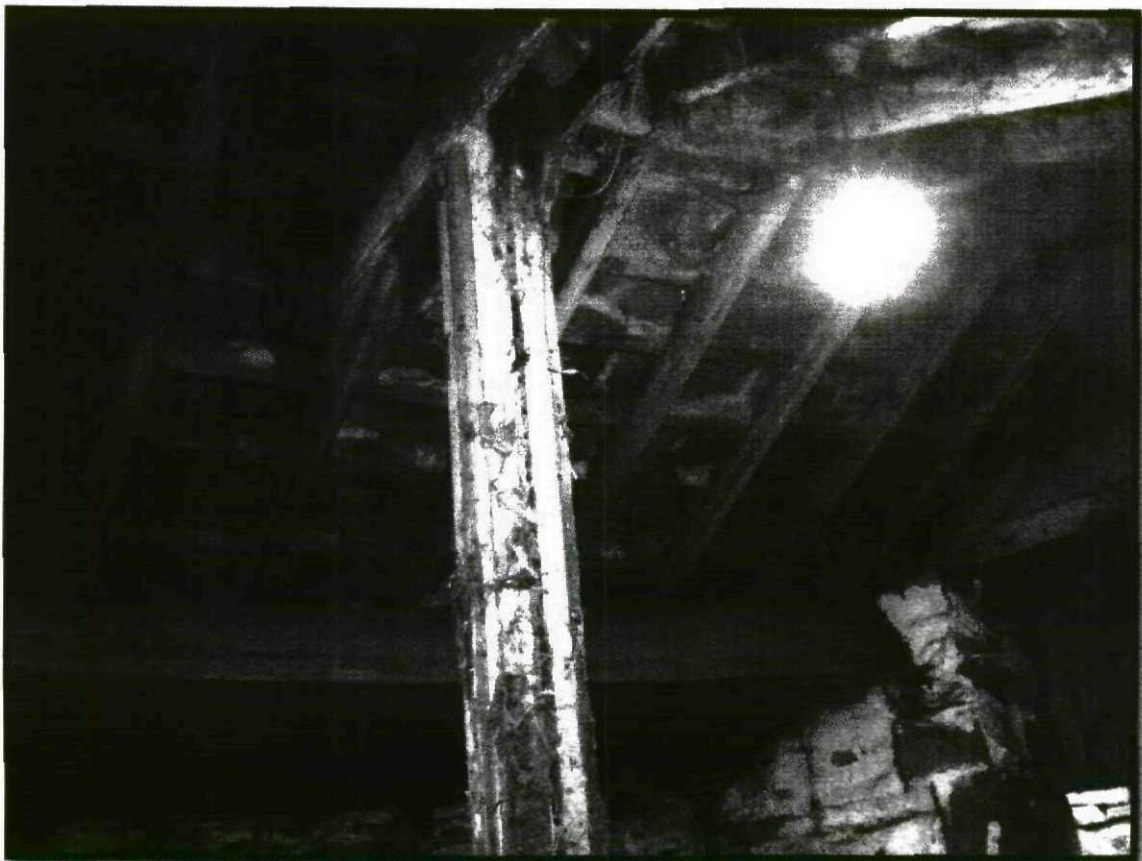
Photograph 68 – View of Annex Roof

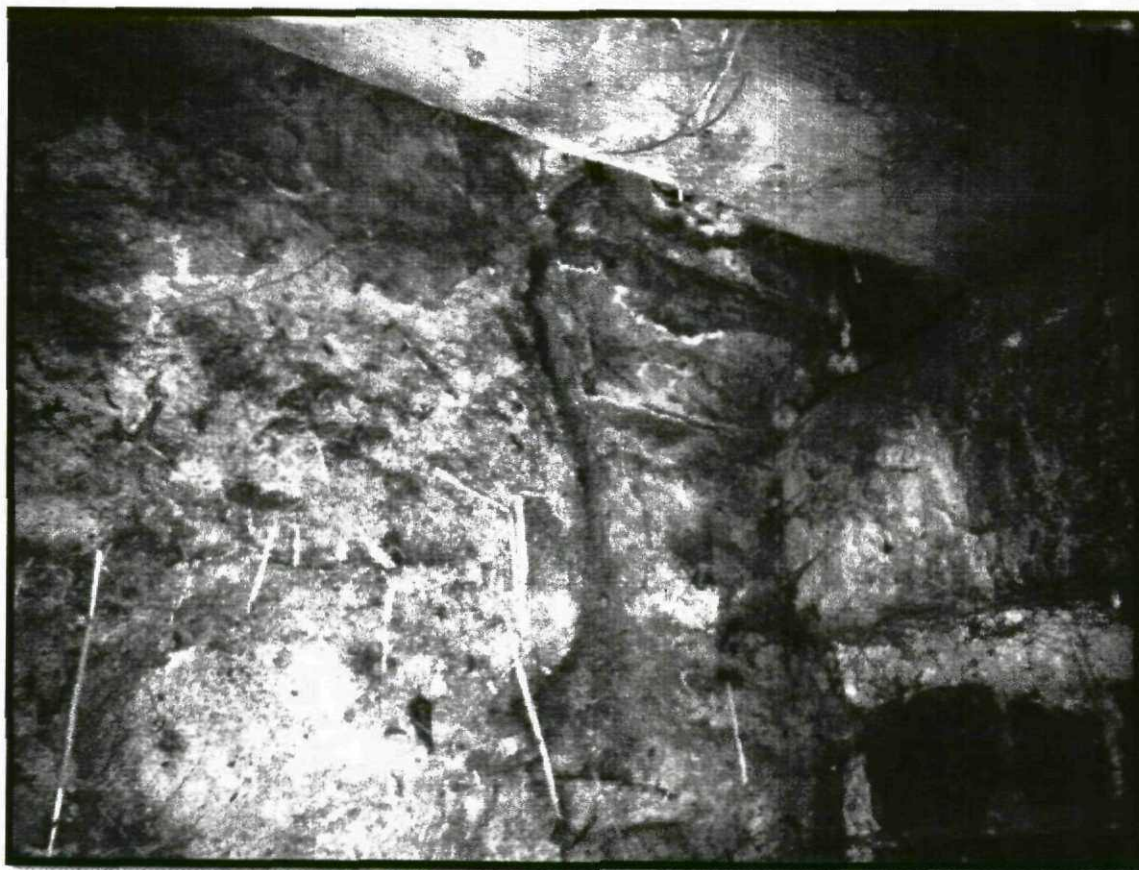
Photograph 69 – View of crack to window in North Elevation
