# Wentworth Castle

## Plaster Ceiling Survey

02/08/2024

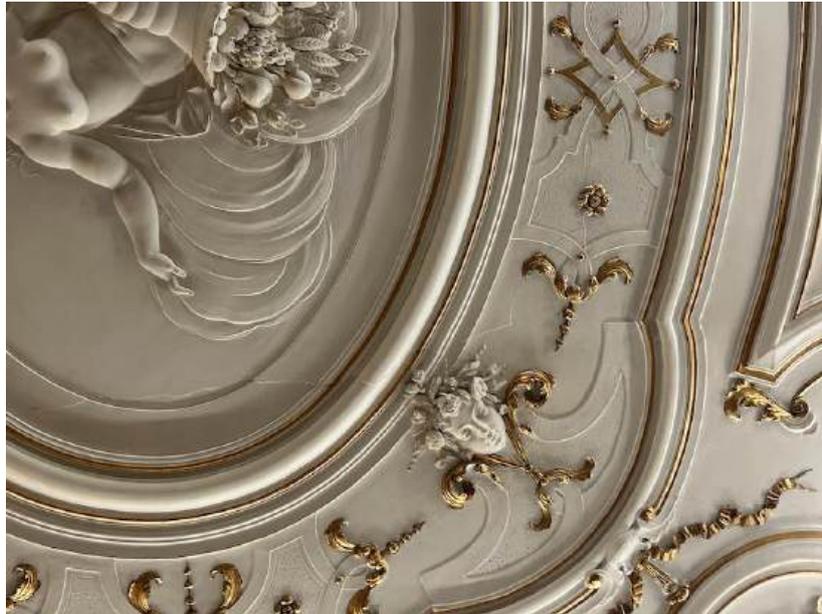
- The Blue Room, North End Room was found to be in good and stable condition.
- Multiple hairline fractures were noted throughout the ceiling and through the decorative details and cornice (Figure 3).
- There were multiple fractures noted at the junction between the ceiling and mouldings.
- The ceiling was found to be solid and stable from push testing.

*Figure 3. Image of hairline fracture running through the decorative plaster ceiling.*

- The ceiling expanse was found to be in stable condition from observation and tactile testing of the underside.
- If possible, observation of the upper side of the ceiling is recommended to ensure stability of the ceiling and its composing elements.

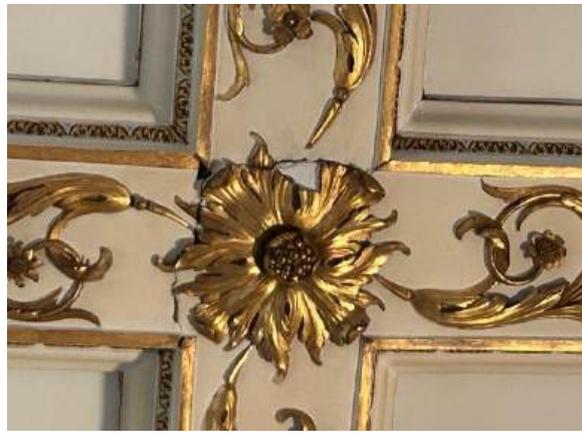
- Multiple hairline fractures were noted throughout the plaster, decorative elements, and cornice (Figure 8).
- Hairline fractures were noted on multiple enrichments; however, these may have been deliberate cuts created for the historic stabilization work on the upper ceiling (Figure 9).

*Figure 9. Fracture which could be a deliberate cut noted on multiple enrichments.*

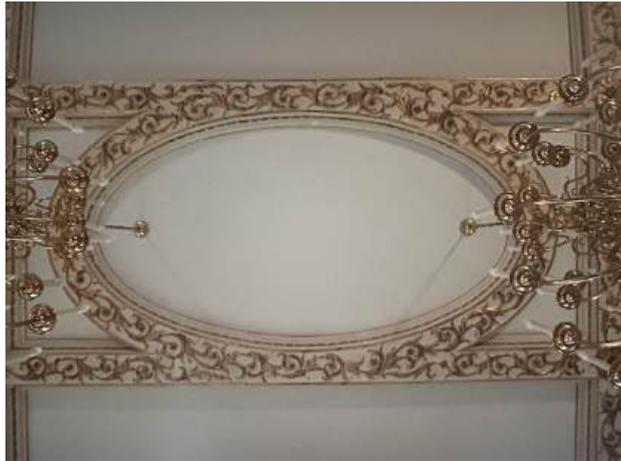
- Multiple hairline fractures were noted along the enriched decorative beams in equally spaced sequences. These also appeared to be deliberate cuts which could have been from the previous stabilization work to the upper side of the ceiling. Evidence supporting the insertion of deliberate cuts is aided by the visible presence of multiple bolts found between each fractured section. (Figure 11). These were found mirrored on both the East and West ends of the central decorative oval (Figure 12). These bolts match to the stabilization bolts viewed from the upper ceiling (Figure 13).

*Figure 12. Equally spaced fractured mirrored on East and West sides of the central decorative oval.*

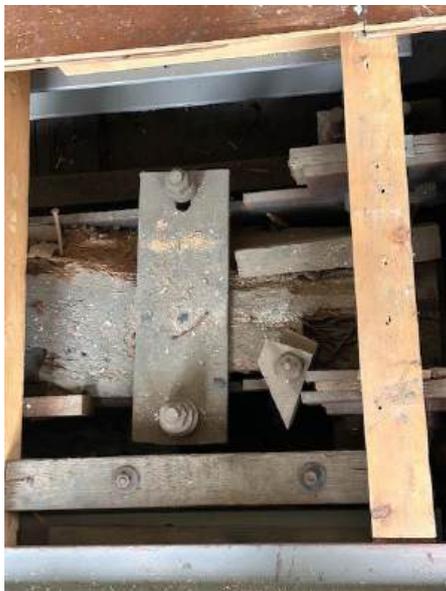
*Figure 13. Bolts visible from the upper side of the ceiling matching the location of the bolts visible on the underside of the ceiling.*

- The fractures and bolts which were visible from the underside of the ceiling give evidence that sections of plasterwork were removed to allow the fitting of the main steels, which run East to West. The plaster was then refixed and screwed in place using bolts. The deflection in the ceiling also therefore corresponds with the placement of the replaced beams above (Figure 22) and could have been caused by the loss and rotting of the original structural elements.

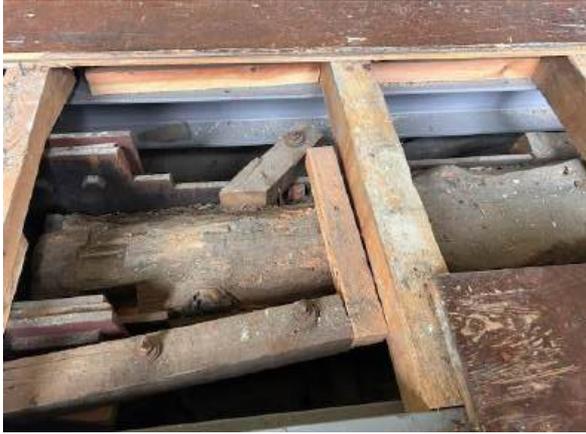
- Nibs and Laths were overall found to be in good condition (Figure 17).
- It appears that there were two major phases of renovation historically to the Blue Room ceiling. This is evidenced by red coloured inserted steel beams running East to West (Figure 17) and grey coated steel beams of a later manufacture found inserted running North to South (Figure 18). The later grey coated beams have bat straps attached which are fixed to the plaster ceiling below. Earlier steels were also found affixed in a support system for the remaining original timber beams (Figure 19).

*Figure 19. Earlier steels shown supporting timber beam with grey coated beams inserted parallel to the timber beams.*

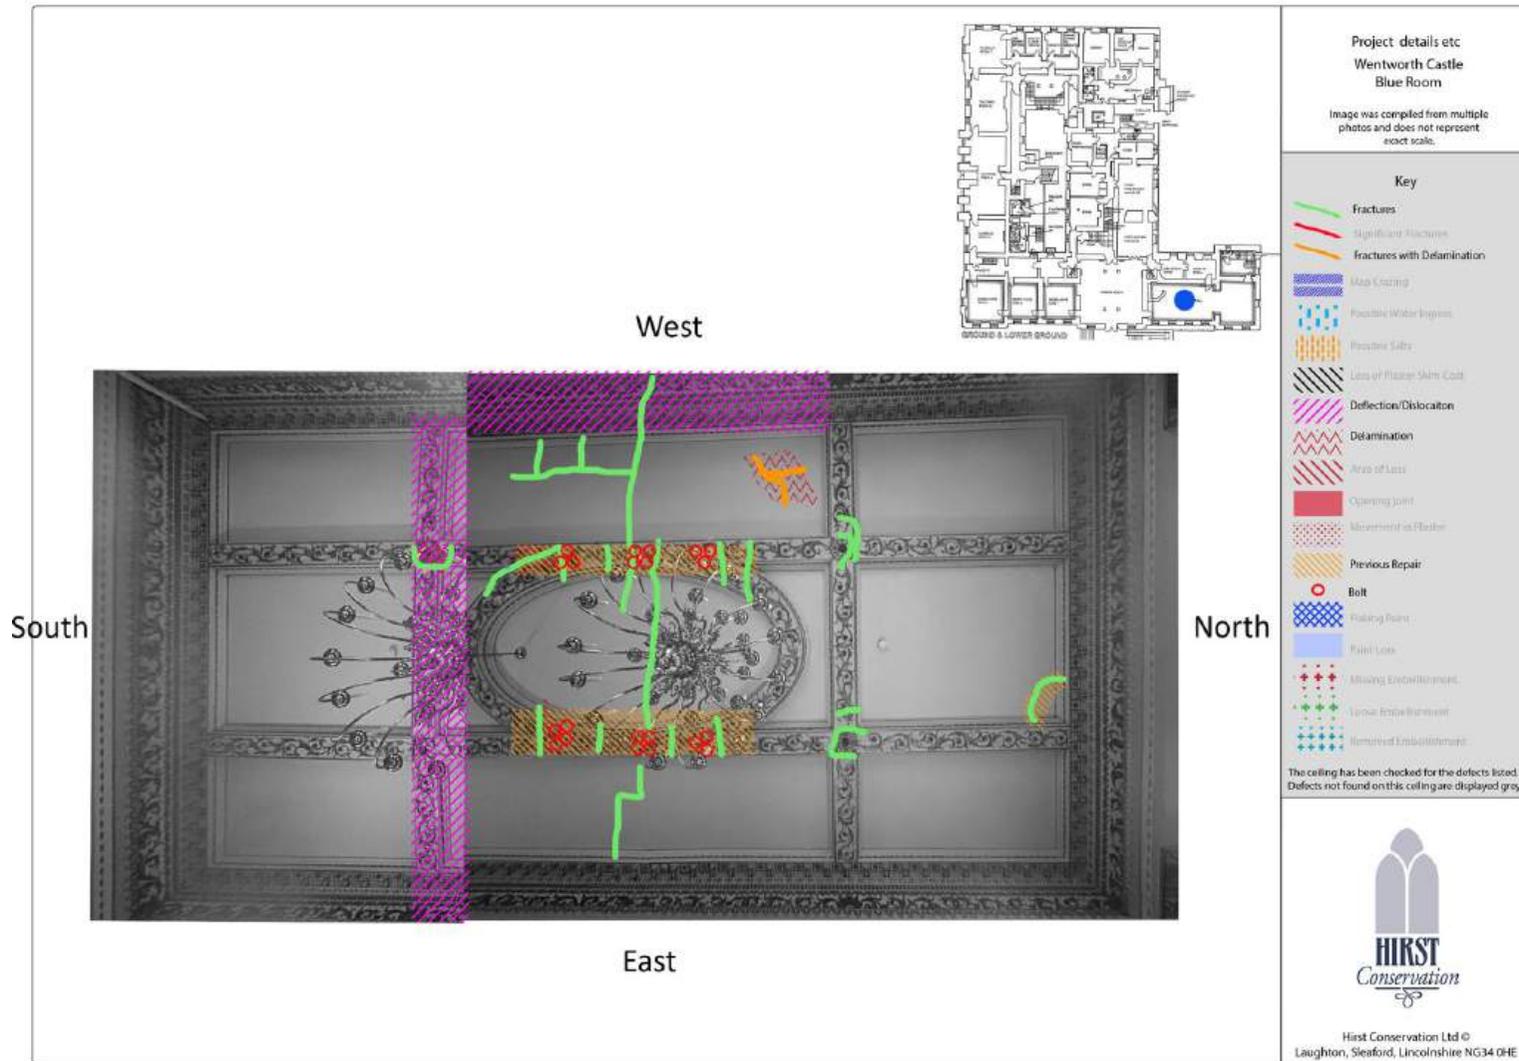
## 2.2.6. Blue Room Defect Diagram

- The full ceiling exhibited evidence of displacement, observed as bowing from East to West along the full expanse of the ceiling (Figure 6).
- Bowing and displacement were noted on the West facing wall's cornice from North to South (Figure 7).

- The Blue Room plaster ceiling appears to be sound and stable due to the previous interventive stabilizing works which took place to the upper floor.
- From the information gathered to date, no areas observed were found to be of immediate concern regarding stability. However, please note that not all areas of the ceiling could be assessed as only a limited number of floorboards had been lifted.

- Extra support to the two timber joists which were found to be loose during the survey was recommended on site and a plan was devised with the architect for design and placement of the added support (Figure 24).

- It is recommended that the close consultation with the structural engineer is conducted to inform the best course of action for any additional stabilization requirements or plans.

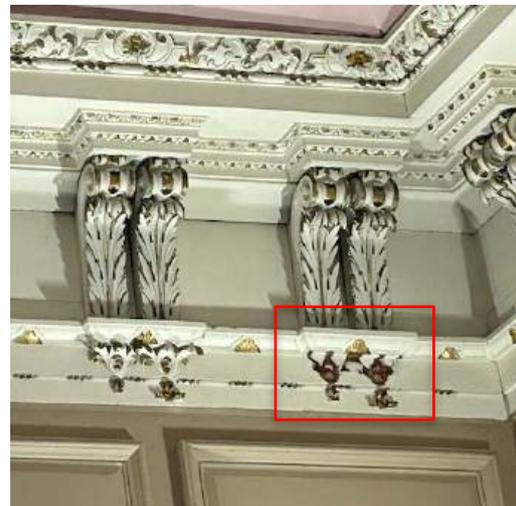
*Figure 42. Multiple embellishments missing throughout the cornice.*

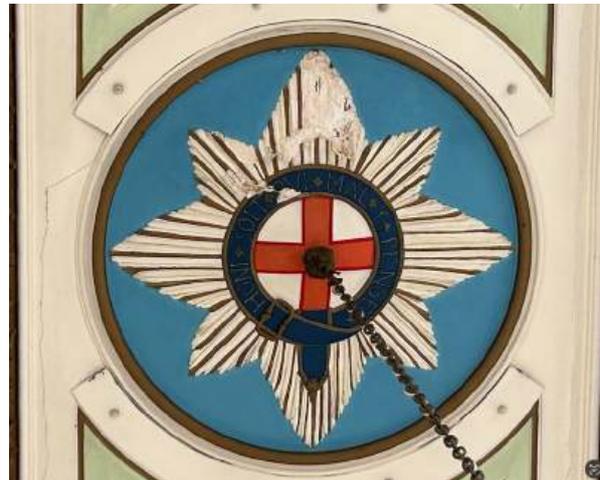
*Figure 48. Area of loss in central rose.*

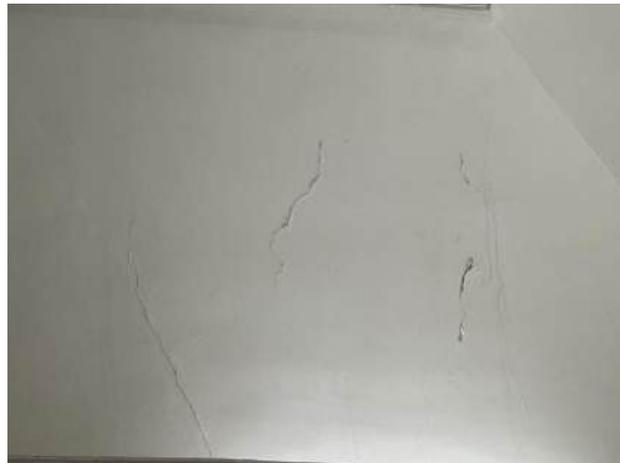
*Figure 55. Fractures with delamination and potential water ingress or salts visible.*

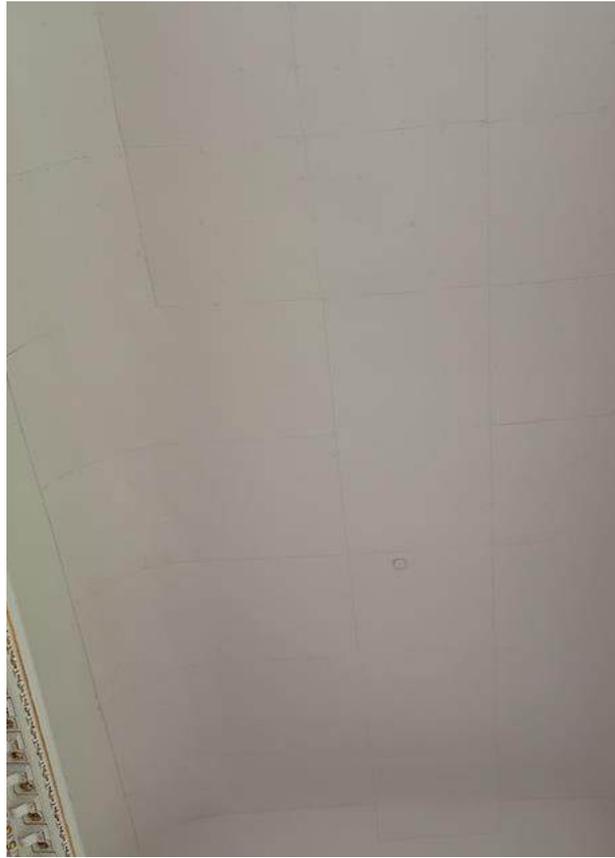
*Figure 59. Plasterboard meeting seams visible on large expanse of the ceiling.*

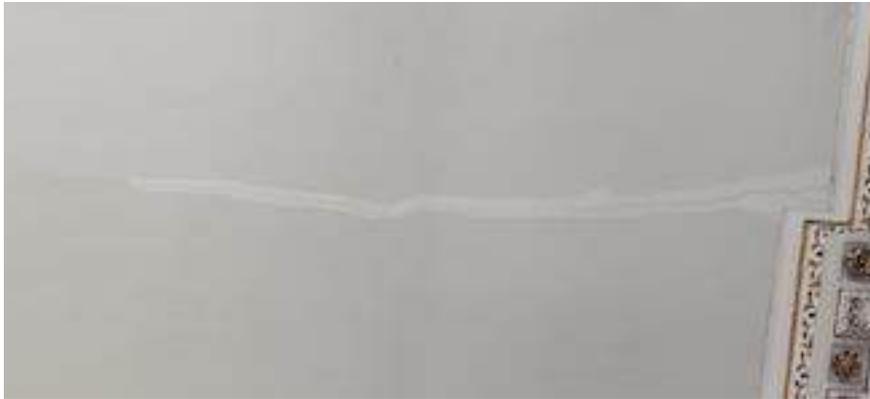
*Figure 62. Fracture visible on the ceiling.*

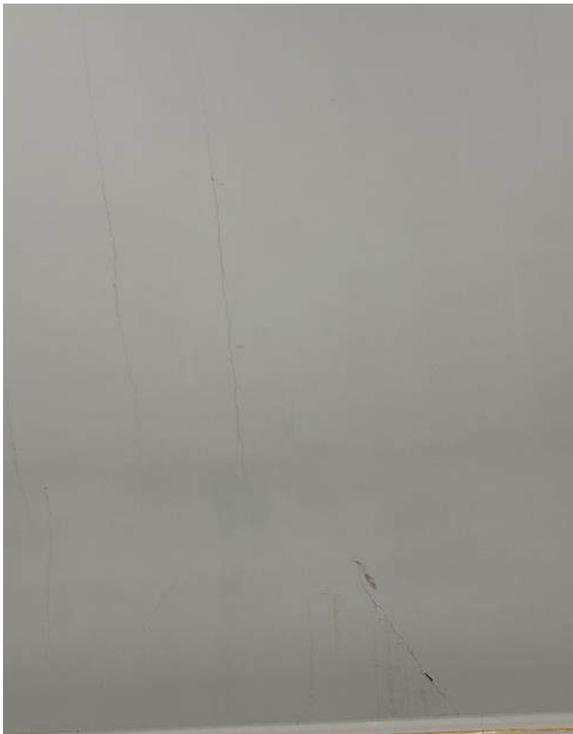
*Figure 65. Multiple fractures running through ceiling.*

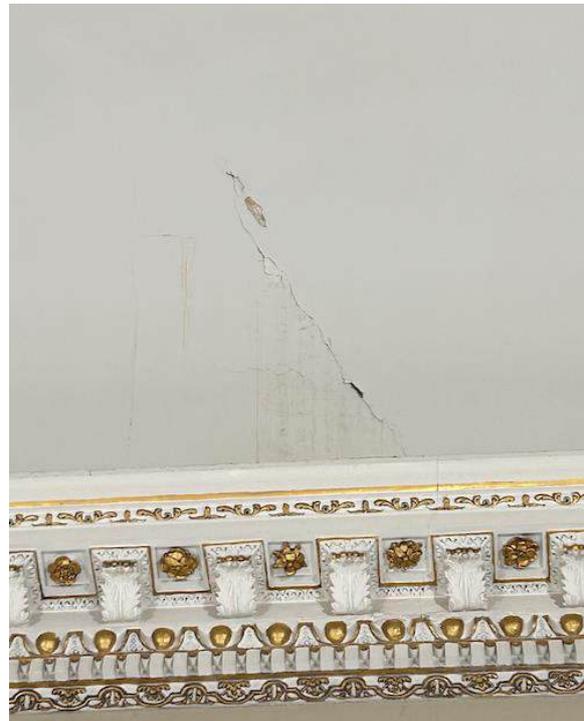
*Figure 66. Fracture resulting in loss and possible ingress.*

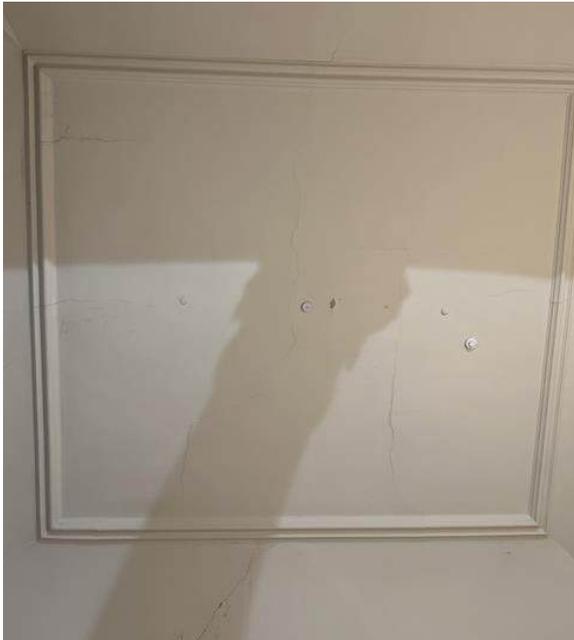
*Figure 69. Fractures seen throughout ceiling expanse.*

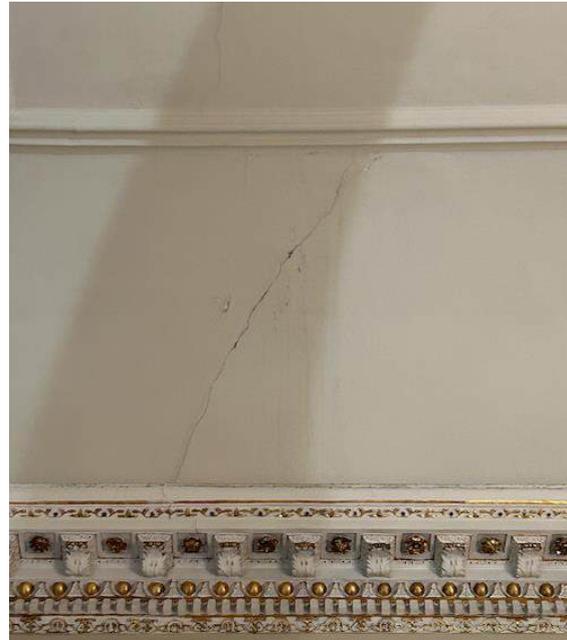
*Figure 70. Fracture with loss and delamination and possible water ingress.*

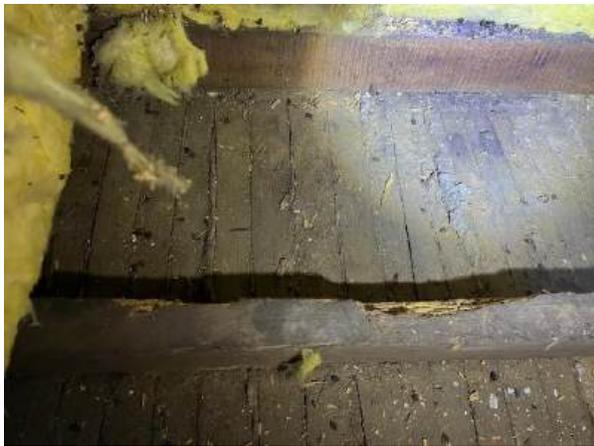
This has impacted the formation of the nibs which act as a supportive key to hold the plaster to the ceiling. The historic failure of the ceiling was likely caused by the water ingress, softening and adding weight to the plaster, and the lack of supportive nibs caused by incorrect spacing of the lath promoted the failure.

*Figure 73. Location \*1 lath to the North end of the Long Gallery, showing the spacing is too close together.*

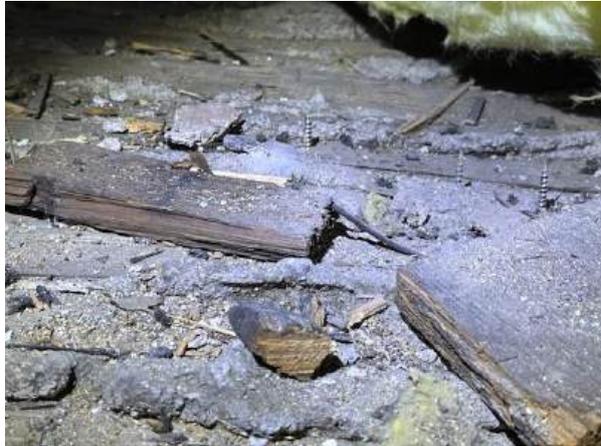
*Figure 74. Screws through the lime plaster where the boards have been fixed to the ceiling. Note the lime plaster is still present in this area. Note the debris on the top side of the ceiling, located at \*4 of the diagram.*

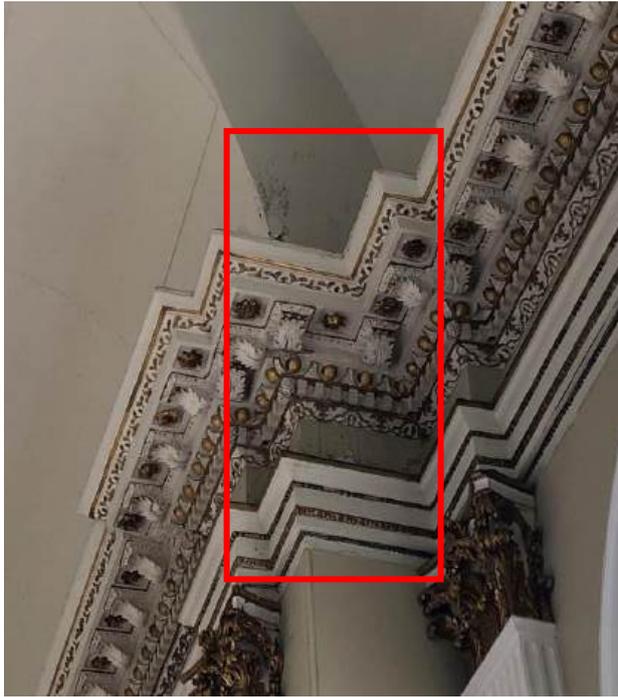
By looking at the approximate location of the ductwork on the floorplan, the ceiling directly below the North End rainwater trough, particularly the cornice to the East wall, has significant evidence of water ingress, it is not known if this is recent. However this evidence suggests that water may be leaking around the seal of the trough to the ceiling and wall below, causing the deterioration noted during inspection. However, the shape of the ceiling above this area may promote the flow of any water towards this area. Inspection of the roof and ductwork will inform further.

*Figure 75. Evidence of historic water ingress, the rain trough may be above this area to the North side of the Long Gallery.*

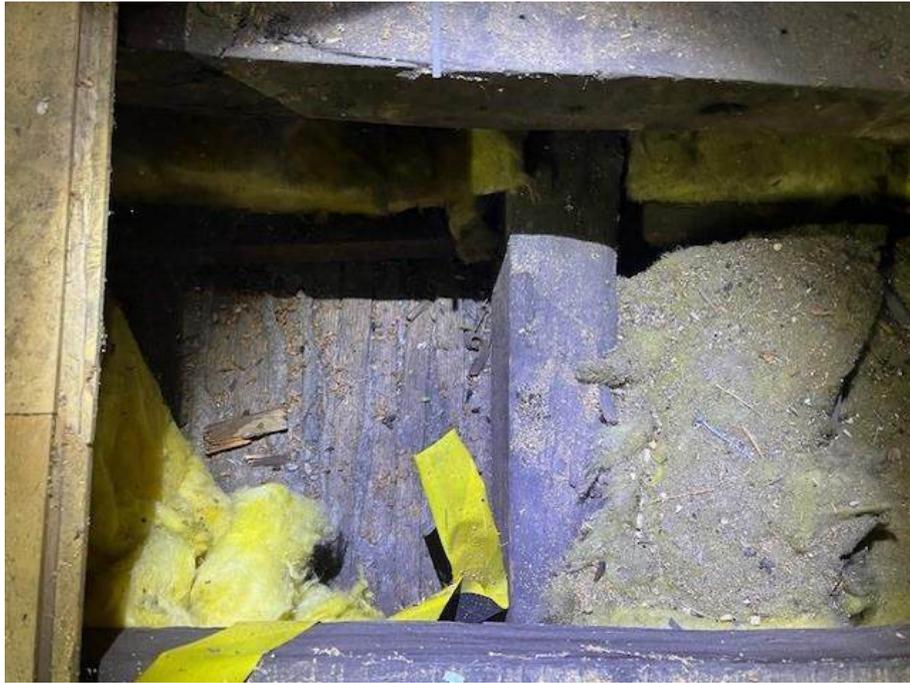
*Figure 77. Location \*5 showing the lath are spaced close together with minimal nibs present.*

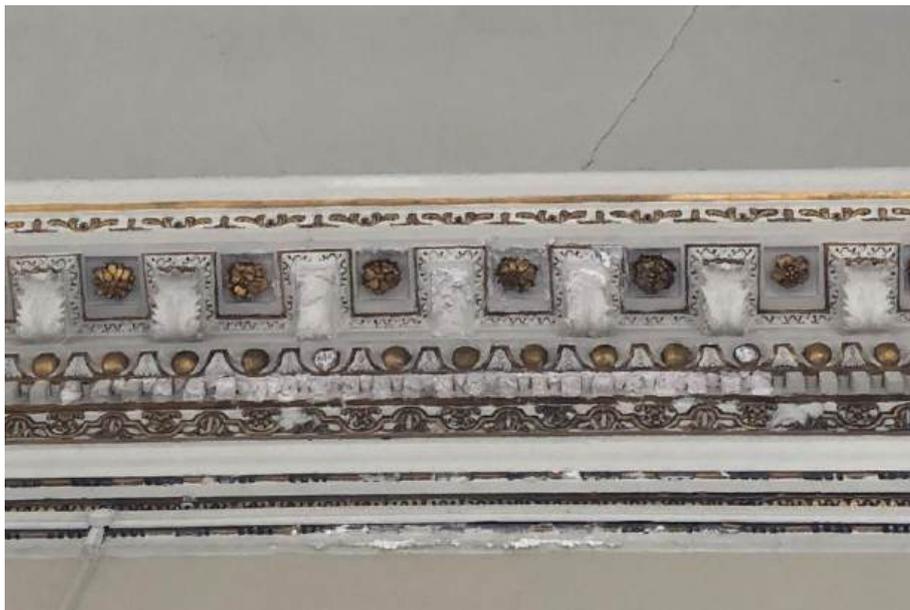
The area of cornice and plaster mouldings underneath on the East wall has suffered from significant deterioration from water ingress (See Fig. 78). Moisture readings may be effective in evaluating how much moisture is present in the wall/ ceiling to see if levels are high.

*Figure 78. Deterioration of the cornice, Egg and Dart and Dental Blocks.*

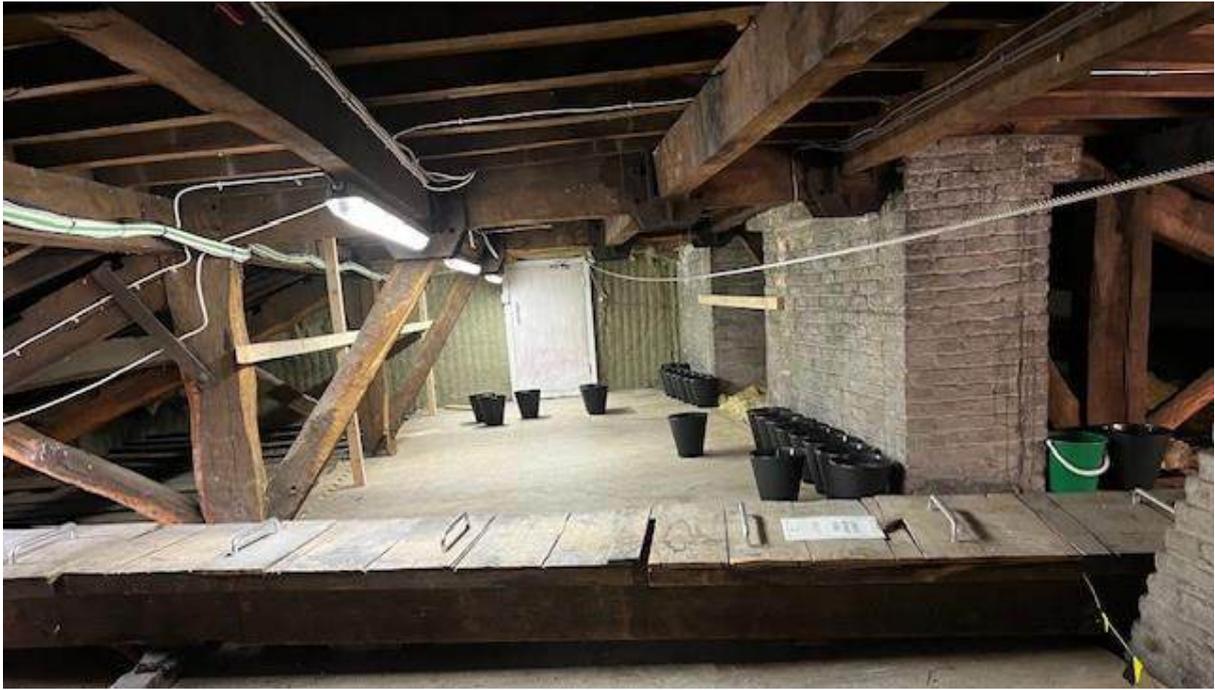
*Figure 80. Location of the South End rainwater trough. Note the buckets placed along the chimney suggesting lead flashing leak and strategically placed buckets in the walkway.*

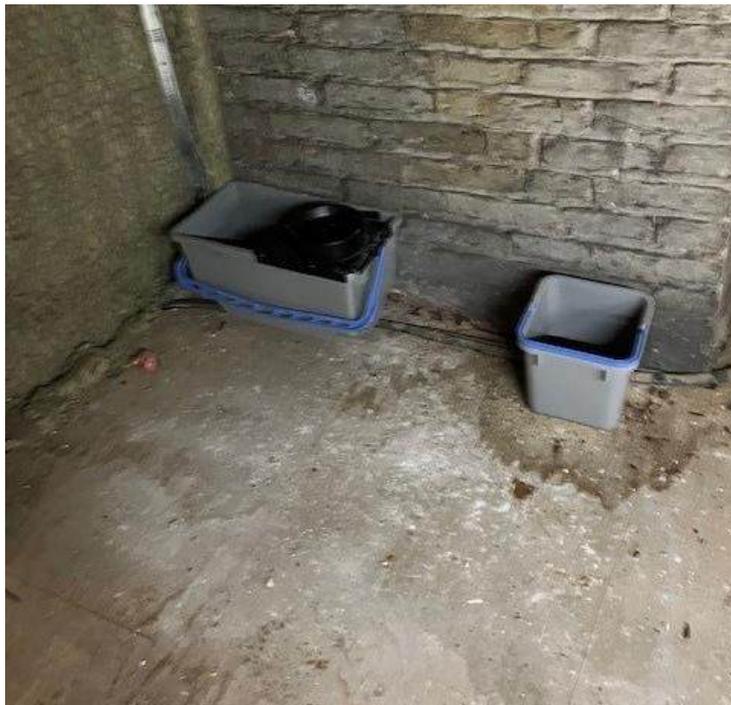
*Figure 79. Water staining of the plywood surrounding buckets suggesting leaks in the area of the bucket.*

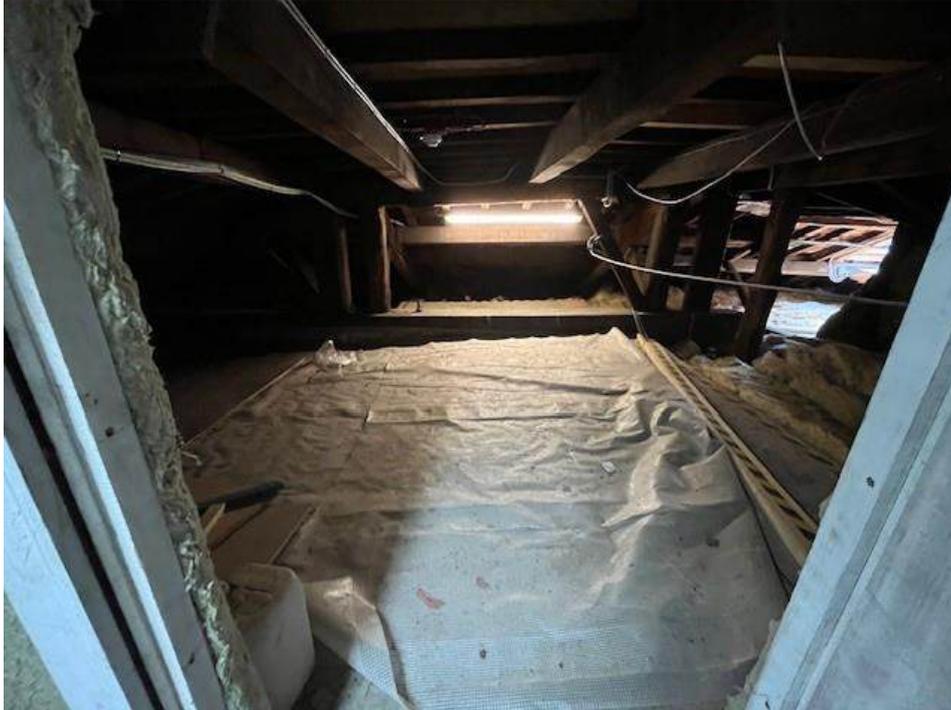
The single ceiling to the south end of the Long Gallery could not be inspected during the 06 August 2024 survey due to is being covered with sheeting and not known if the floor is stable.

*Figure 81. South End ceiling where plastic sheeting is present covering the walkway.*

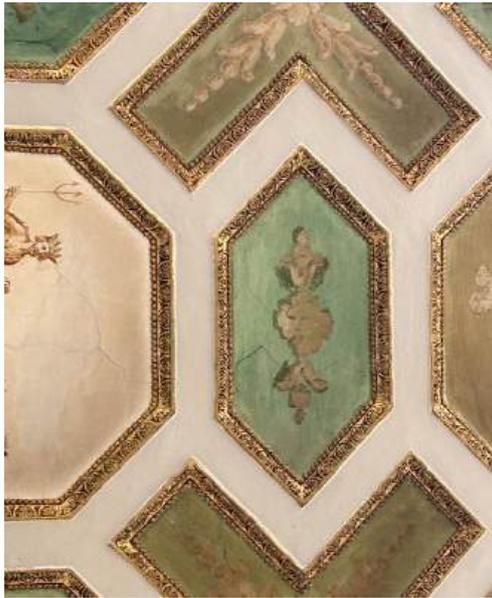
*Figure 88. Hairline fractures found throughout the ceiling.*

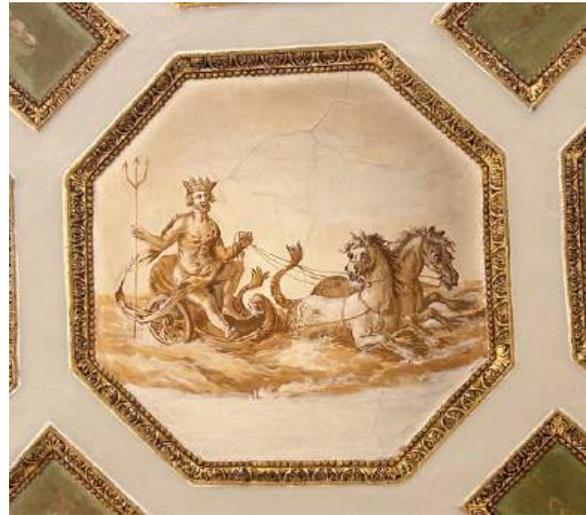
*Figure 89. Map crazing found on a painted panel.*

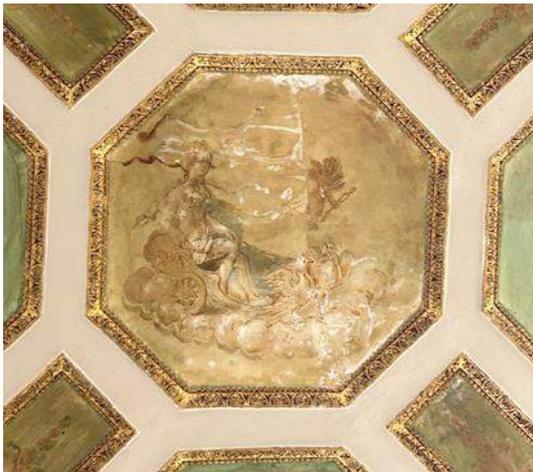
*Figure 90. Possible water ingress resulting in paint loss and discolouration.*

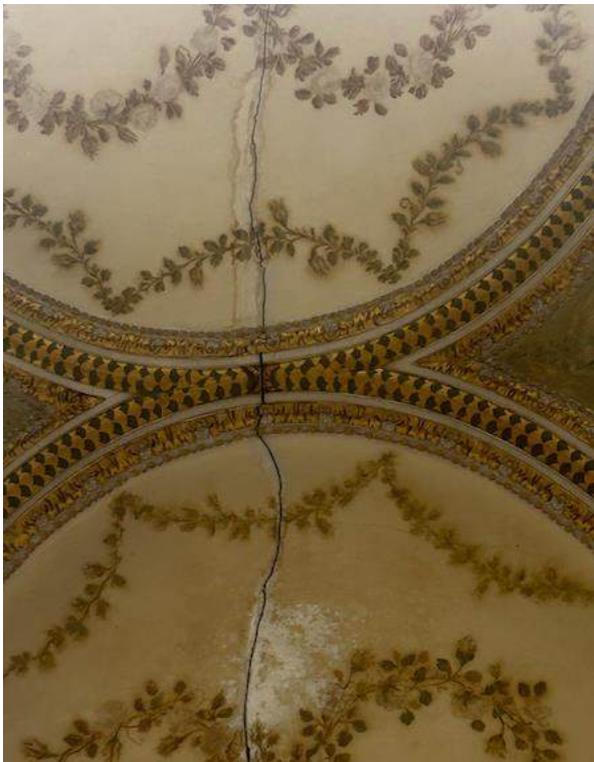
*Figure 95. Possible water ingress observed around fracture.*

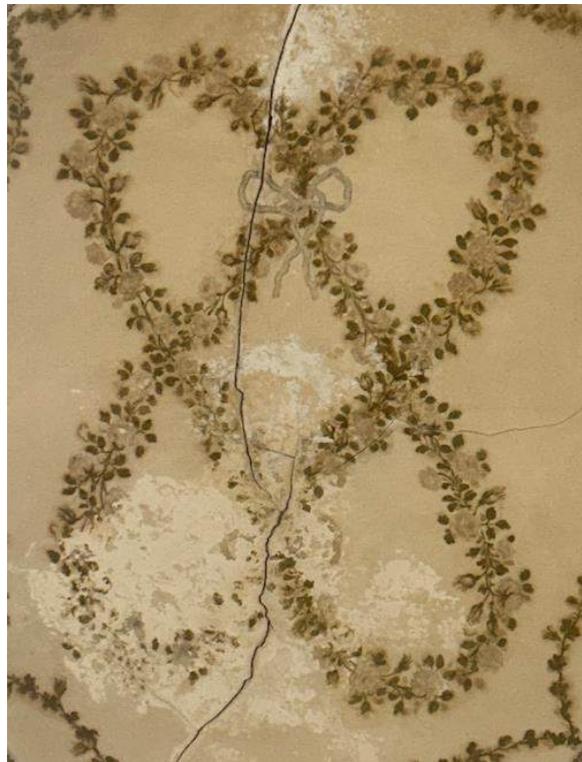
*Figure 96. Paint loss, flaking, and fading seen throughout the painted ceiling expanse.*

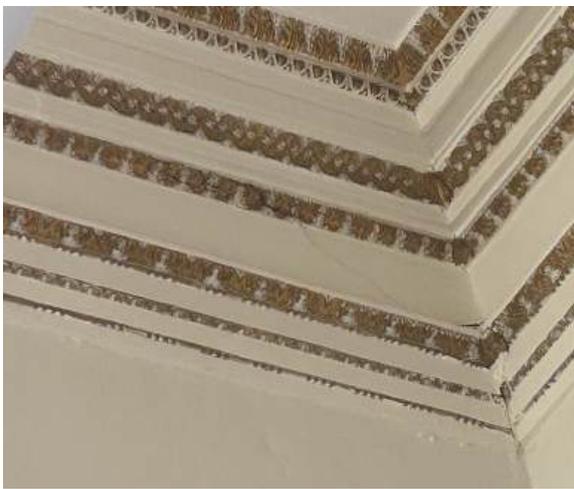
*Figure 101. Fracture running along cornice.*

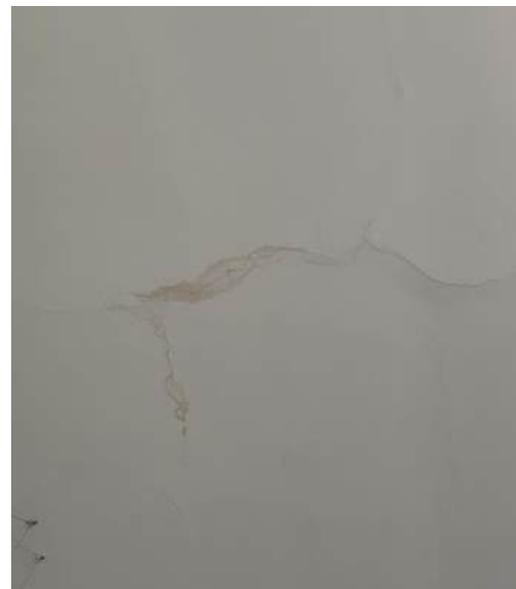
*Figure 102. Possible water ingress visible surrounding fractures.*

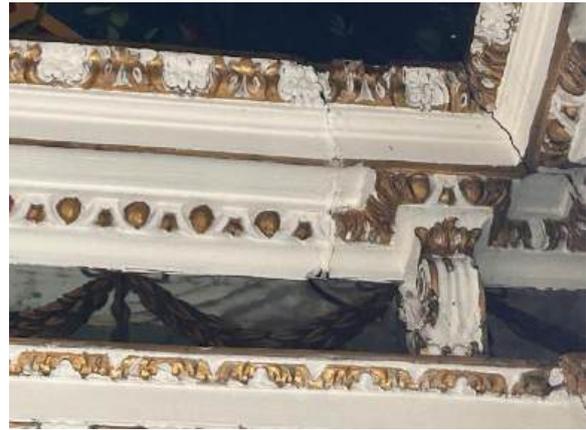
*Figure 106. Crack running through cornice and causing a break in the mirrored frieze panel.*

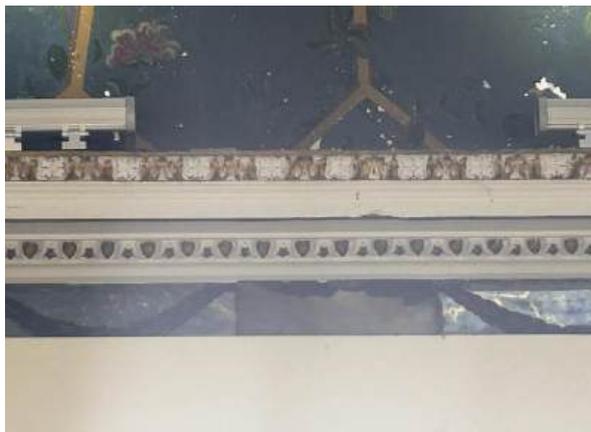
*Figure 107. Loss of mirrored frieze panel.*

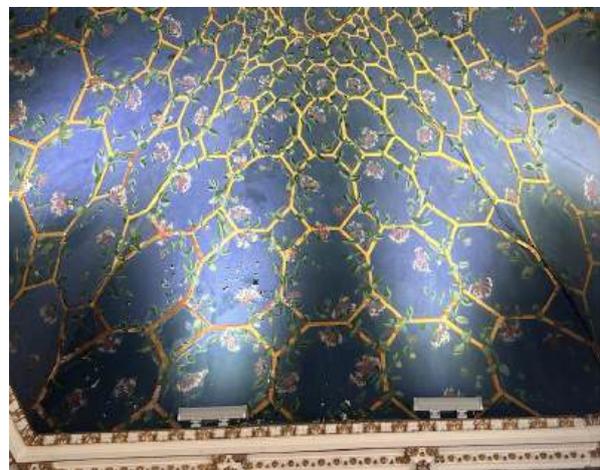
*Figure 110. Loss, flaking, and discolouration visible.*

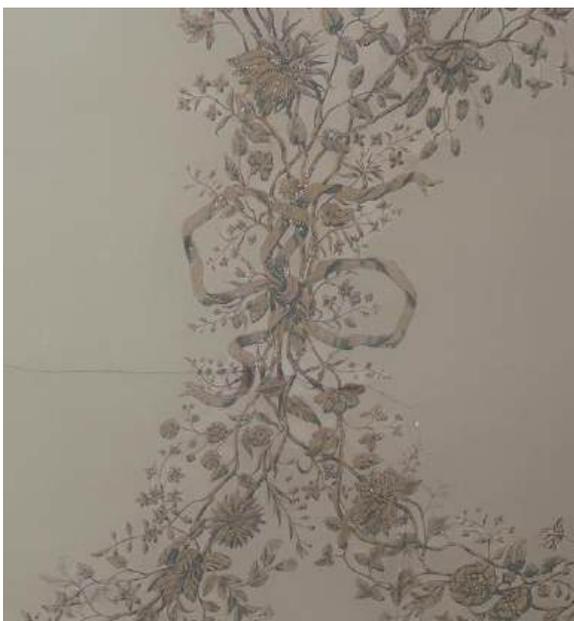
*Figure 117. Paint loss and flaking visible.*

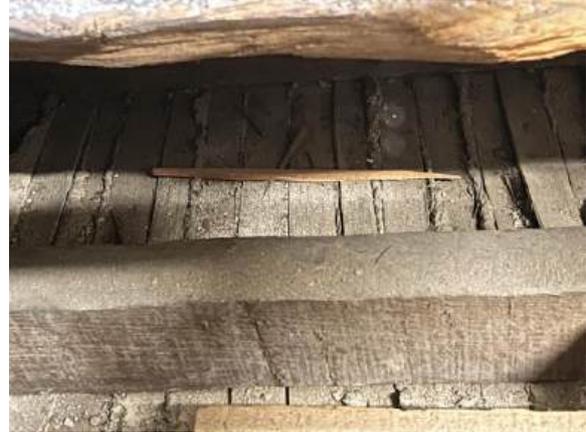
*Figure 120. View of laths and nibs, laths are tight and nibs are sparse.*

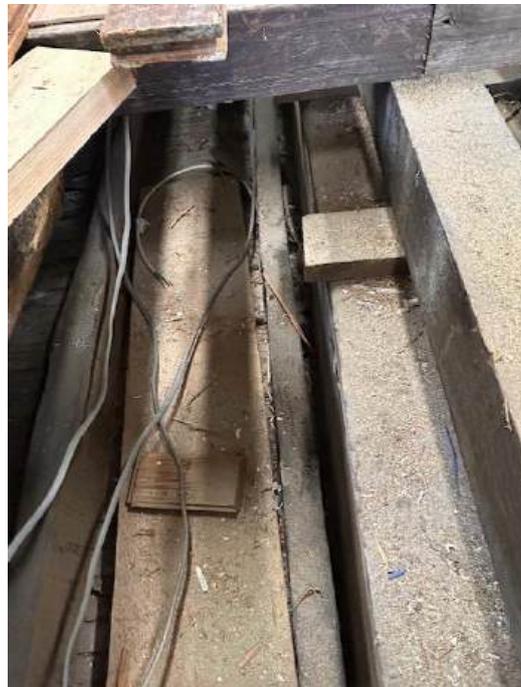
*Figure 121. Timber board seen resting on plaster laths and nibs.*
