ARBORICULTURAL REPORT & Impact Assessment to BS 5837:2012 at:

***St John's Community Centre,
Church Street,
Penistone,
Barnsley,
South Yorkshire
S36 6AR***

Date: August 2020

Reference: AWA3309

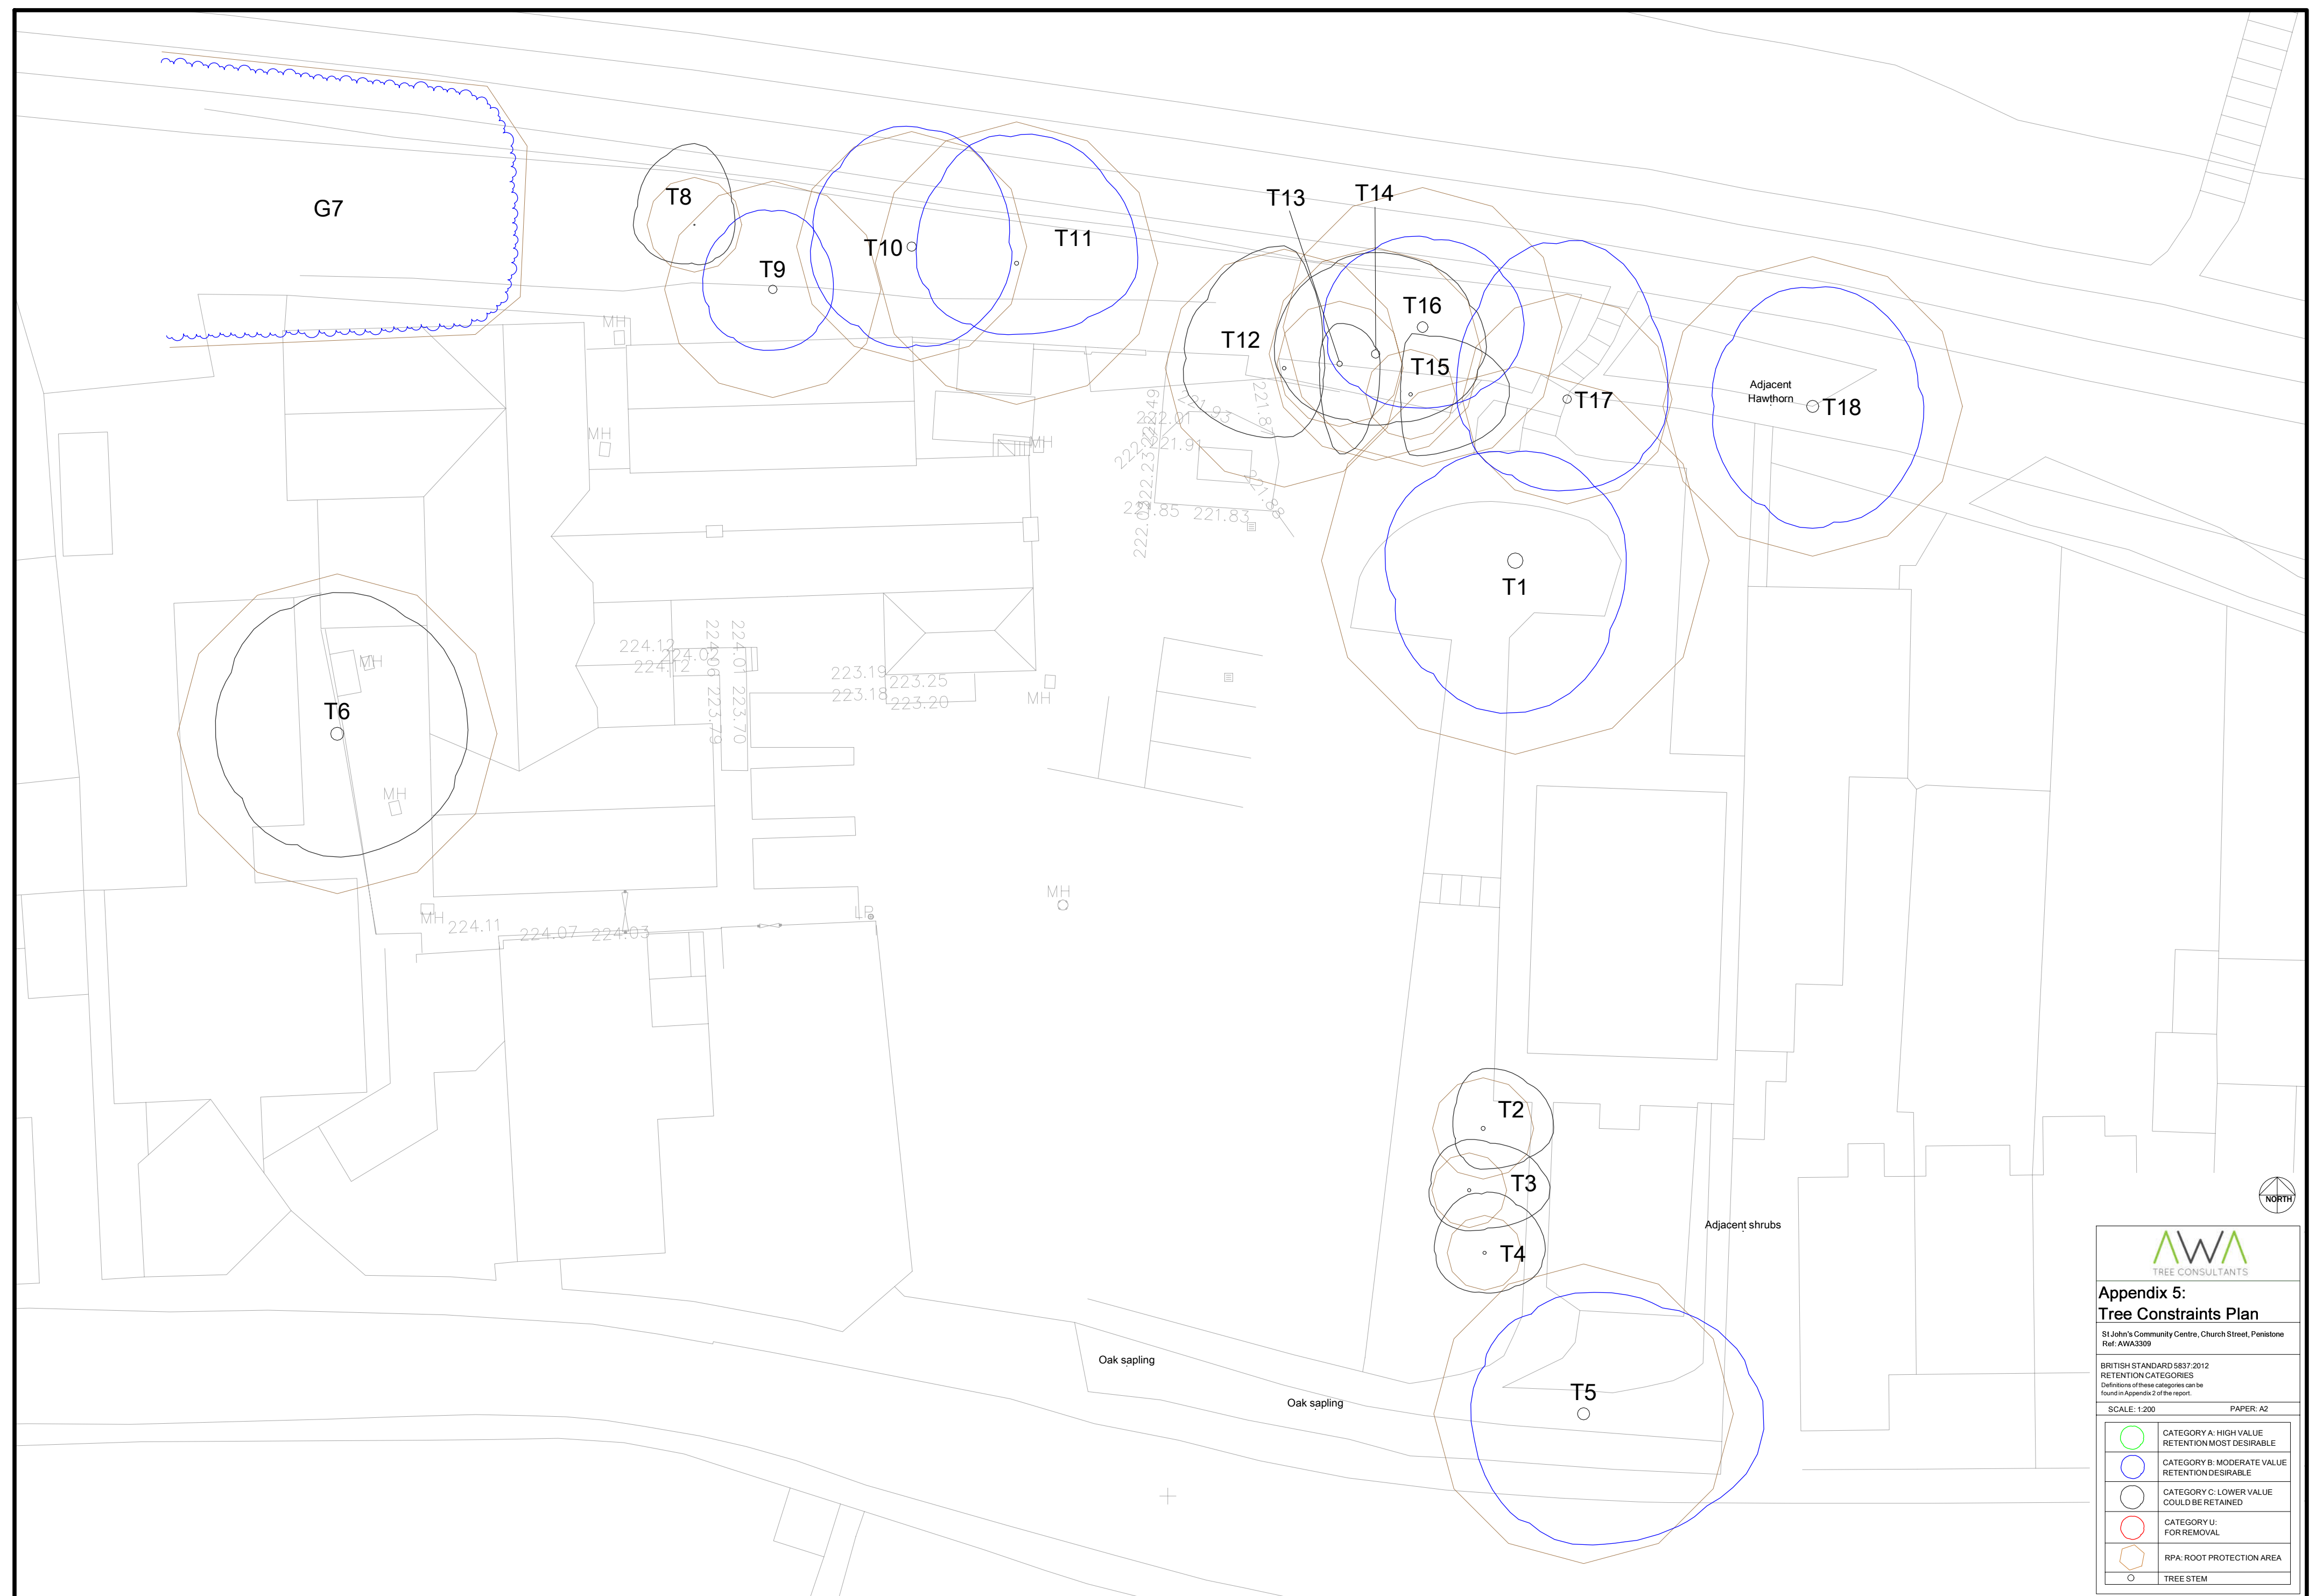
Appendix 5: Tree Constraints Plan

- 3.2.10 Trees G7, T9 to T14 and T16 were covered in dense Ivy which prevented detailed inspections of the trees being undertaken.
- 3.2.11 The tree Root Protection Area (RPA) detailed on the Tree Constraints Plan at Appendix 5 has been used as a layout design tool, to inform on the area around a tree where the protection of the roots and soil structure is treated as a priority.

- 3.2.13 The RPA for each tree has been plotted as a polygon centred on the base of the stem. Due to the presence of roads, structures, topography (and past tree management) the RPA is likely to be a simplified representation of the tree roots actual morphology and disposition. However, detailed modifications to the shape of the RPA would largely be based on conjecture and so have been avoided.

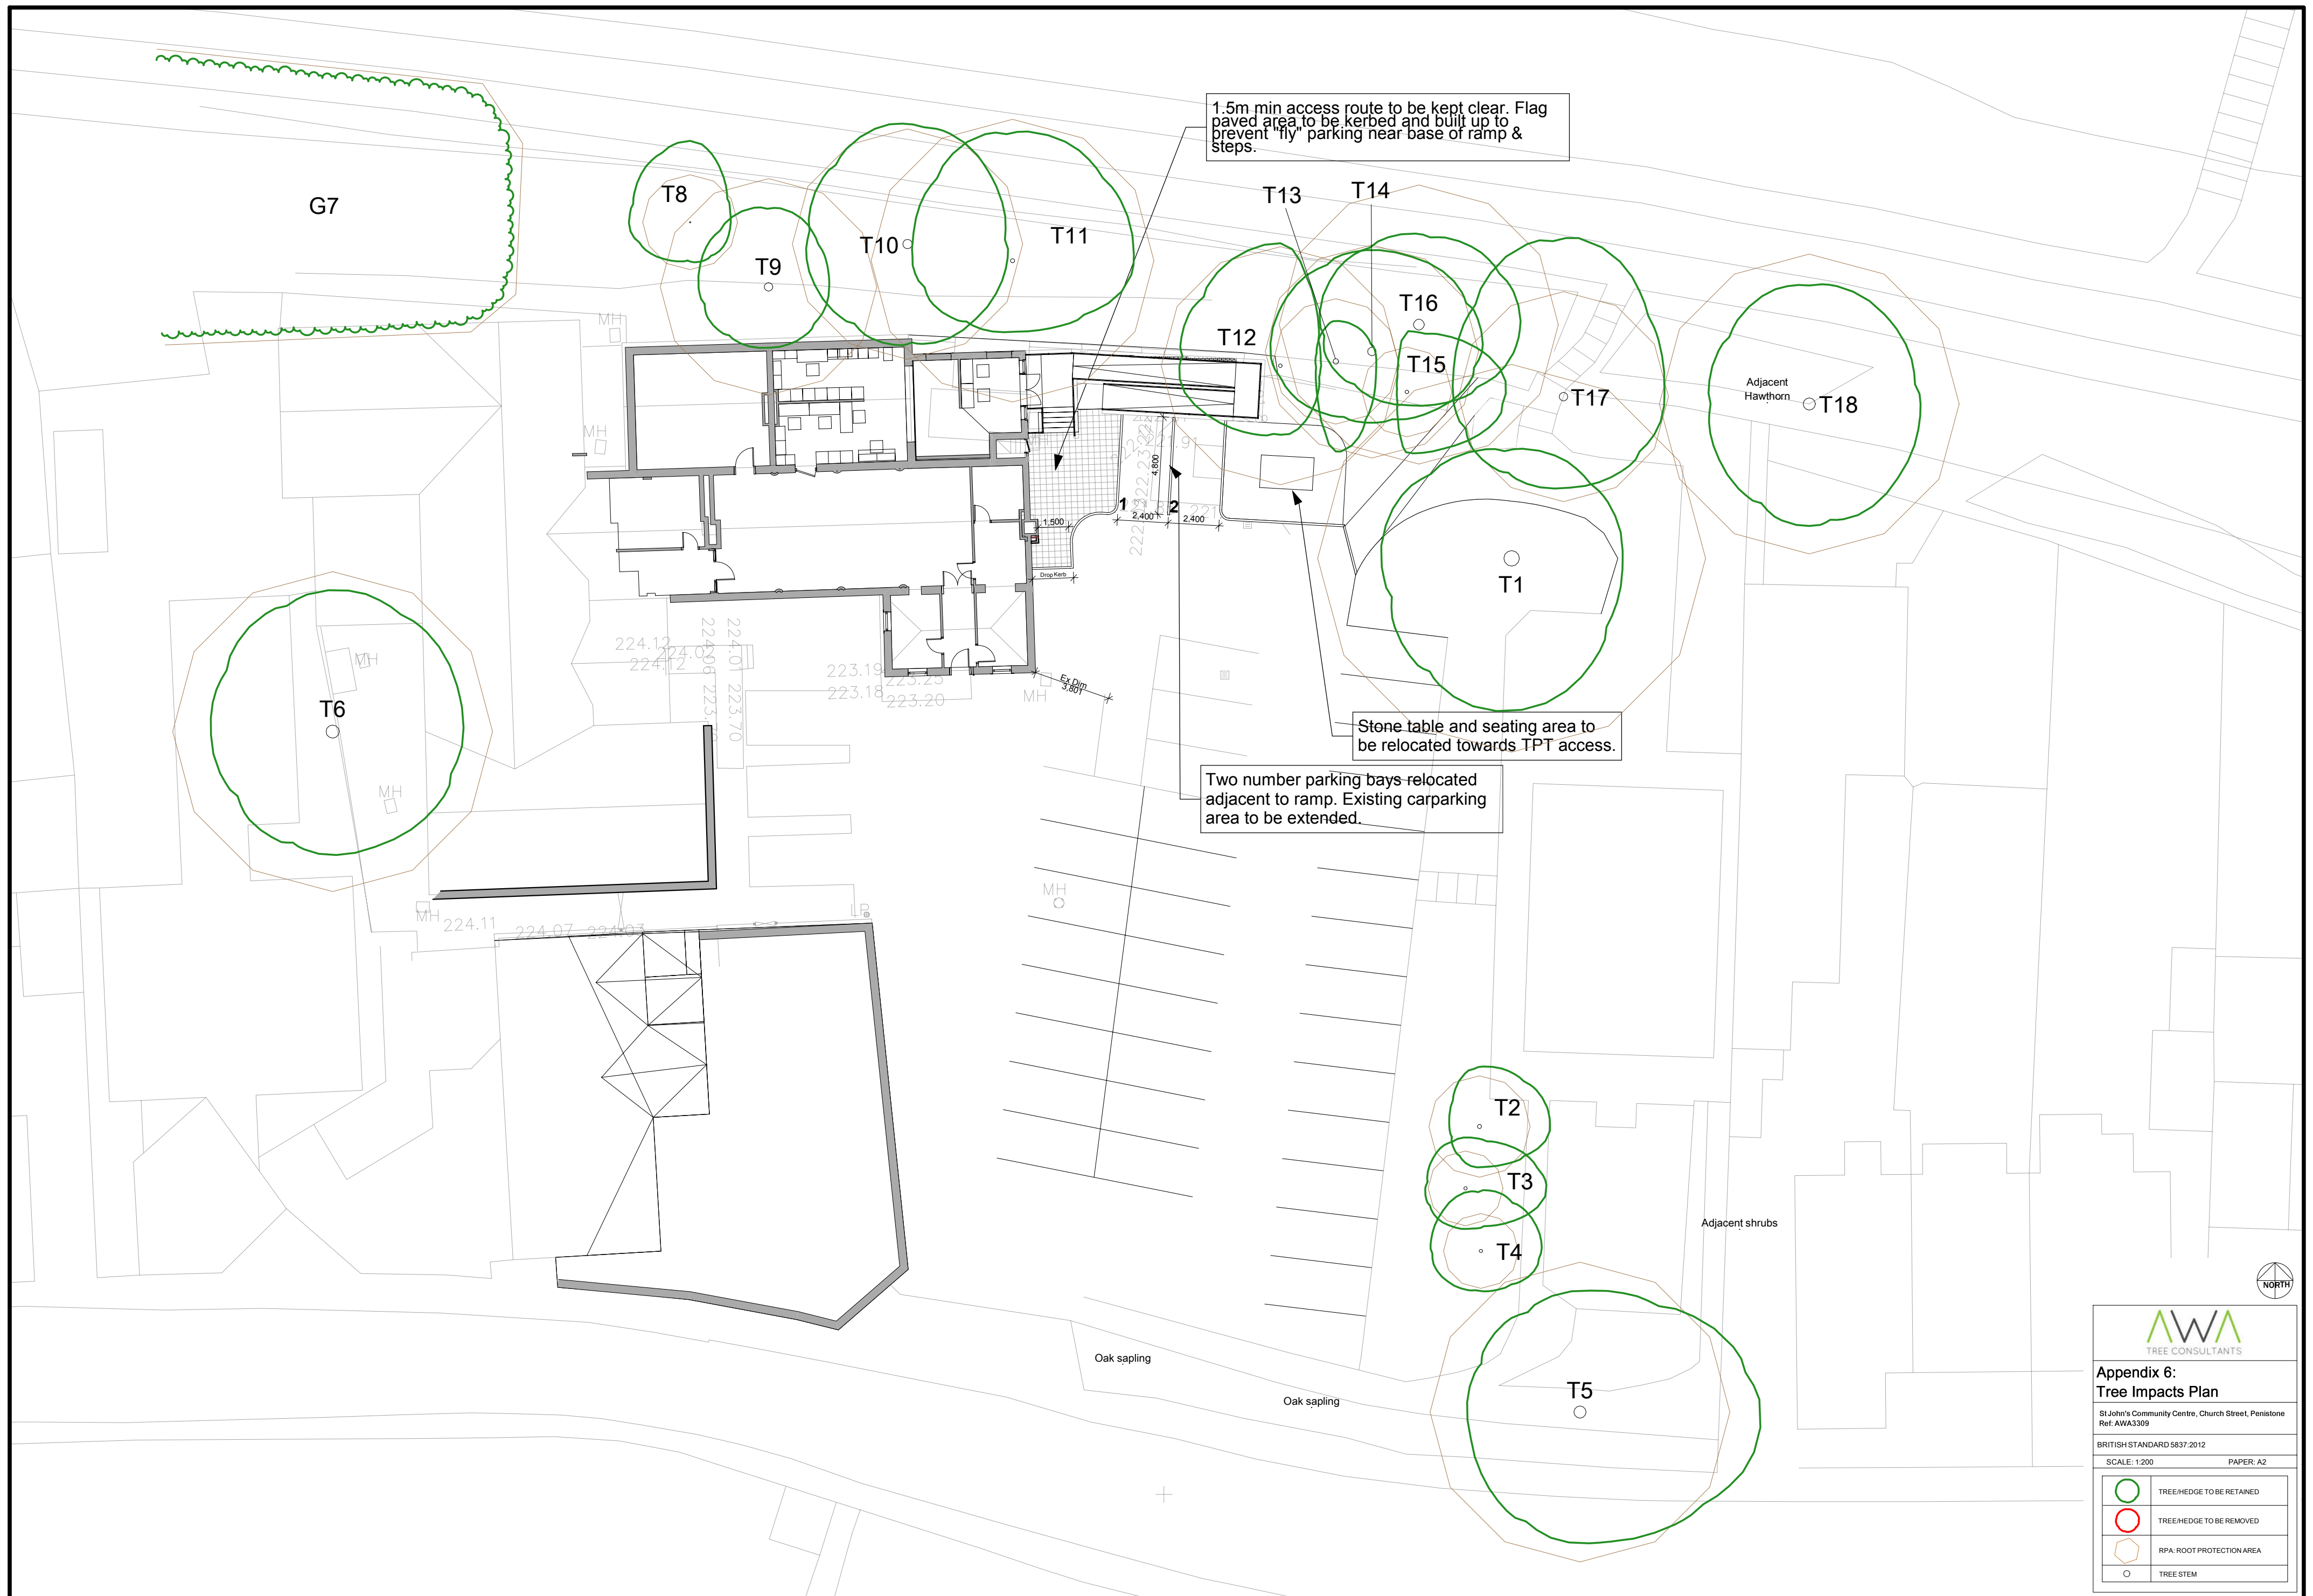
**Appendix 6:
Tree Impacts Plan**

- 4.3.2 Potentially damaging activities are proposed in the vicinity of retained trees. The proposed new extension encroaches into the detailed RPA of the adjacent Ash T10 and Sycamore T11. Construction within the RPA can have negative impacts on tree roots, however, due to the existing brick outbuilding and hardstanding in this area, and the existing brick retaining wall situated between the trees and the site, T10 and T11 should remain largely unaffected by the works, provided care is taken during construction.

- 4.3.3 The proposed new access ramp is situated within the RPA of the adjacent Sycamore T11 and Ash T12, however, due to the existing hardstanding in this area, and the existing brick retaining wall situated between the trees and the site, T11 and T12 should remain largely unaffected by the works, provided care is taken during construction.

- 4.4.1 The retained trees may require protection by fencing in accordance with

BS 5837: 2012, during the development phase.

- 4.4.2 If required by the Local Planning Authority, an associated Arboricultural Method Statement, detailing protective fencing specifications and construction methods close to the retained trees can be provided.
