Far Westhorpe Farm
Heritage Statement
Historic Barns -
Work to the roof covering and
external walls etc
24-001-303

Revision B – Issued for approval 18-02-26

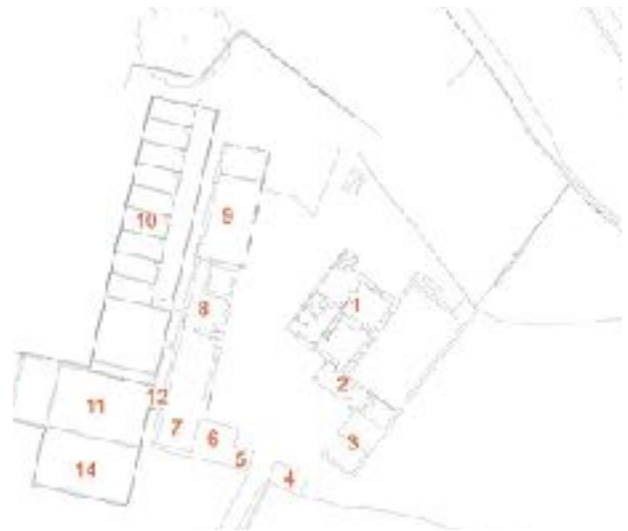
Figure 6 (top) - Location of buildings identified by number in **Table 1** above.

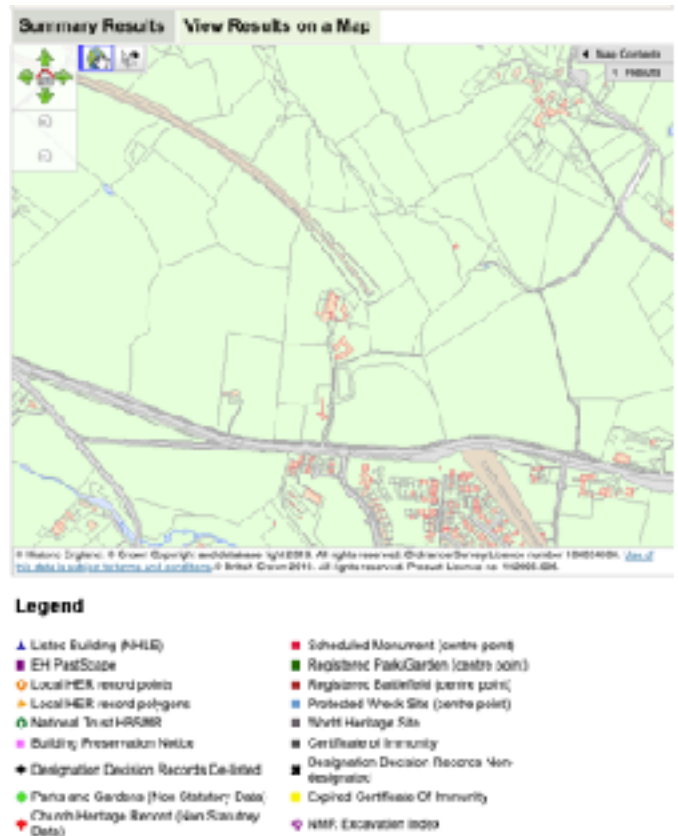
Figure 22 - on-line mapping showing the area within 500m of the site (source the Heritage Gateway)

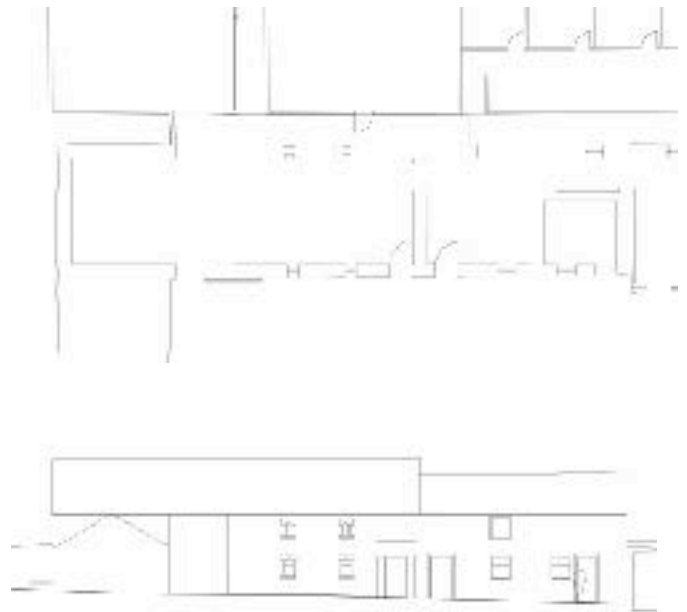
section and elevation, and photographed to record the overall arrangement and details, to enable rebuilding to match the original as closely as possible.

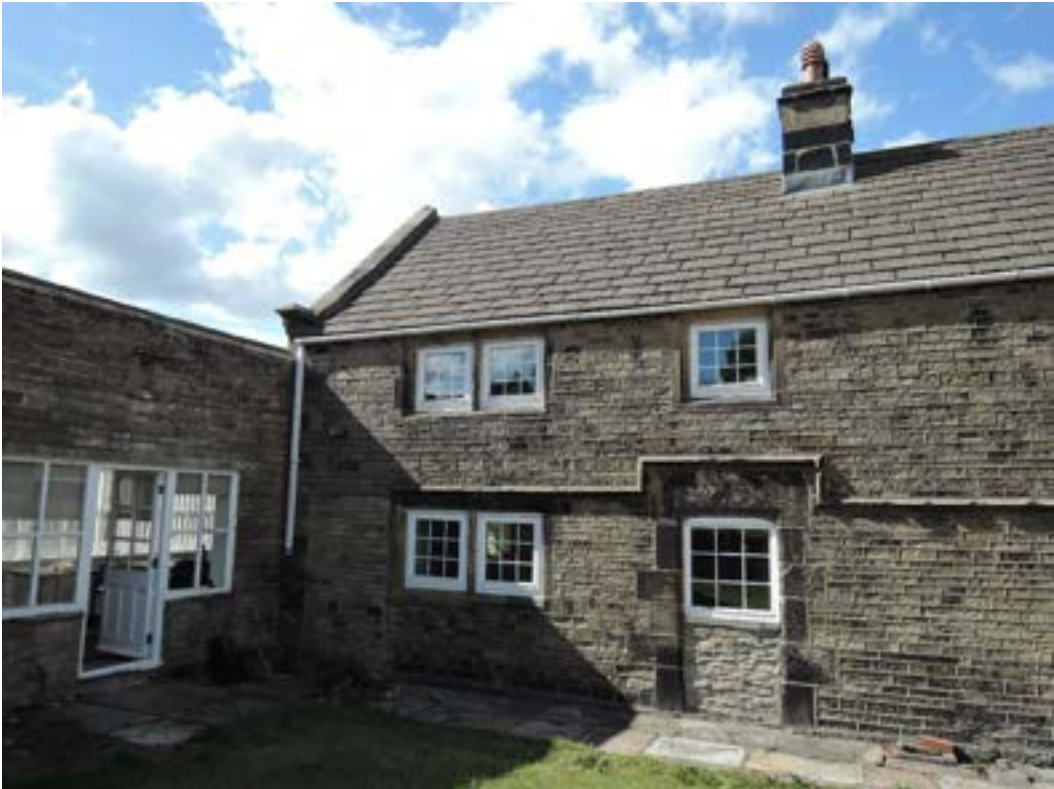
Left end of garden elevation. Extension on left to be replaced

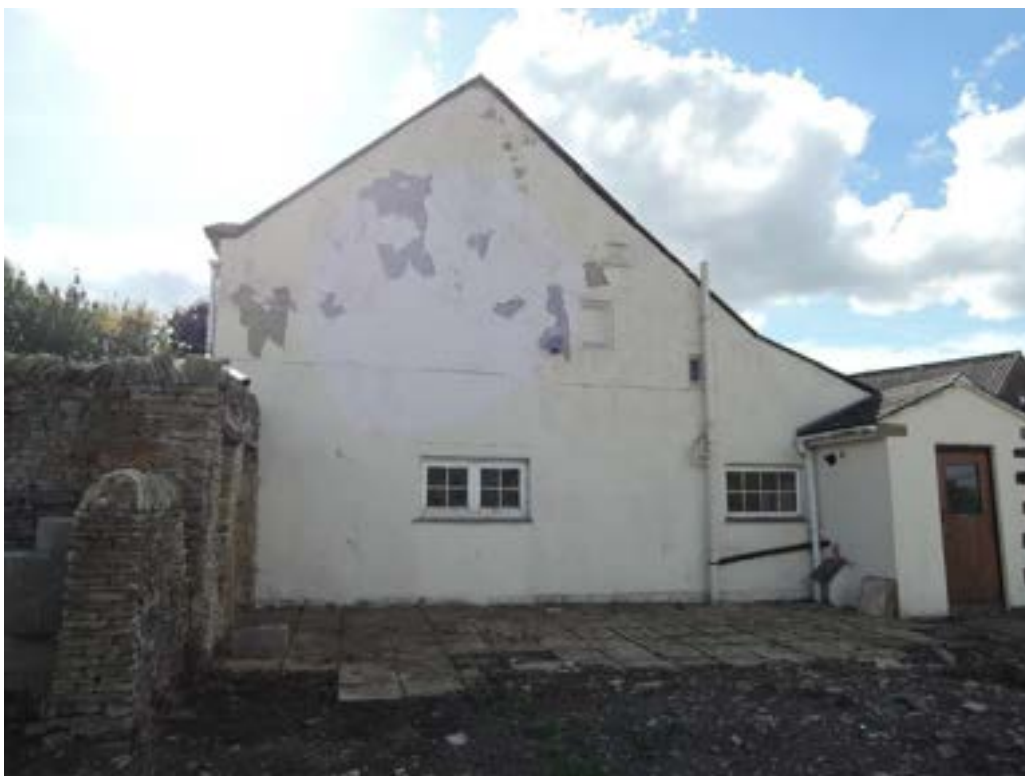
Northeast gable. Tired and peeling paint/render but no major cracks or bulging apparent.

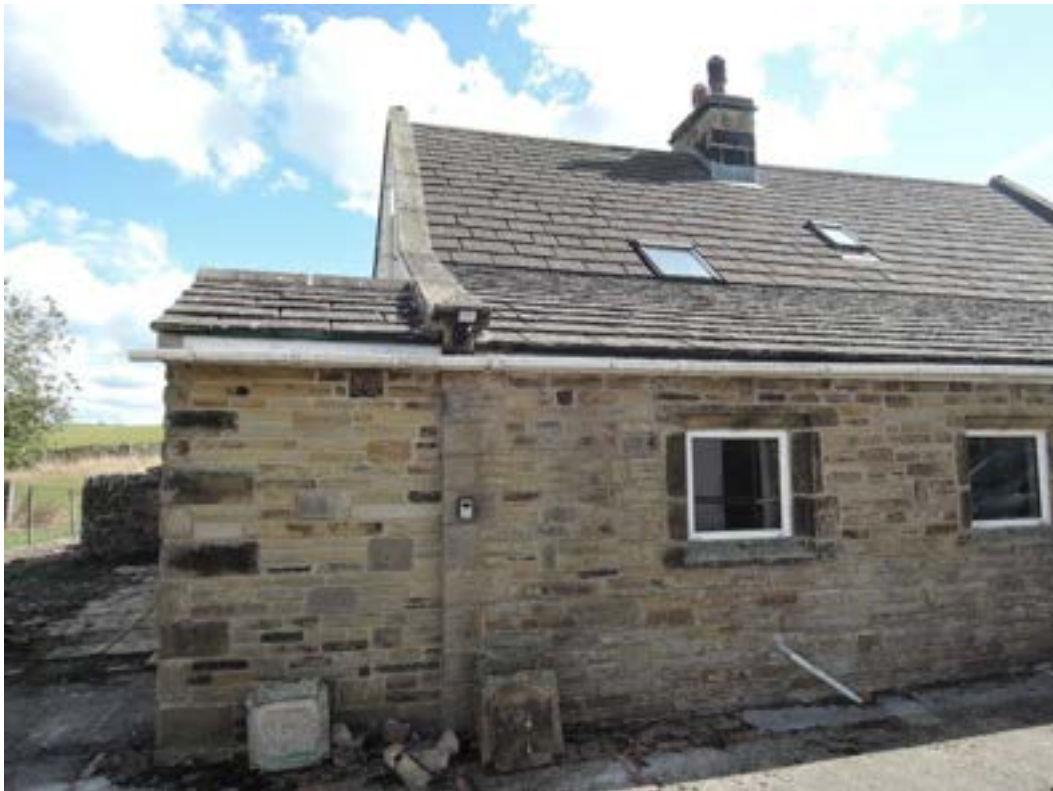
Farmyard side, single storey extension.

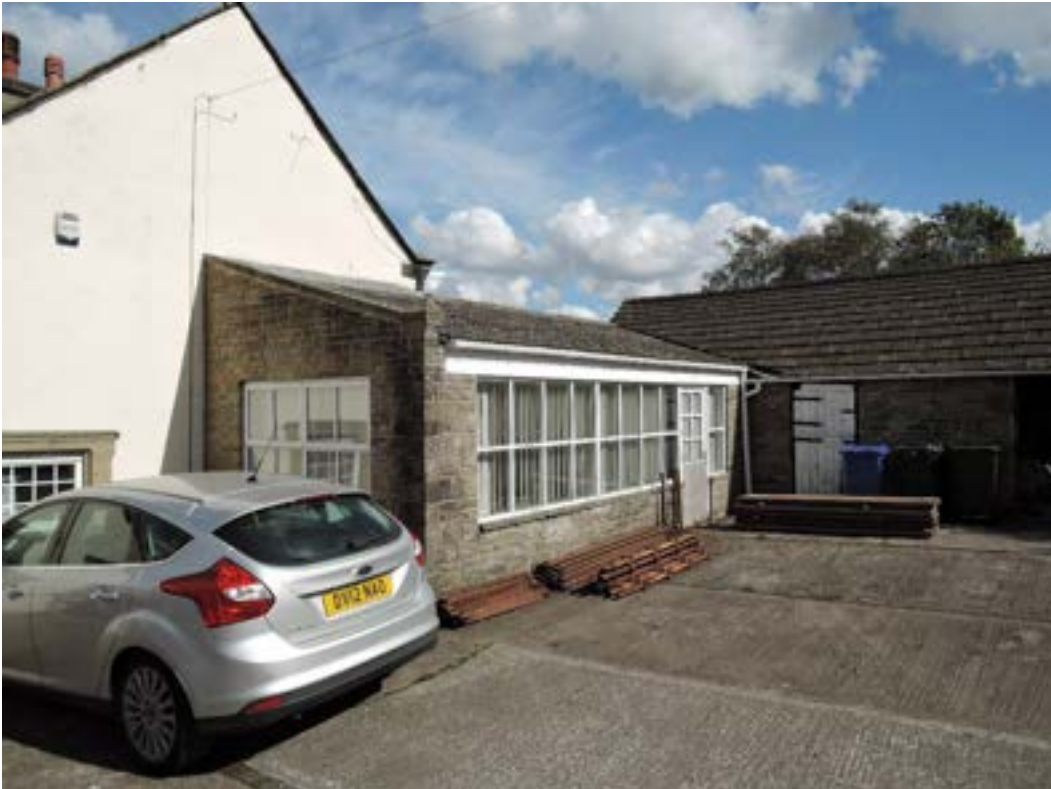
Single storey extension in yard, to be replaced.

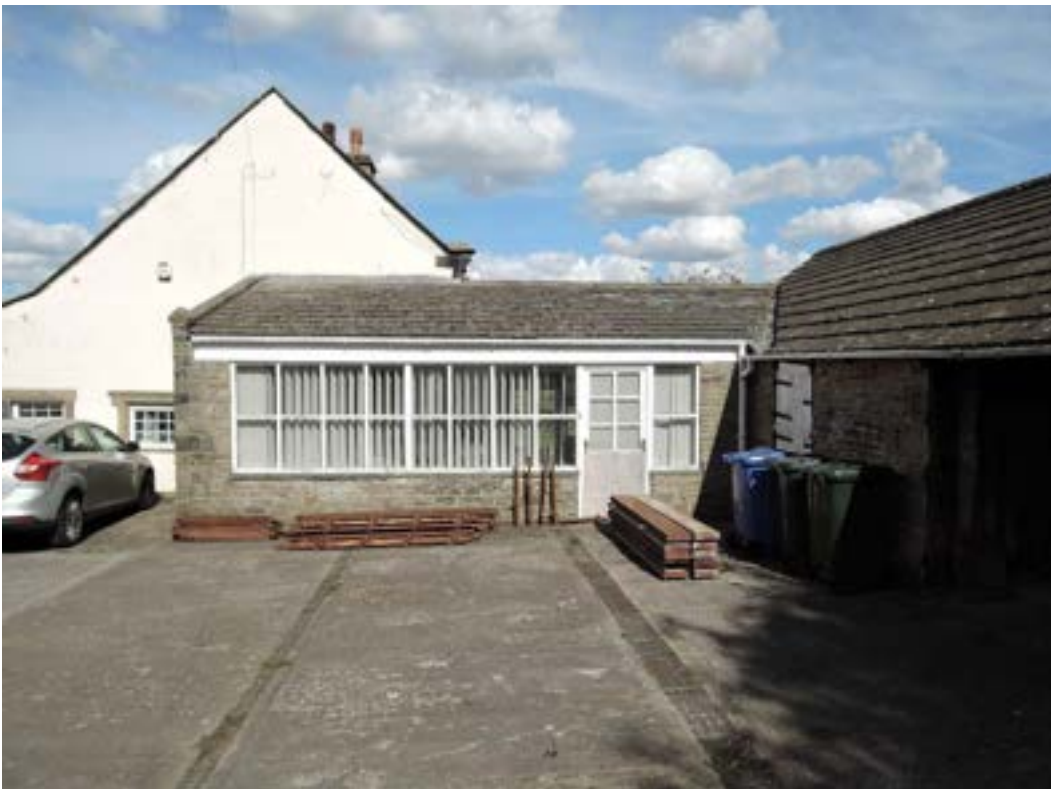
Single storey extension in yard. Cottage gable in good order

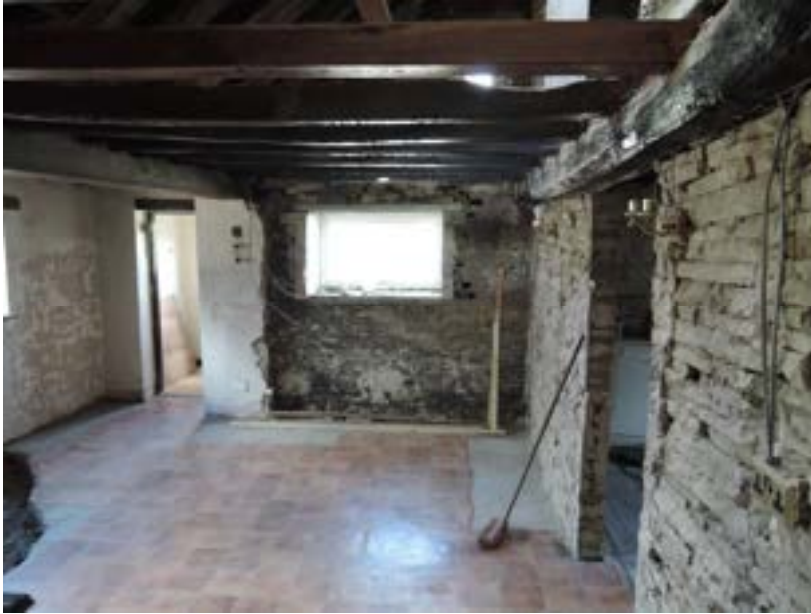
Kitchen. Non load bearing walls unstable under beam on right a touch unstable as they are loosely constructed and have informal head restraint. Take down and rebuild in blockwork as required.

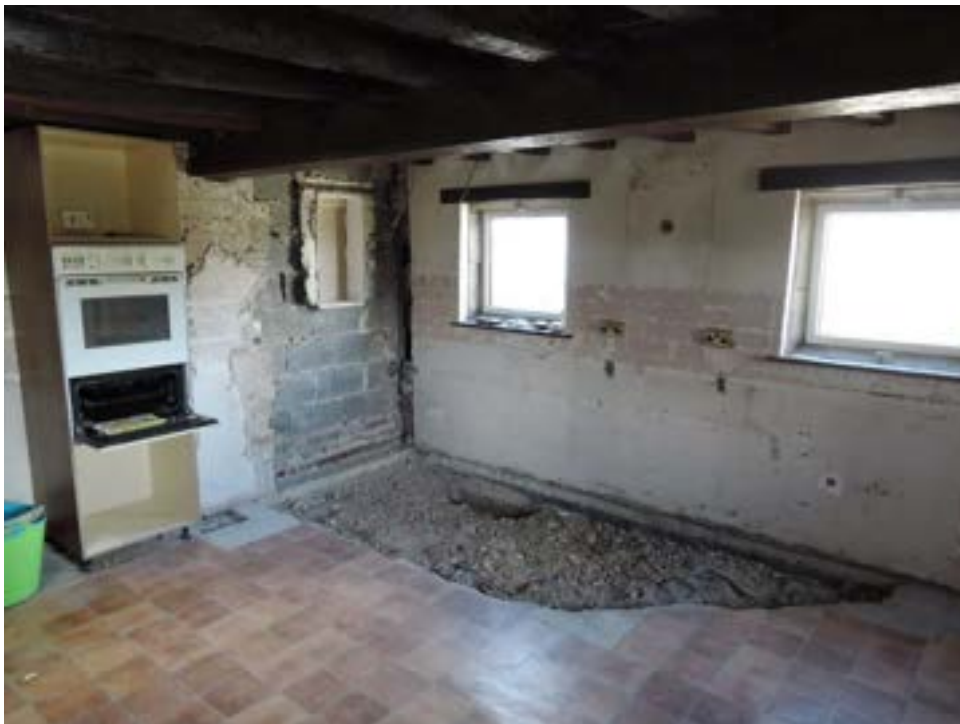
Kitchen: Trial pit revealing foundation to single storey extension

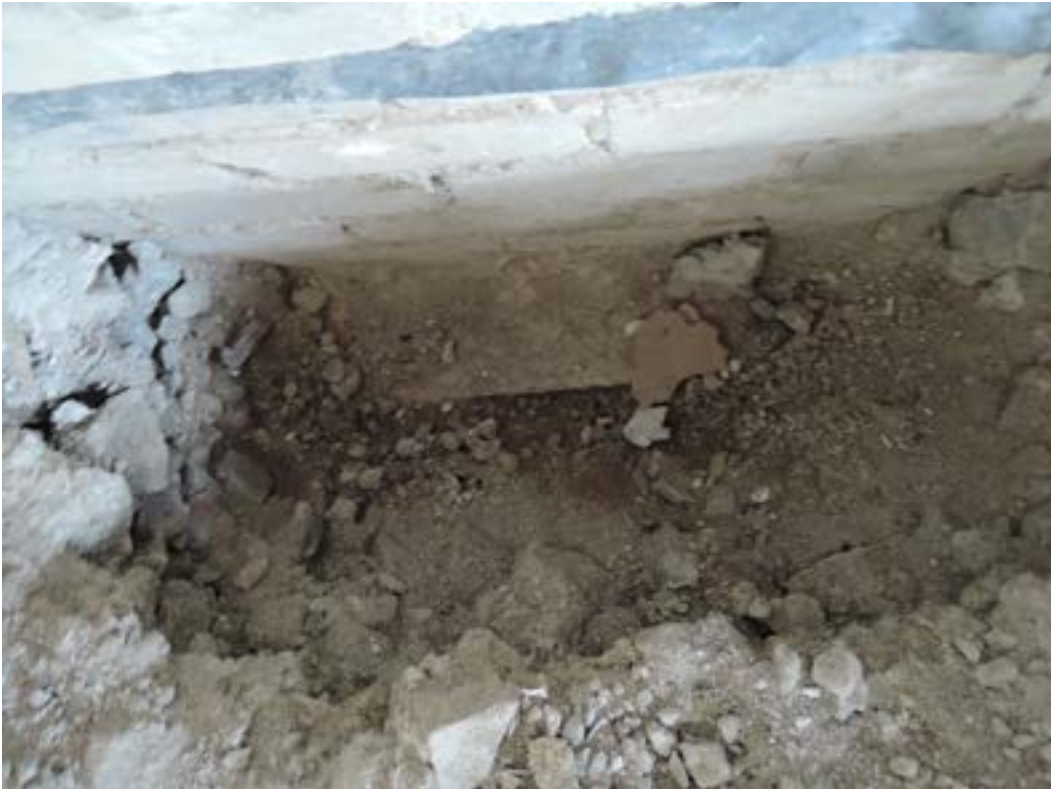
Trial pit showing foundation as concrete with 150mm projection at 300mm below slab. Foundation approx. 500mm – 600mm wide overall and therefore has capacity to support another proposed storey.

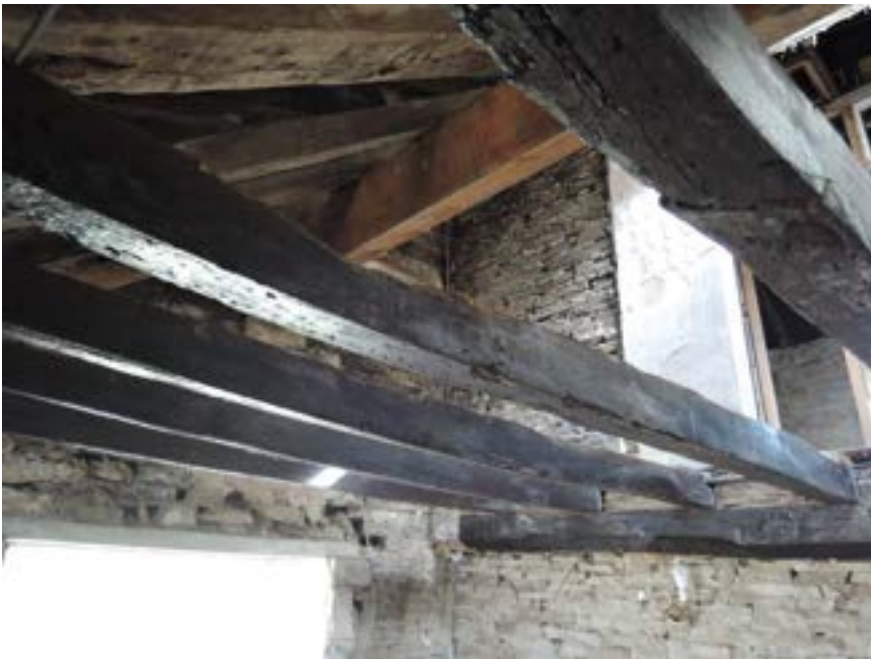
First floor (bathroom) joists over kitchen require replacement

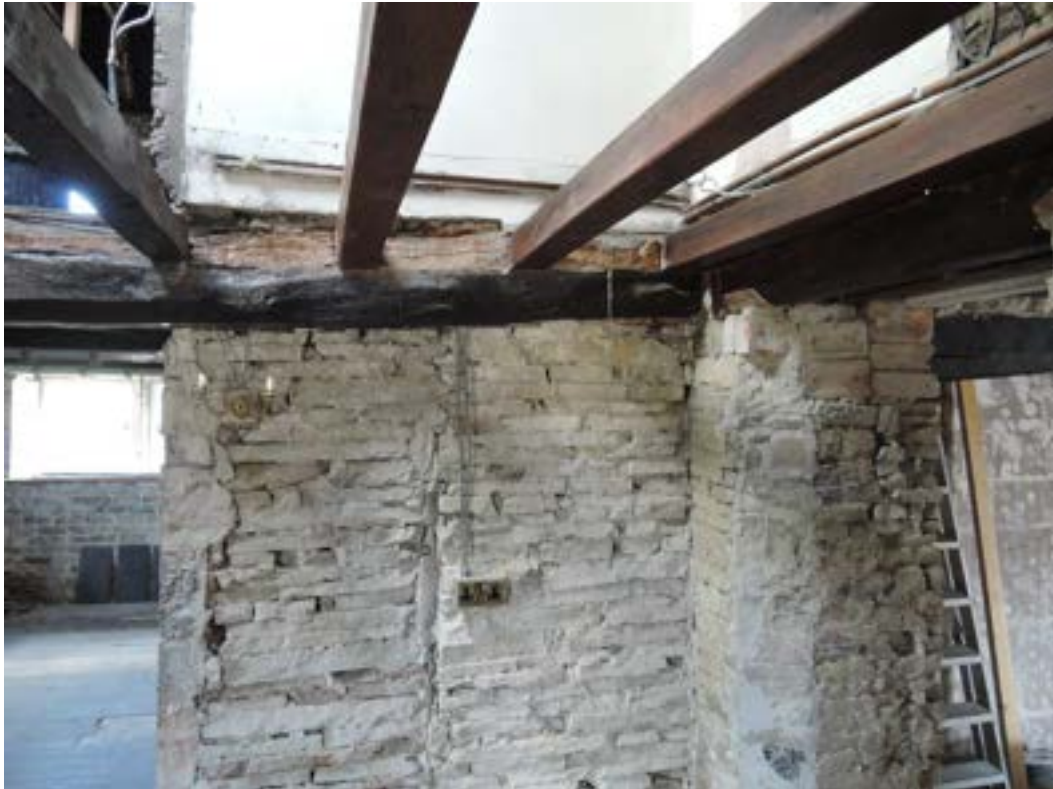
Beam with woodworm on kitchen/dining wall line. Unstable non load bearing wall (see comments under top photo page 9)

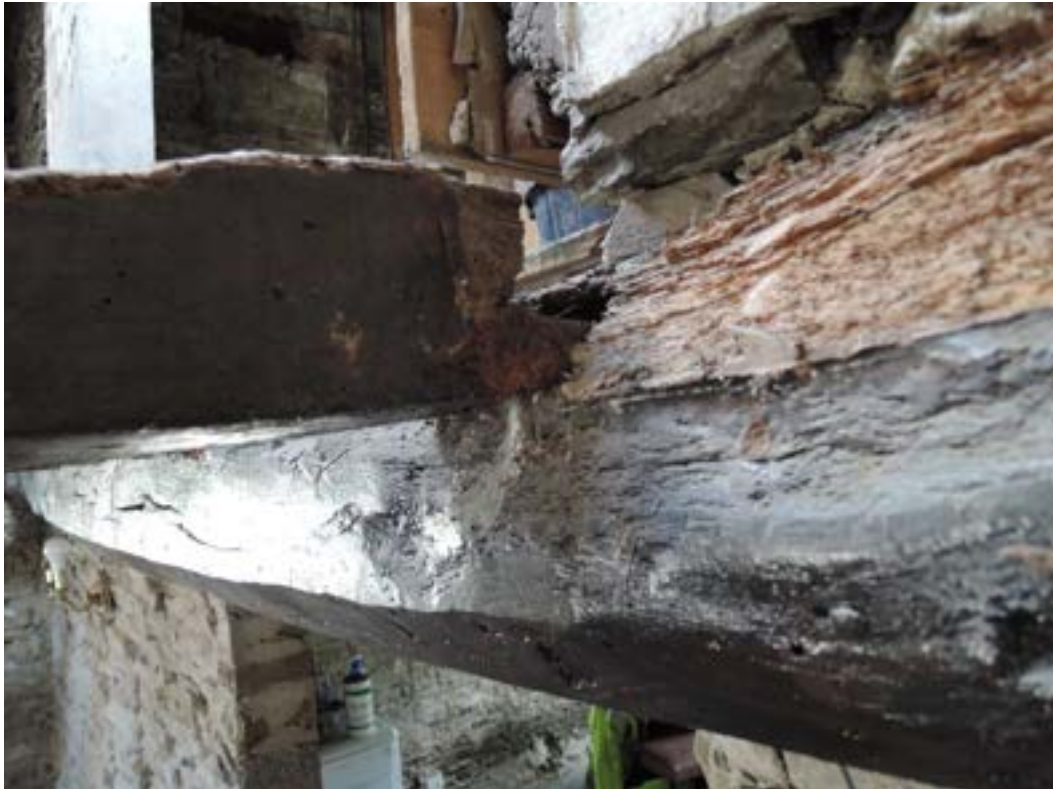
Joist end about to fail (several joists in this state)

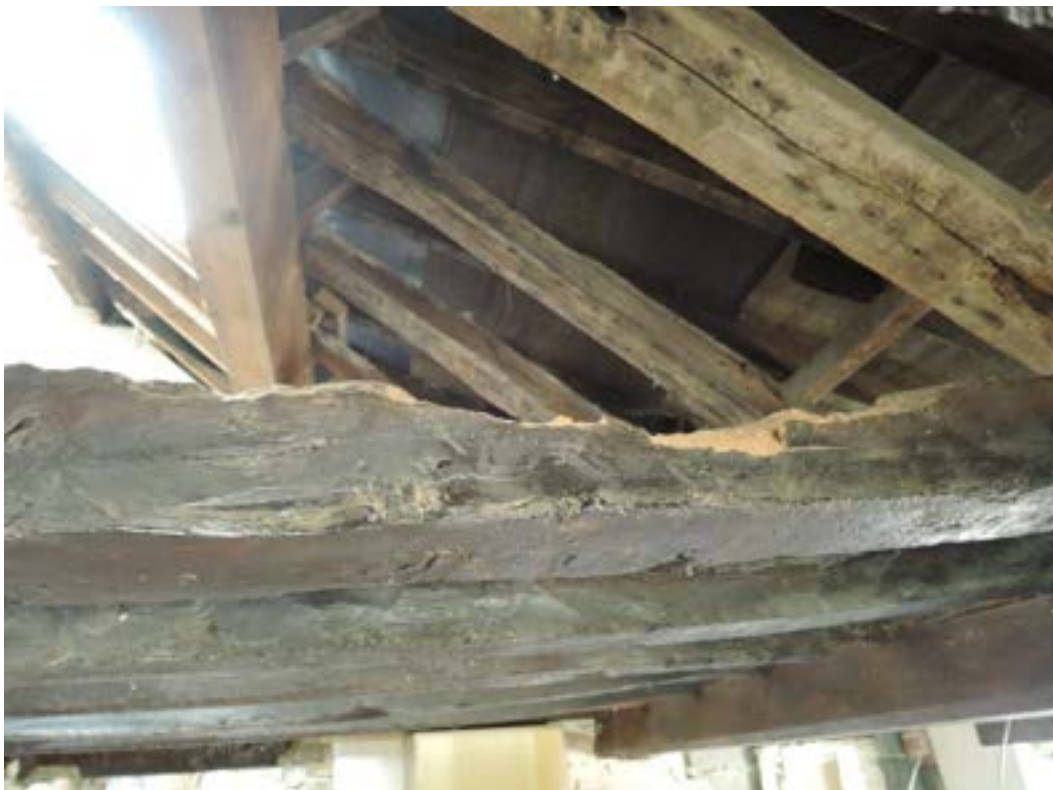
Timber mass losses due to insect attack.

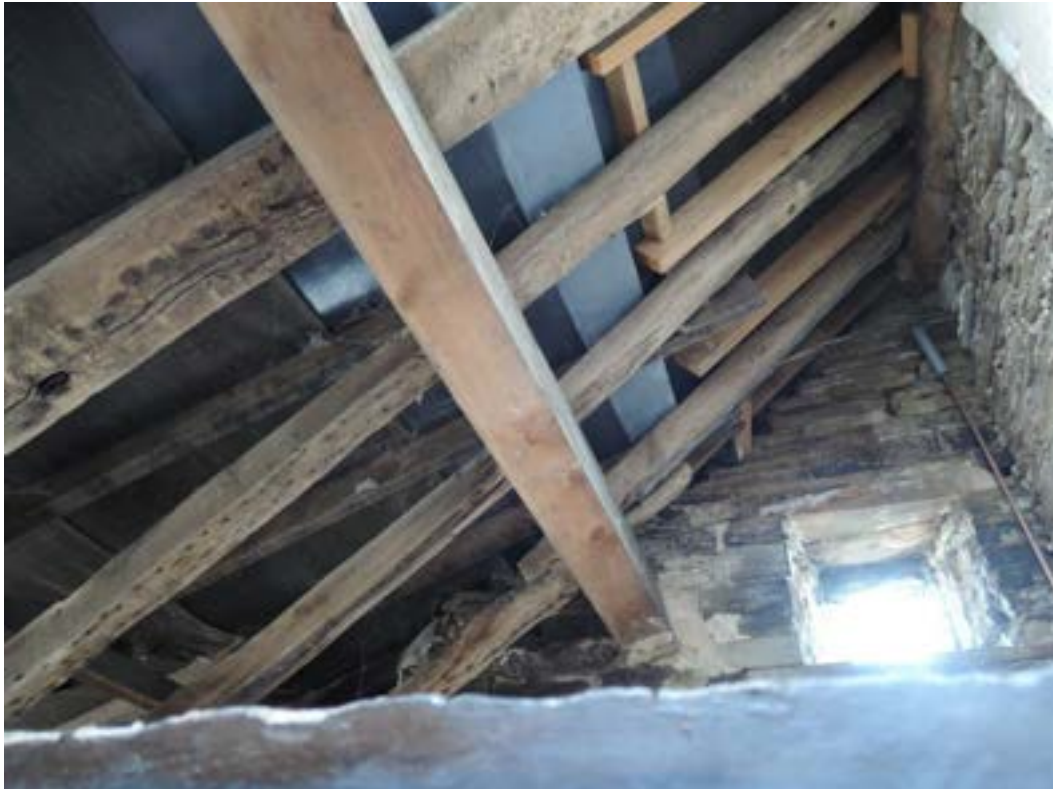
Roof over OK but to be replaced with new storey

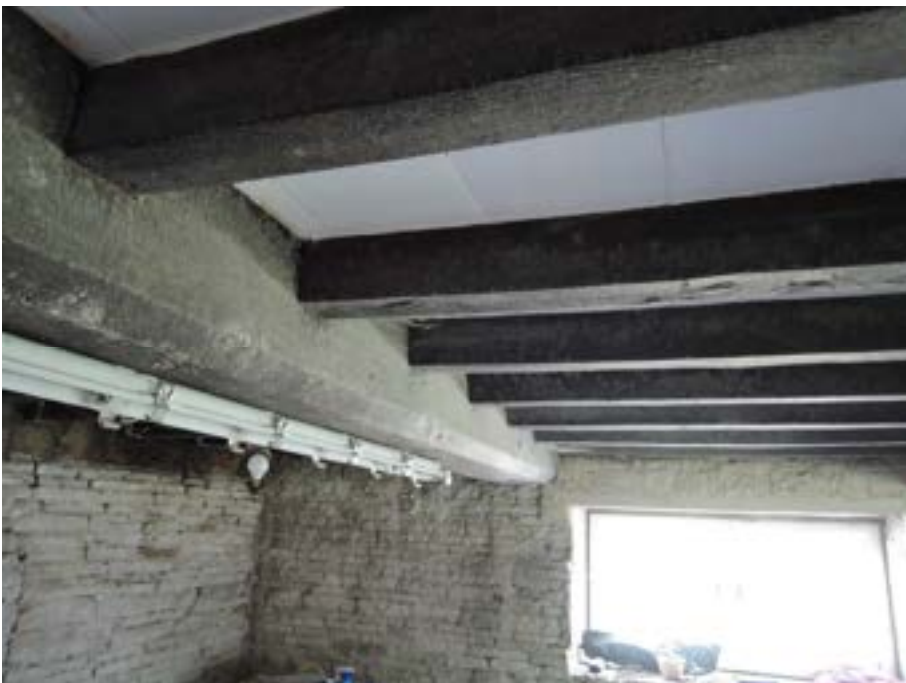
Dining room ceiling. First floor joists and beams in good order (subject to specialist inspection for rot/insect attack). Acceptable bounce under drop heel test.

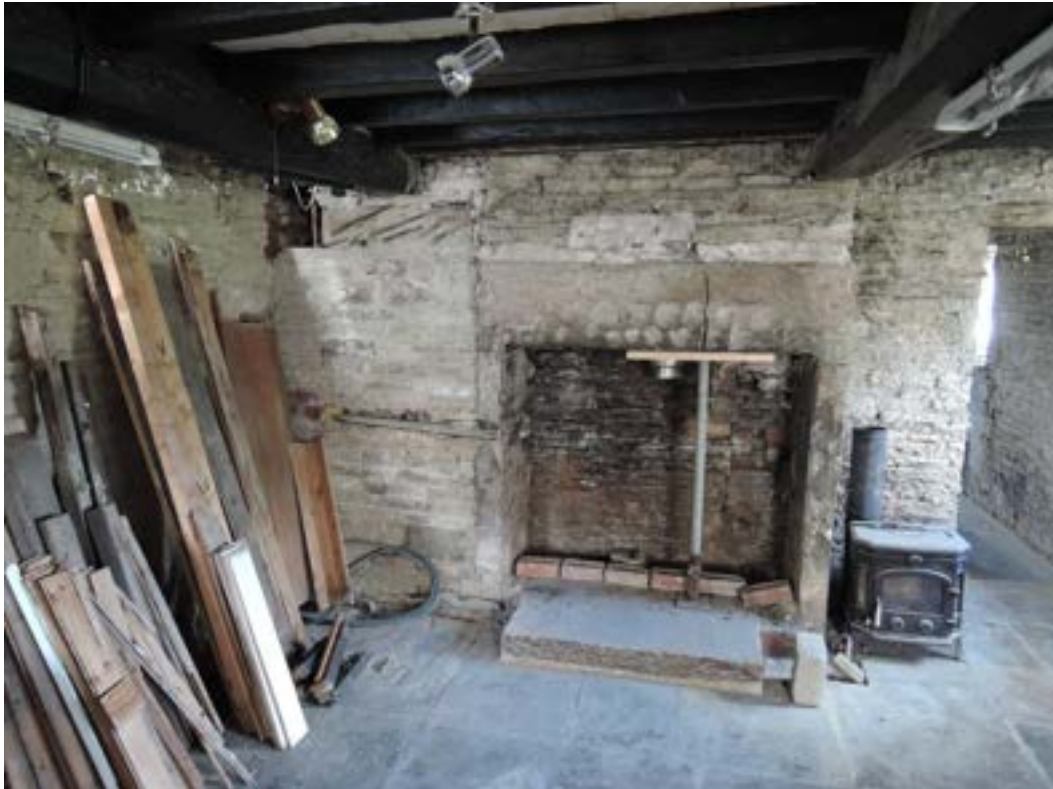
Living room fireplace. Cracked mantel stone with acrow prop. Right cheek wall has yielded out to the right following bending failure of mantel.

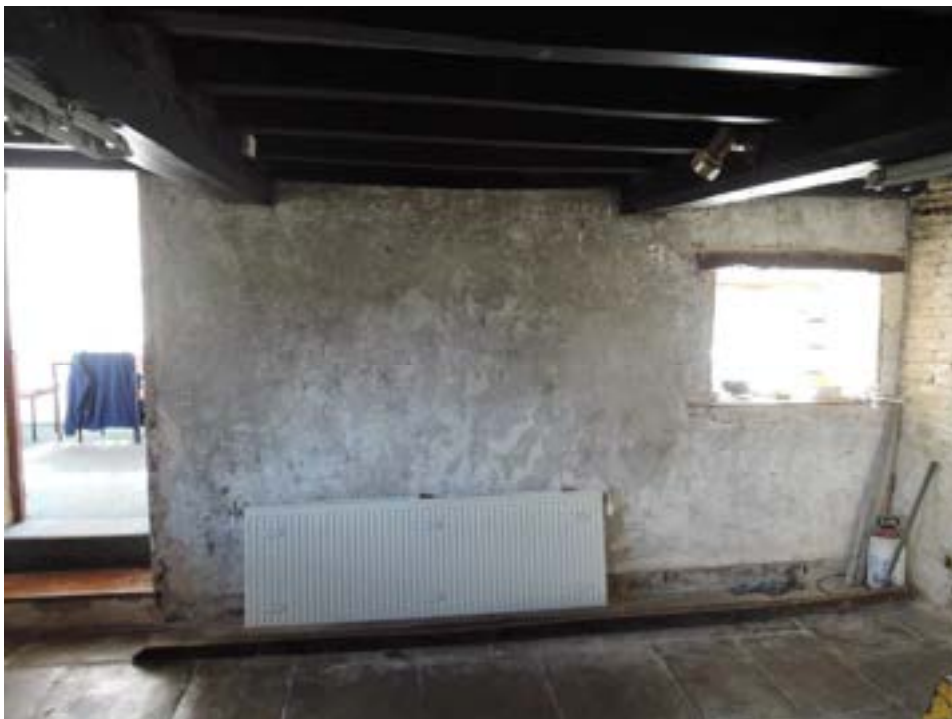
Dining room rear wall looking southwest.

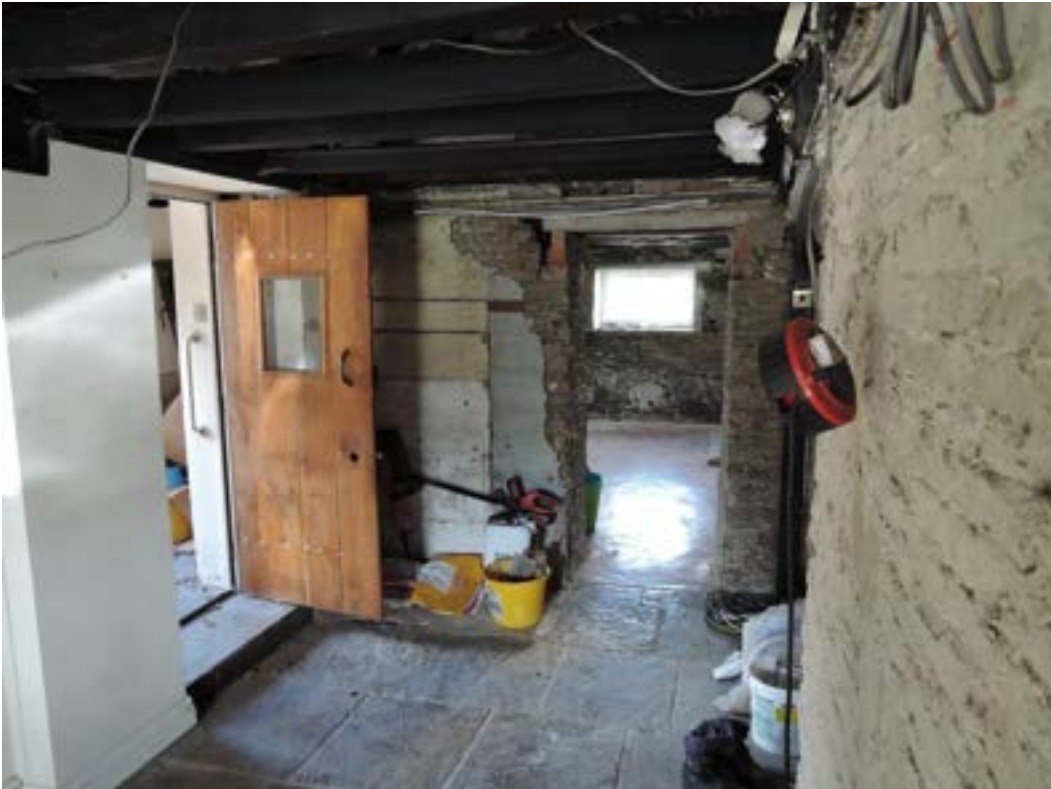
Hallway. Joists over to be replaced in new first floor works

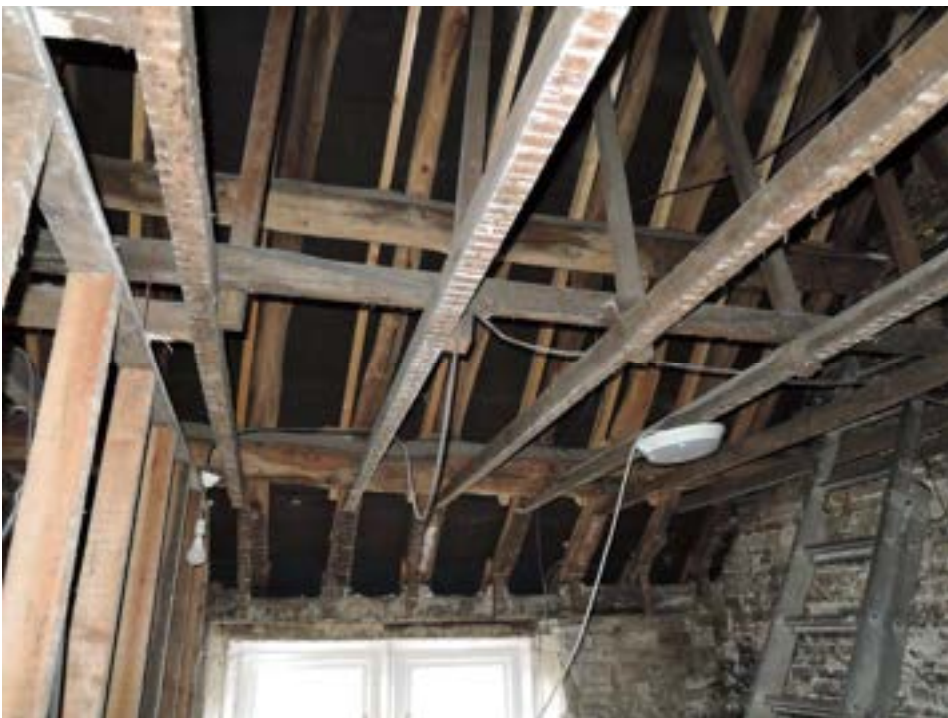
Roof over existing first floor bedrooms. Dry and weathertight. Specialist inspection recommended to check for fungal and insect attack.

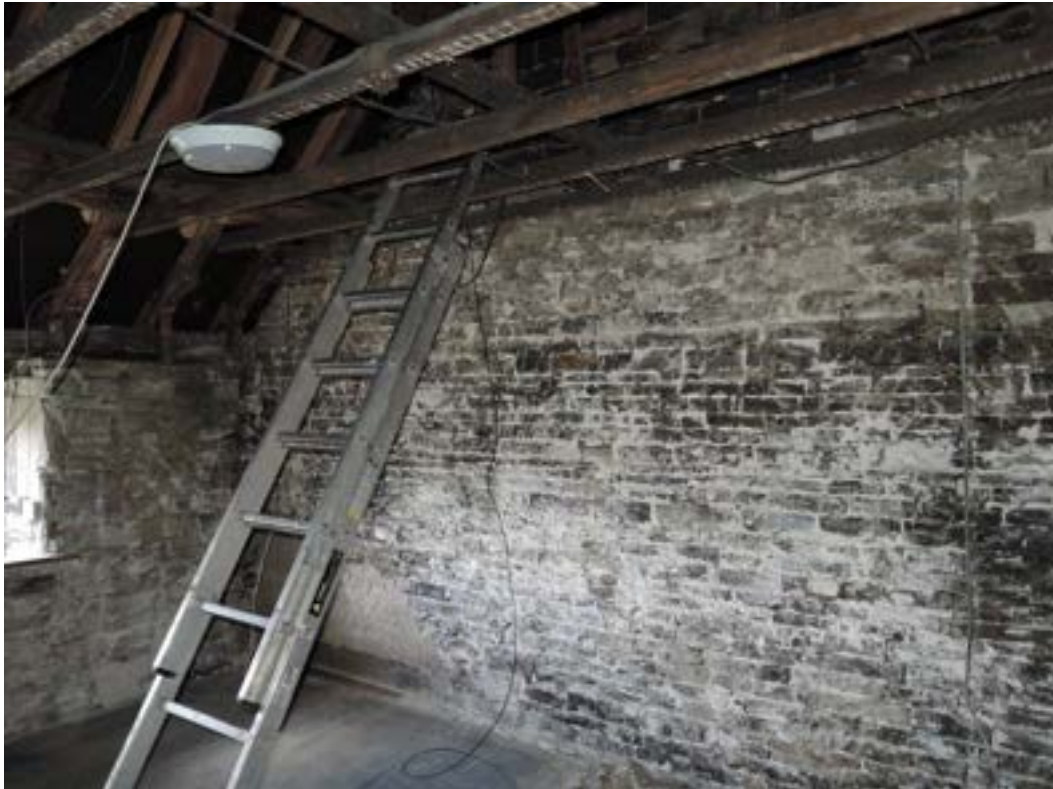
Inside southwest gable

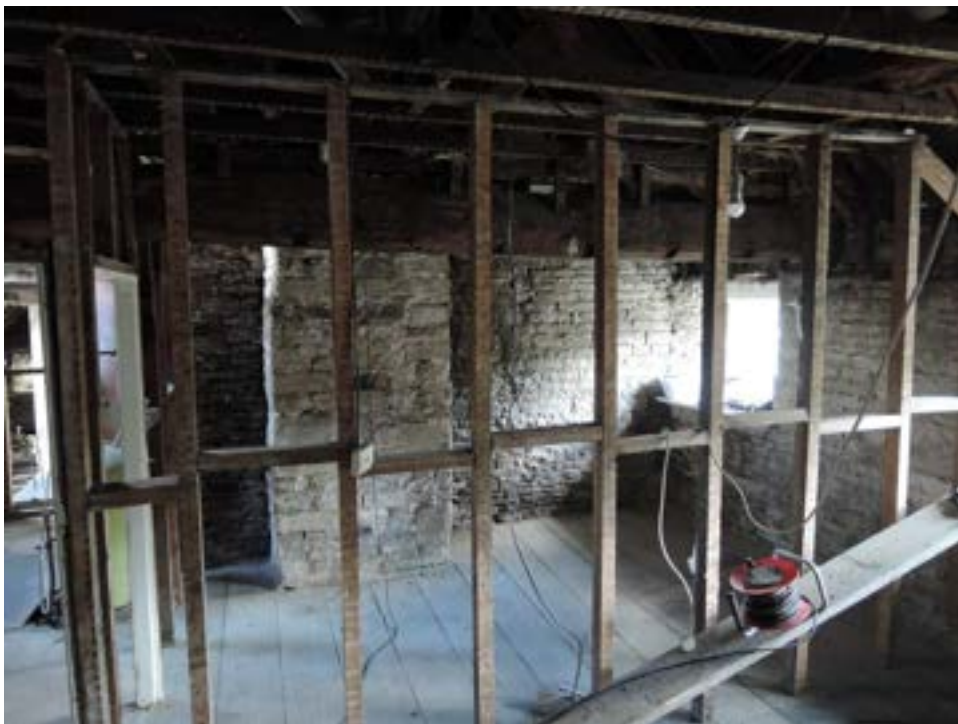
Stone flue from living room below (with cracked mantle). Terminates at ceiling and goes sideways into original chimney

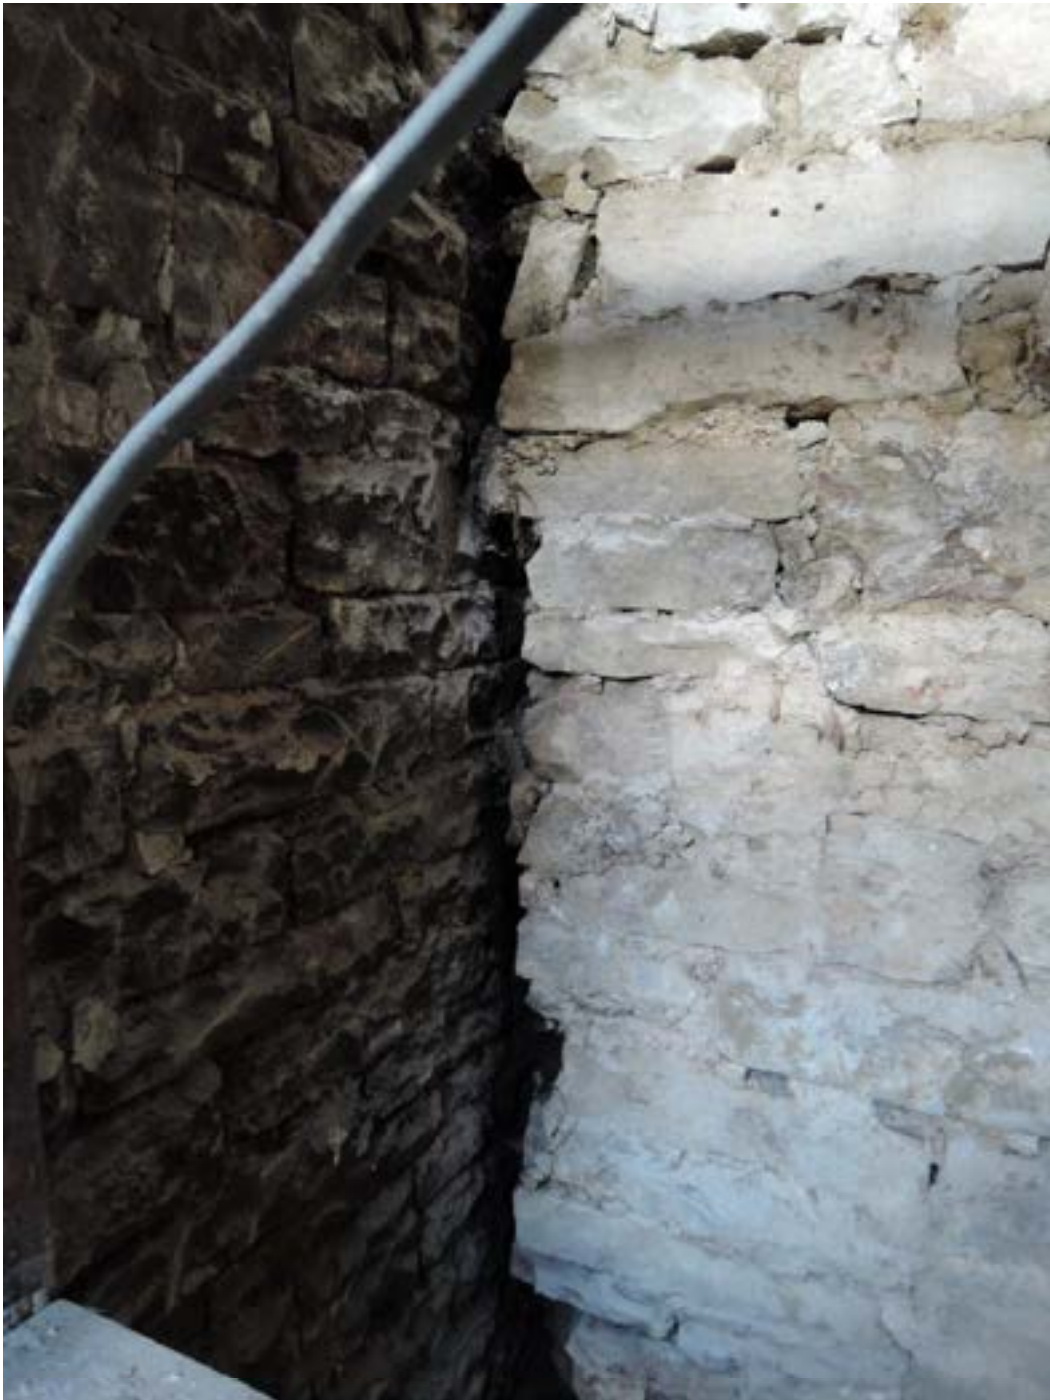
Stone flue left side not bonded into wall

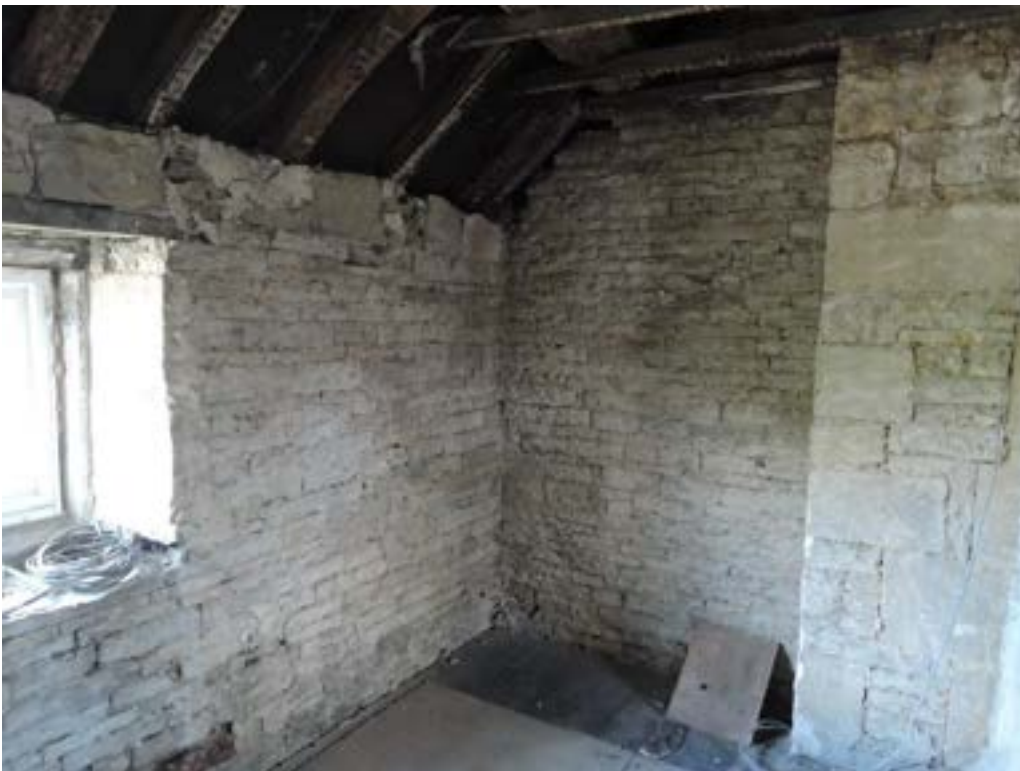
Garden side bedroom wall. Loose stones at head need looking at. Replace timber lintel.

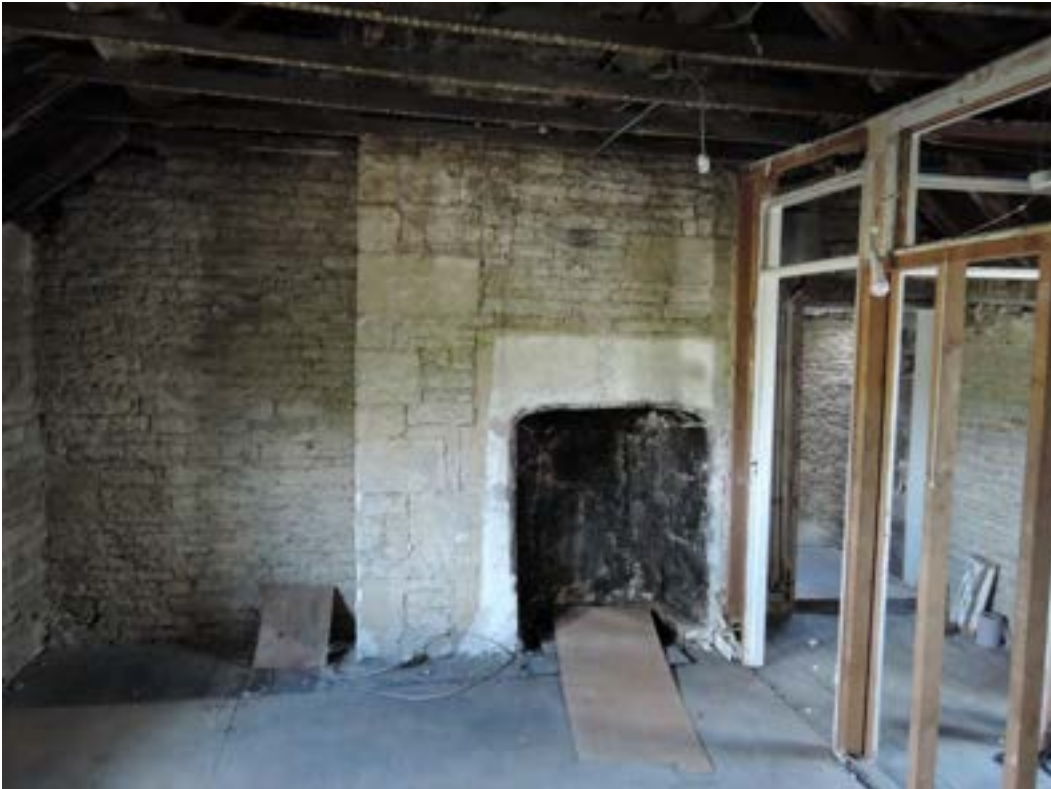
Fireplace in bedroom party wall. Good

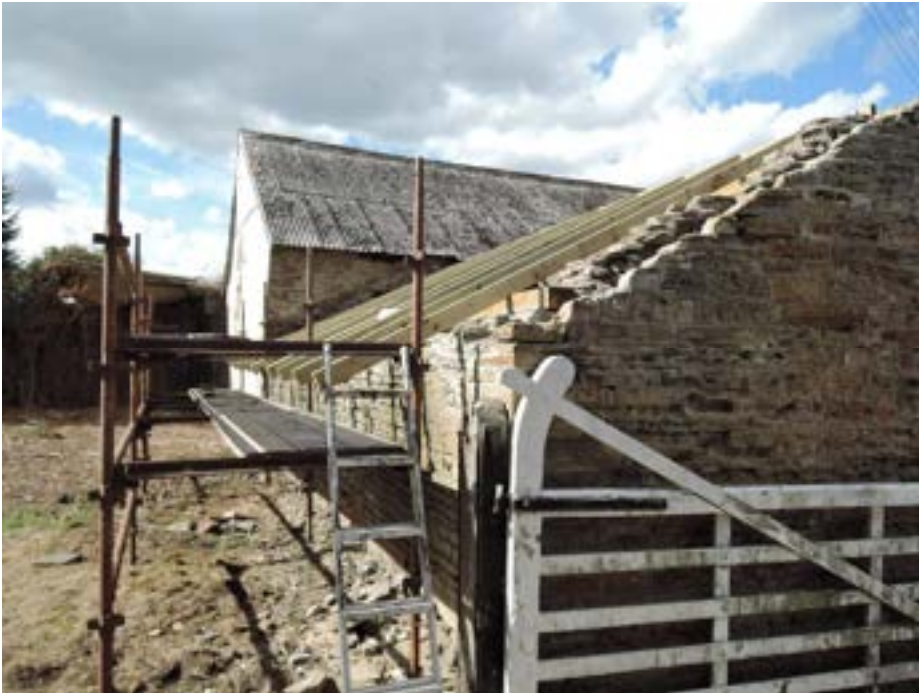
Low level shed under repair receiving new roof. Large barn in background.

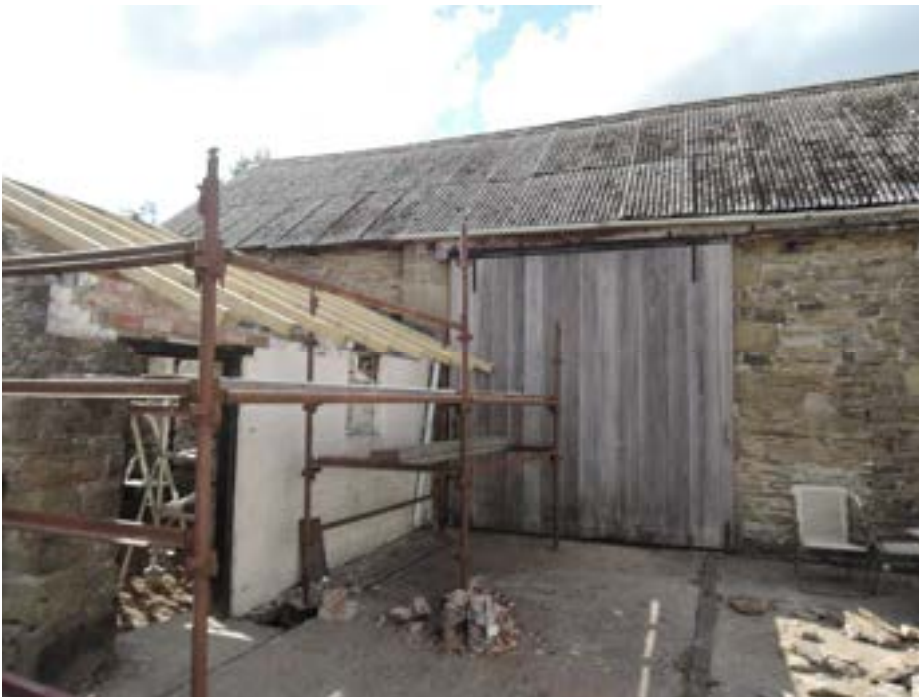
Large barn at south end of yard

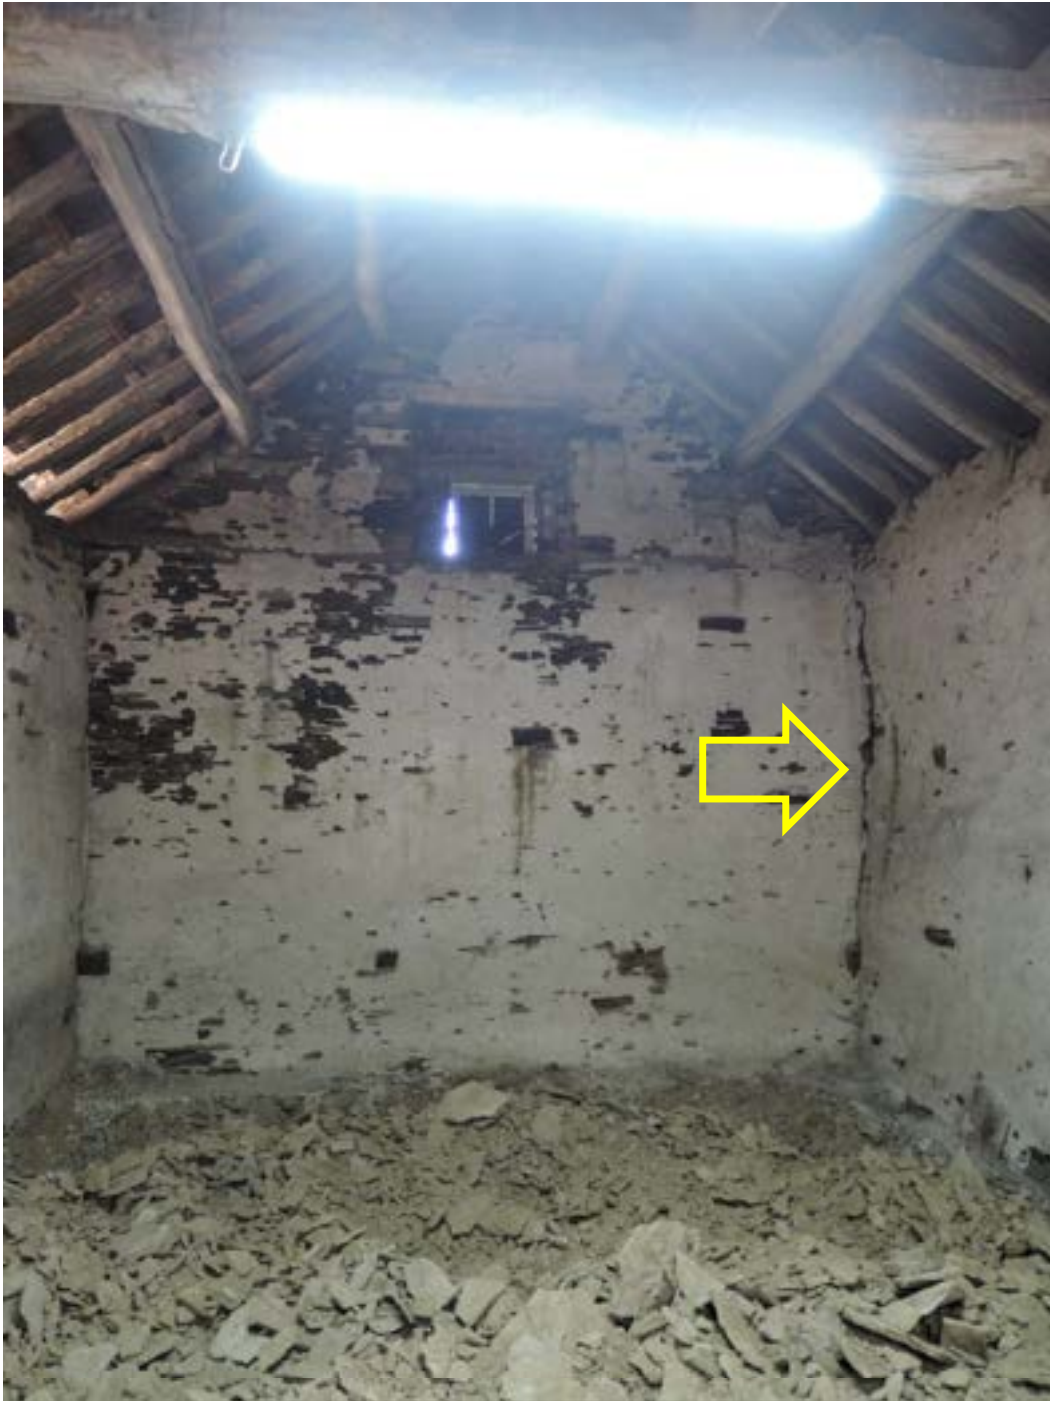
Large barn south gable. Bulge and crack arrowed where flank wall has released. Local dismantling and rebuilding recommended. Add this to the 'take down and rebuild' recommendation of the outward bulging gable (page 22). This picture is the inside face of the south gable
