Far Westhorpe Farm
Heritage Statement
Historic Barns -
Work to the roof covering and
external walls etc
24-001-303

Revision B – Issued for approval 18-02-26

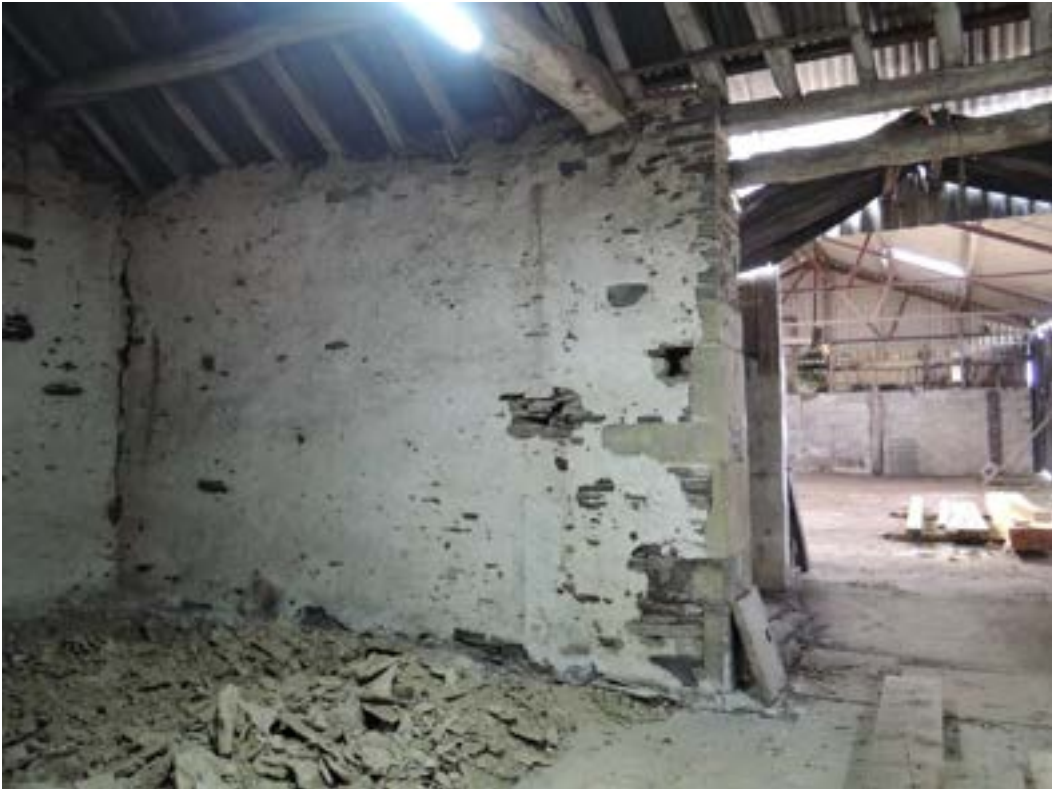
Flank wall (gable on left) entrance to barn to be demolished.

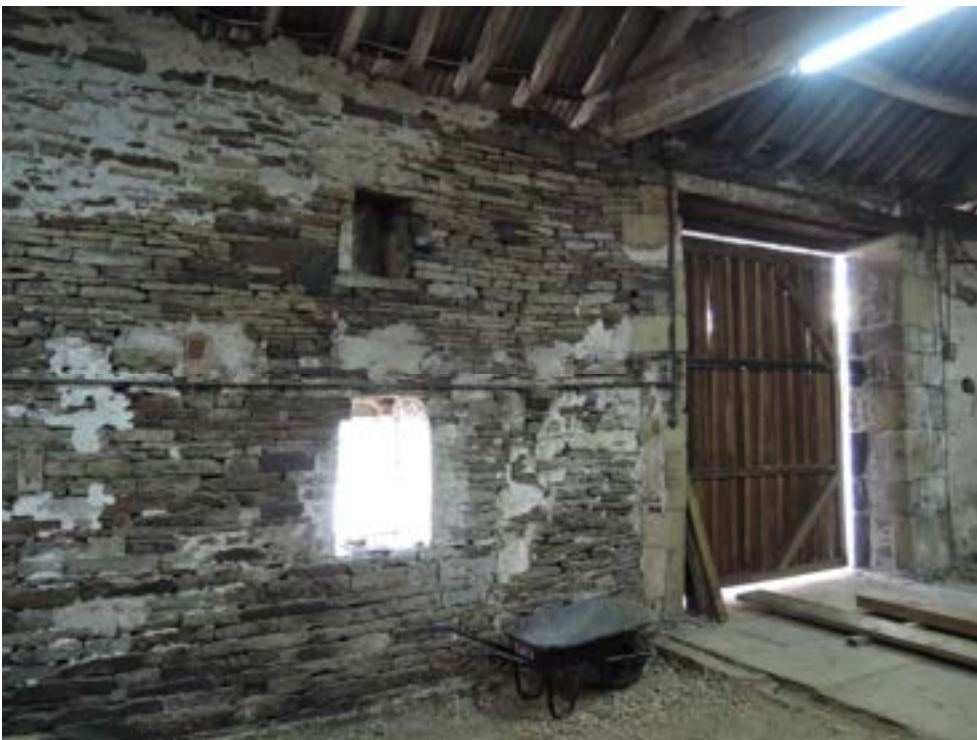
Courtyard wall and main door. Local settlement under truss left of large door. Foundation may need strengthening with local underpinning

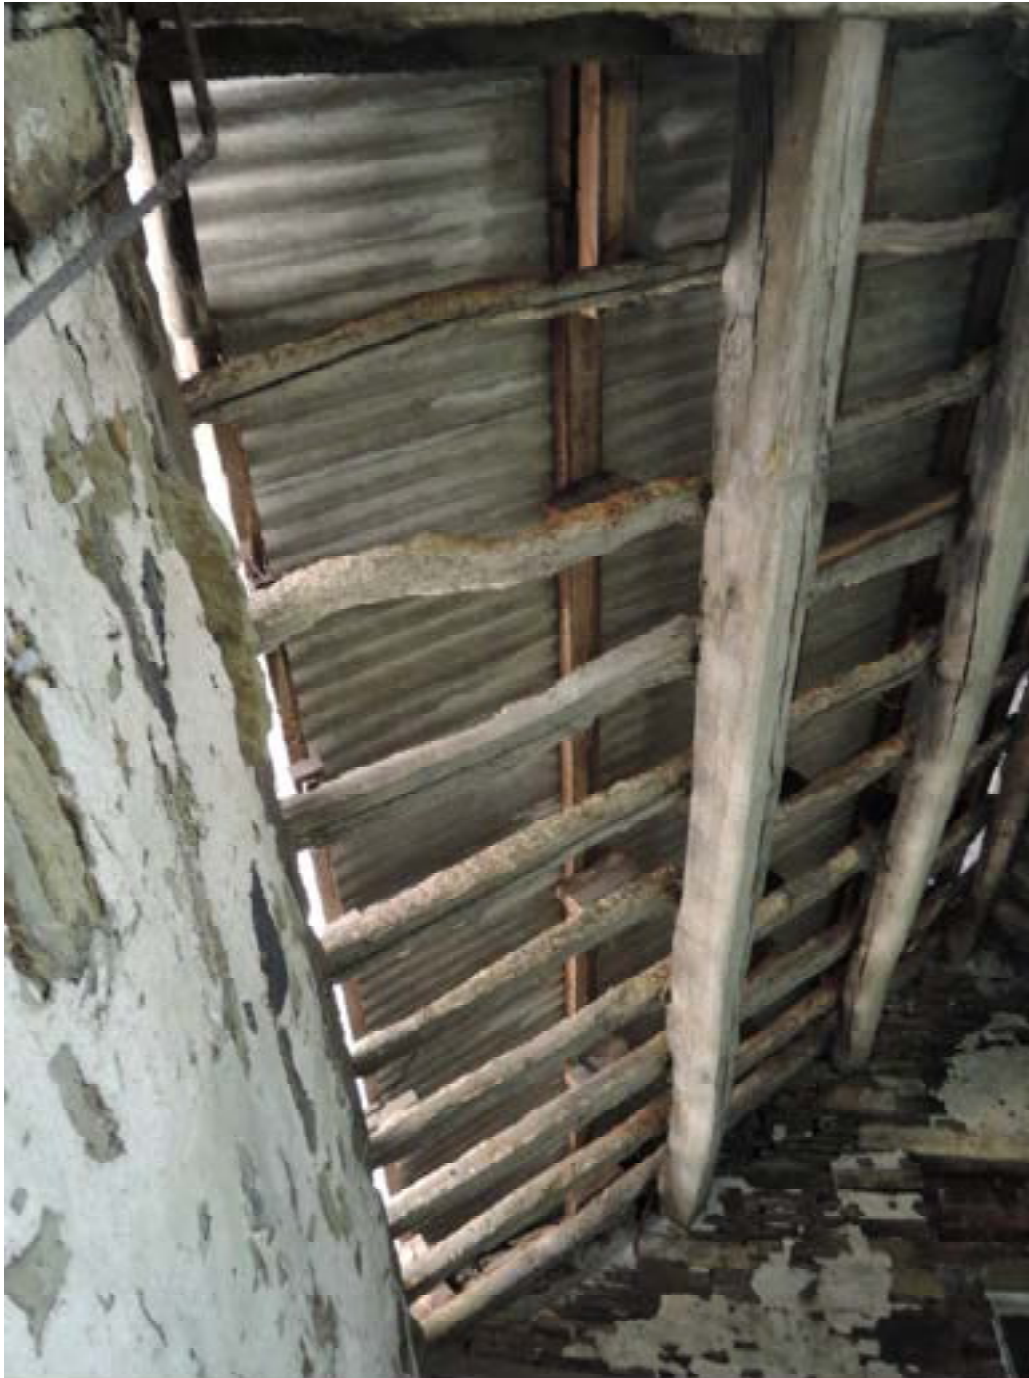
Roof southeast corner, rotting rafters: fairly typical of entire roof. New roof recommended for conversion into habitable building. Purlins and trusses may be suitable for strengthening and refurbishment, but rafters should be considered as end of service life.

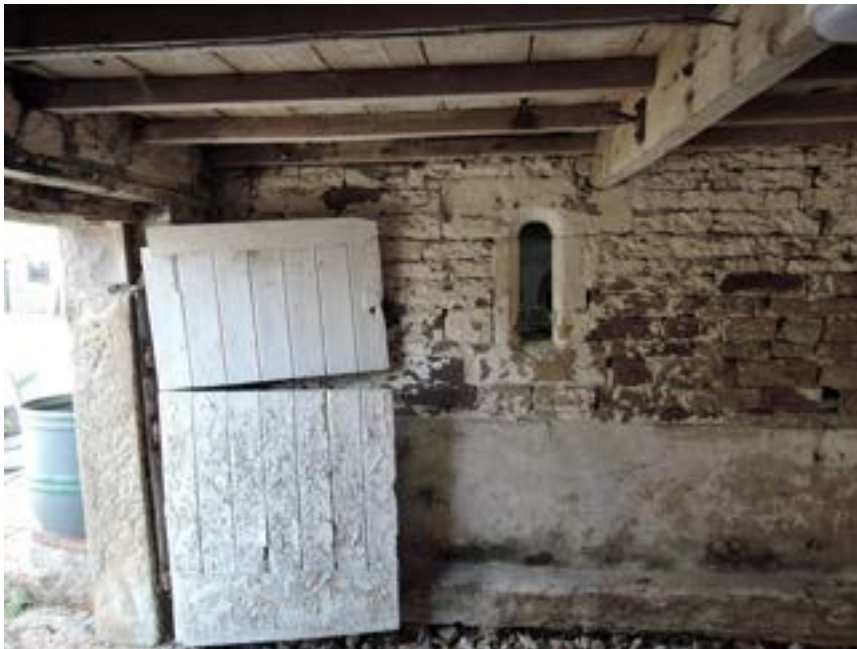
Small barn ground floor party wall with large barn

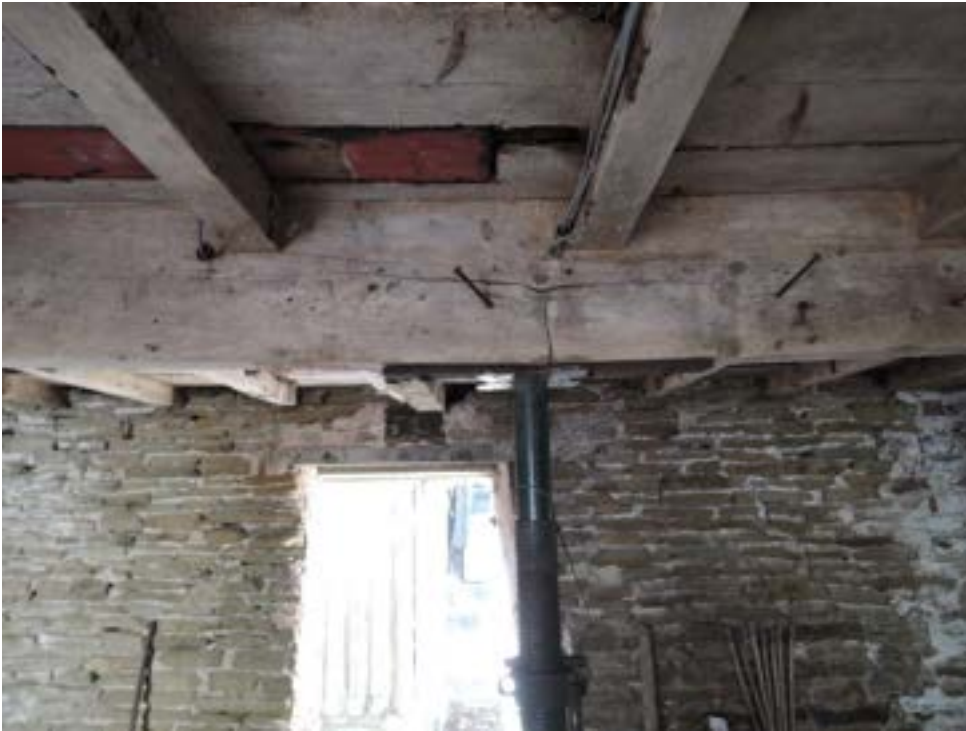
Small barn. Acrow prop to failed 1st floor timber beam

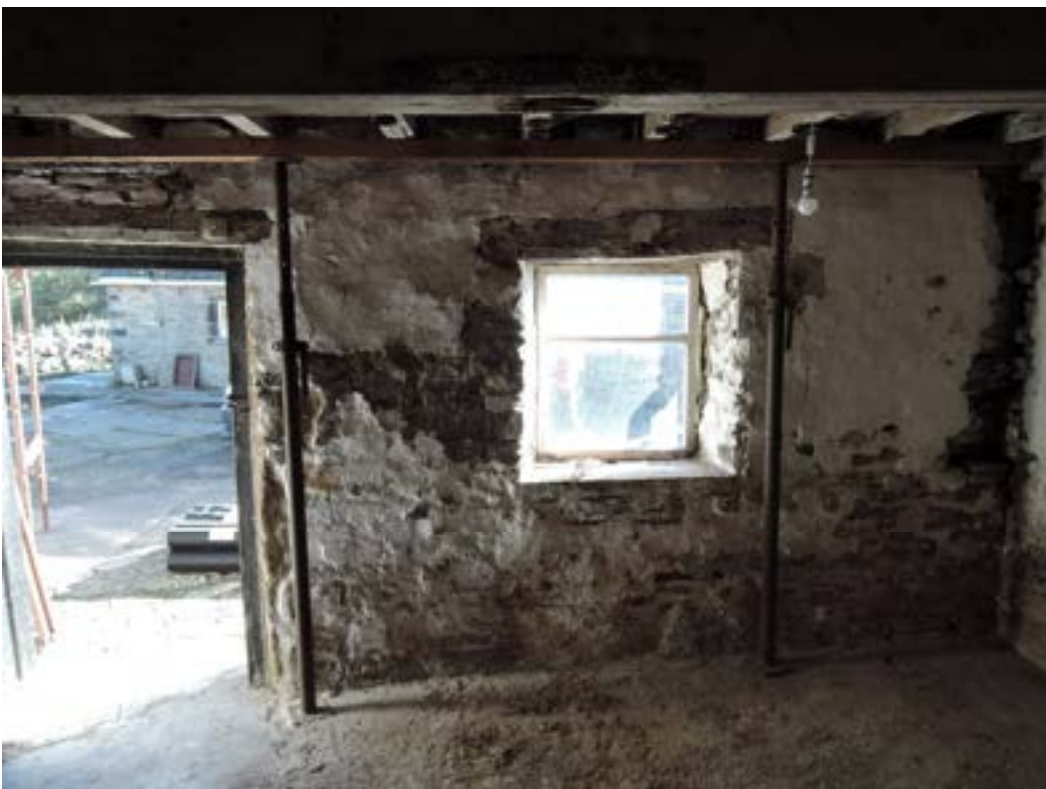
Outward leaning wall has released 1st floor joist ends which are now only supported on a makeshift timber bearer and acrows. Failed/absent wall internal wall buttress bonding full height (far right side of picture)

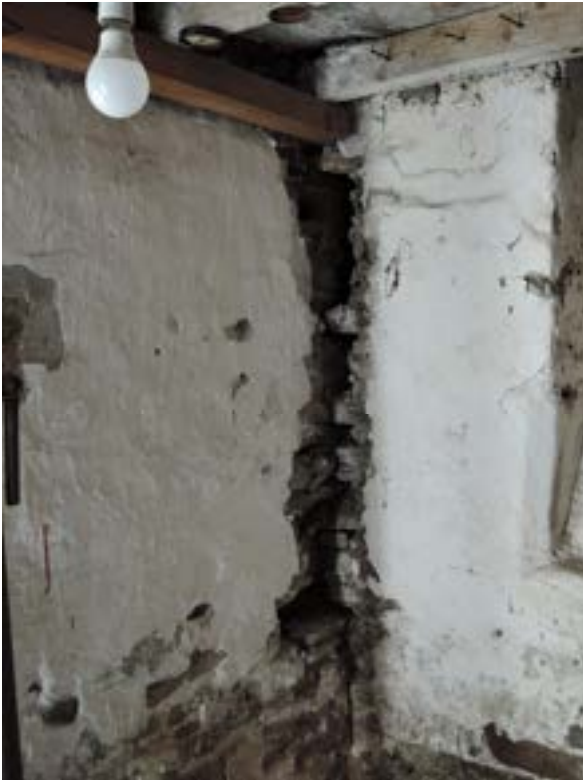
Large gap where courtyard wall is leaning away from internal buttress wall. Failed bonding/tying

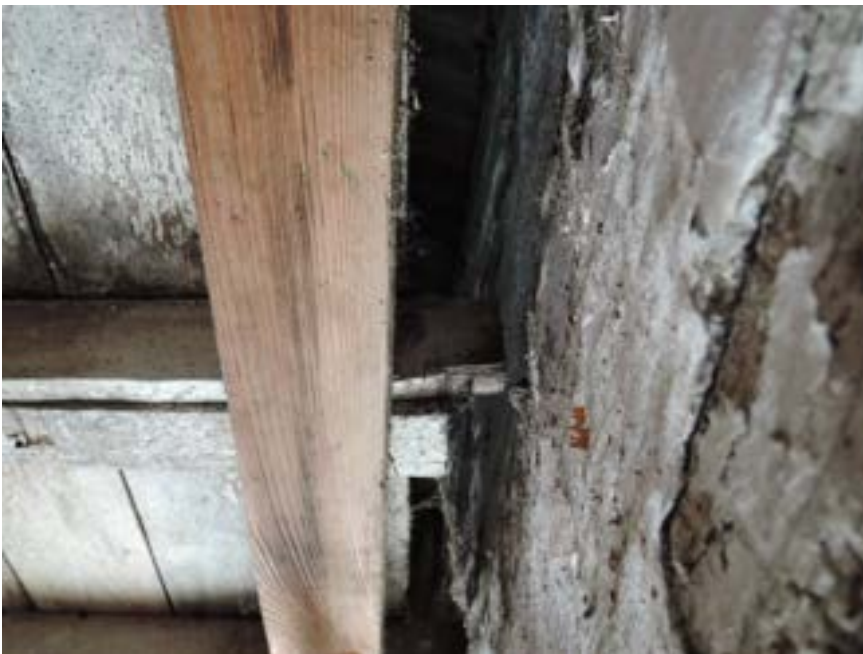
Wall has drifted out circa 75-100 mm completely releasing and abandoning first floor joist ends.

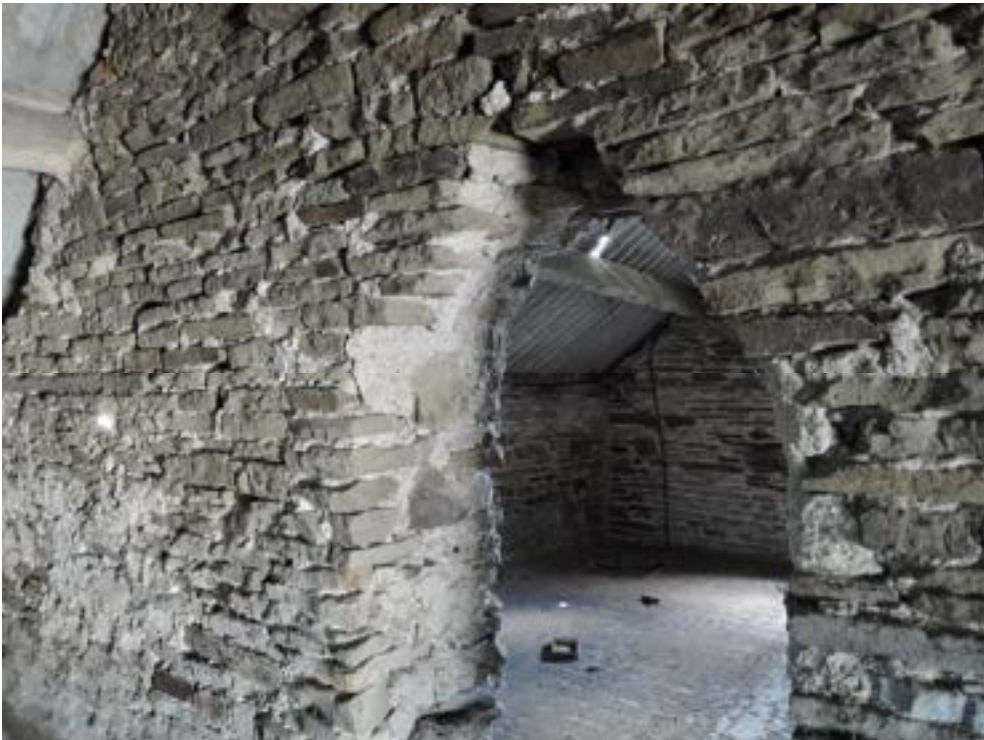
Inner wall first floor. Light repair required at head of arch

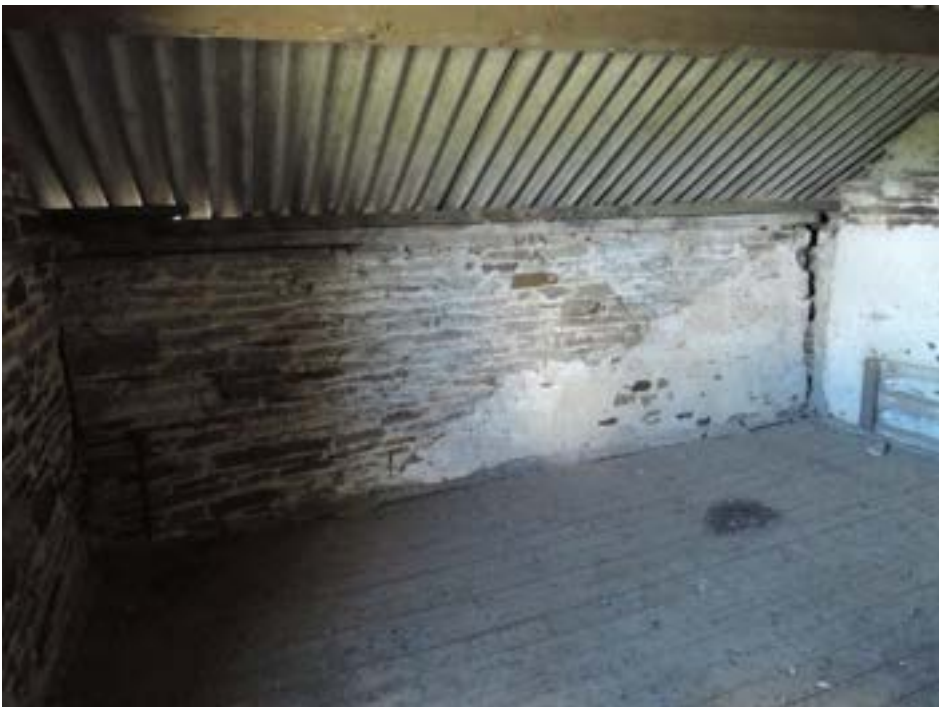
Corner cracking in wall junction indicating outward wall lean and lack of tying in

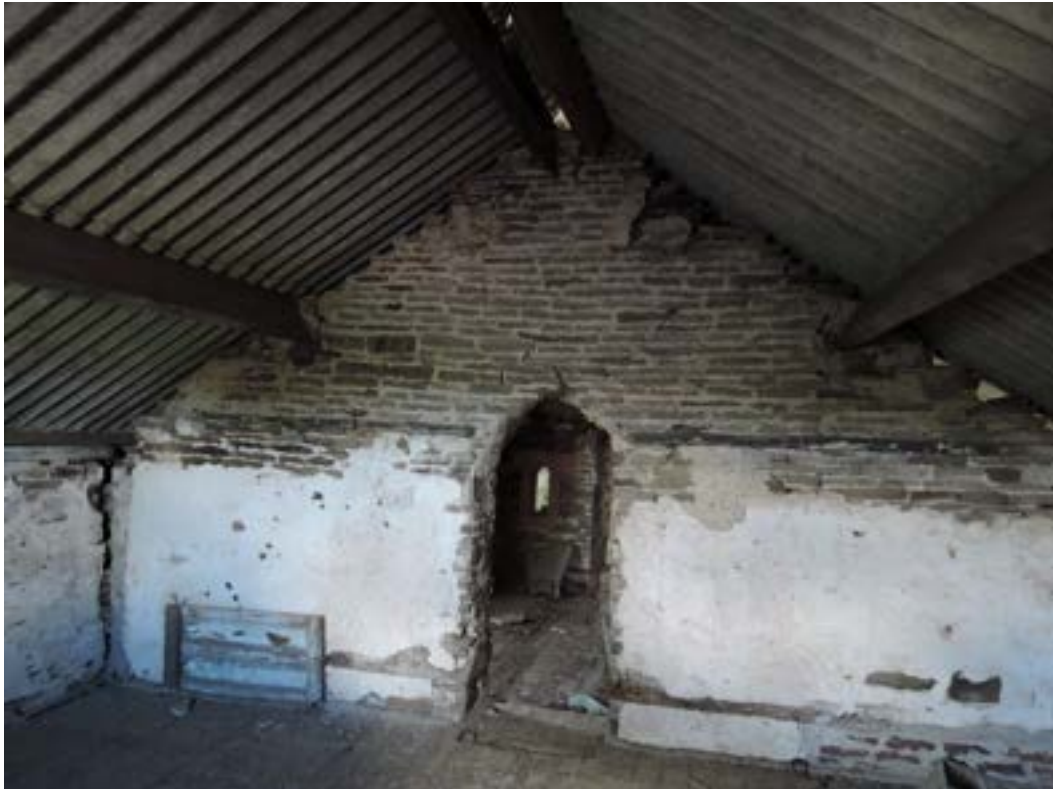
1st floor intermediate wall small barn (same wall as previous pic)
