Arboricultural Consultancy for Lloyds Bank

Insured	Mr & Mrs Brian & Janet Ivermee	Address	51 Lund Avenue, Barnsley, S71 5NW		
Client	Subsidence Management Services	Contact	Ian Domigan	Claim No.	IFS-LBG-SUB-22-0100956
ES Ref	SA-250094	Consultant	Keith Burgess	Contact No.	0330 380 1036
Report Date	01/09/2022

51 Lund Avenue, Barnsley, S71 5NW

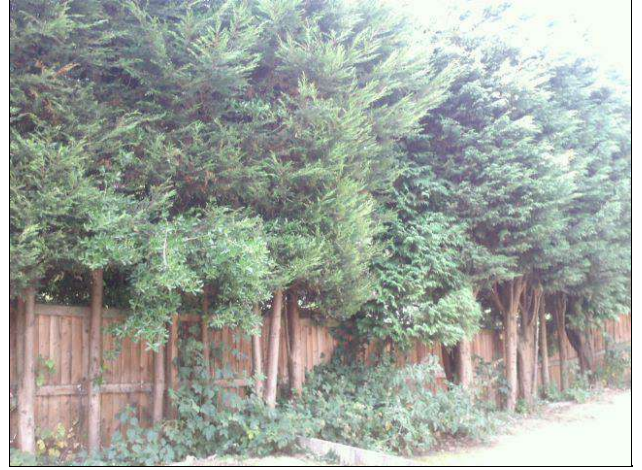
H1 - Cypress

Please note that the footing of the insured property fall within the anticipated rooting distance of additional vegetation which we believe presents a foreseeable risk of future damage and accordingly we have made recommendations in respect of this.

Tree No.	Species	Age Cat	Approx. Height (m)	Distance to Building (m) *	Ownership	Action	Requirement
H1	Cypress	1	6	5.6	C - Insured	Action to avoid future risk	Maintain at, or below current dimensions by way of regular pruning.
T5	Oak	3	9	14	A - Third Party	Action to avoid future risk	Maintain at, or below current dimensions by way of regular pruning.
T6	Magnolia	1	4	5.8	C - Insured	Action to avoid future risk	Maintain at broadly current dimensions by way of regular pruning.
T7	Oak	1	9	12.6	A - Third Party	Action to avoid future risk	Maintain at, or below current dimensions by way of regular pruning.
T8	Sycamore	1	11	7.8	A - Third Party	Action to avoid future risk	Maintain at, or below current dimensions by way of regular pruning.

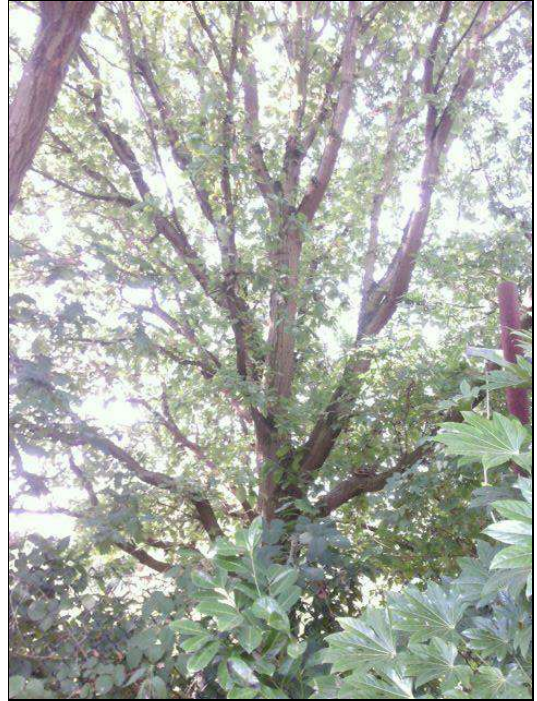
T4 - Oak

With due regards to species profile, size and proximity, the Oak (T1, T3 & T4) are considered the dominant feature proximate to the focal area of movement and accordingly, where vegetation is confirmed to be causal, we have identified them as the primary cause of the current subsidence damage.

Consequently, we have advocated the complete removal of T1, T2, T3 and T4 as it will offer the most certain arboricultural solution likely to restore long-term stability.

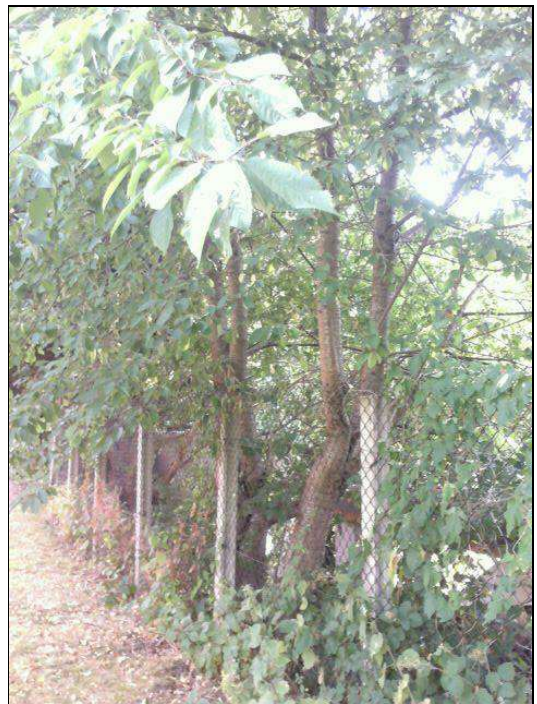
T2 - Cherry

The Cherry (T2) cannot be discounted as contributing to the overall level of soil drying proximate to the area of damage and is/are therefore also considered to retain a contributory influence, albeit in a limited / secondary capacity when compared to T1, T3 & T4.

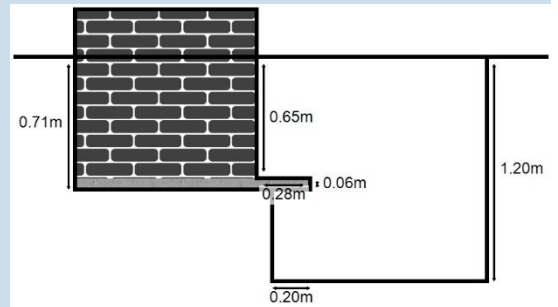
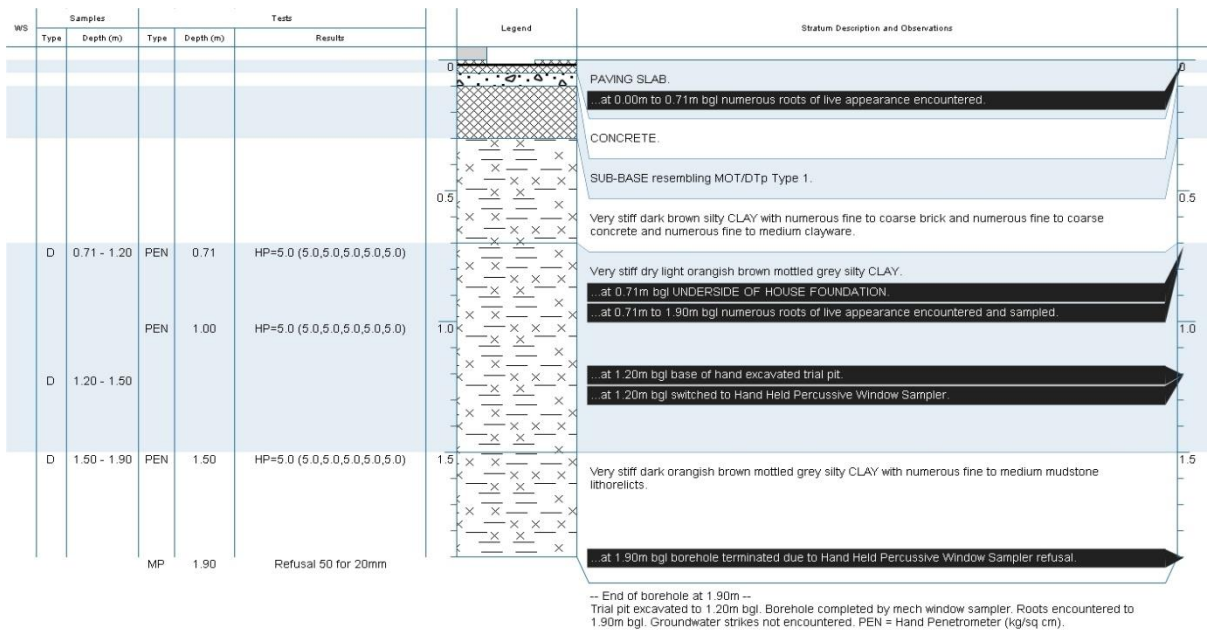
TP/BH1 Foundation Detail and Borehole Log

House foundation comprised of brick wall to 650mm bgl, bearing on concrete to 710mm bgl, with a total projection of 280mm from the elevation. Underside of foundation (USF) was exposed to 200mm back from the face of the foundation and probed 300mm back from the face of the foundation.

At 0.71m bgl UNDERSIDE OF HOUSE FOUNDATION in TP/BH1.

At 0.00m to 0.71m bgl numerous roots of live appearance encountered in TP/BH1.

At 0.71m to 1.90m bgl numerous roots of live appearance encountered and sampled in TP/BH1.

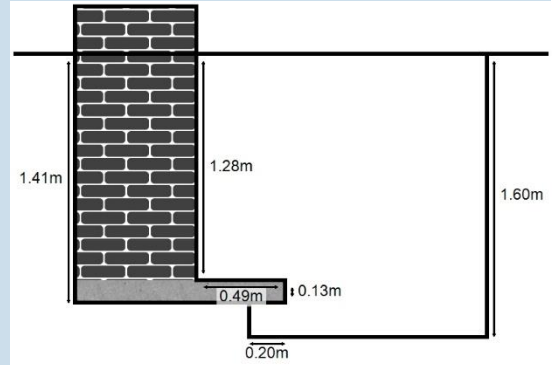
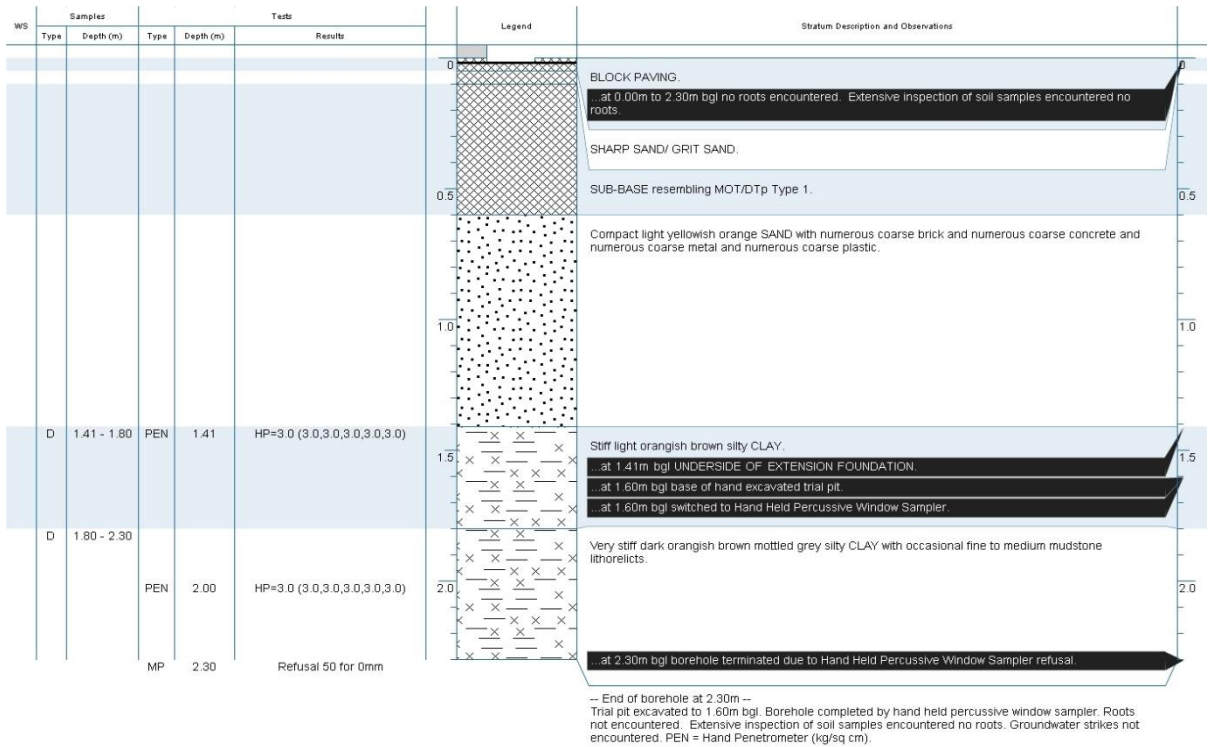
TP/BH2 Foundation Detail and Borehole Log

Extension foundation comprised of brick wall to 1280mm bgl, bearing on concrete to 1410mm bgl, with a total projection of 490mm from the elevation. Underside of foundation (USF) was exposed to 200mm back from the face of the foundation and probed 300mm back from the face of the foundation.

At 1.41m bgl UNDERSIDE OF EXTENSION FOUNDATION in TP/BH2.

At 0.00m to 2.30m bgl no roots encountered. Extensive inspection of soil samples encountered no roots in TP/BH2.

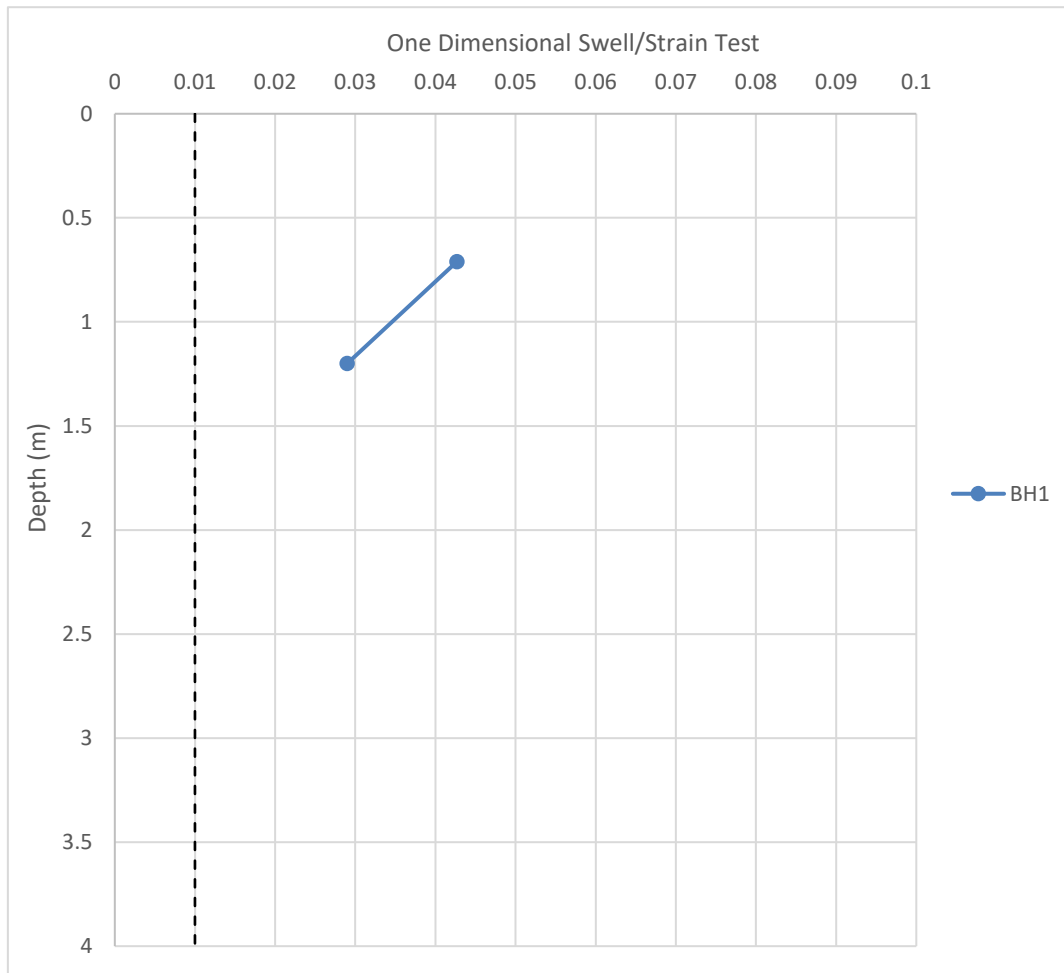
Summary of Oedometer Testing for BH1

Lab Ref	Depth (m)	Strain	Heave (mm)	Remarks
1	0.71	0.0427	15.2	
2	1.2	0.029	7.1	
3	1.5

BH 1 estimate of heave	22mm
------------------------	------

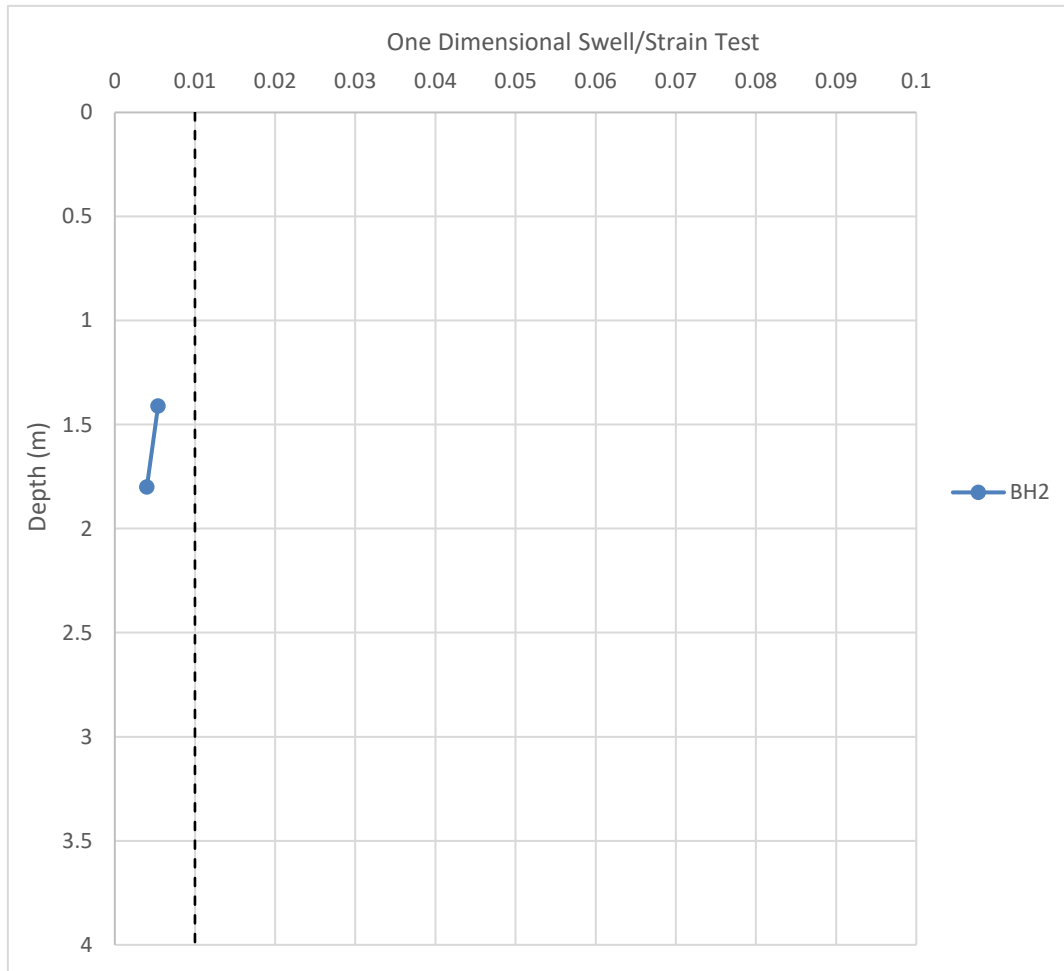
Lab Ref	Depth (m)	Strain	Heave (mm)	Remarks
4	1.41	0.0054	0	
5	1.8	0.004	0

BH 2 estimate of heave	0mm
------------------------	-----

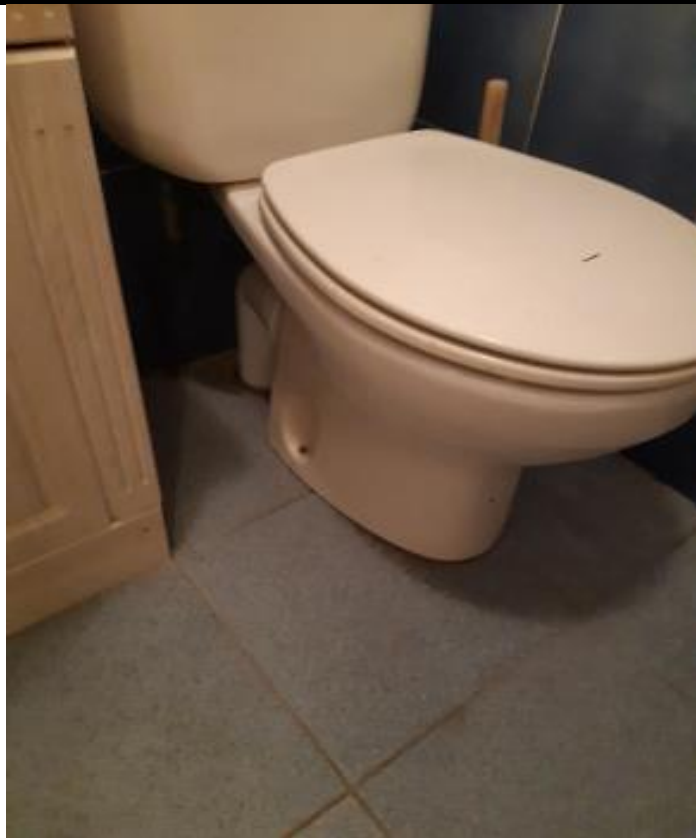
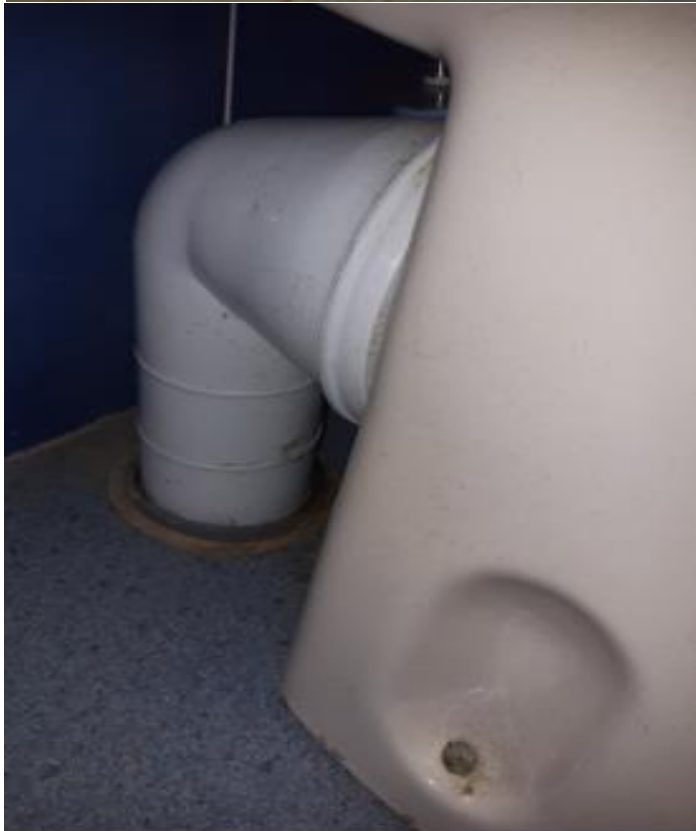
We have carried out investigations and noted there are several rain water gullies in the area of concern.

We have also found there is a WC which connects onto the pipework serving a rain water gully via a blind junction. We will need enabling contractors to remove the WC to allow a survey to be carried out. See Photos.

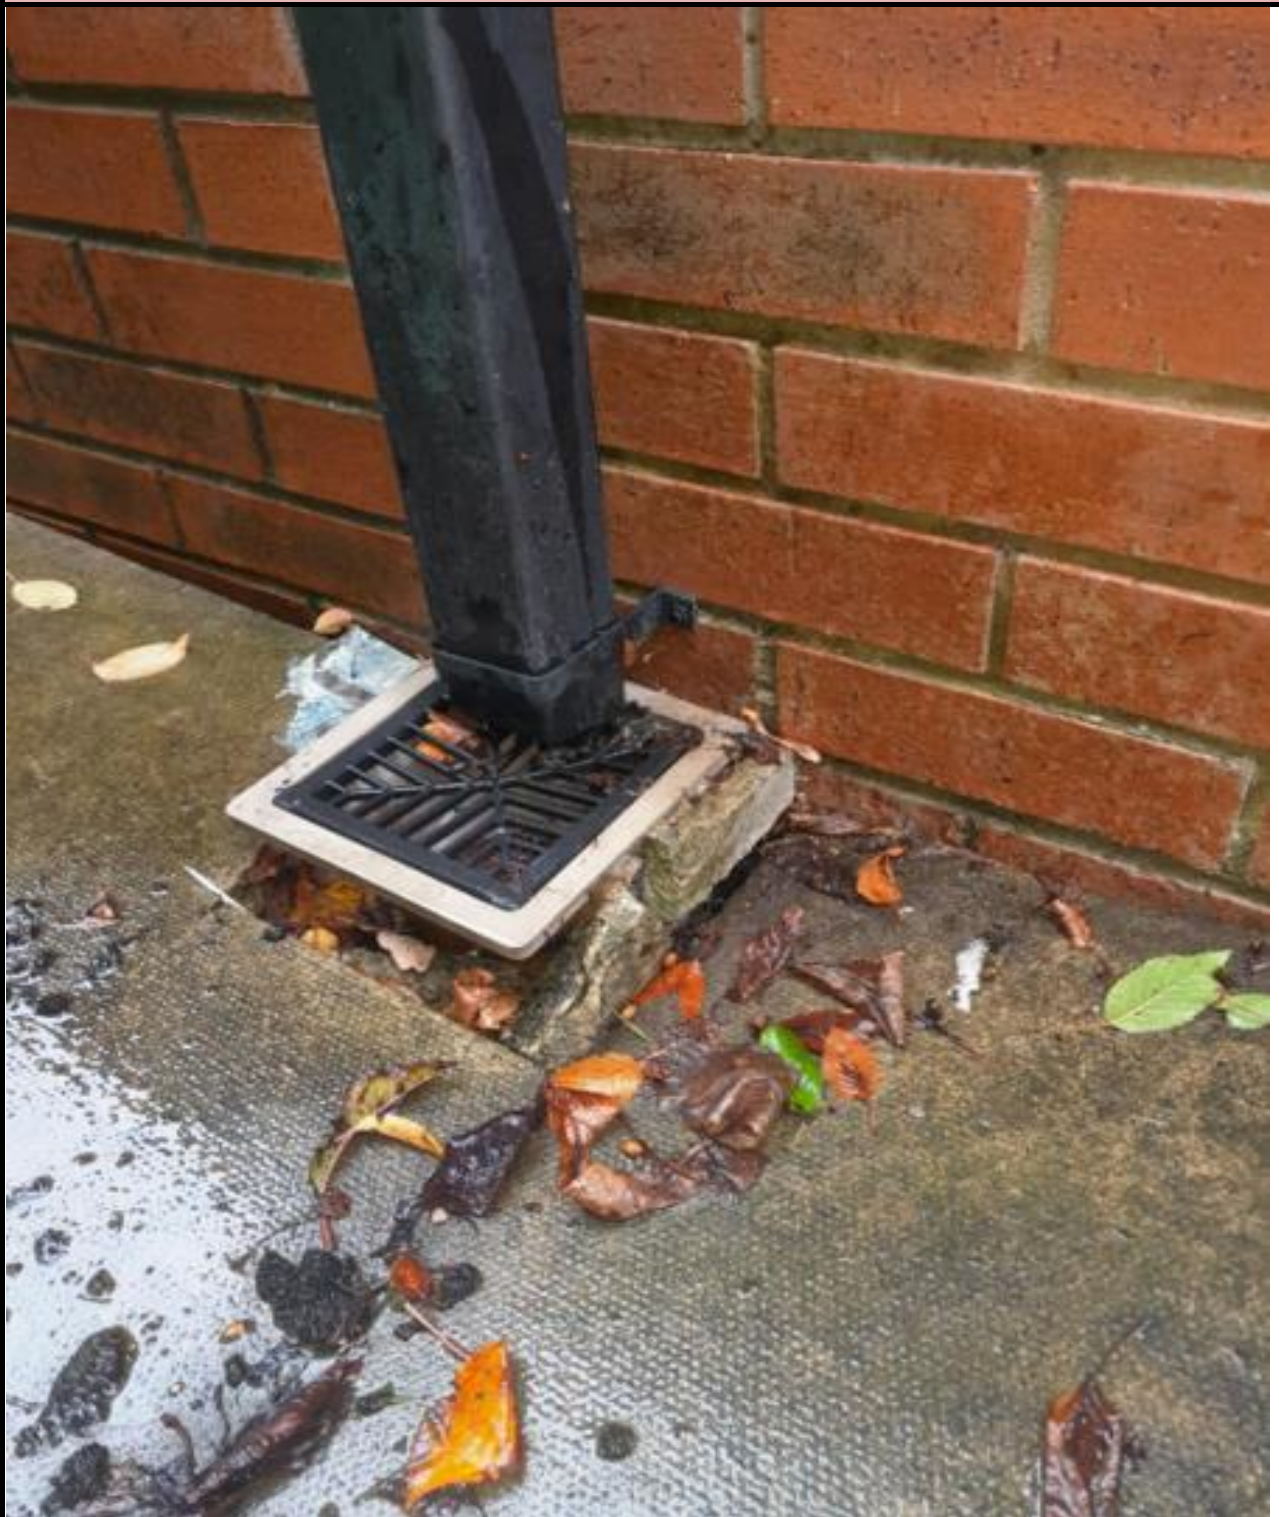
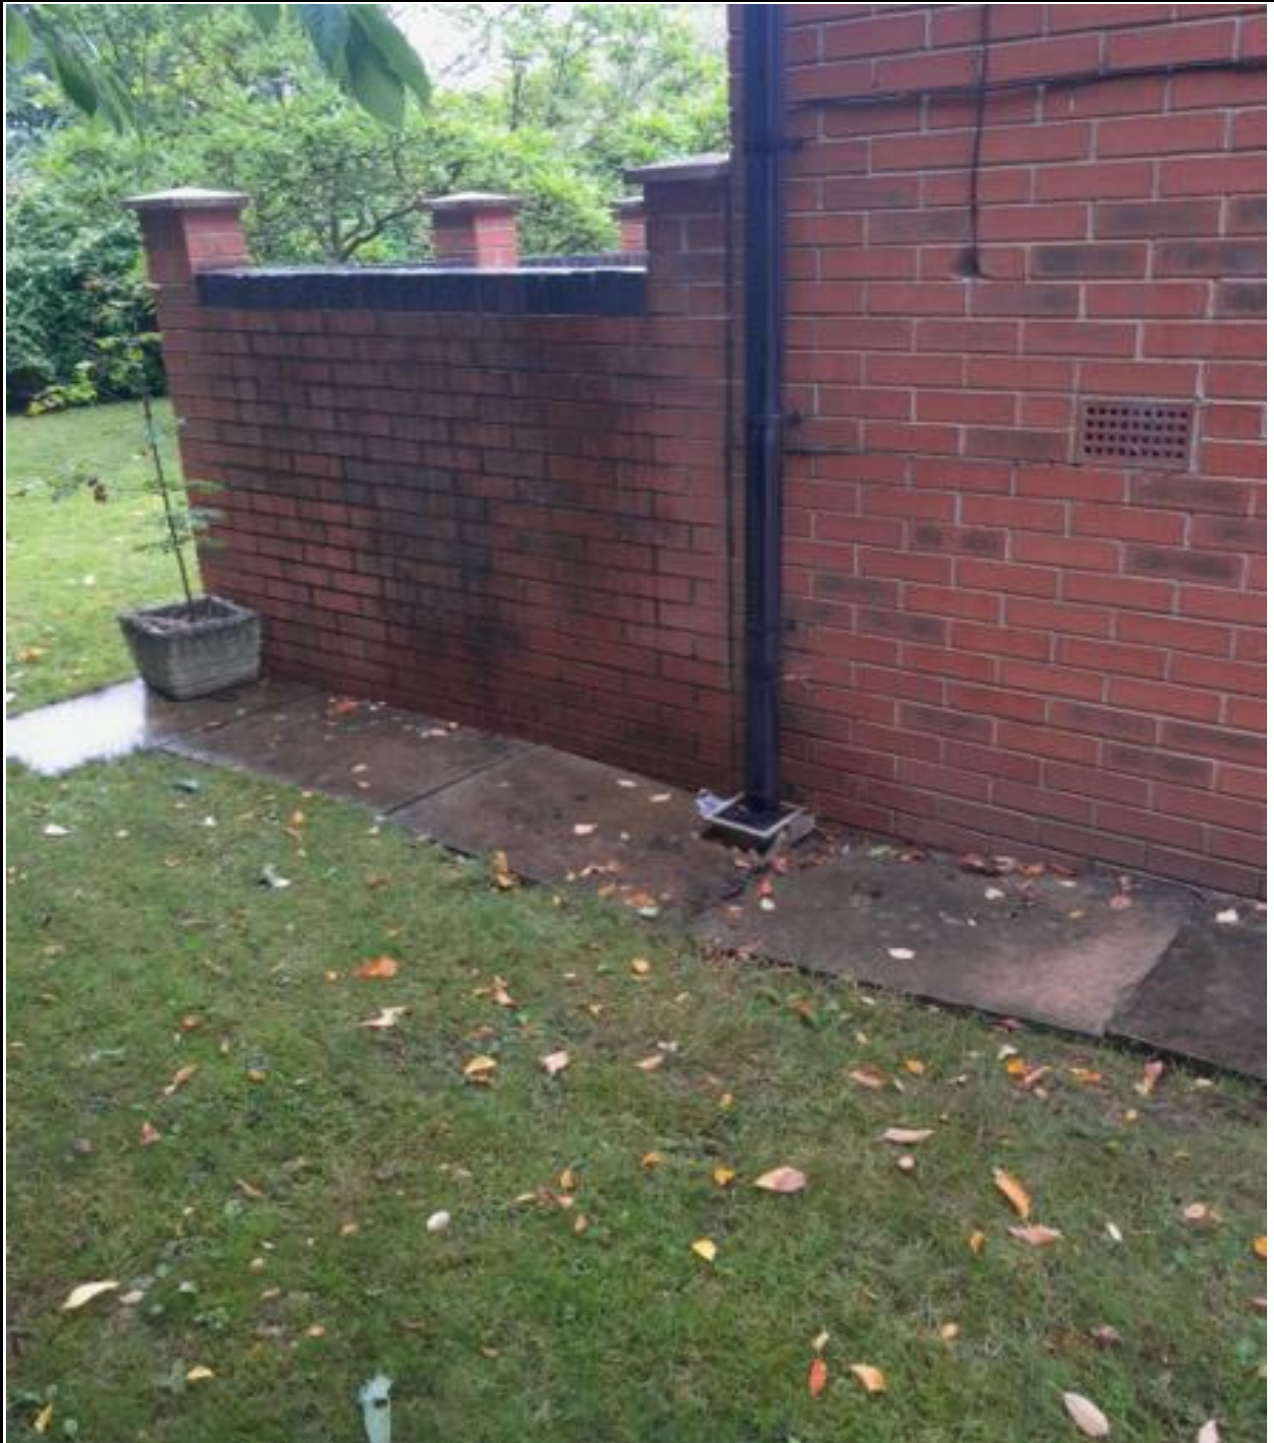
CCTV Survey Result: Structural damage

We noted the flag stones adjacent to RWG5 (Run J) have dropped by approx 6" - see photos

Excavate and replace RWG5 together with pipework down to Run E, approx 1m
