10th October 2016
Ref: AWA1678

Arboricultural Report

'Plot 2', Delf Garth, High Street, Dodworth, Barnsley

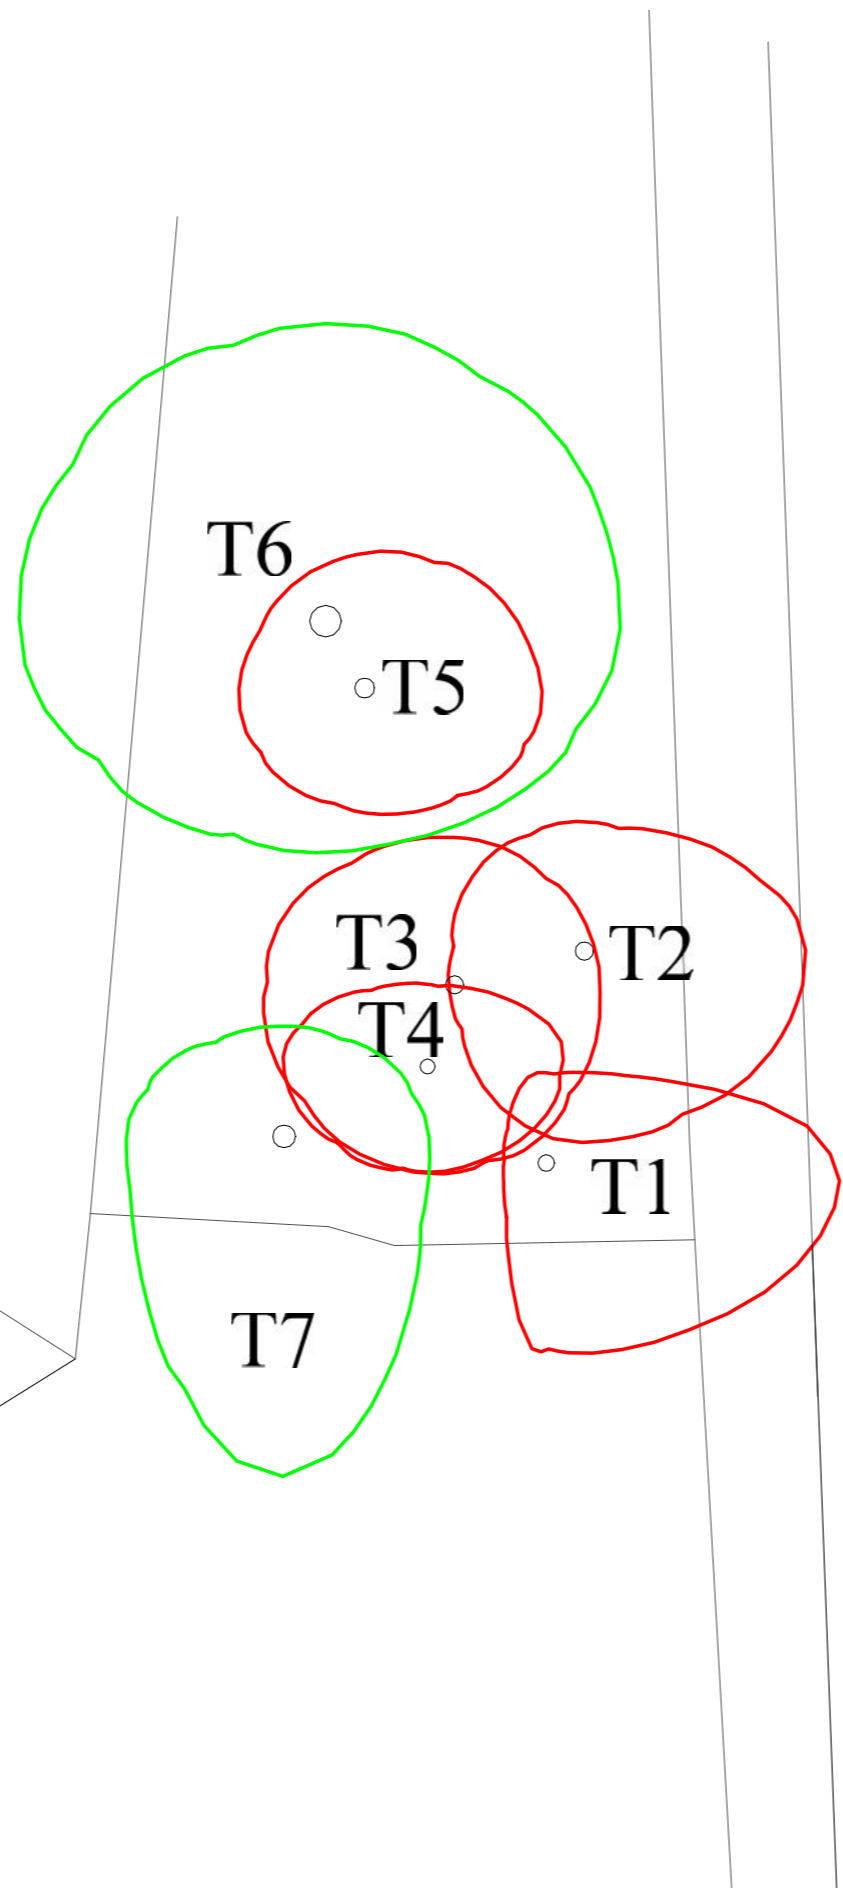
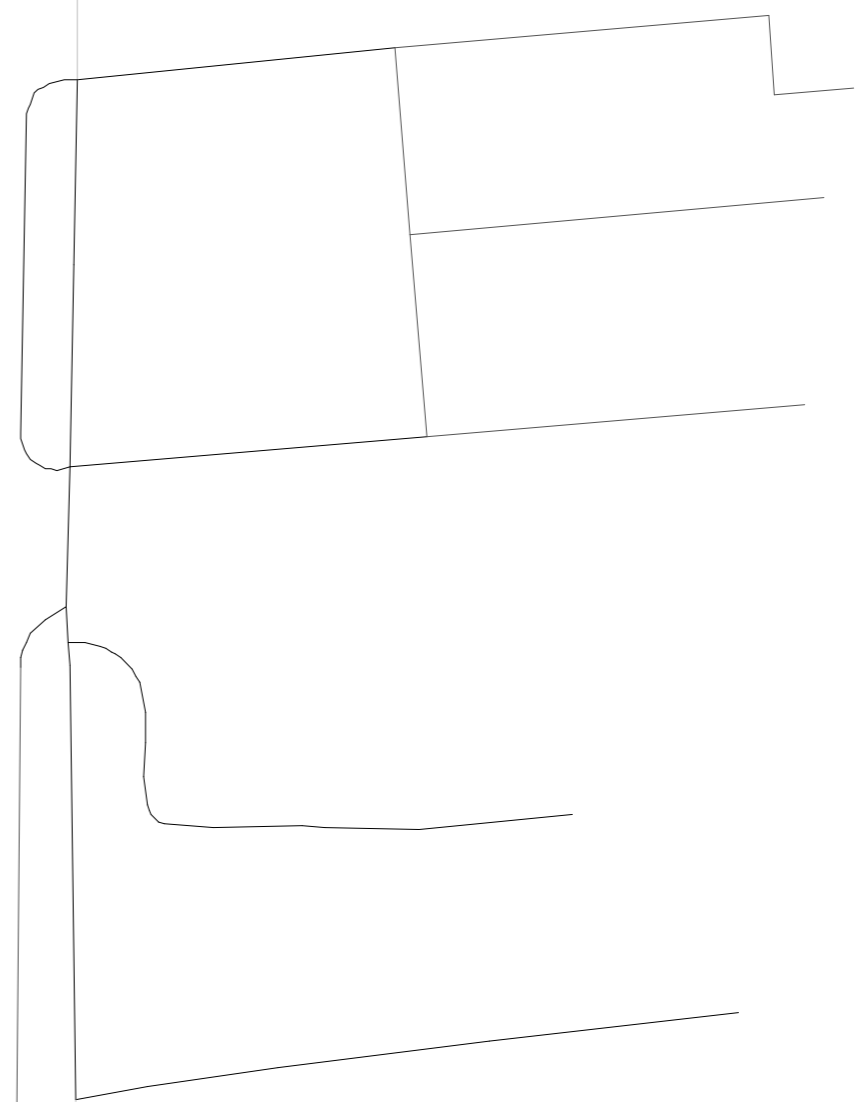
TREE PLAN
 Plot 2, Delf Garth, High Street, Dodworth
 Ref: AWA1678
 SCALE: 1:200 PAPER: A3

I am of the opinion that it is very likely that roots from the tree T1 to T2 will be growing up to and along the boundary wall. It is also probable that roots from the trees T3 to T5 will be growing up to the boundary wall. I am of the opinion that the roots of T1 to T5 will have contributed to the damaged the boundary wall, from the result of the direct pressure of the tree roots pressing against the retaining wall. In the future, as the tree roots continue to grow, it is foreseeable that the damage to the wall will increase. Trees T6 and T7 are situated further away from the damaged wall and so will be less likely to have impacted upon the walls poor condition.

Following my inspection, I am of the opinion that the trees T1 to T5 are contributing to the current damage to the boundary wall, and it is foreseeable this will increase over time. The excavations required to repair the wall will result in the severing of tree roots. I am of the opinion that this will lead to a loss of tree vigour of trees T1 to T5 and make the trees T1 and T2 unstable. As such, it is recommended to remove the trees prior to repairing the wall and to undertake suitable replacement planting.
