# ARBORICULTURAL REPORT

To **BS5837:2012** at:

***13 Woodhouse Road,  
Hoyland,  
Barnsley,  
South Yorkshire  
S74 9AW***

Reference: *AWA3012*

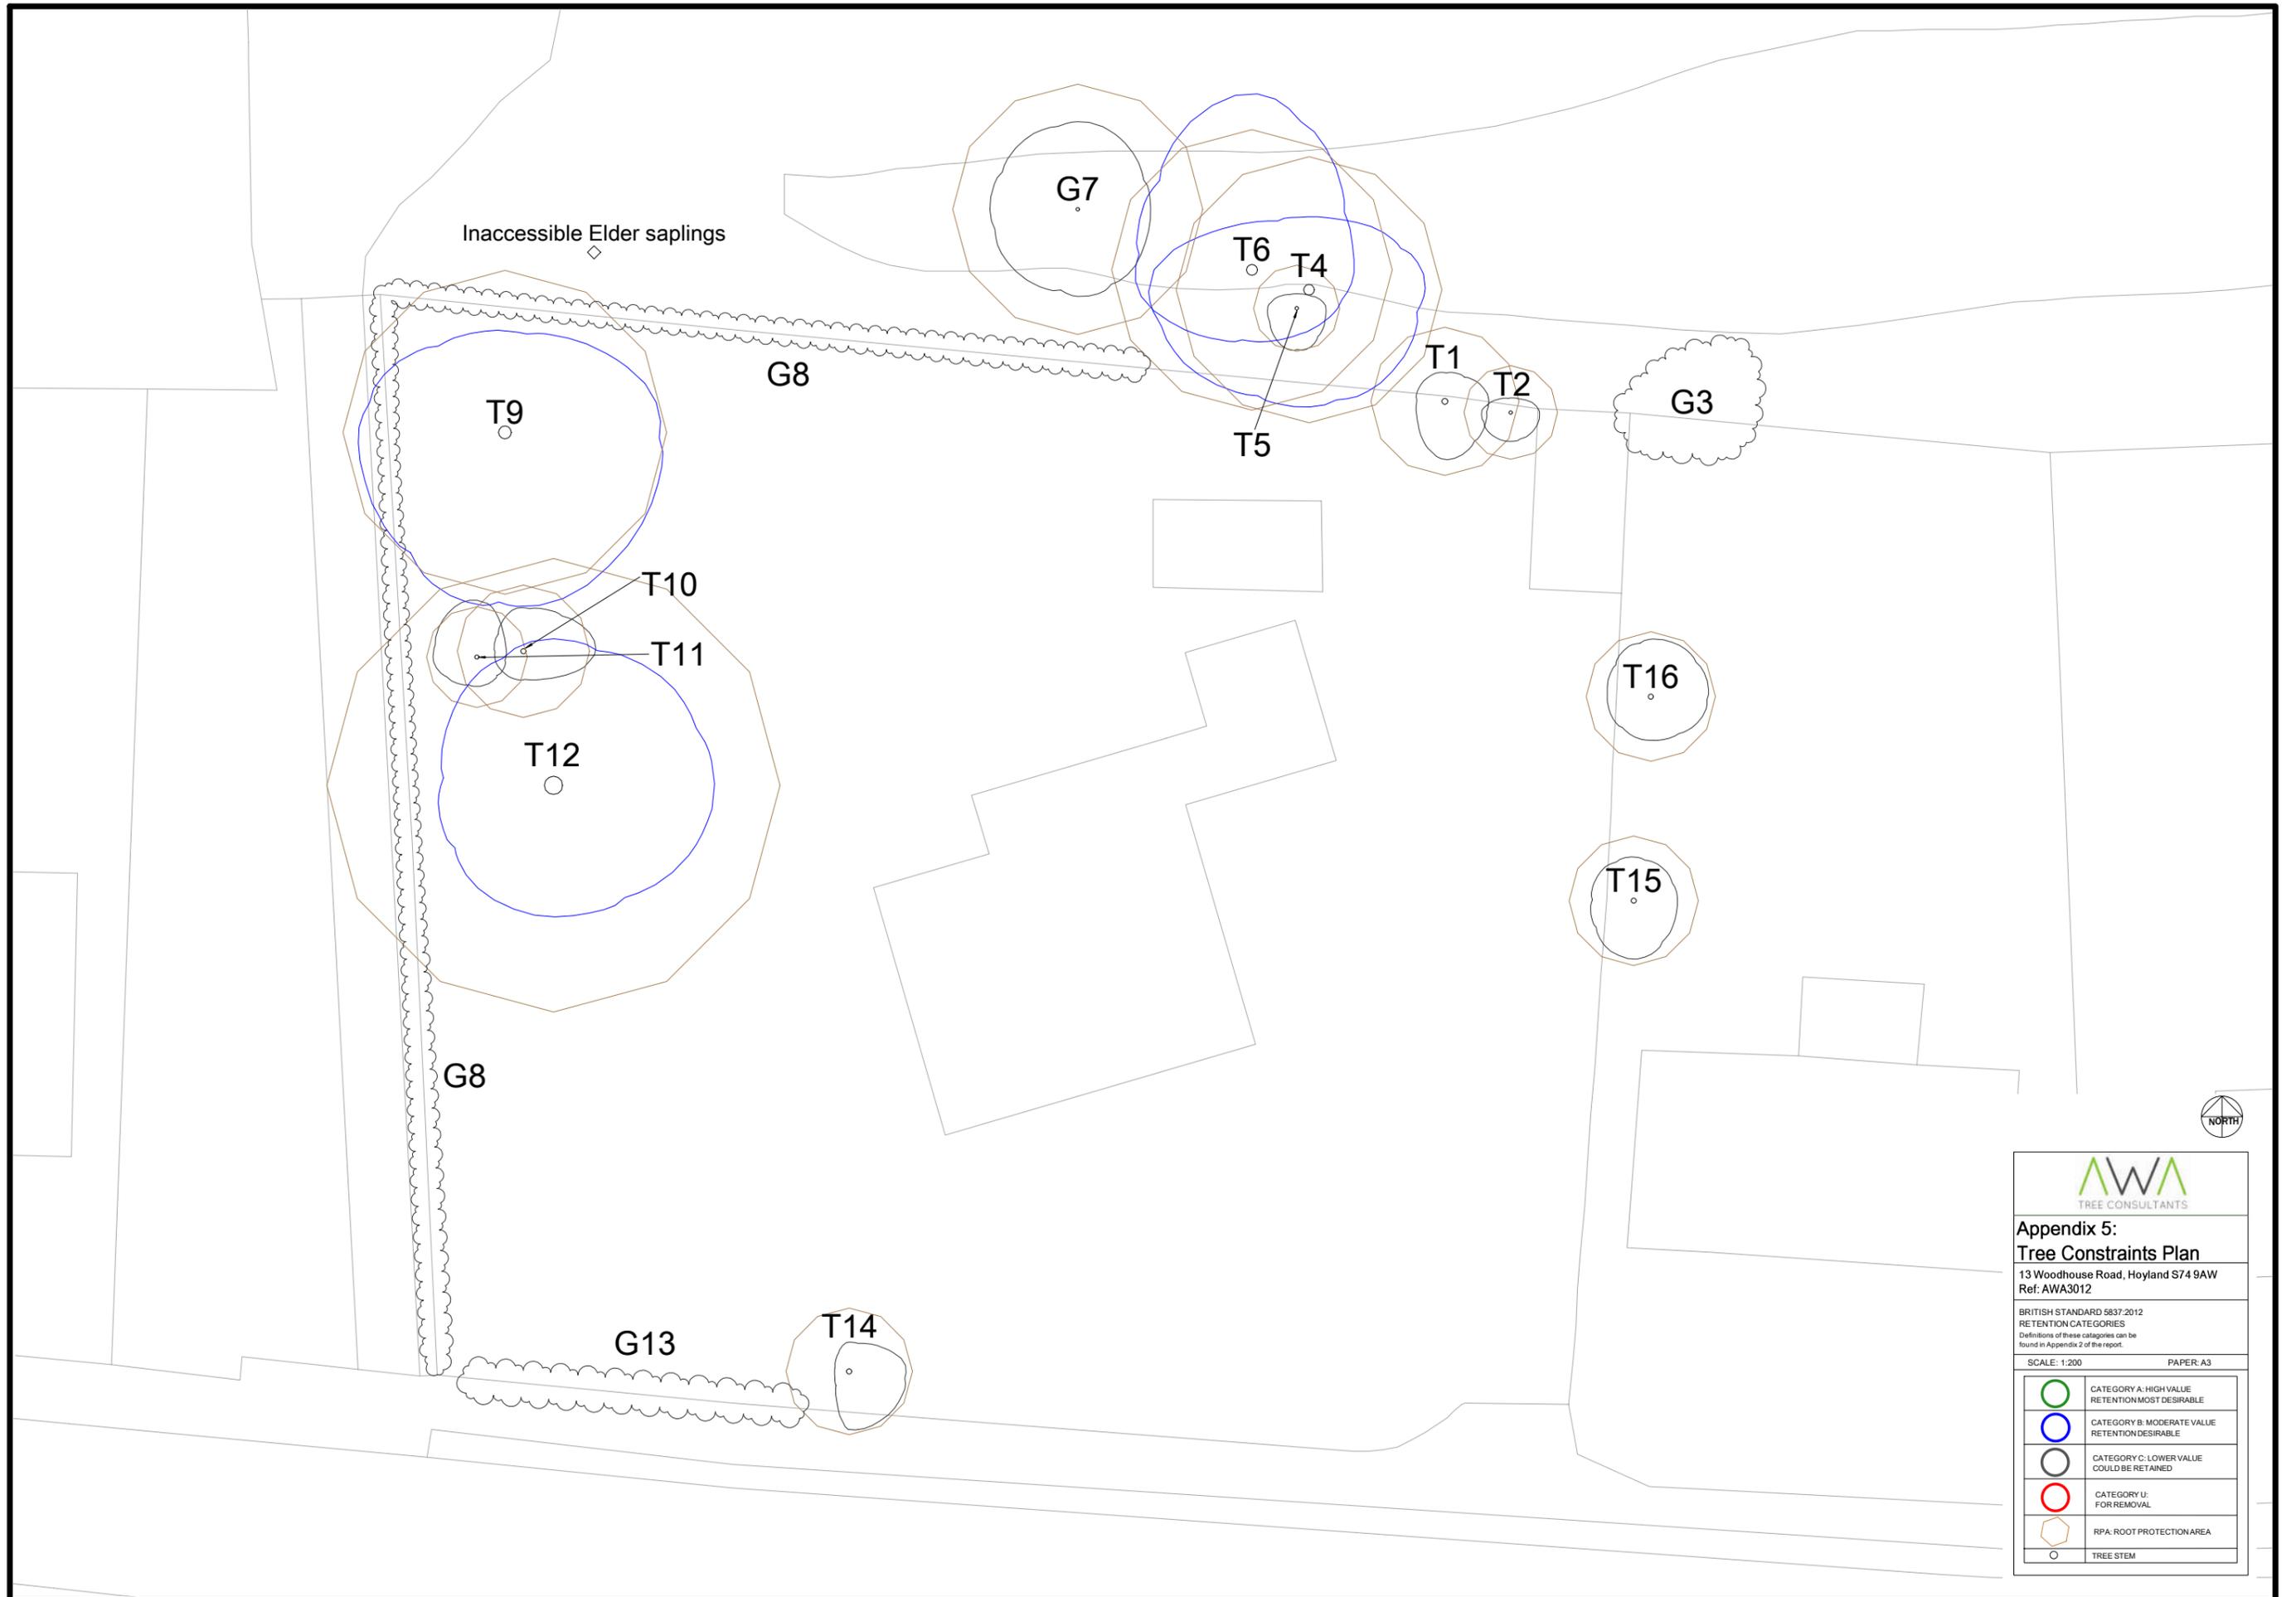
**Appendix 5:  
Tree Constraints Plan**

- 3.2.6 Situated between the northern site boundary, and the shelterbelt beyond, are Ash T4 and Cherry T6. These trees are taller than many of the trees on site and provide good amenity value to the property both individually and collectively.

- 3.2.10 The tree Root Protection Area (RPA) detailed on the Tree Constraints Plan at Appendix 5, has been used as a layout design tool, to inform on the area around a tree where the protection of the roots and soil structure is treated as a priority.

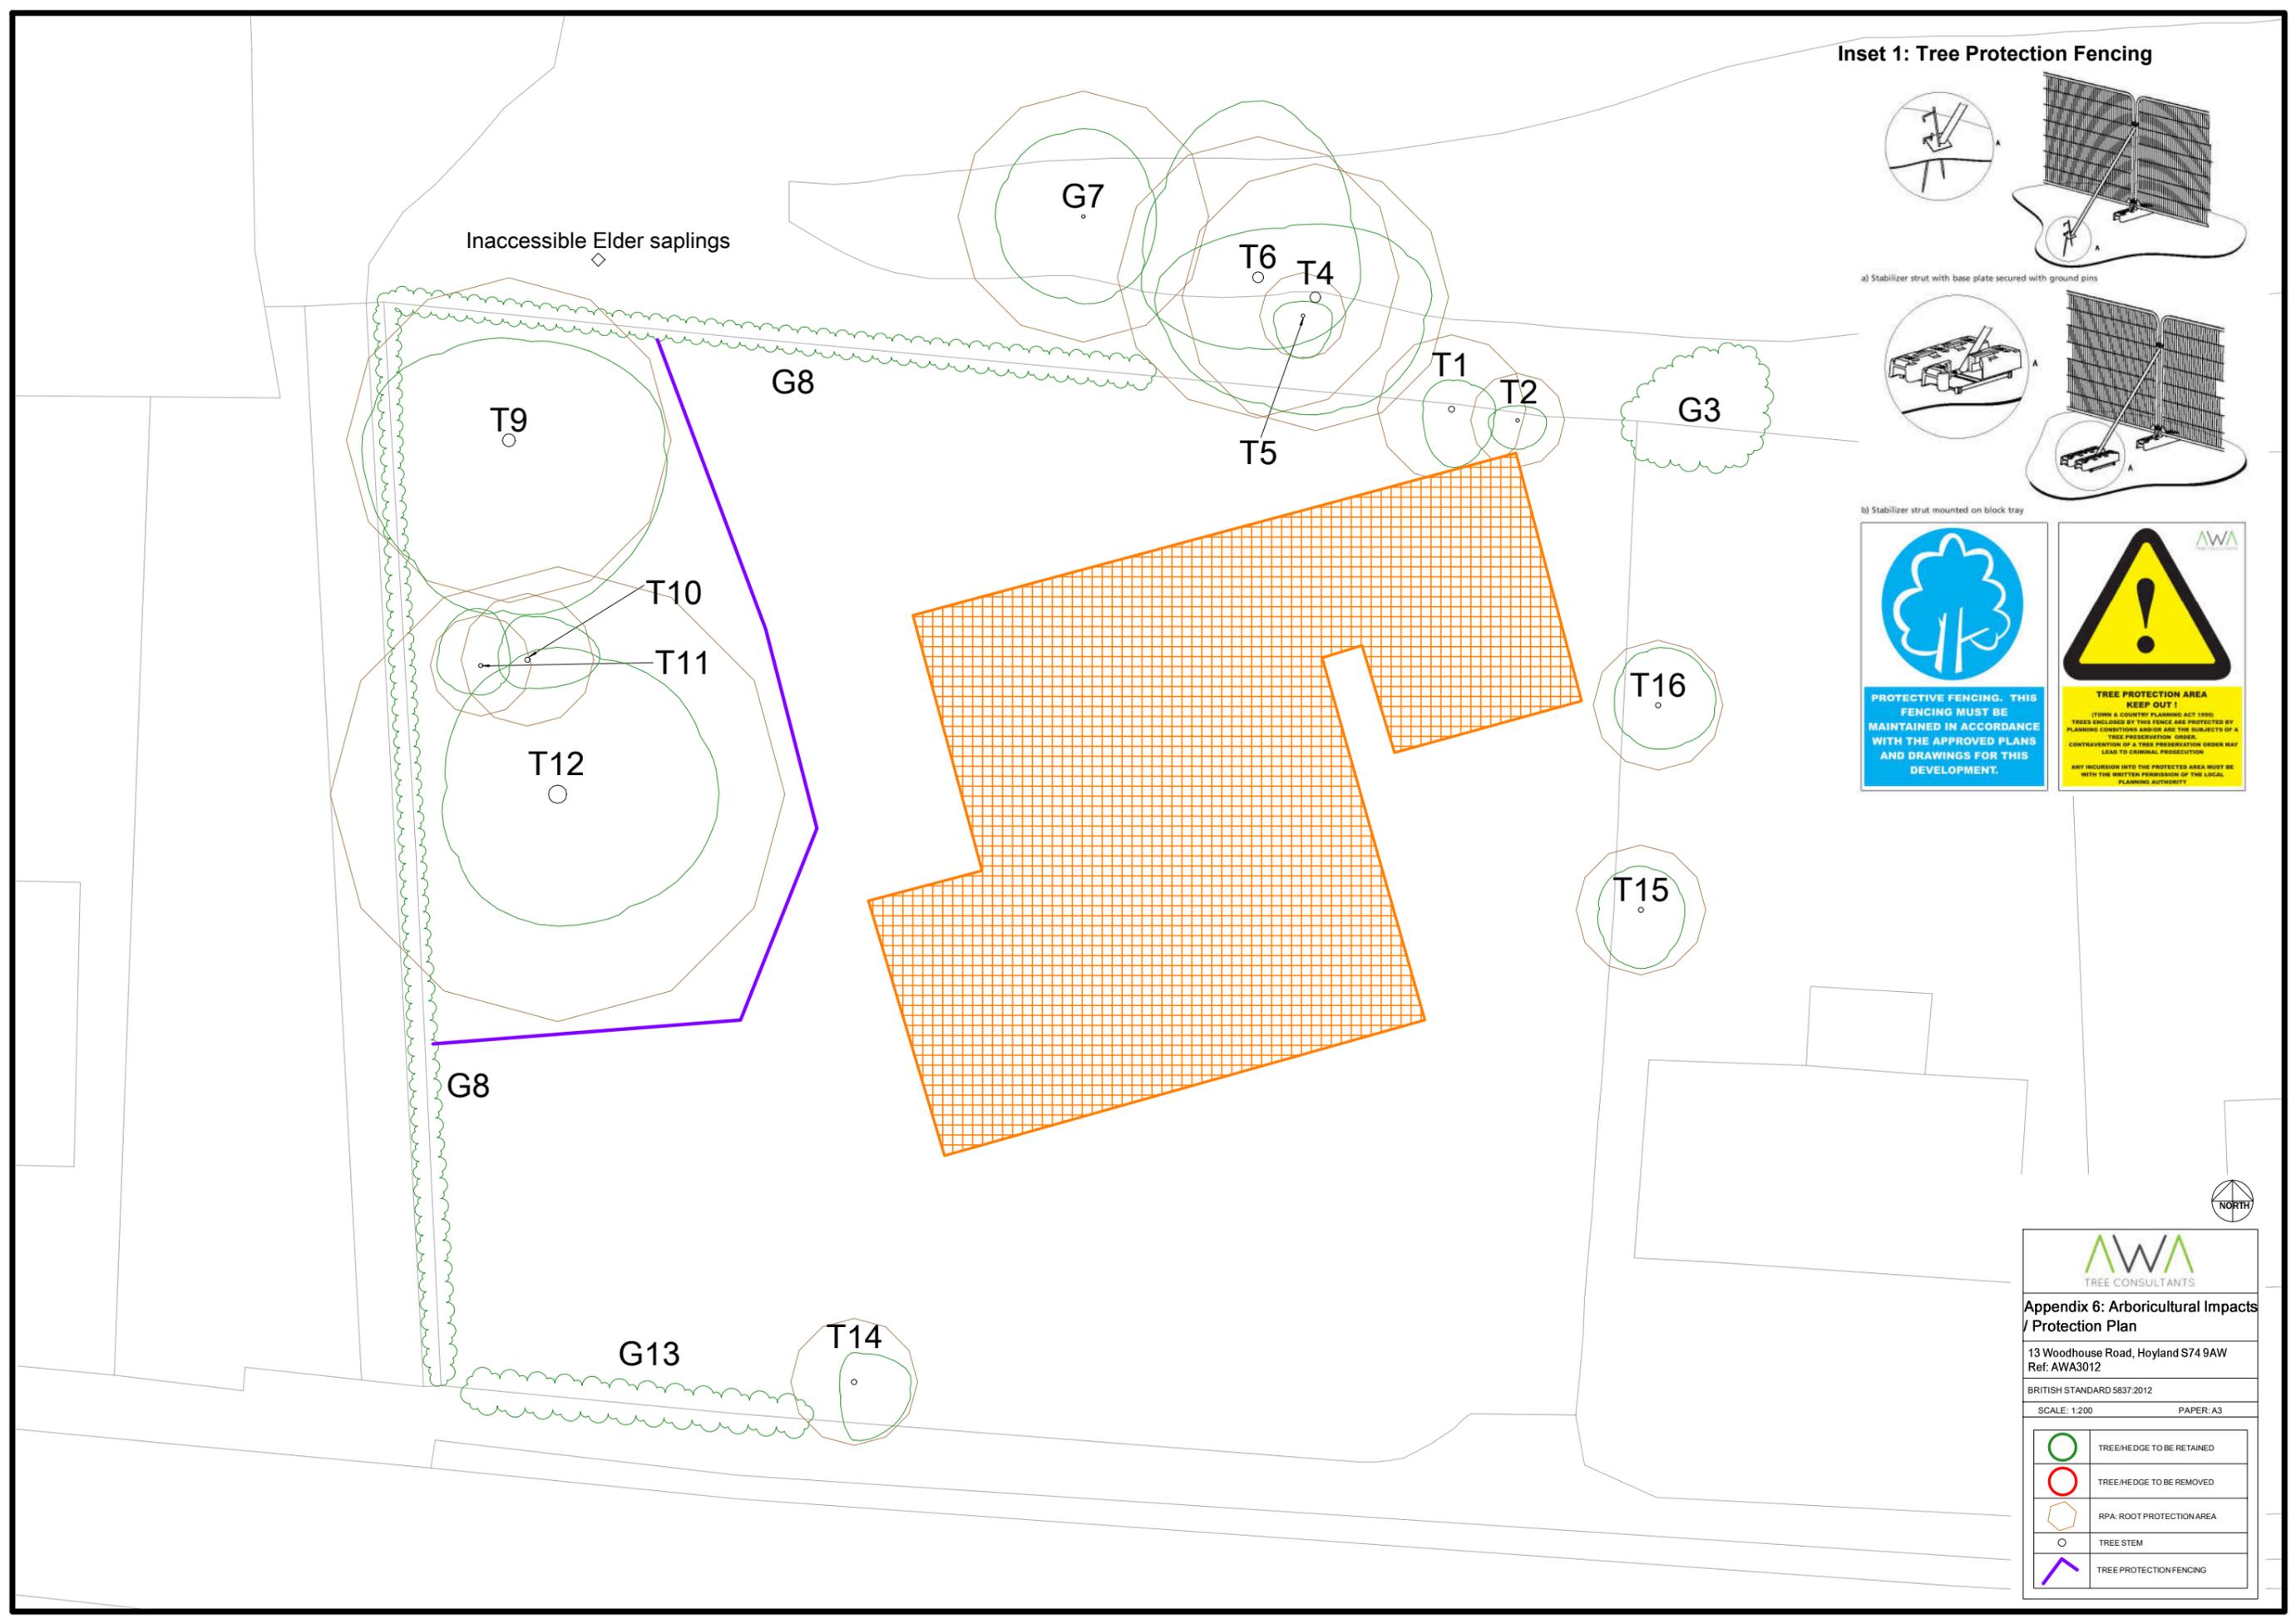
**Appendix 6: Arboricultural Impacts / Protection Plan**

4.2.2 The crowns of the shrubby holly trees T1 and T2 will require minor pruning to facilitate the new development. This will not negatively impact the prospects of value of the trees.

4.2.3 The proposed new garage encroaches close to and into the edge of the RPA of the Holly T1. Construction within the RPA, can have negative impacts on tree roots. However, the encroachment is minor, and it is unlikely that significant roots will be within these areas and the retained tree should remain largely unaffected by the works, provided care is taken during construction.

- 4.3.1 The retained trees will require protection by fencing in accordance with BS 5837: 2012, during the development phase.
- 4.3.2 The protective fencing for this site should be located as shown on the Tree Protection Plan (TPP) at Appendix 6 (as illustrated with a thick purple line).

- 4.3.4 The protective fencing will be appropriate to the degree and proximity of likely construction works. In this instance, the default BS5837 (2012) tree protection fencing is deemed disproportionate. It is suggested (if acceptable by the LPA) an adequate level of protection for the trees could be provided by 'Heras' type fencing, of welded mesh panels on rubber or concrete feet.
