**Structural Inspection Report**  
for

**Lower Coates Farm**

**Silkstone**

**September 2020**

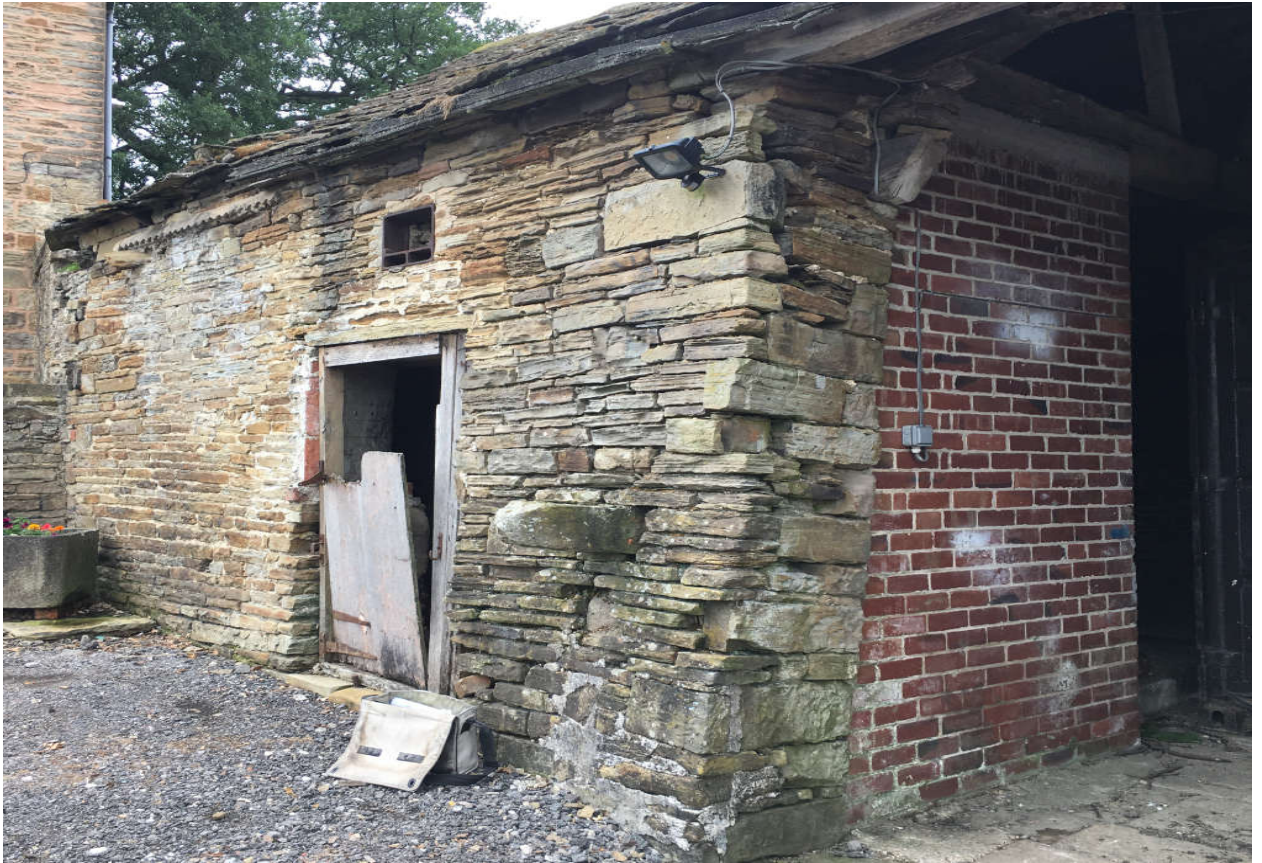
- 4.2 The walls local to the main opening on the east elevation appeared to lean into the building significantly and were buttressed by newer internal brickwork walls. The wall to the west elevation appeared to lean outwards by a modest degree. The majority of the stonework to the outer faces of the walls on the east elevation appeared to be very heavily weathered, with little mortar pointing evident.

- 5.1 The brick buttressing piers appeared to have been installed to prop up the leaning walls to the east elevation local to the main opening. It is not clear what has caused the outer walls to move so significantly, though a combination of foundation movement and a lack of head restraint was considered most likely. It was also thought possible that the opening had been enlarged at some point in the past and that this work had adversely affected the walls adjacent to the opening. The lean in the west wall was modest and considered likely to be the result of a loss of head restraint, most likely associated with the movement local to the opening in the east wall. The thickness of the wall was sufficient that, with the exception of the areas local to the main opening, the overall stability was not impaired.

7. Leaning Wall to Building 1 (LHS of opening)

- 6.1 Due to the significant lean in the external stone walls local to the main opening on the east elevation, it is considered necessary that they be taken down and re-built. The extent of these works would be approximately 1.0m from the left-hand edge of the opening and 2.0m from the right-hand edge.

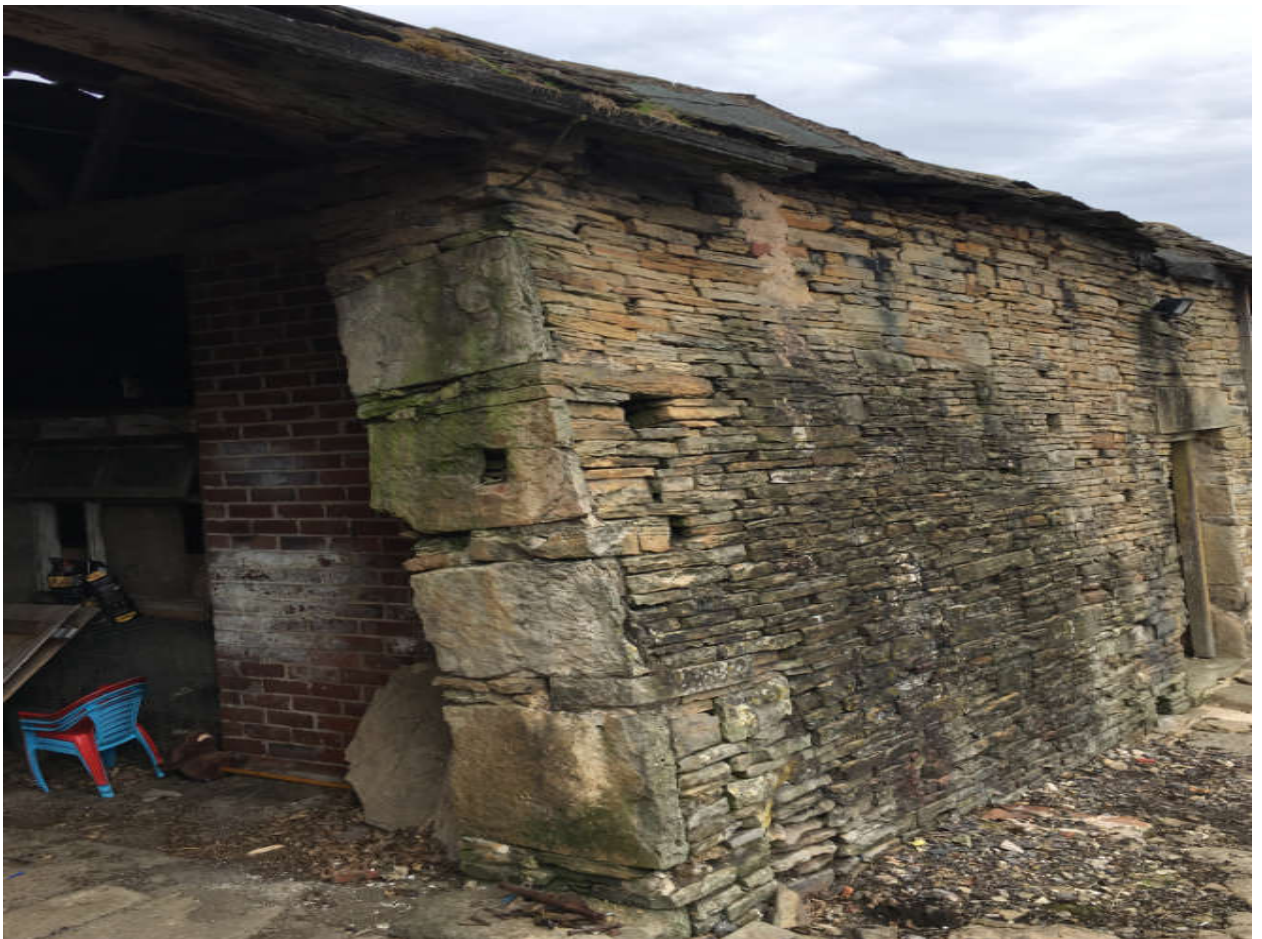
8. Leaning Wall to Building 1 (RHS of opening)

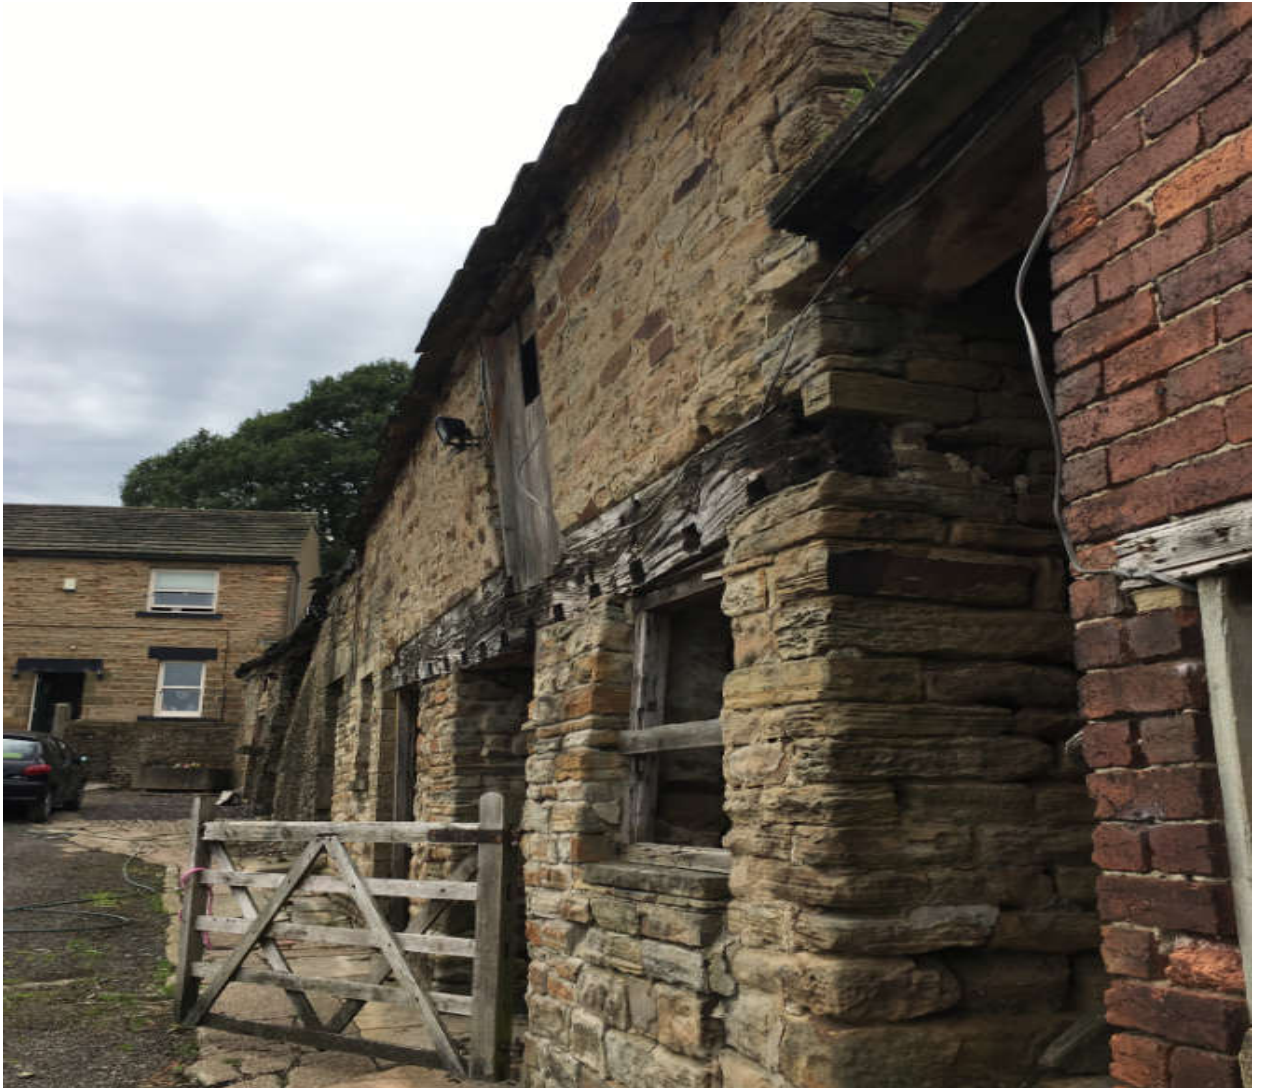
9. Leaning Wall and Timber Lintel to Building 3

- 6.9 The walls appeared sound and the only structural works considered necessary are the replacement of the timber lintel over the openings on the east elevation.
- 6.10 The timber roof structure was in reasonable condition and could be left insitu, subject to an inspection by a timber/damp specialist.
- 6.11 The timber first floor would need to be completely removed due to rot and infestation being apparent throughout, though it may be possible to salvage and re-use some of the larger sections, subject to an inspection by a timber/damp specialist
- 6.12 The existing ground floor slab will need to be removed so that a new damp-proofed and insulated slab can be cast, to suit the intended habitable usage.

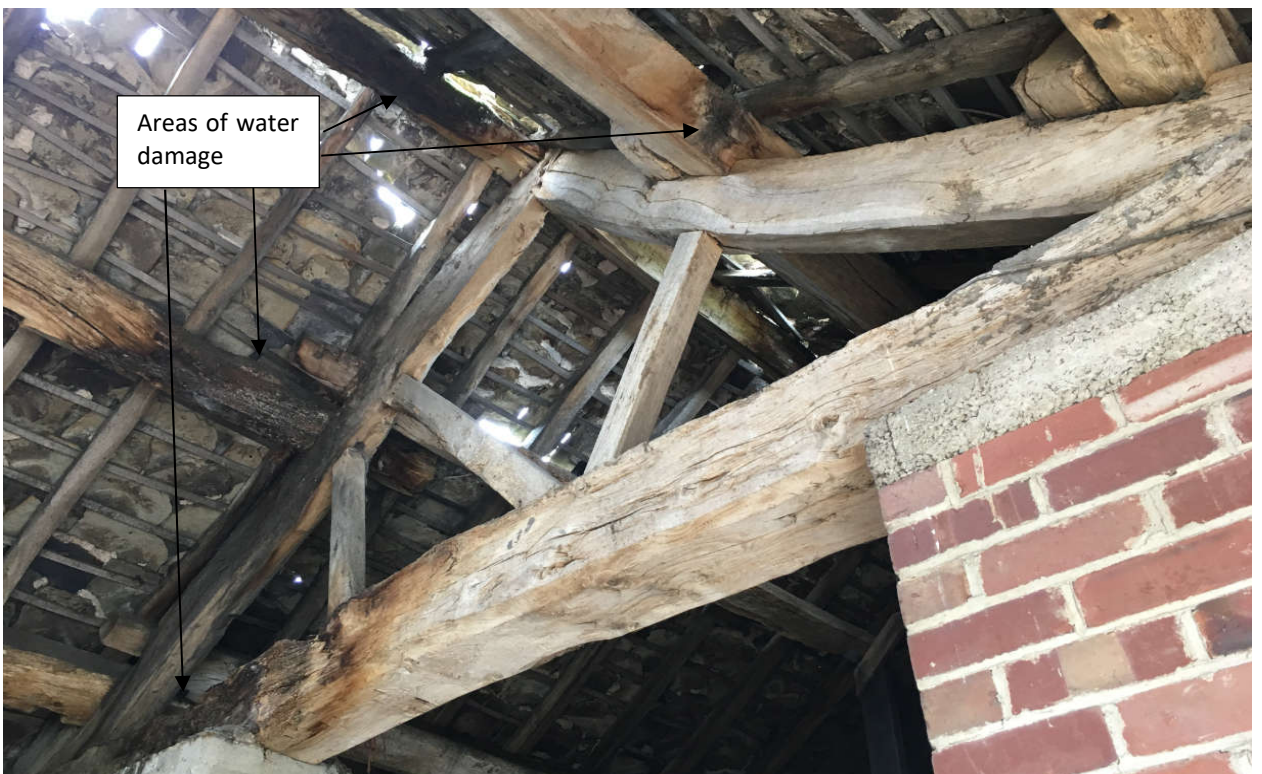
- 5.2 The structural timbers to the roof appeared to be in generally poor condition due to water ingress, though a close inspection could not be undertaken due to access issues. The two trusses closest to the farmhouse were formed from rough cut timbers of significant size. Several of the timber members had notches and holes in them, suggesting they had been reclaimed from another roof truss. Due to the size of the timbers, it was considered possible that they could be re-used if the apparent damage were restricted to a thin layer on the surface. The third truss appeared to be in much better condition.

10. Timber Truss in Building 1

- 6.3 It is considered unlikely that the existing timber trusses could be retained. Water ingress appears to have caused rot and decay in various members and damage from wood boring insect larvae is likely to be present, based on evidence seen elsewhere in the outbuildings. However, it may be possible to reclaim individual timber members from the trusses along with purlins and rafters for re-use in the conversion, subject to them being checked by a timber/damp specialist.

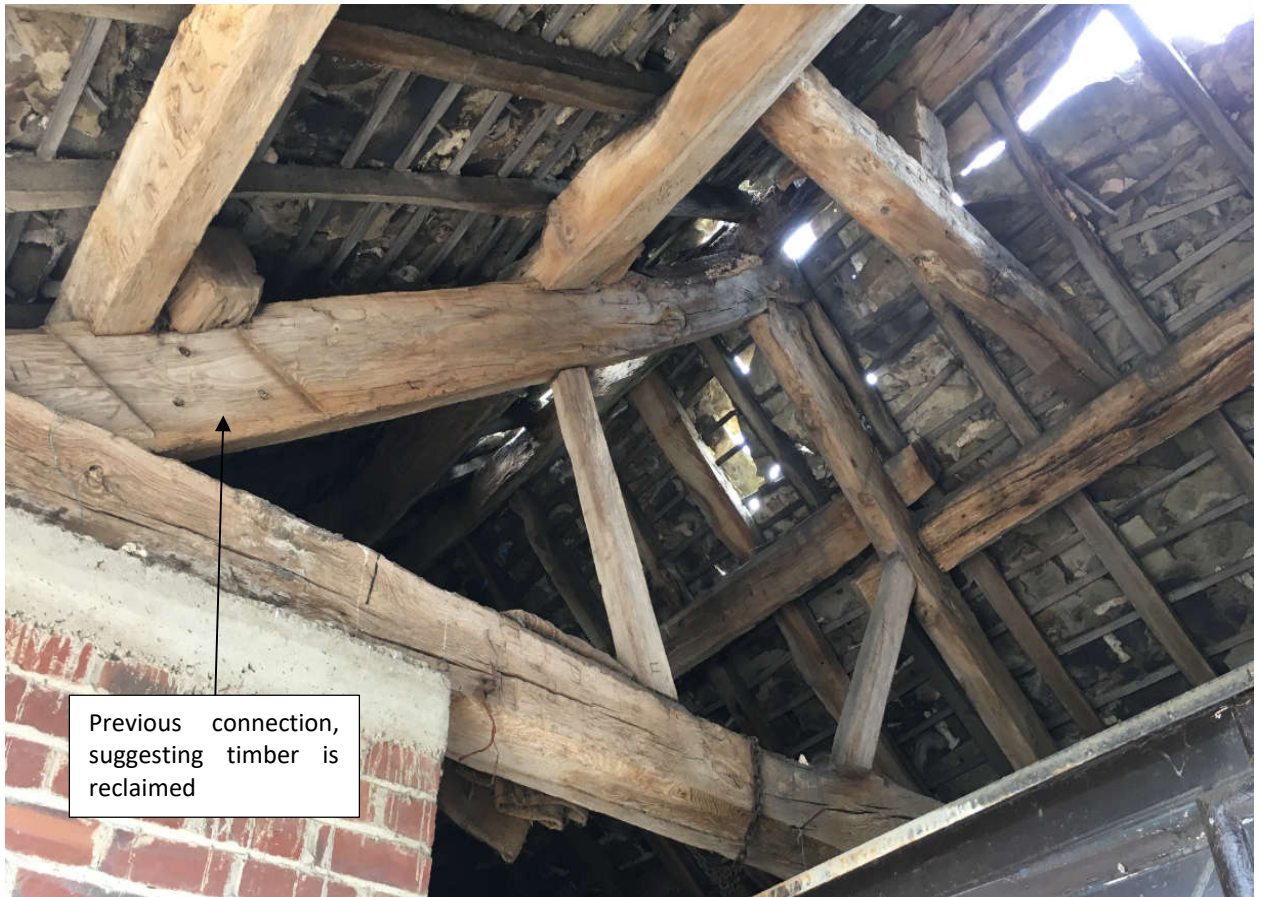
Previous connection,  
suggesting timber is  
reclaimed

11. Timber Truss in Building 1

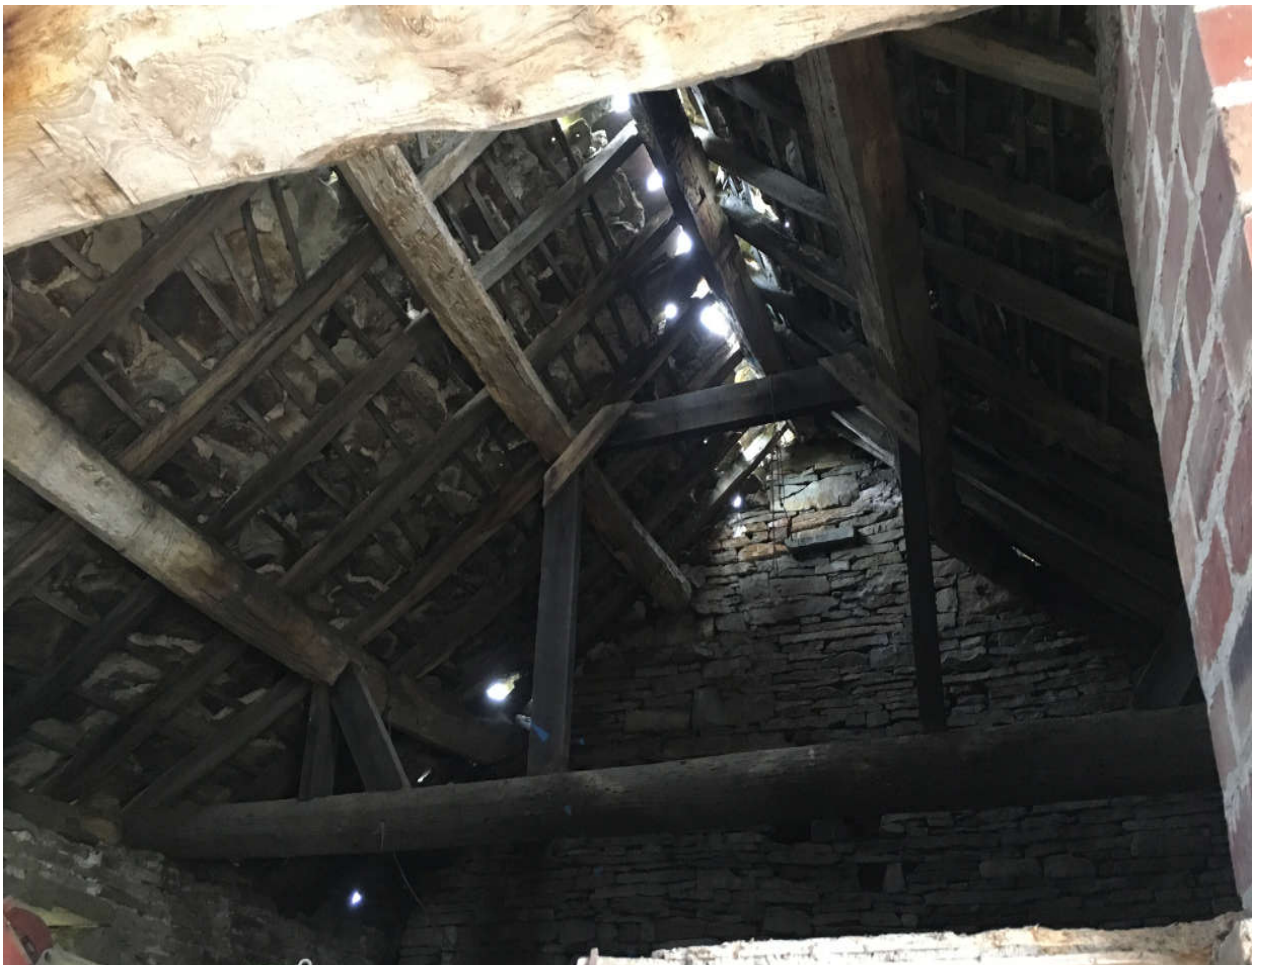
12. Timber Truss in Building 1

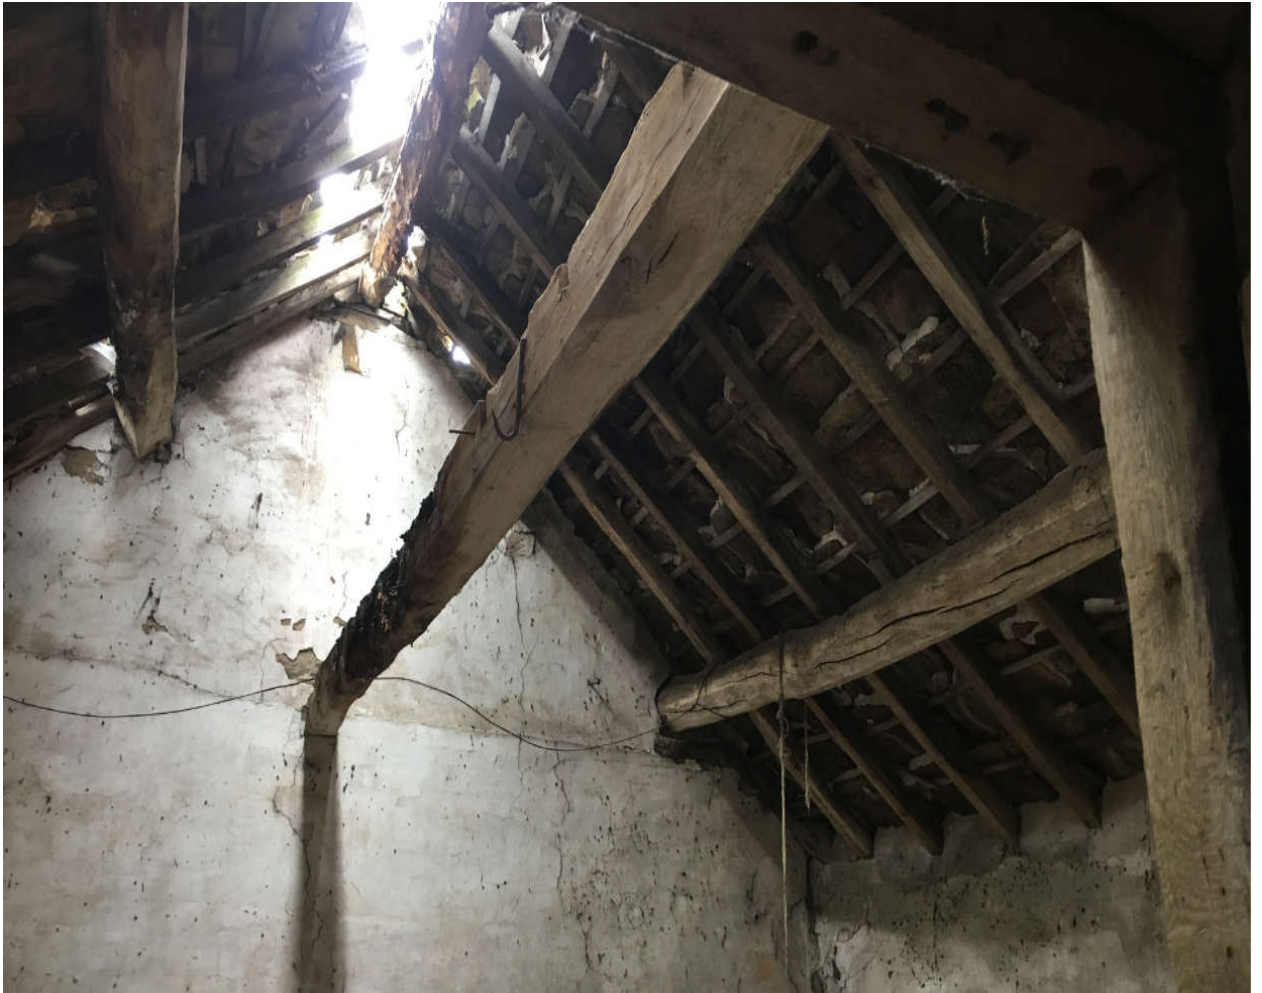
- 5.5 It was noted that the ridge timber was in very poor condition and that most of the defects in the roof covering were local to the ridge. Purlins and rafters further down the roof slope appeared to be in much better condition and potentially suitable for re-use. The rafters were from sawn timber while the purlins appeared to be rough cut timber.

13. Roof Structure to Building 2

- 6.6 Whilst the ridge beam and the ends of timbers connecting to it were in poor condition and would require replacing, the remainder of the timber members in the roof could be left in place, subject to an inspection by a timber/damp specialist.

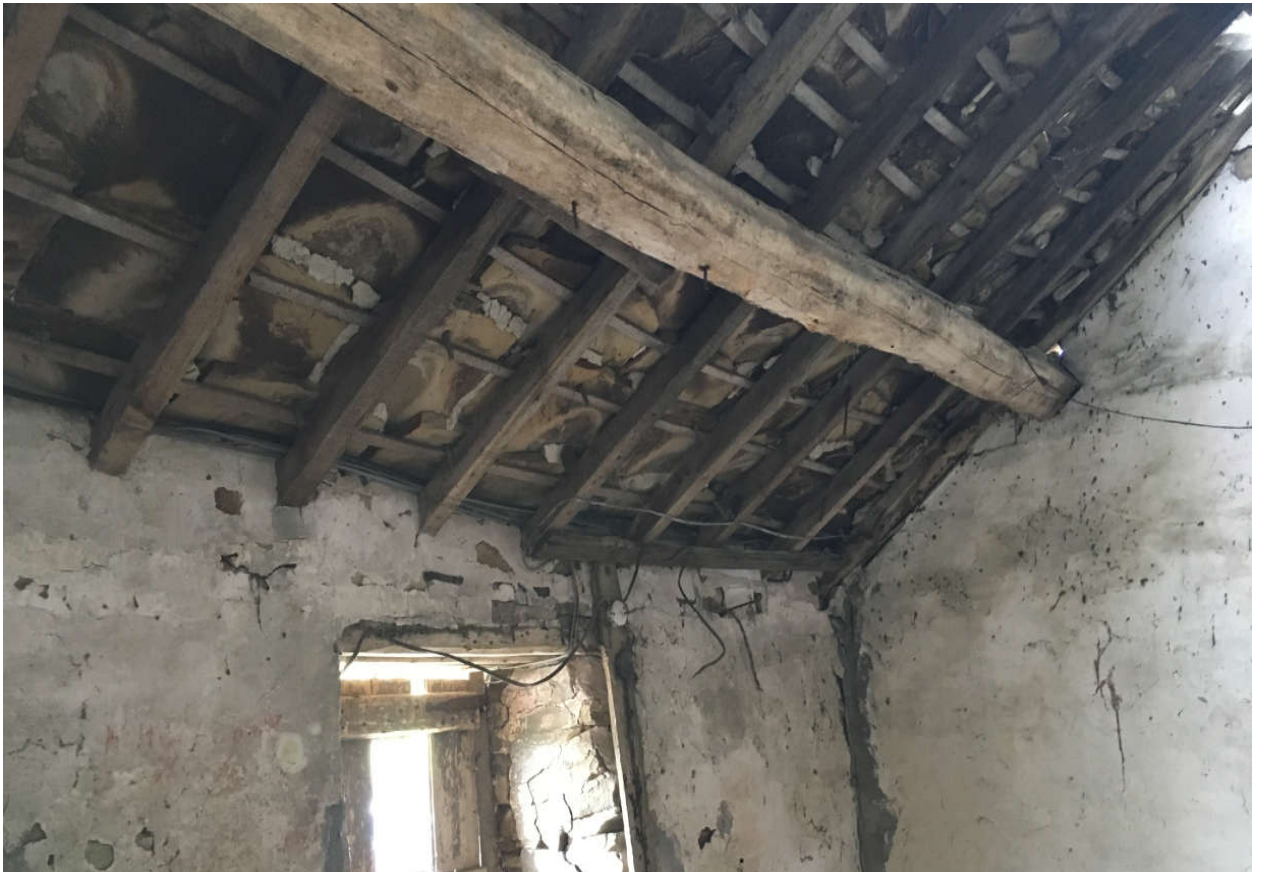
14. Roof Structure to Building 2

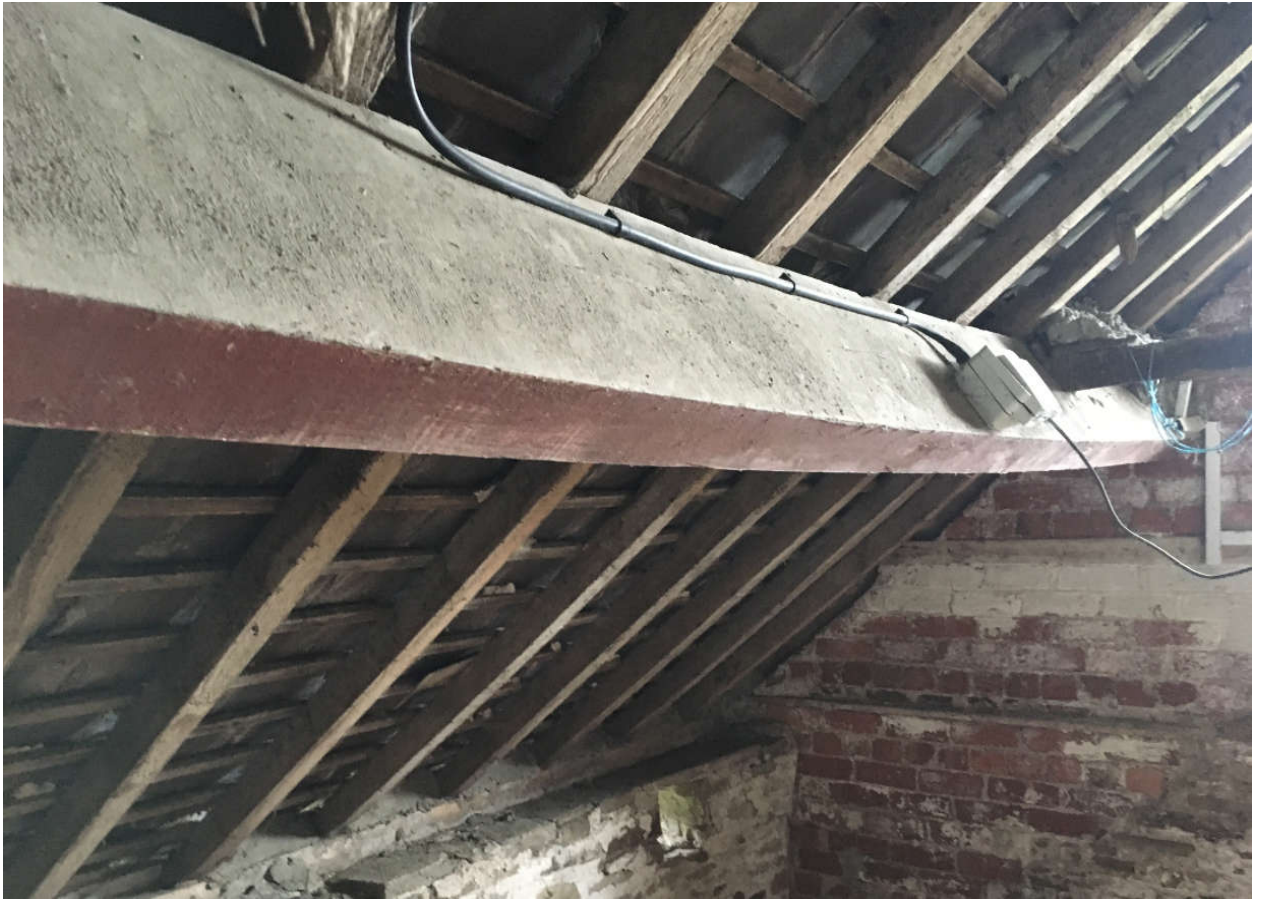
- 5.8 The brickwork walls were in reasonable condition and appeared relatively plumb, as did the stone walls to the west elevation.
- 5.9 The roof structure appeared to be in reasonable condition, with no obvious indications of rot or decay being evident. The slight bow in the purlins was not significant and all the timber elements were considered to be potentially suitable for re-use.

15. Purlin in Building 3 (Two storey part)

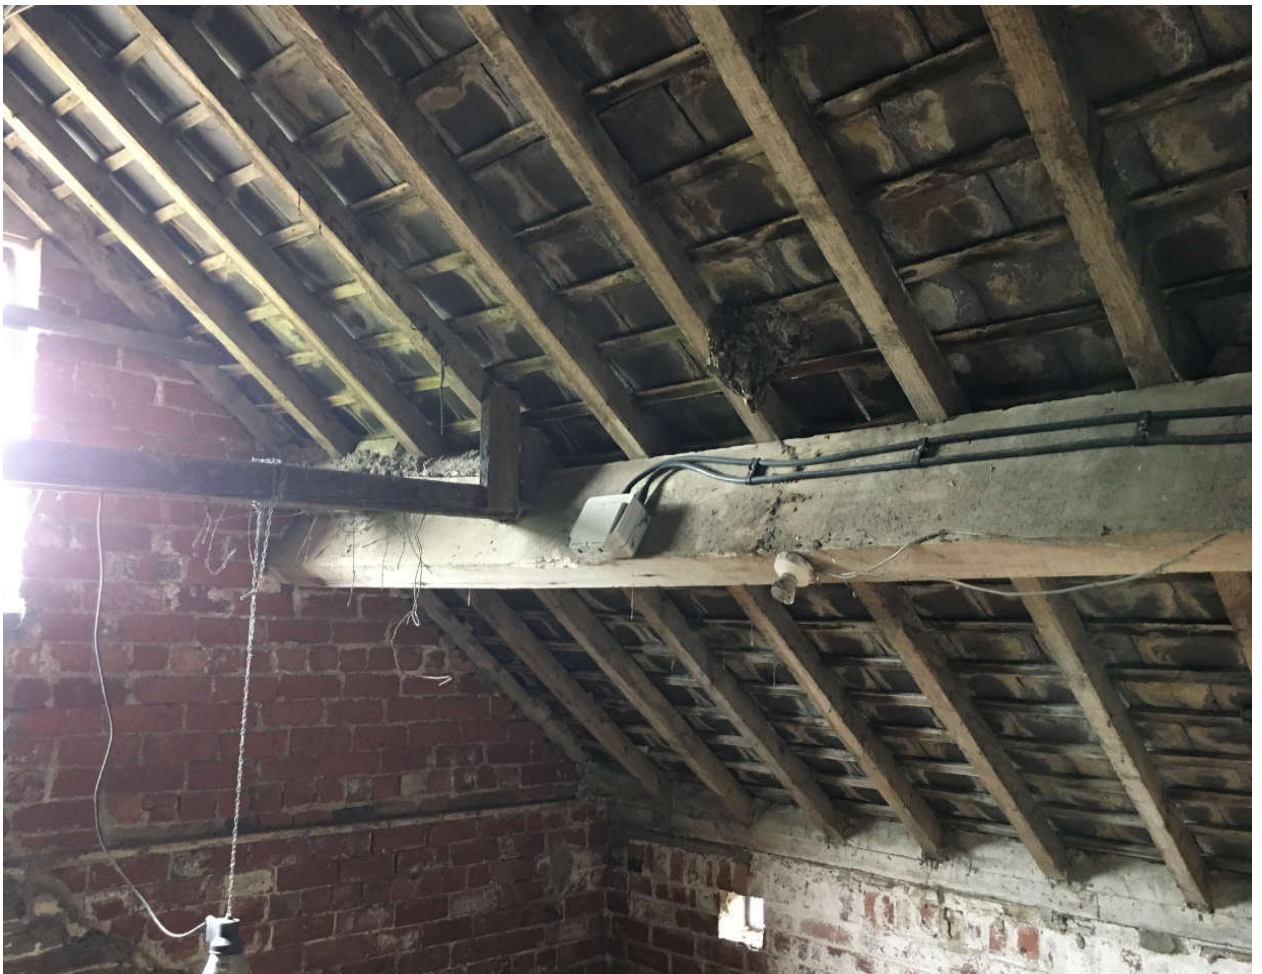
16. Purlin in Building 3 (Two storey part)

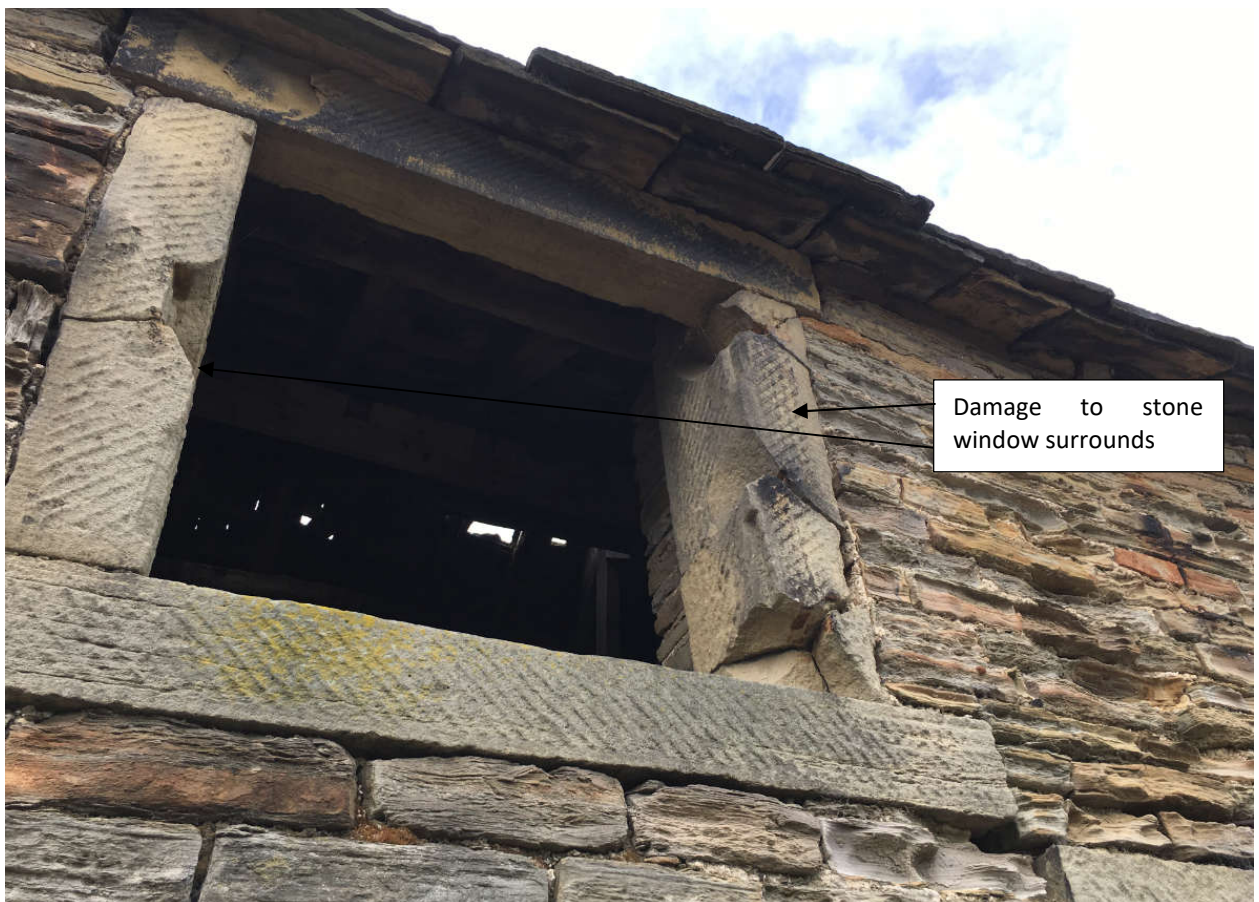
- 4.16 The walls to all four elevations appeared to be reasonably plumb, but exhibited signs of weathering, both to mortar joints and the outer faces of individual stones. Severe cracking and spalling were noted to the stone surrounds to the first-floor window on the east elevation.

- 5.12 The stonework walls were reasonably plumb to all elevations and the weathering was not considered to be causing any structural issues. The cracking and loss of section evident in the stone window surrounds was not considered to be of particular concern as the lintel above the window was only supporting a small width of roof structure along with its own weight.

18. Damaged Window Surrounds to Building 4

- 6.13 The walls appeared generally sound and the only structural works considered necessary are the replacement of the stone window surrounds to the first-floor window on the east elevation.
- 6.14 It is possible that the timber truss could be re-used, subject to a specialist inspection to confirm it is free from decay and insect larvae. The purlins may also be salvageable but at least one of them appeared to have defects that would preclude re-use.
- 6.15 The timber first floor would need to be completely removed due to rot and infestation being apparent throughout, though it may be possible to salvage and re-use some of the larger sections, subject to an inspection by a timber/damp specialist.
- 6.16 The existing ground floor slab will need to be removed so that a new damp-proofed and insulated slab can be cast, to suit the intended habitable usage.

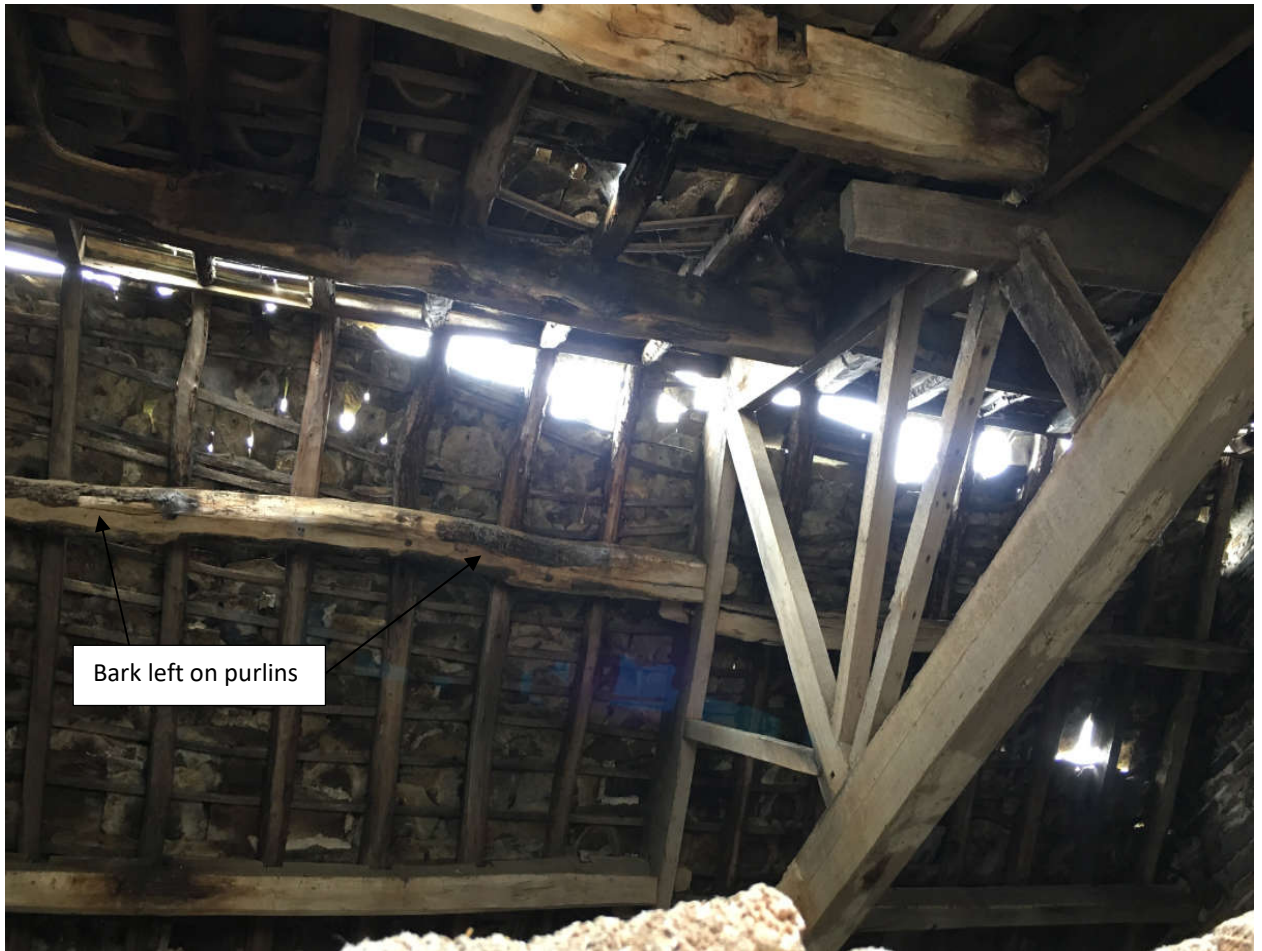
- 5.13 The single truss was formed from cut timber elements and appeared to be in reasonable condition. The purlins were also in reasonable condition, with occasional areas of dampness evident where water had run down individual rafters. Several of the purlins appeared to have areas of bark on their surfaces, suggesting they were formed from trees felled near the site. The appearance of the rafters suggested that they had been formed in a similar way. The intermediate purlin on the eastern roof pitch was noted to exhibit significant deflection local to its bearing on the wall shared with building 3. This was considered to be due to the fact that the purlin had a much smaller cross section near the bearing than over the rest of its length, perhaps due to loss of material from decay or rot. The lower purlin had notches cut into it at regular centres, suggesting it had been recovered from another building. It was also noted to contain a significant split near mid-span.

19. Roof Structure to Building 4

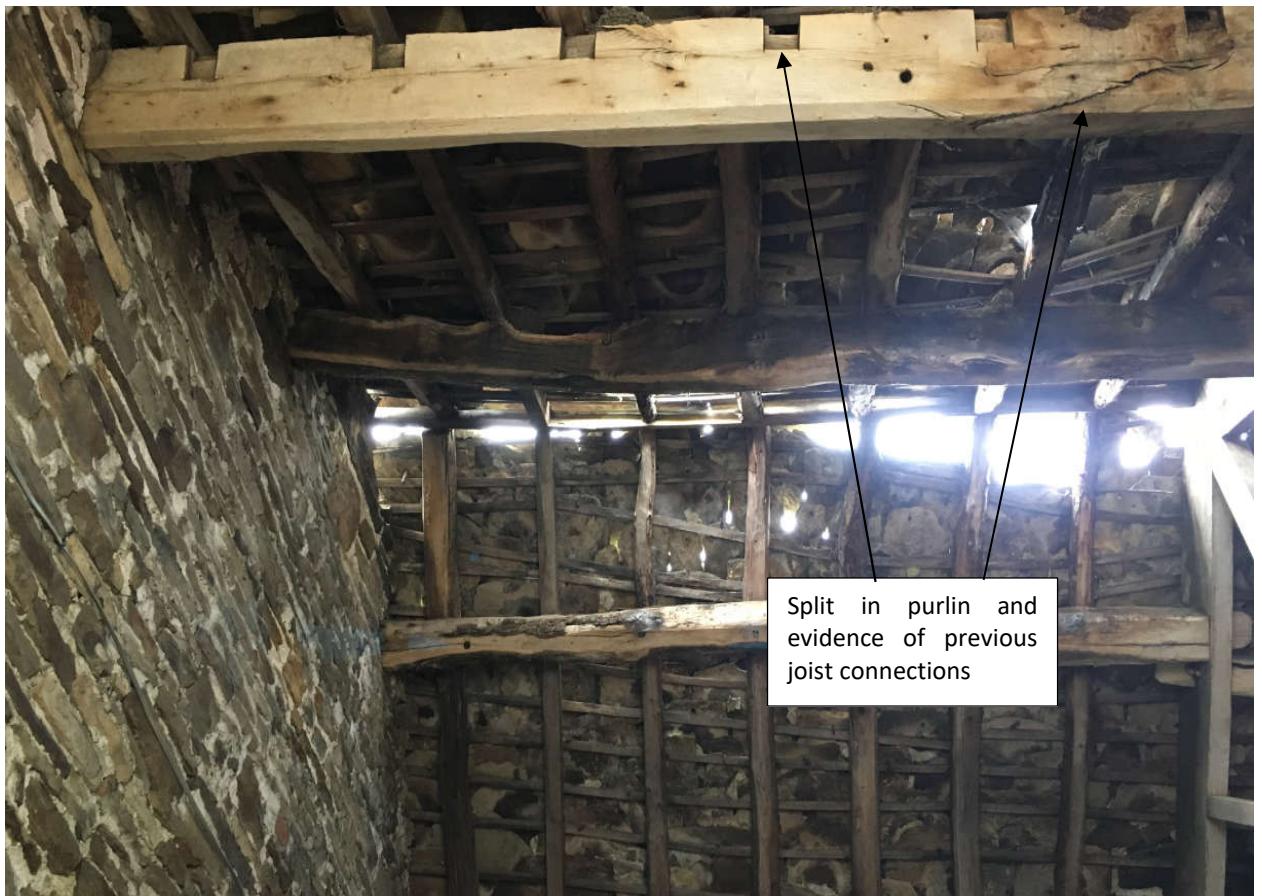
20. Purlins to Building 4

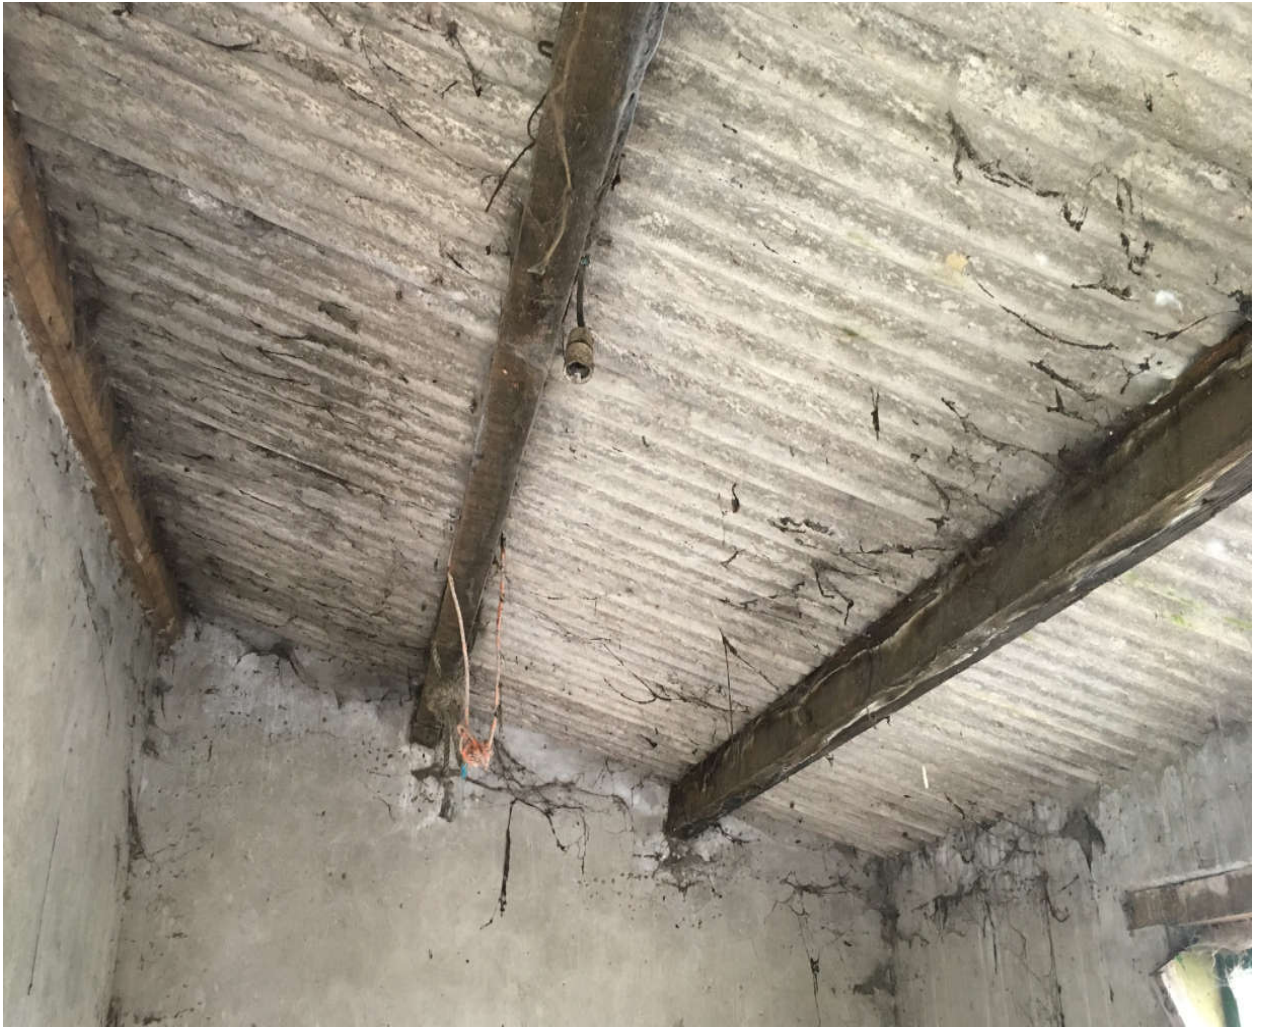
- 5.16 The walls and roof to the lean-to appeared to be in reasonable condition, with no indications of movement or structural distress. The corrugated roof sheet was considered likely to be made from asbestos cement.
- 5.17 Whilst the ground floor slab appeared substantially sound, it was considered unlikely that it would be retained as part of a residential conversion, due to lack of DPM and insulation.

21. Roof Structure to Building 5

- 6.17 Both the walls and roof could remain insitu, with no structural works being considered necessary to either element. It is likely that the roof sheeting would be removed as part of any refurbishment works, and this should be tested for asbestos before being disposed of in an appropriate manner.
- 6.17 The existing ground floor slab will need to be removed so that a new damp-proofed and insulated slab can be cast, to suit the intended habitable usage.

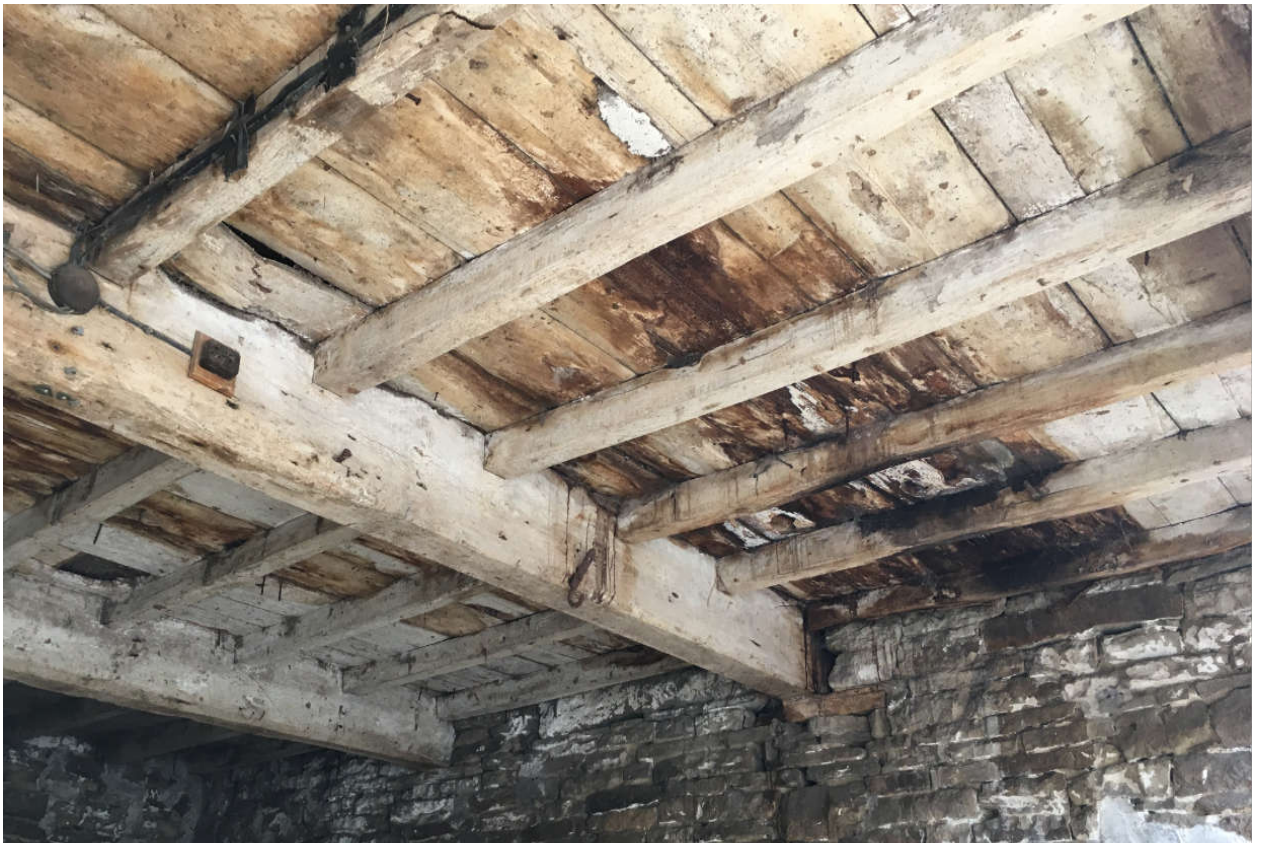
- 5.6 The timber first floor was in uniformly poor condition with evidence of rot and infestation throughout. Several areas were noted where rotten boards had broken or fallen away and left voids in the floor. The two main floor beams were of significant cross-section and it was considered possible that they could be re-used if the apparent damage were restricted to a thin layer on the surface.

22. Floor Structure to Building 2

- 6.7 The timber first floor would need to be completely removed due to rot and infestation being apparent throughout, though it may be possible to salvage and re-use some of the larger sections, subject to an inspection by a timber/damp specialist.

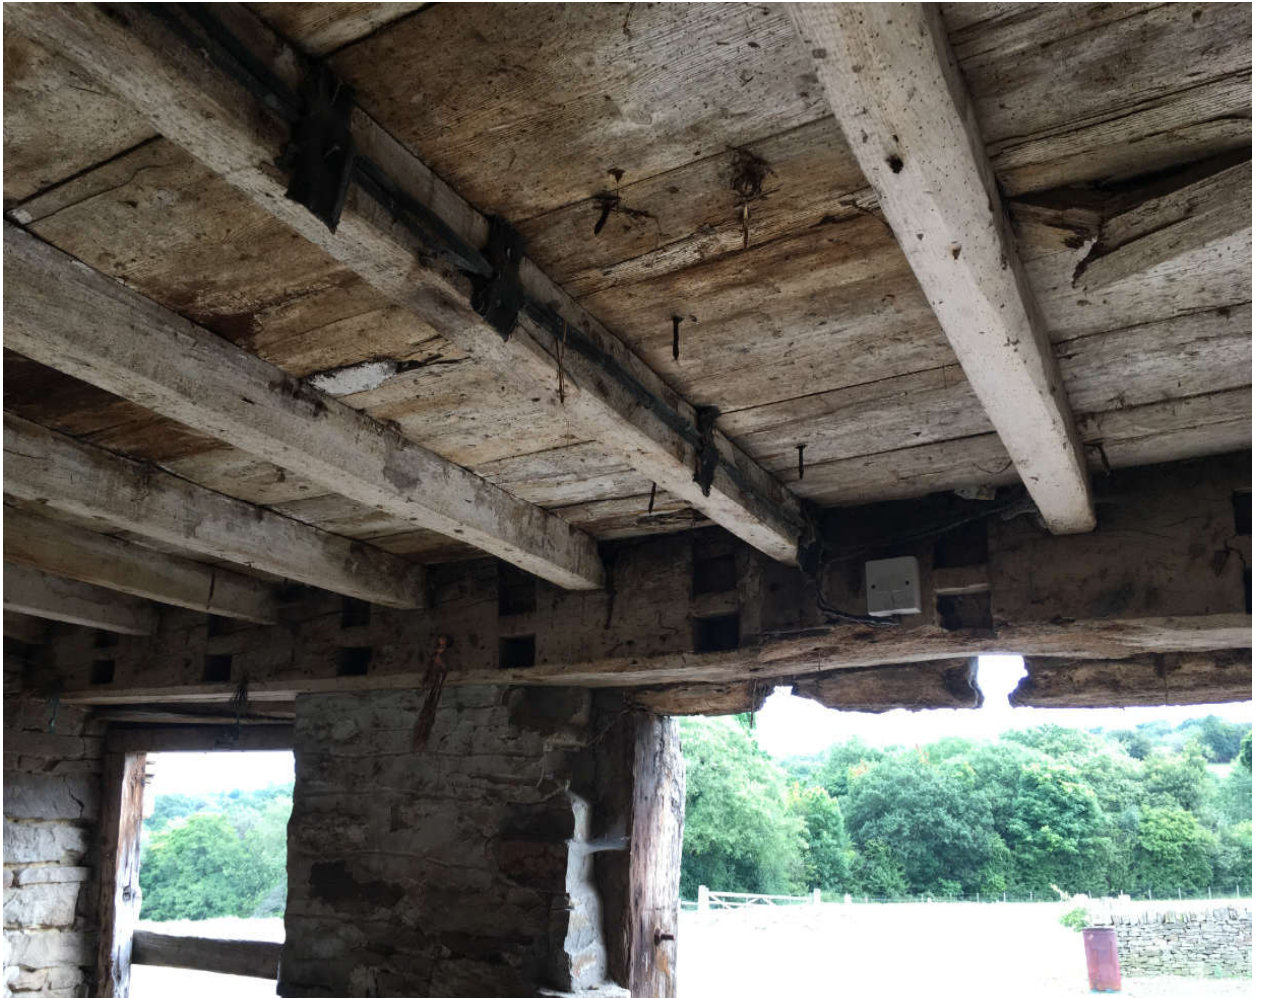
23. Floor Structure to Building 2

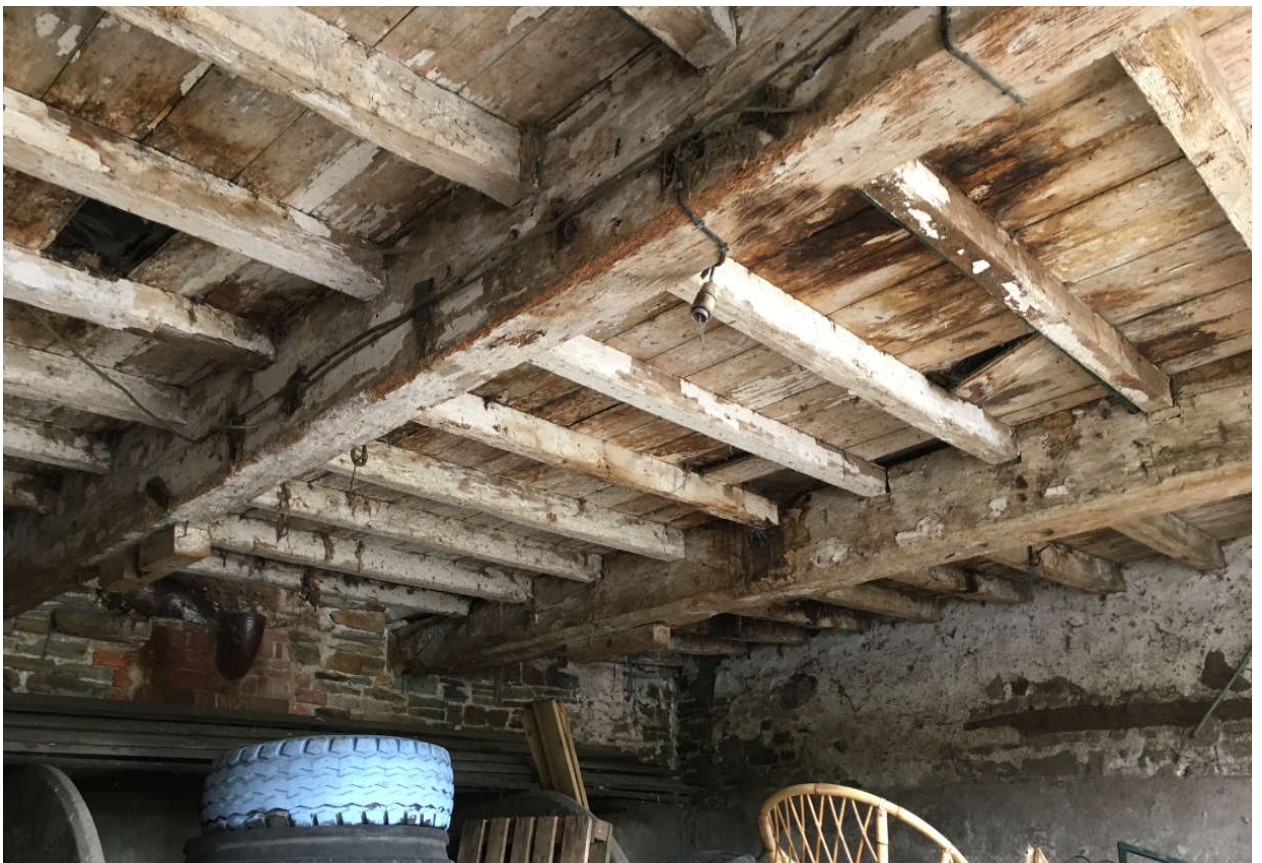
- 5.14 The timber first floor was in uniformly poor condition with evidence of rot and infestation throughout. Several areas were noted where rotten boards had broken or fallen away and left voids in the floor. The two main floor beams were of significant cross-section and it was considered possible that they could be re-used if the apparent damage were restricted to a thin layer on the surface.

24. Floor Structure to Building 4
