**Structural Inspection Report**  
for

**Lower Coates Farm**

**Silkstone**

**September 2020**

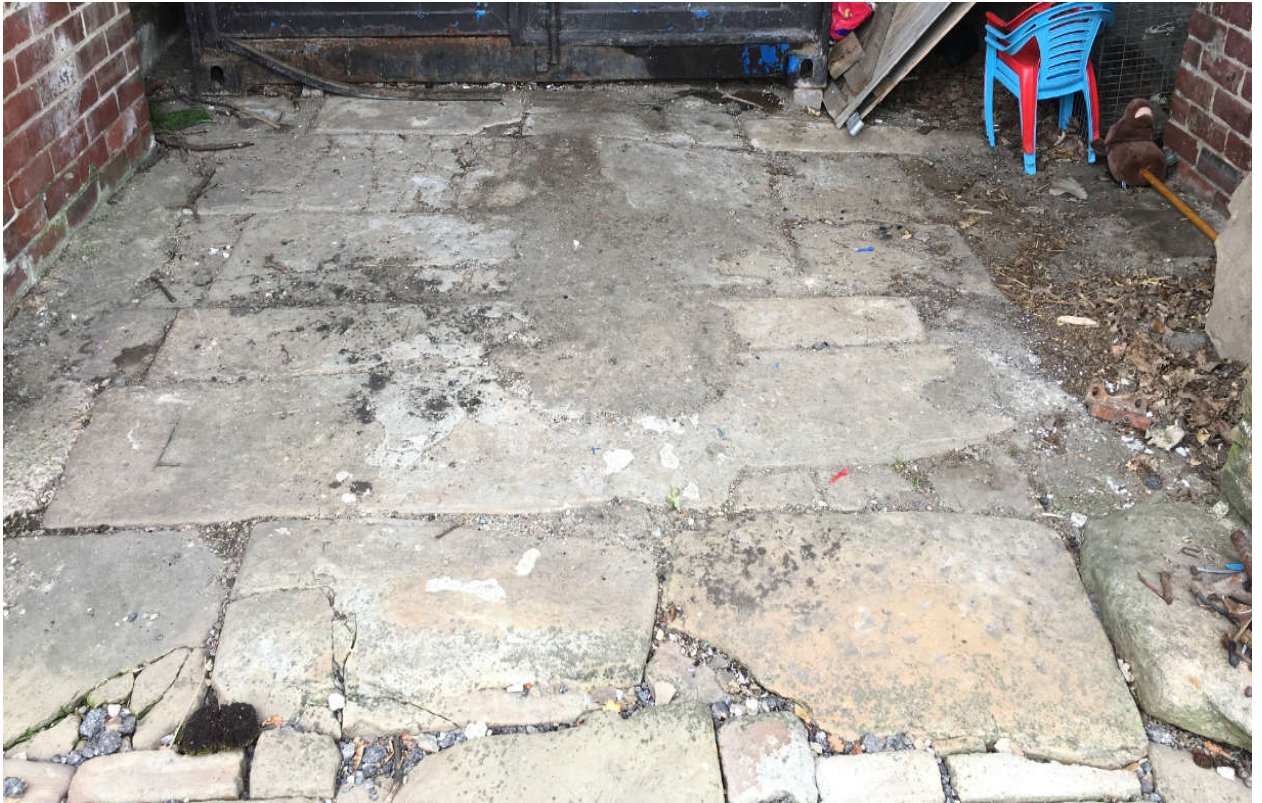
- 5.3 Although the areas of ground floor slabs that could be inspected appeared to be in poor condition, it was considered likely that the stone slabs could be recovered and re-used.

25. Stone Flags to Floor of Building 1

- 6.4 The existing ground floor slab will need to be removed so that a new damp-proofed and insulated slab can be cast, to suit the intended habitable usage.

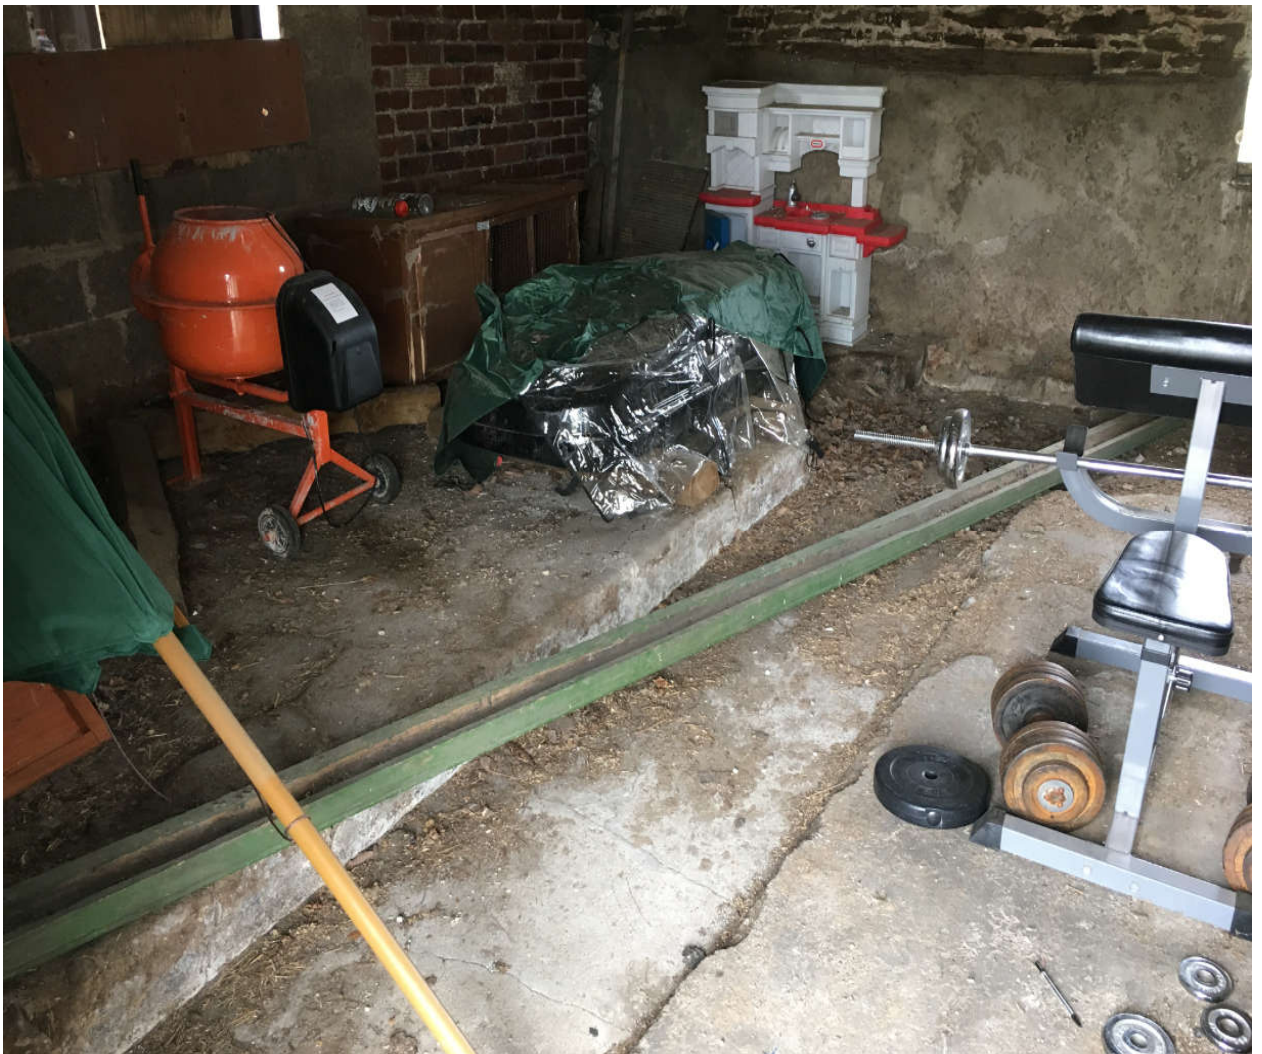
- 5.7 Whilst the ground floor slab appeared substantially sound, it was considered unlikely that it would be retained as part of a residential conversion, due to lack of DPM and insulation.

26. Floor to Building 2

- 6.8 The existing ground floor slab will need to be removed so that a new damp-proofed and insulated slab can be cast, to suit the intended habitable usage.
