Drainage Report

Barnsley Hospital, Gawber Road

Barnsley Hospital - CCTV Survey Report : 28/01/19

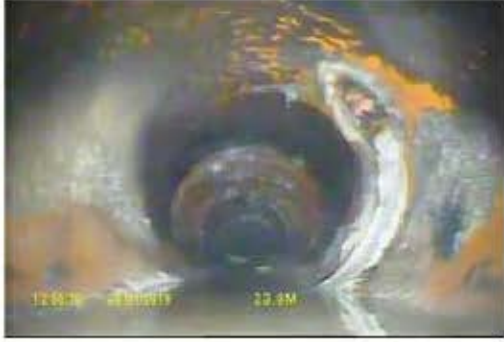
23.80m	0:01:38	DEE	Attached deposits, encrustation from 12 o'clock to 06 o'clock: 10% Cross sectional area loss - Severity 3	<p>Image Provided - Ref: 0_4</p>

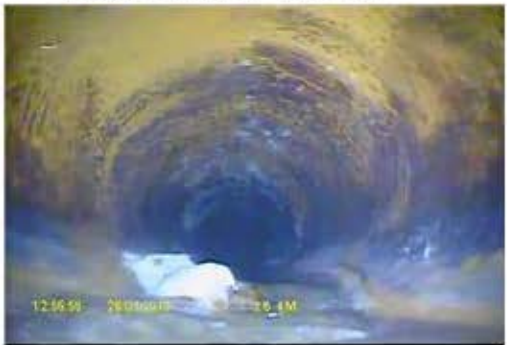
26.40m	0:02:14	D	Deformed drain/sewer: 10% Height/Diameter - Severity 4	Image Provided - Ref: 0_6

26.40m		SA	Survey abandoned Unable to pass deformed pipe.

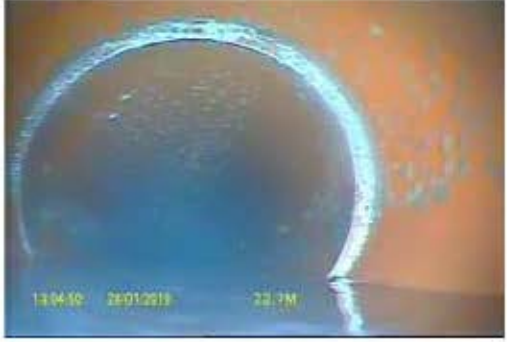
22.70m	0:01:15	JDM	Joint displaced medium - Severity 3	<p>Image Provided - Ref: 1_4</p>

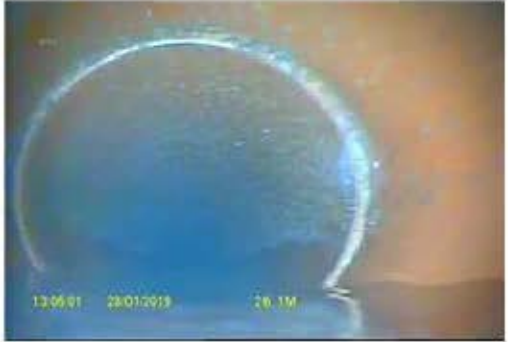
Pos	Video Ref	Code	Description	Image
26.10m	0:01:25	JDM	Joint displaced medium - Severity 3	Image Provided - Ref: 1_5

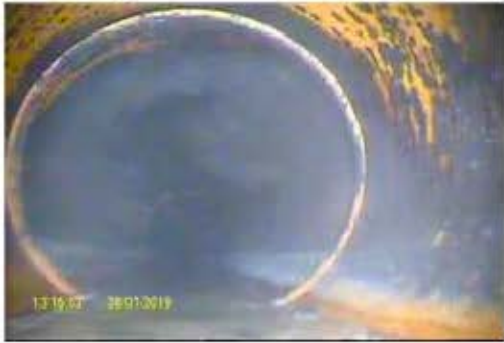
19.80m	0:01:34	JDM	Joint displaced medium - Severity 3	<p>Image Provided - Ref: 2_5</p>

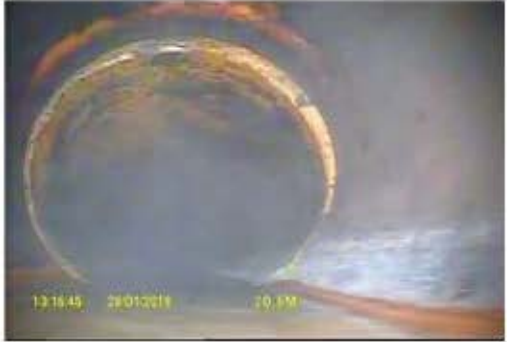
Pos	Video Ref	Code	Description	Image
20.50m	0:02:17	JDM	Joint displaced medium - Severity 3	Image Provided - Ref: 2_6

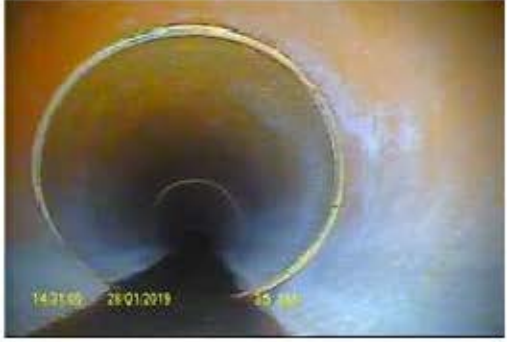
35.30m	0:01:20	JDM	Joint displaced medium - Severity 3	Image Provided - Ref: 4_4

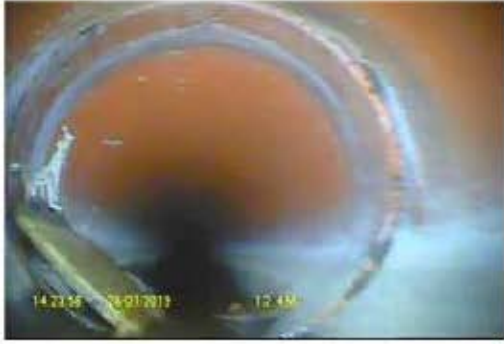
11.30m	0:00:47	OB	Other obstacles: 30% Cross sectional area loss - Severity 3	Image Provided - Ref: 5_4

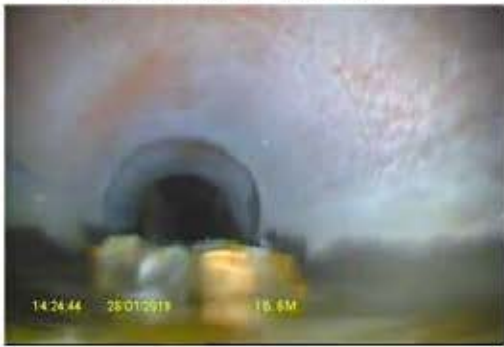
15.60m	0:01:33	OB	Other obstacles: 30% Cross sectional area loss - Severity 3	Image Provided - Ref: 5_6

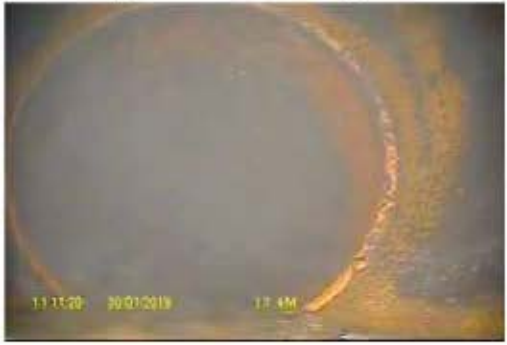
17.40m	0:01:29	JDM	Joint displaced medium - Severity 3	<p>Image Provided - Ref: 9_4</p>

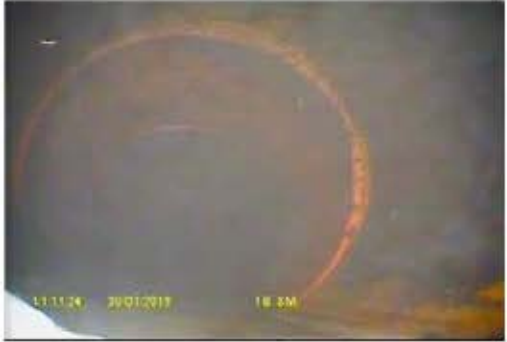
Pos	Video Ref	Code	Description	Image
18.80m	0:01:33	JDM	Joint displaced medium - Severity 3	Image Provided - Ref: 9_5

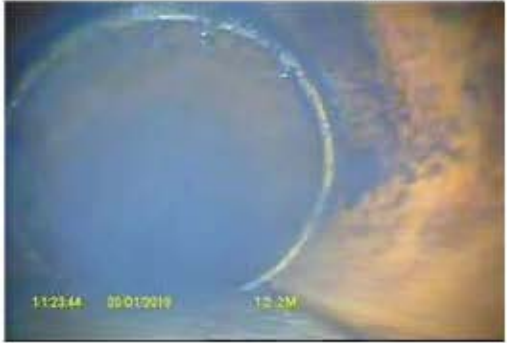
12.20m	0:00:39	JDM	Joint displaced medium - Severity 3	Image Provided - Ref: 10_5

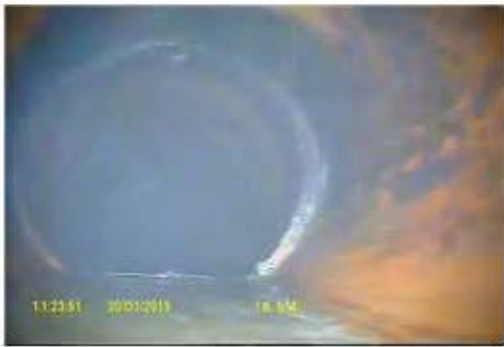
Pos	Video Ref	Code	Description	Image
16.60m	0:00:46	JDM	Joint displaced medium - Severity 3	Image Provided - Ref: 10_6

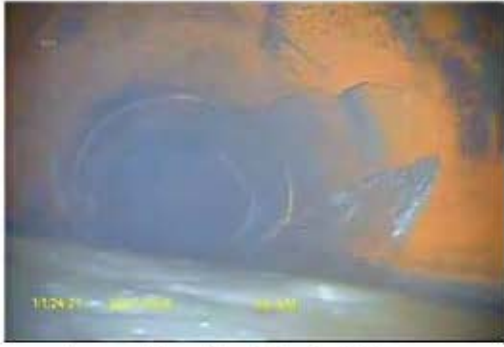
18.60m	0:00:54	S1 WL	Water level 18.6m - 30m: 40% Height/Diameter	
26.40m	0:01:04	CM	Cracks, multiple from 12 o'clock to 06 o'clock - Severity 2	Image Provided - Ref: 10_8

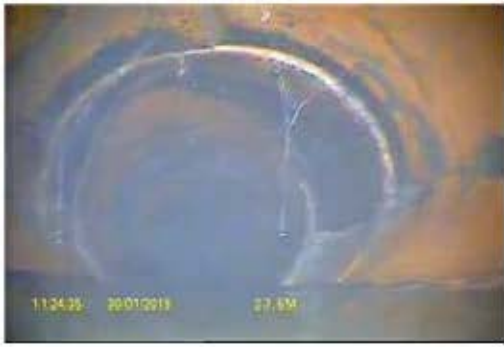
27.60m	0:01:31	CM	Cracks, multiple from 09 o'clock to 03 o'clock - Severity 2	Image Provided - Ref: 10_9

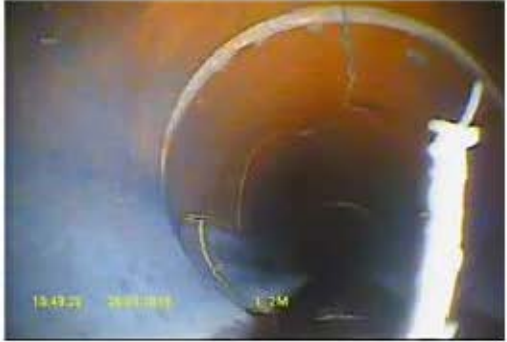
Pos	Video Ref	Code	Description	Image
00.00m		MH	Start node type, manhole MH04	
00.00m	0:00:00	WL	Water level: 0% Height/Diameter	
01.20m	0:00:14	JDM	Joint displaced medium - Severity 3	Image Provided - Ref: 12_2

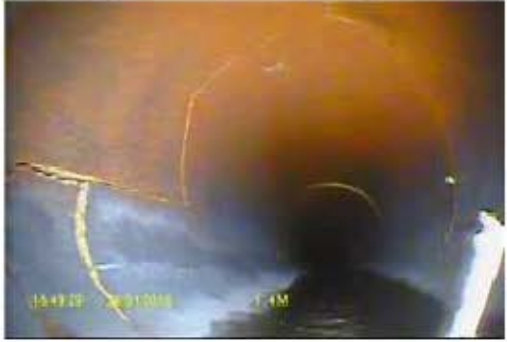
01.40m	0:00:15	CC	Crack, circumferential from 06 o'clock to 12 o'clock - Severity 1	Image Provided - Ref: 12_3

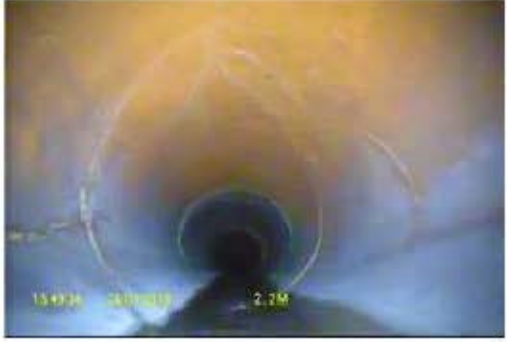
02.20m	0:00:20	CC	Crack, circumferential from 03 o'clock to 09 o'clock - Severity 1	Image Provided - Ref: 12_4

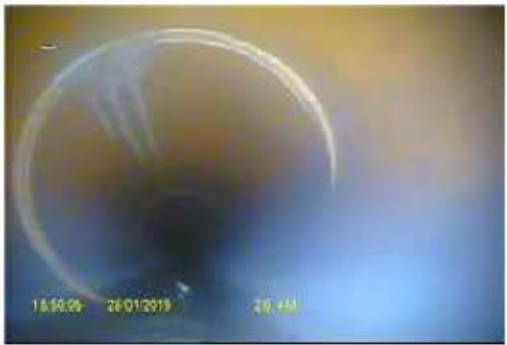
20.40m	0:00:53	JDM	Joint displaced medium - Severity 3	Image Provided - Ref: 12_7

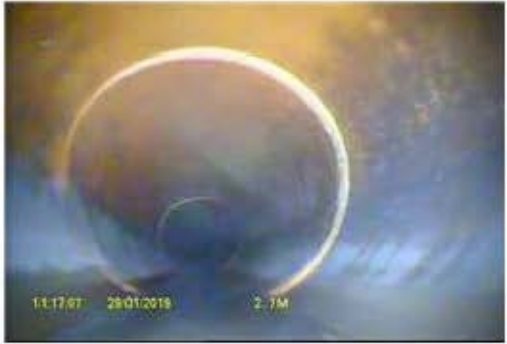
Pos	Video Ref	Code	Description	Image
00.00m		MH	Start node type, manhole MH06	
00.00m	0:00:00	WL	Water level: 0% Height/Diameter	
02.70m	0:00:27	JDM	Joint displaced medium - Severity 3	<p>Image Provided - Ref: 16_2</p>

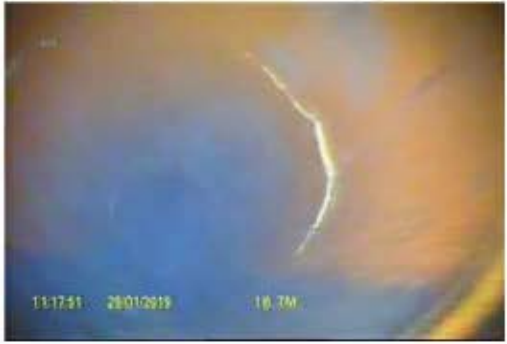
16.70m	0:01:11	CC	Crack, circumferential from 12 o'clock to 06 o'clock - Severity 1	<p>Image Provided - Ref: 16_3</p>

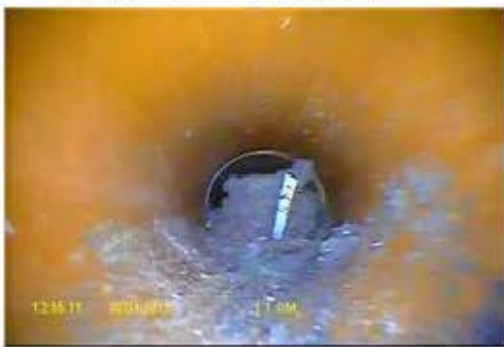
11.00m	0:00:47	DES	Settled deposits fine: 90% Cross sectional area loss - Severity 3	Image Provided - Ref: 18_8

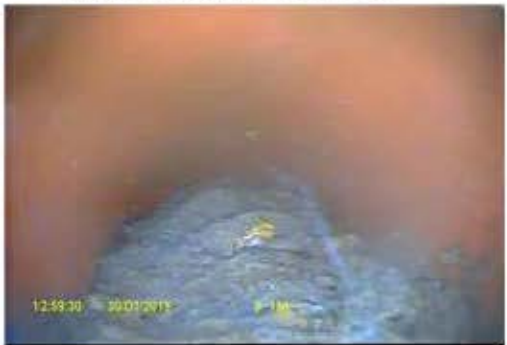
09.10m	0:00:52	DES	Settled deposits fine: 100% Cross sectional area loss - Severity 3	Image Provided - Ref: 19_6

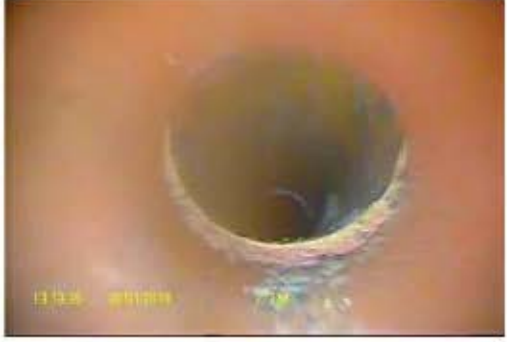
07.70m	0:00:22	JDL	Joint displaced large - Severity 4	Image Provided - Ref: 20_4

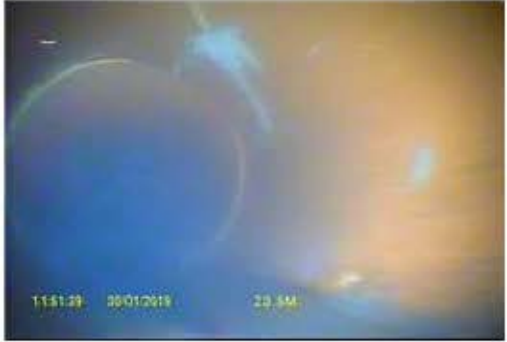
Pos	Video Ref	Code	Description	Image
00.00m		MH	Start node type, manhole MH08	
00.00m	0:00:00	WL	Water level: 0% Height/Diameter	
23.50m	0:00:44	CL	Crack, longitudinal at 12 o'clock - Severity 1	<p>Image Provided - Ref: 21_2</p>

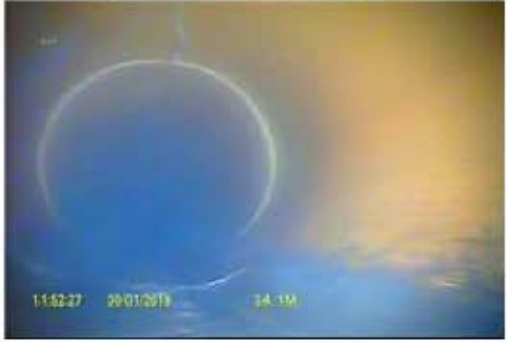
34.10m	0:01:31	CM	Cracks, multiple from 12 o'clock to 06 o'clock - Severity 2	<p>Image Provided - Ref: 21_3</p>

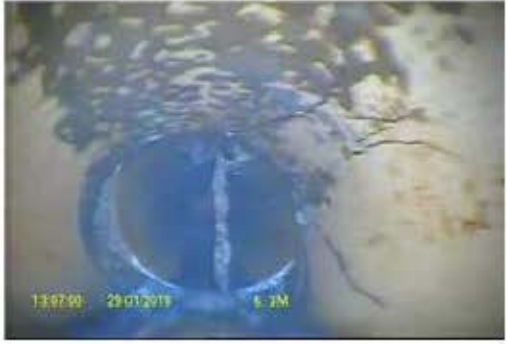
06.30m	0:00:22	JDL	Joint displaced large - Severity 4	Image Provided - Ref: 27_4

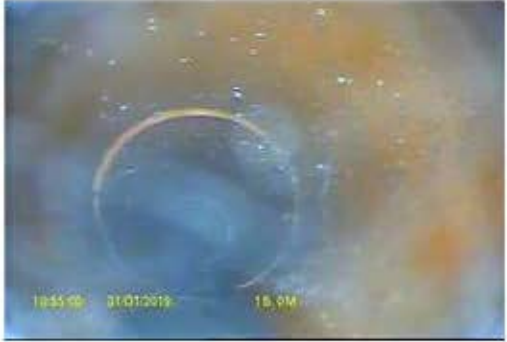
Pos	Video Ref	Code	Description	Image
00.00m		MH	Start node type, manhole MH17	
00.00m	0:00:00	WL	Water level: 0% Height/Diameter	
15.00m	0:00:49	JDM	Joint displaced medium - Severity 3	Image Provided - Ref: 37_2
