# Engineer's Report

| Our Reference | <b>IFS-RBS-SUB-11-0031530</b> |

| Address | <b>The Gables, Carlton Road, Carlton, Barnsley,<br/>S71 3JD</b> |

The Gables, Carlton Road, Carlton, Barnsley

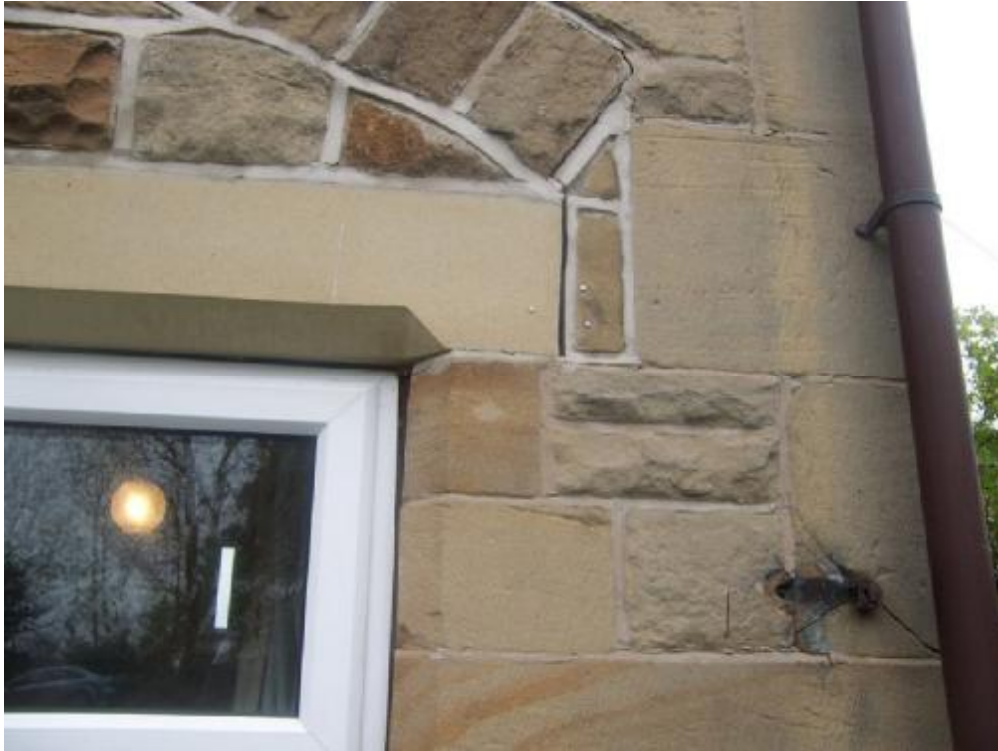
Stepped diagonal cracking, up to approximately 10mm wide, was noted above and below the front and side lounge window openings, and also to the rear elevation of the cottage, reflecting the internal damage within the various rooms.

FIGURE 3 External damage to cottage

The pattern and location of the cracks to the cottage, together with the fact that they increase in width with height is indicative of minor localised subsidence. This appears to have occurred as a result of shrinkage of the clay subsoil due to the moisture extracting influence of nearby vegetation.

Generally cracks 1mm wide or less will be filled (internal) or re-pointed (external). Internally, where the cracks are wider than 1mm, but less than 5mm the underlying brickwork/stonework will be exposed and prior to making good the plaster finishes the cracking will be covered with expanded metal lathe. Where cracks are 5mm across or wider, some form of bed joint reinforcement may be introduced, where practicable.

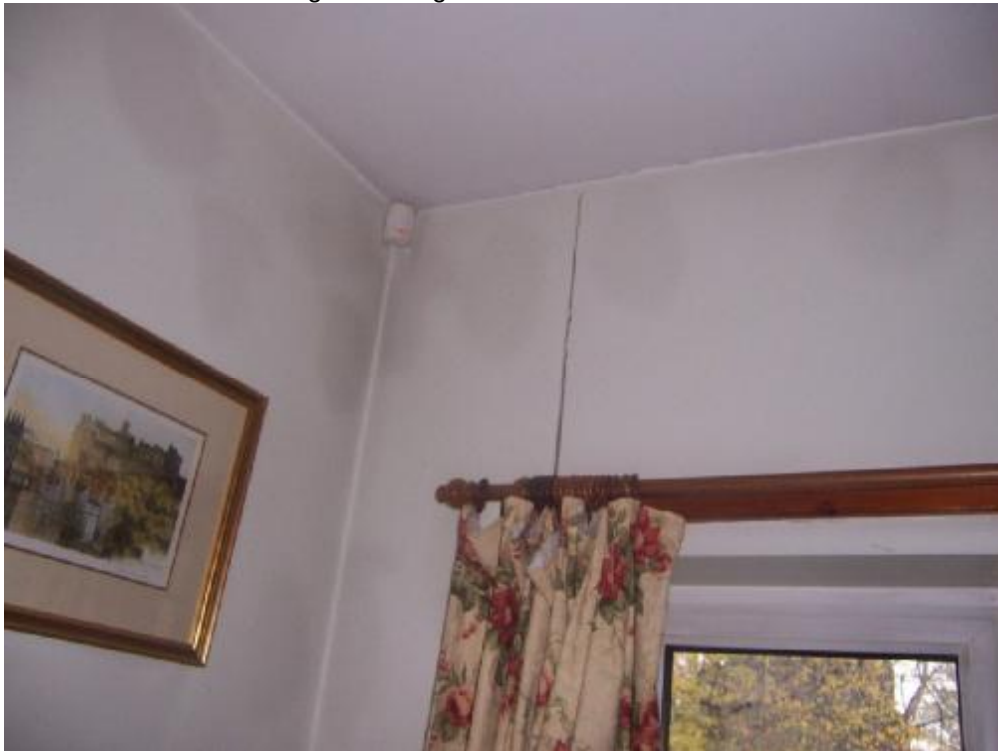
Up to approximately 10mm wide cracking was noted above and below the window openings on the front and side walls, with some minor vertical cracking also evident at the rear left corner of the room.

The damage was generally orientated towards the right hand side of the cottage.

FIGURE 4 Internal damage to lounge

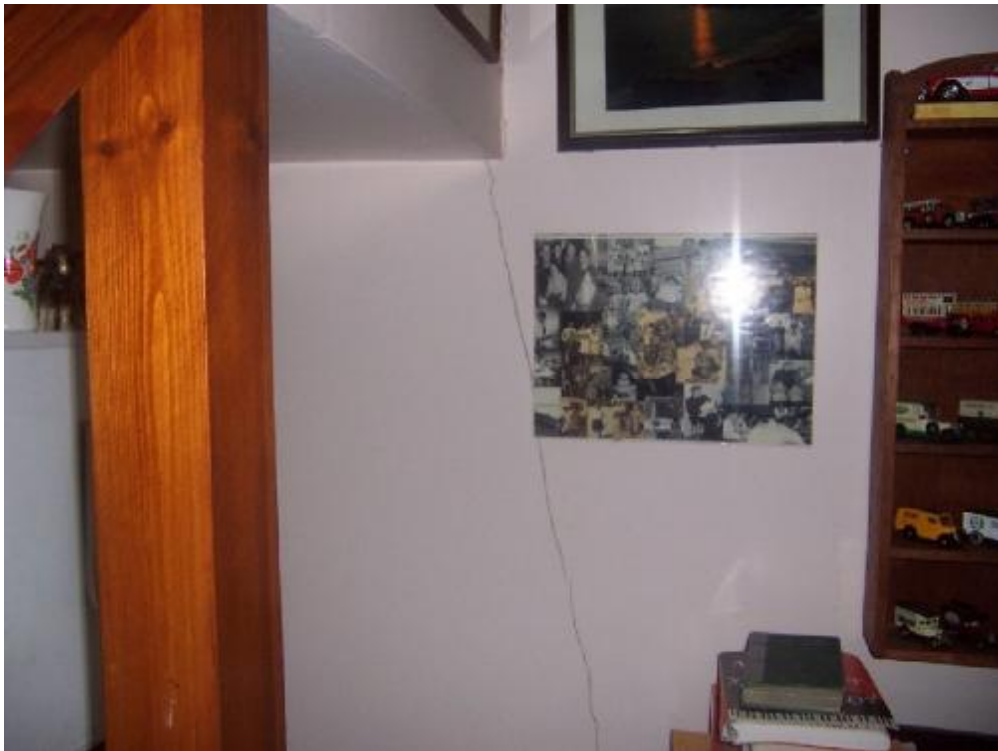
Up to approximately 1/2mm wide cracking was noted below the front window and also to the front right corner junction, with some cracking up to 3mm wide also evident beneath the staircase, on the right hand side wall.

FIGURE 5 Internal damage to dining room

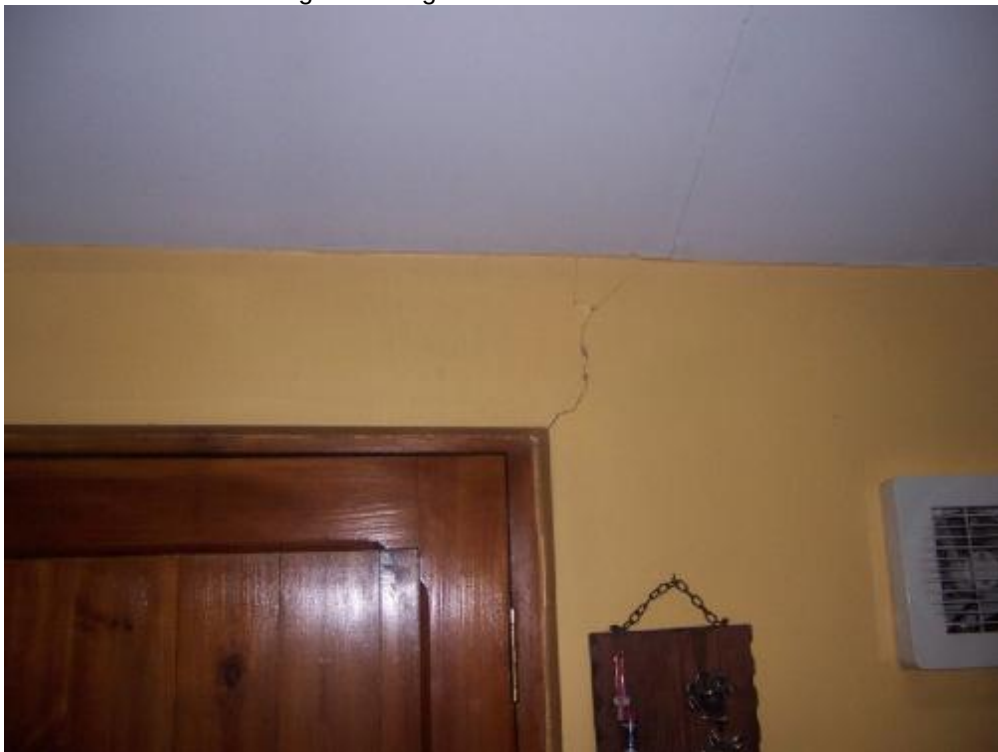
Minor cracking, up to approximately 1mm wide was noted above the front kitchen window.

FIGURE 6 Internal damage to kitchen
