1227 – 3 Rydal Close
BS 5837:2012 Arboricultural
Report, Impact Assessment
and Method Statement

Mr & Mrs Godley

Site: 3 Rydal Close, Penistone, S36 8HN
 Report: BS 5837:2012 Arboricultural Report, Impact Assessment and Method Statement
 Reference: 1227
 Client: Mr and Mrs Godley
 Issue Date: 23/05/2025
 Produced By:

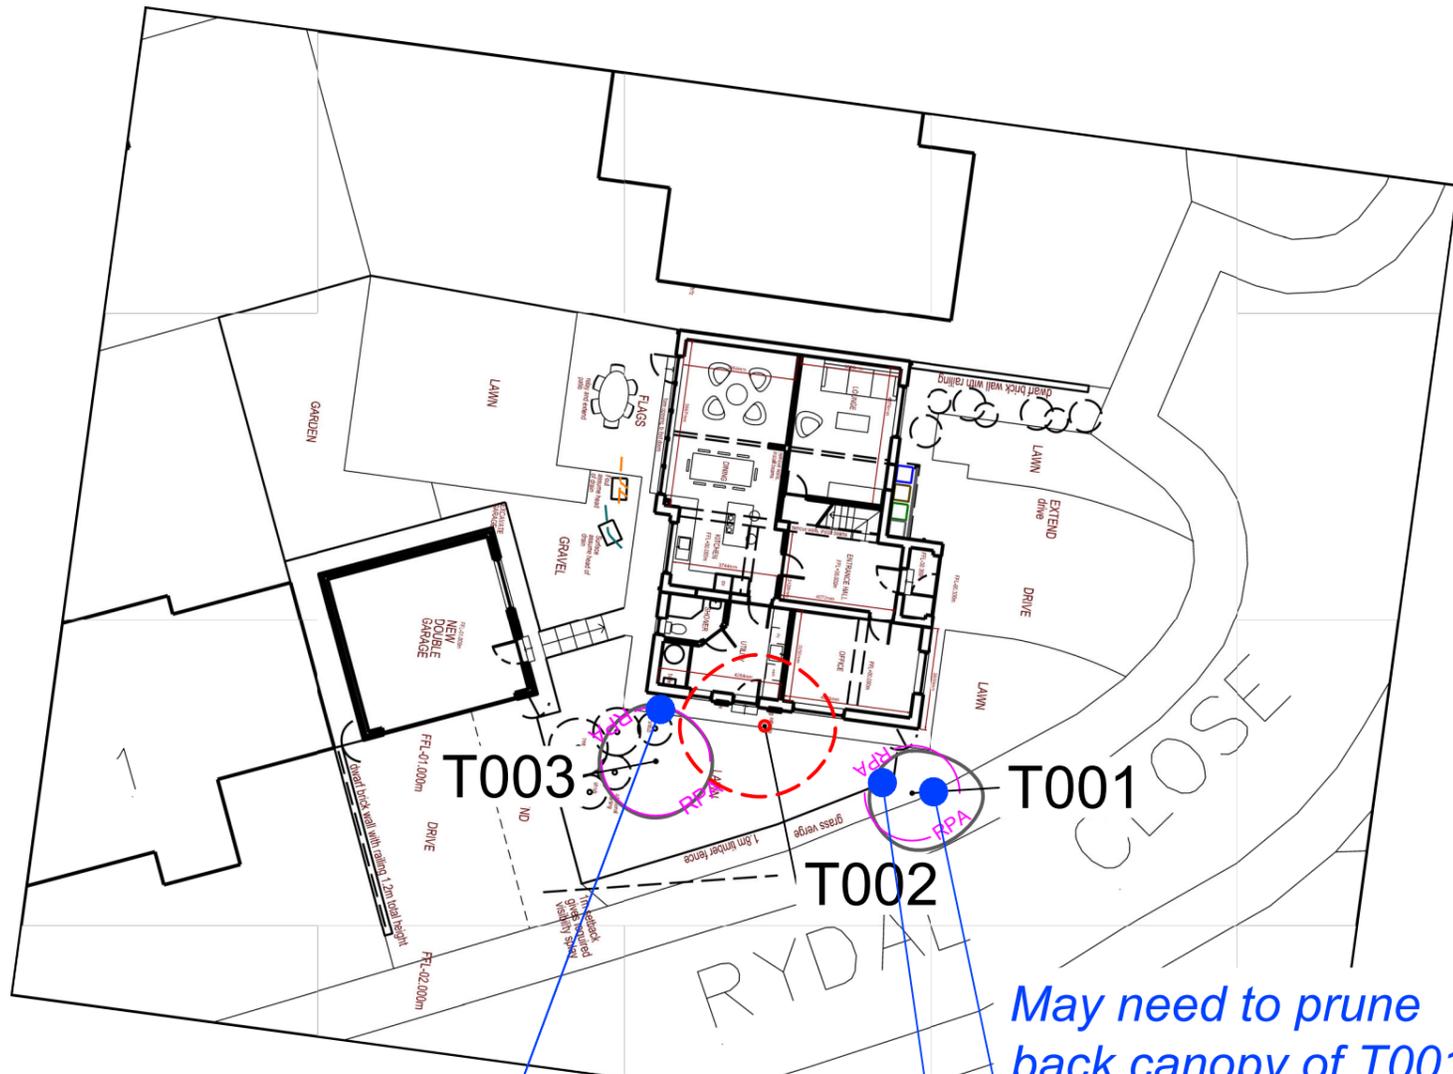
Drawing Title
Figure 3 - Tree Impacts Plan

5.8 A new hard surfaced footpath is proposed within the RPA of the retained trees T001 and T003, as shown on the Tree Impacts Plan at Appendix 3. In this instance the encroachment into the RPA is particularly minor and the tree is therefore unlikely to be significantly affected.

Encroachment of proposed paving into the RPA of retained trees here

Proposed fence within RPA of T001 here

May need to prune back canopy of T001 to allow for installation of tree protection fencing
