# DRAINAGE INVESTIGATION REPORT

CLIENT Strata Homes Ltd

SITE BURNTWOOD ROAD,  
GRIMESTHORPE

DATE 17/11/2009 JOB No. 3149

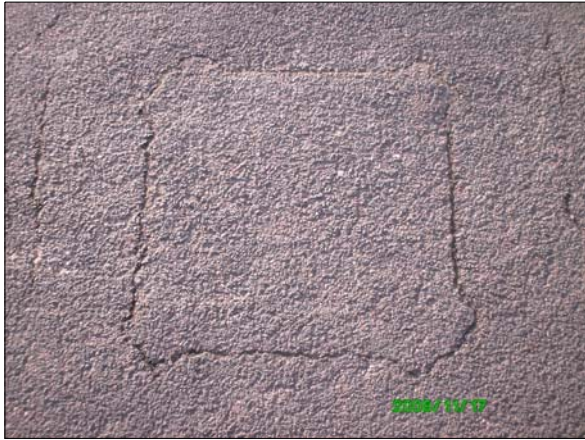
Title: GP5

Description: EDS9 - UNABLE TO RAISE

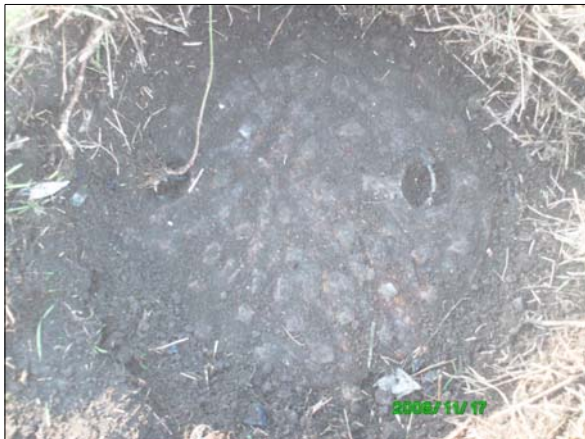
Title: GP7

Description: EDS8 - POST DIGGING OUT

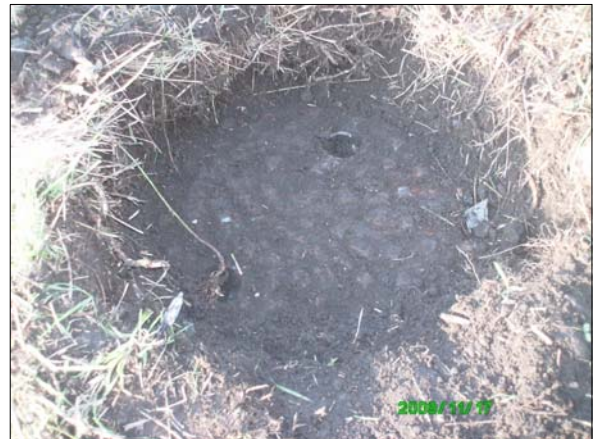
Title: GP8

Description: EDS8 - POST DIGGING OUT

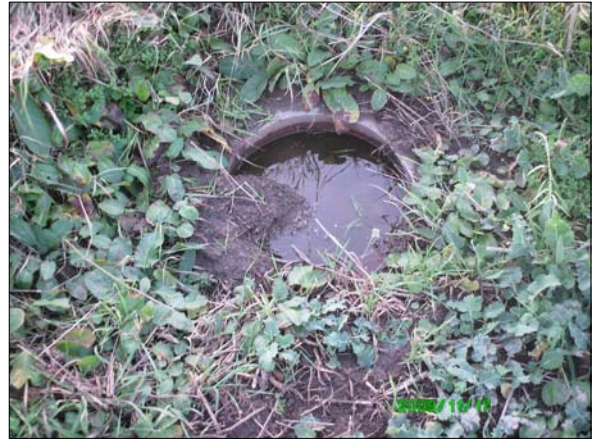
Title: GP10

Description: APPROX. LOCATION OF 6902 -  
COVER & FRAME UPSIDE DOWN IN FIELD

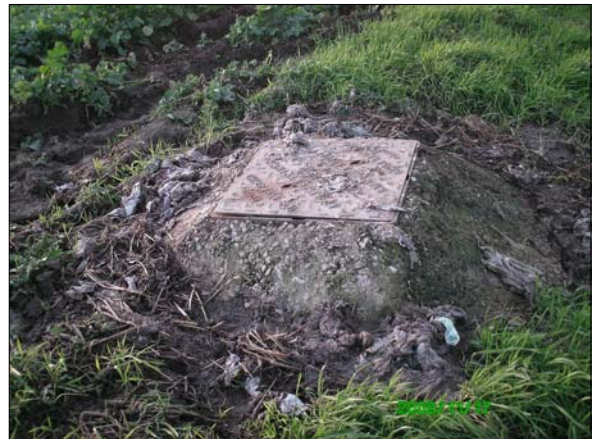
Title: GP12

Description: 6001 - VIEW OF ESCAPING  
SEWAGE

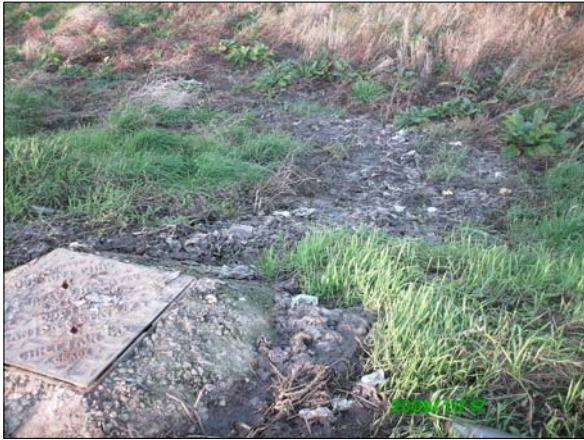
Title: GP13

Description: 6001 - VIEW OF ESCAPING SEWAGE

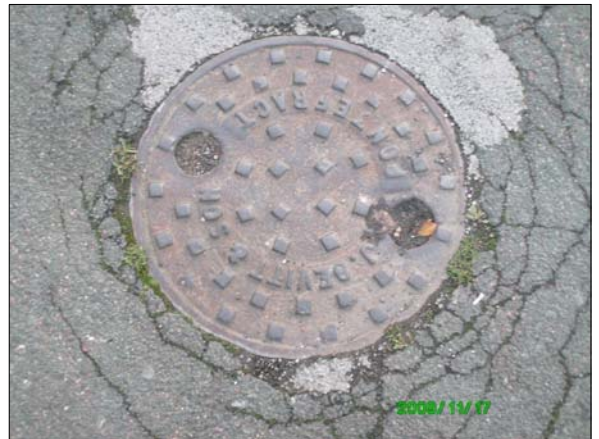
Title: GP24

Description: EDS7 - UNABLE TO RAISE
