VCS Report

Project: Hoyland, Barnsley

Job No: PTS21335-01

This report describes the Visual Condition Survey of the Hoyland, Barnsley scheme. This can be identified on the site plan within Appendix A. The survey was undertaken in June 2021 in the daytime using a HD resolution video survey.

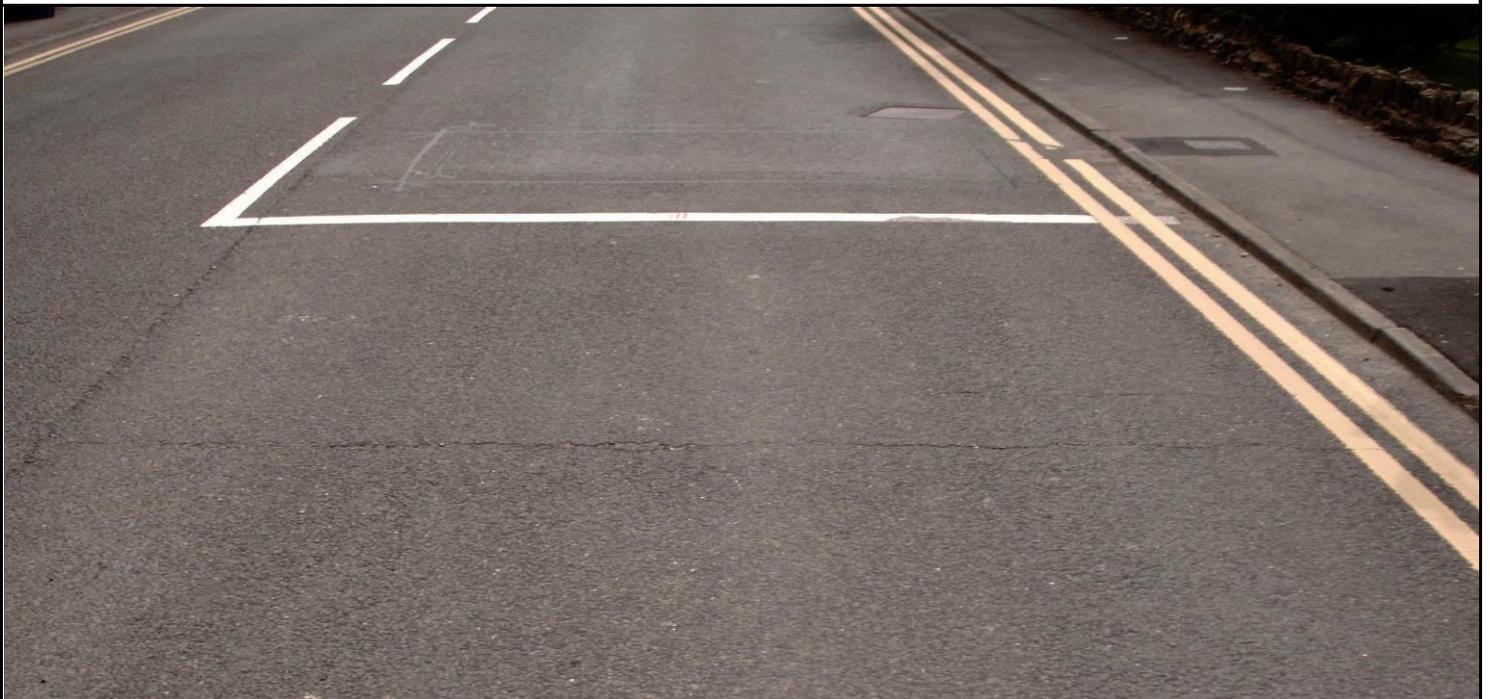
Feature / Defect : Major Transverse Cracking

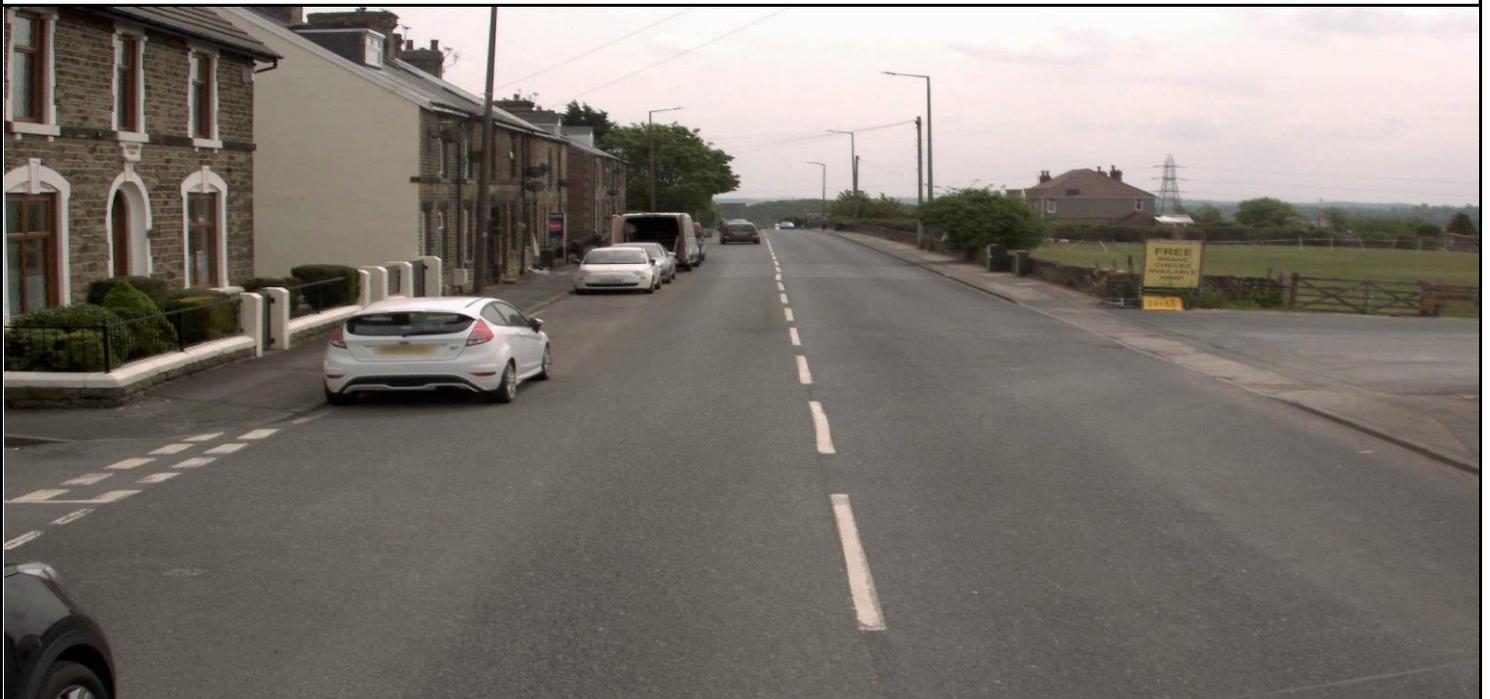
Feature / Defect : Major Surface Defectiveness

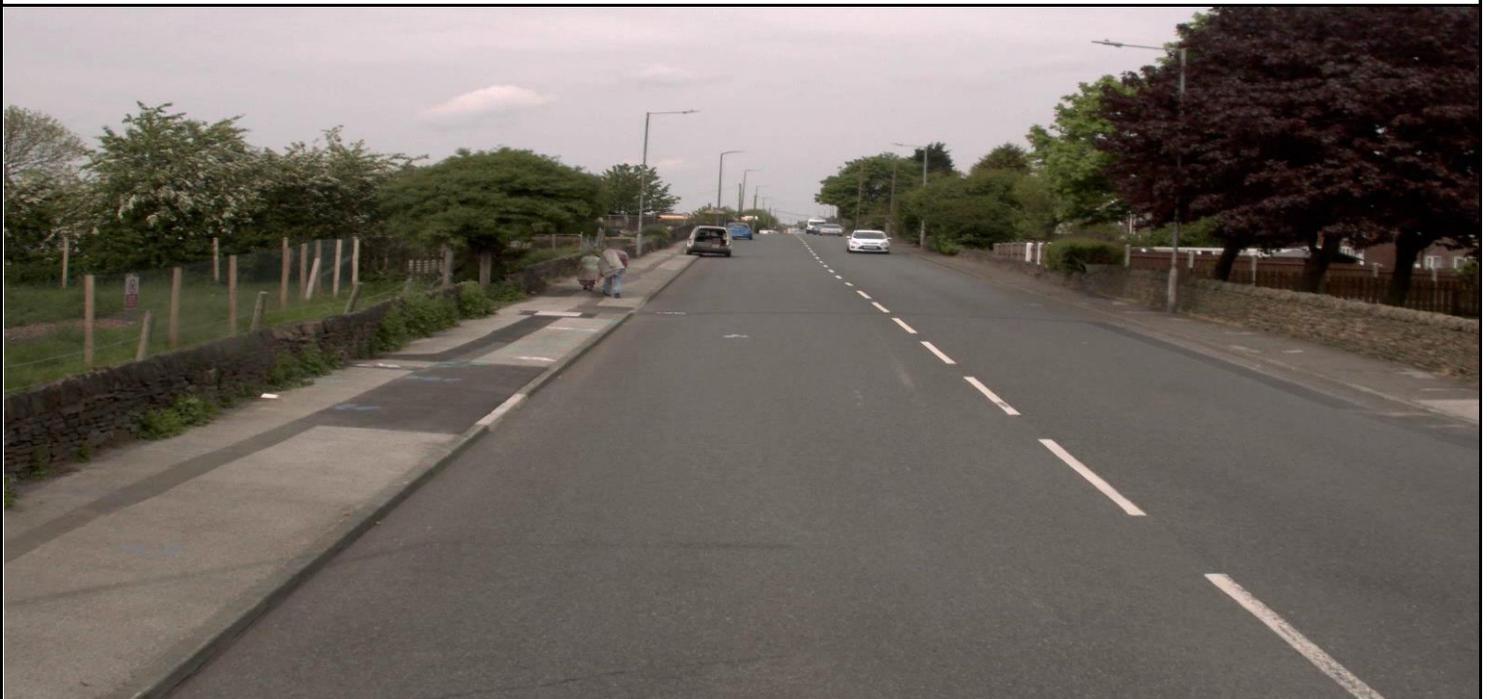
Feature / Defect : Major Cracking

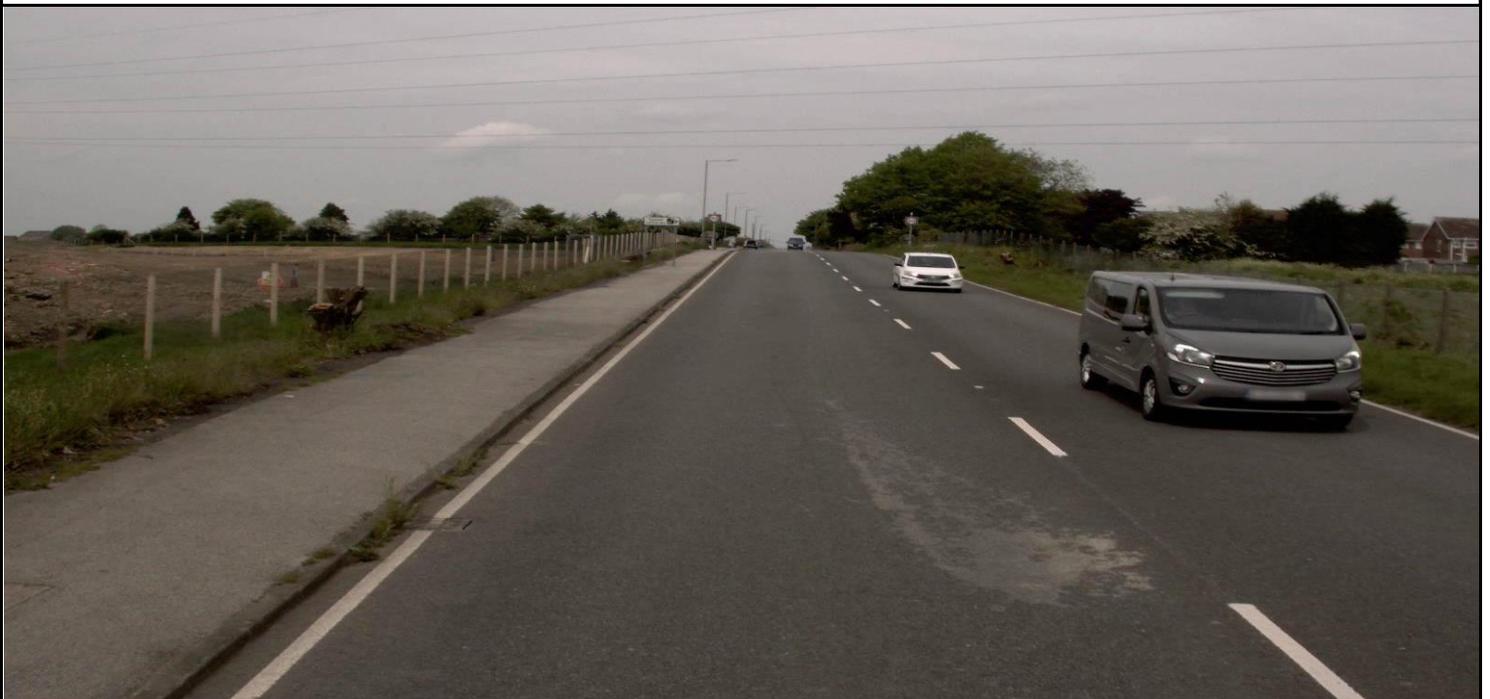
Feature / Defect : Major Surface Defectiveness

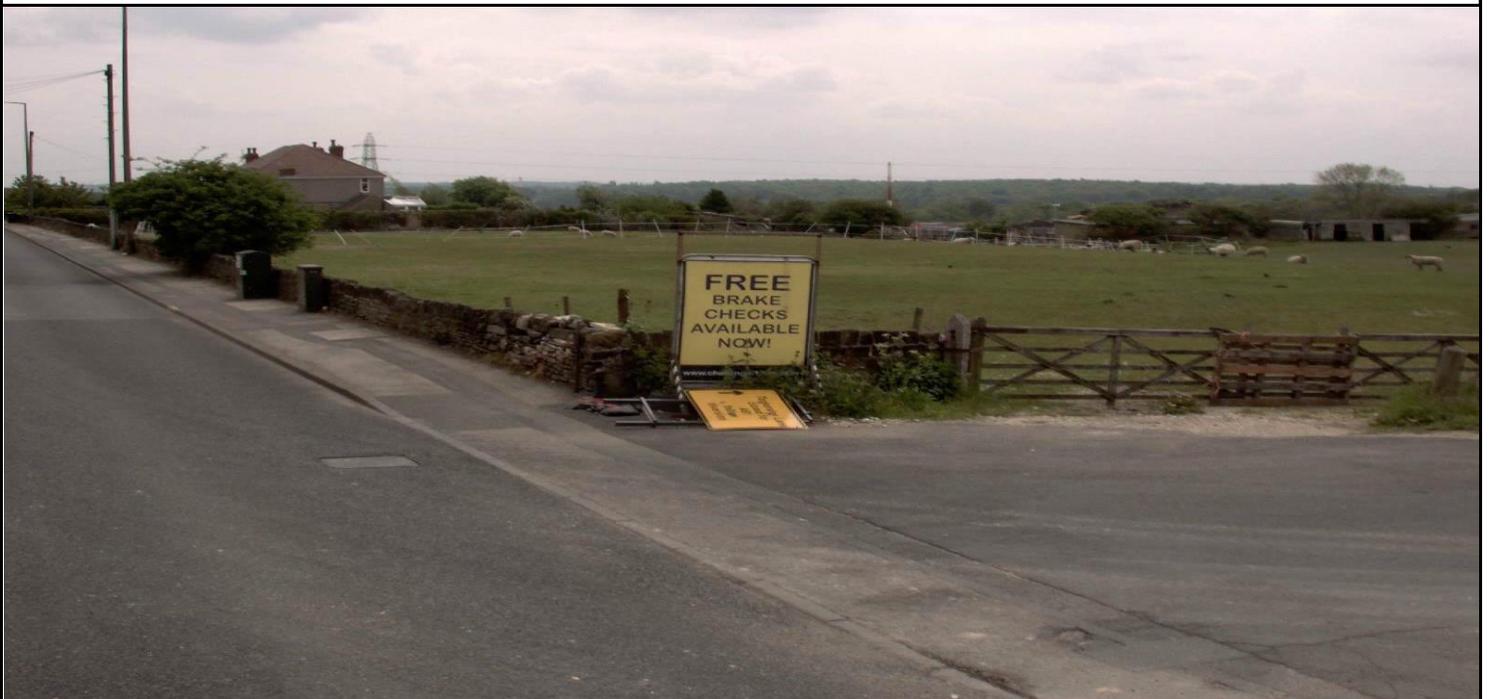
Photo Ref : 12	Section : Turn off by Shell
Chainage : 0m	Feature / Defect : Major Cracking

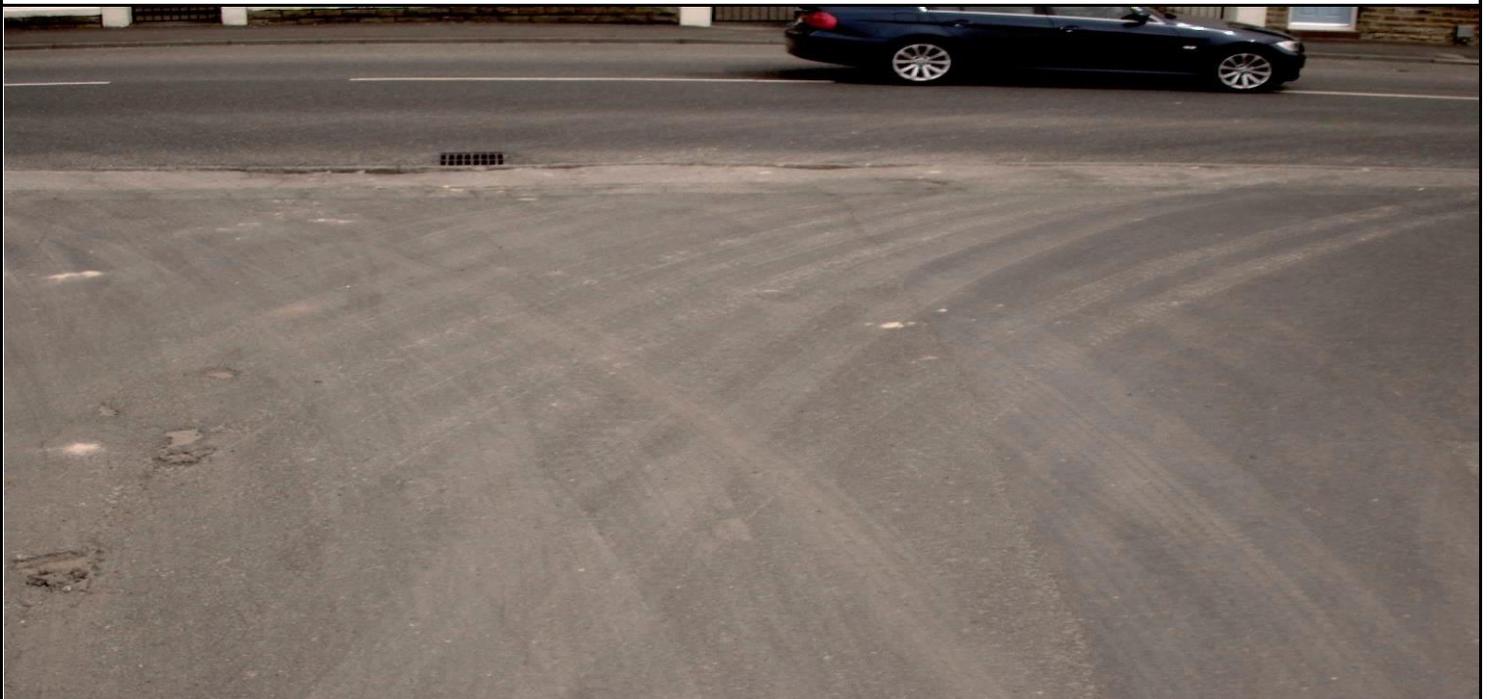
Feature / Defect : Major Surface Defectiveness

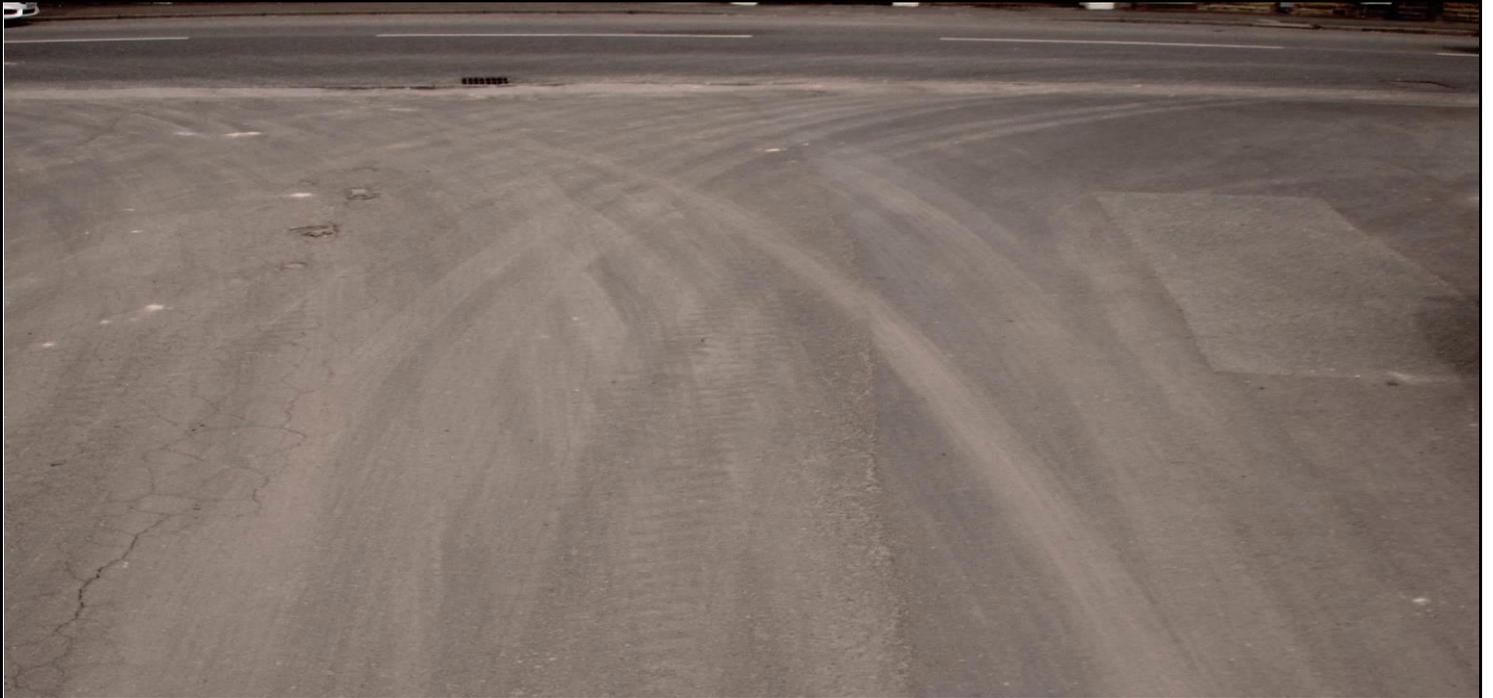
Feature / Defect : Major Cracking

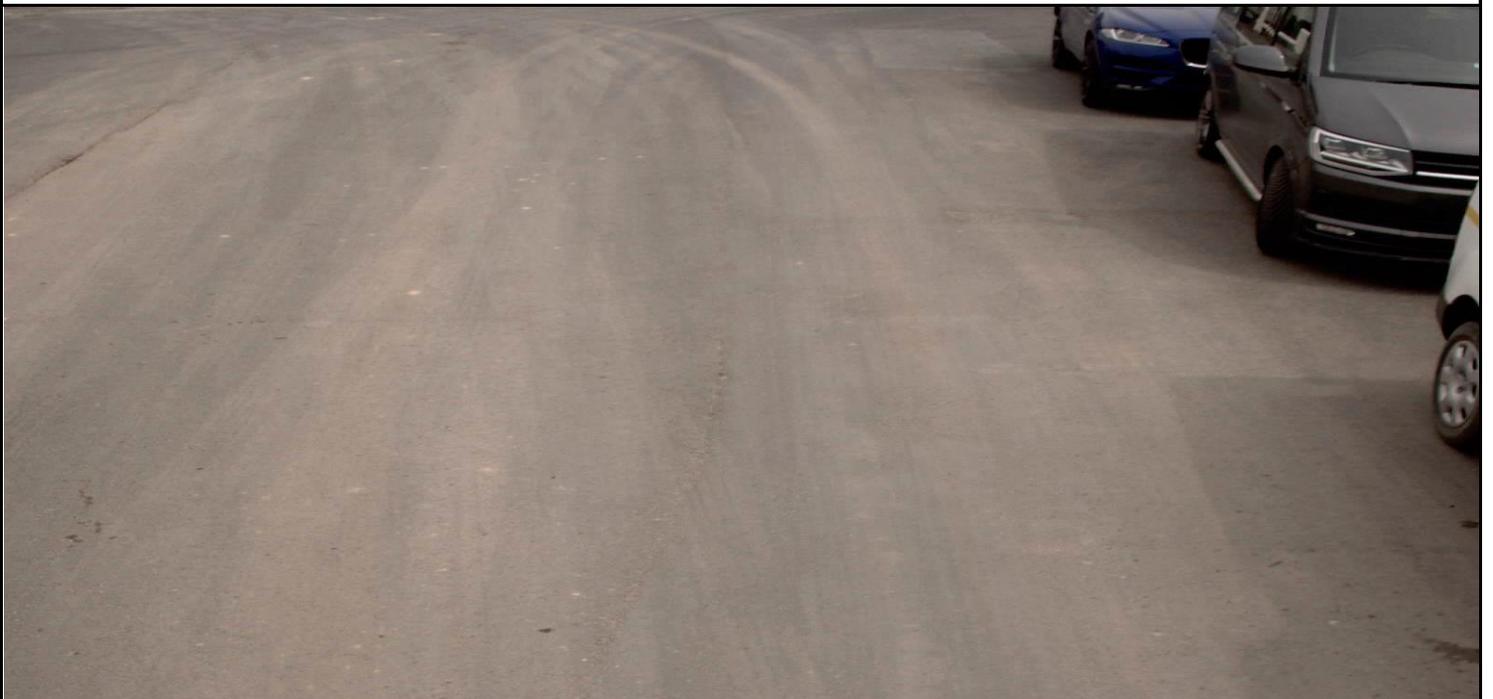
Photo Ref : 16

Feature / Defect : Minor Cracking

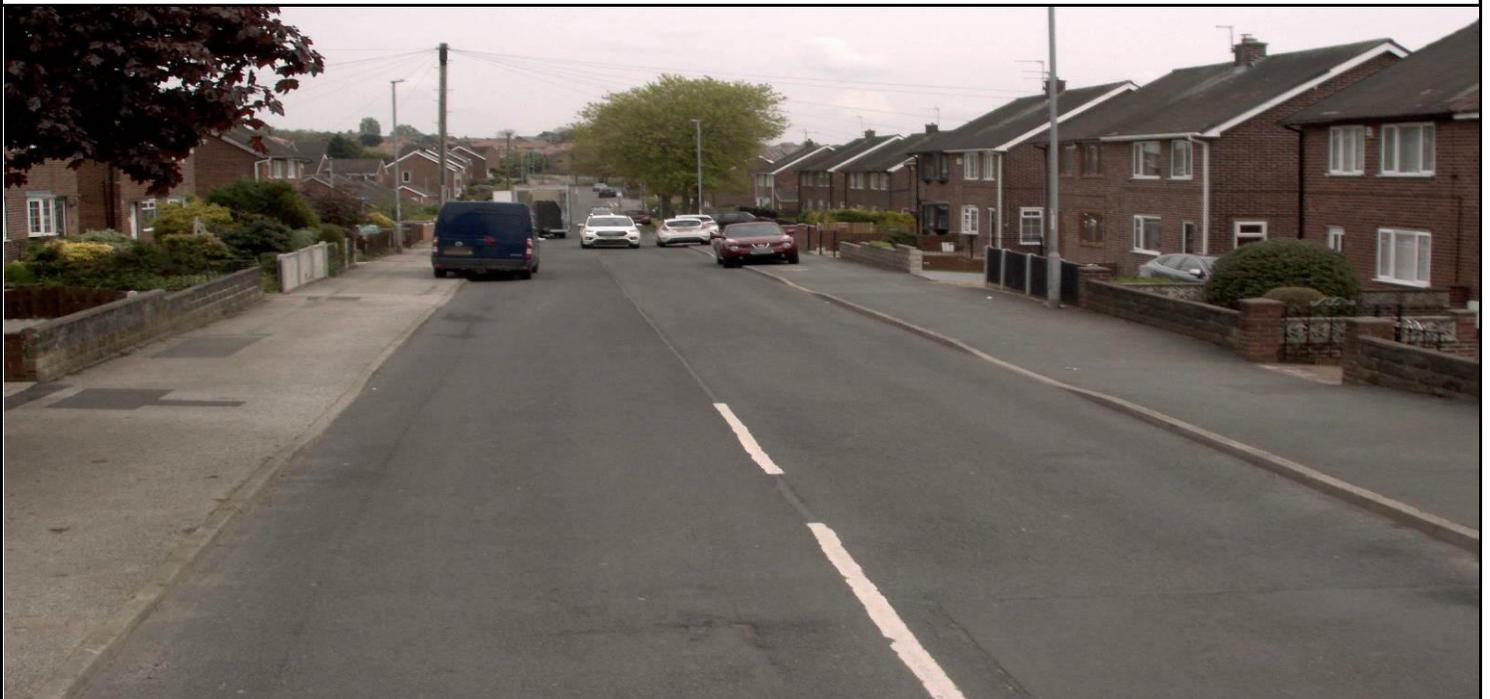
Feature / Defect : Major Surface Defectiveness

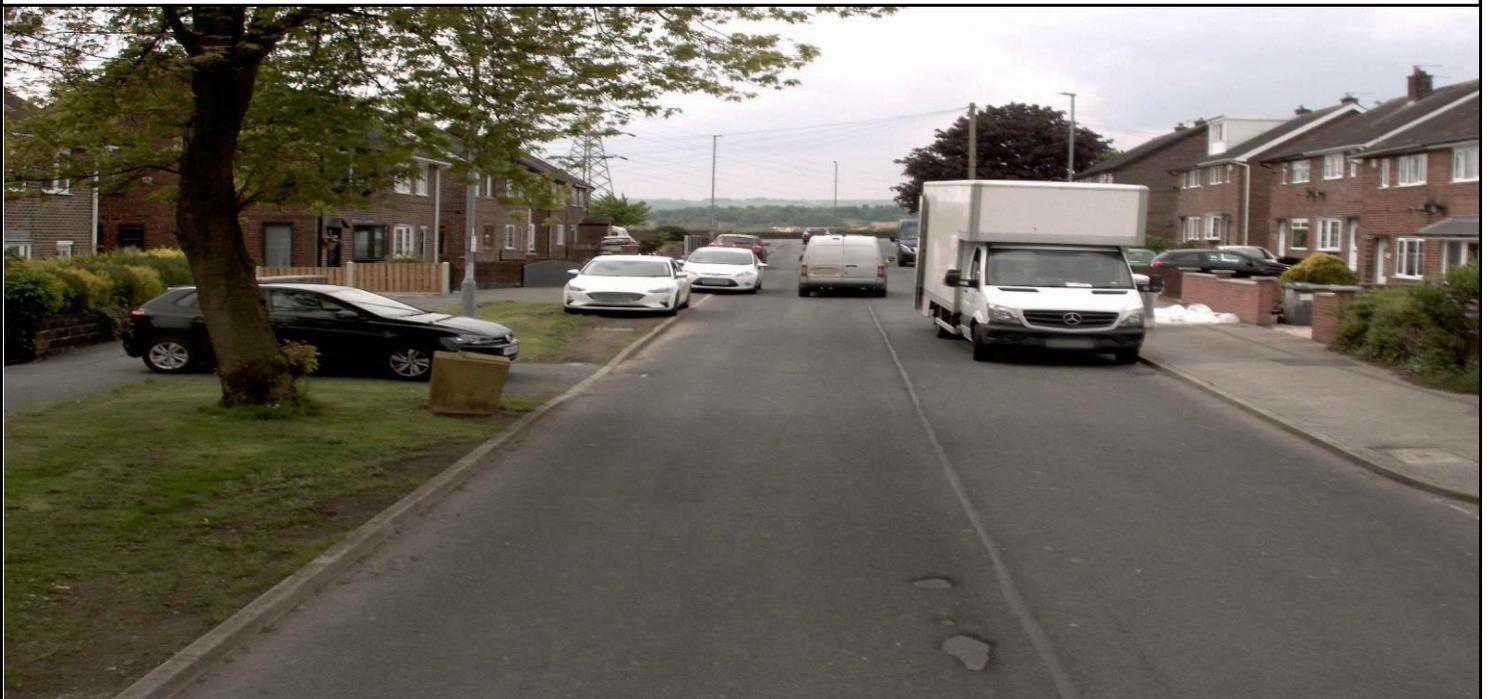
Feature / Defect : Major Surface Defectiveness

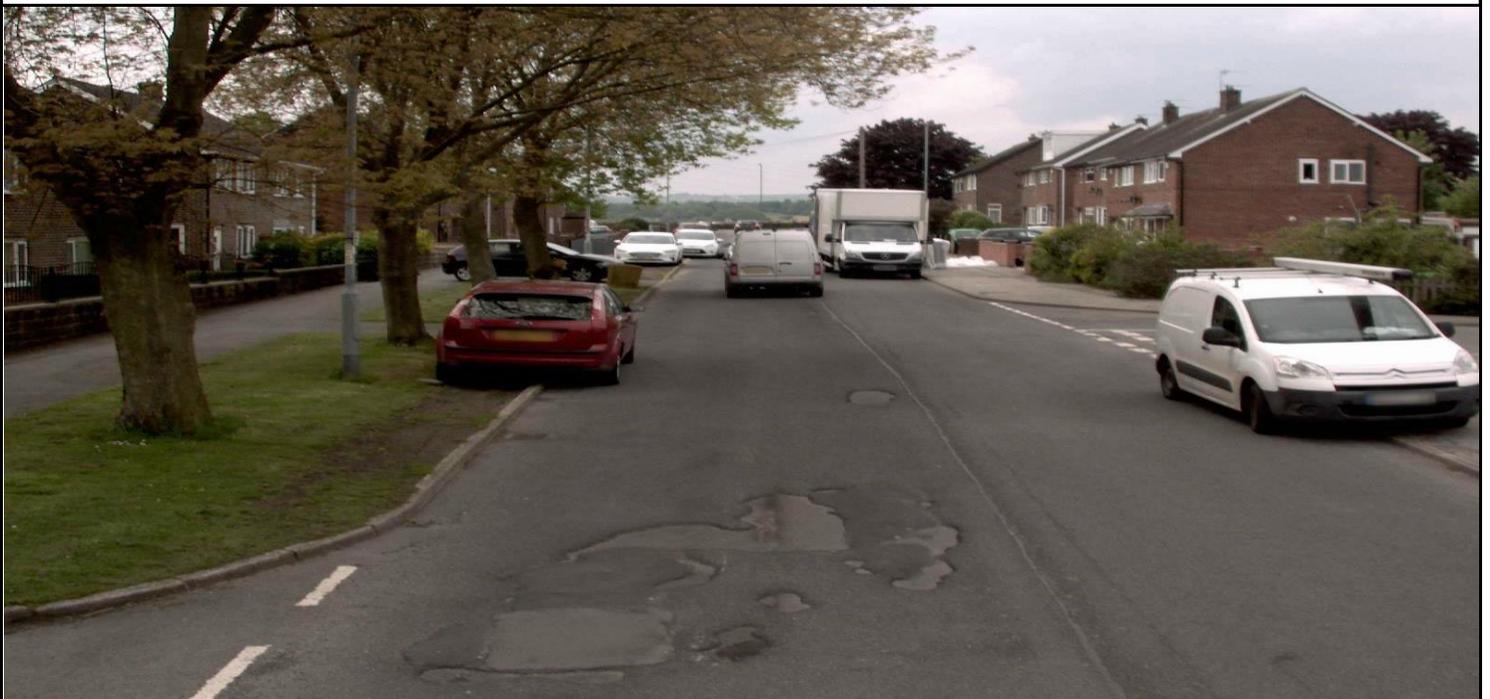
Feature / Defect : Major Surface Defectiveness

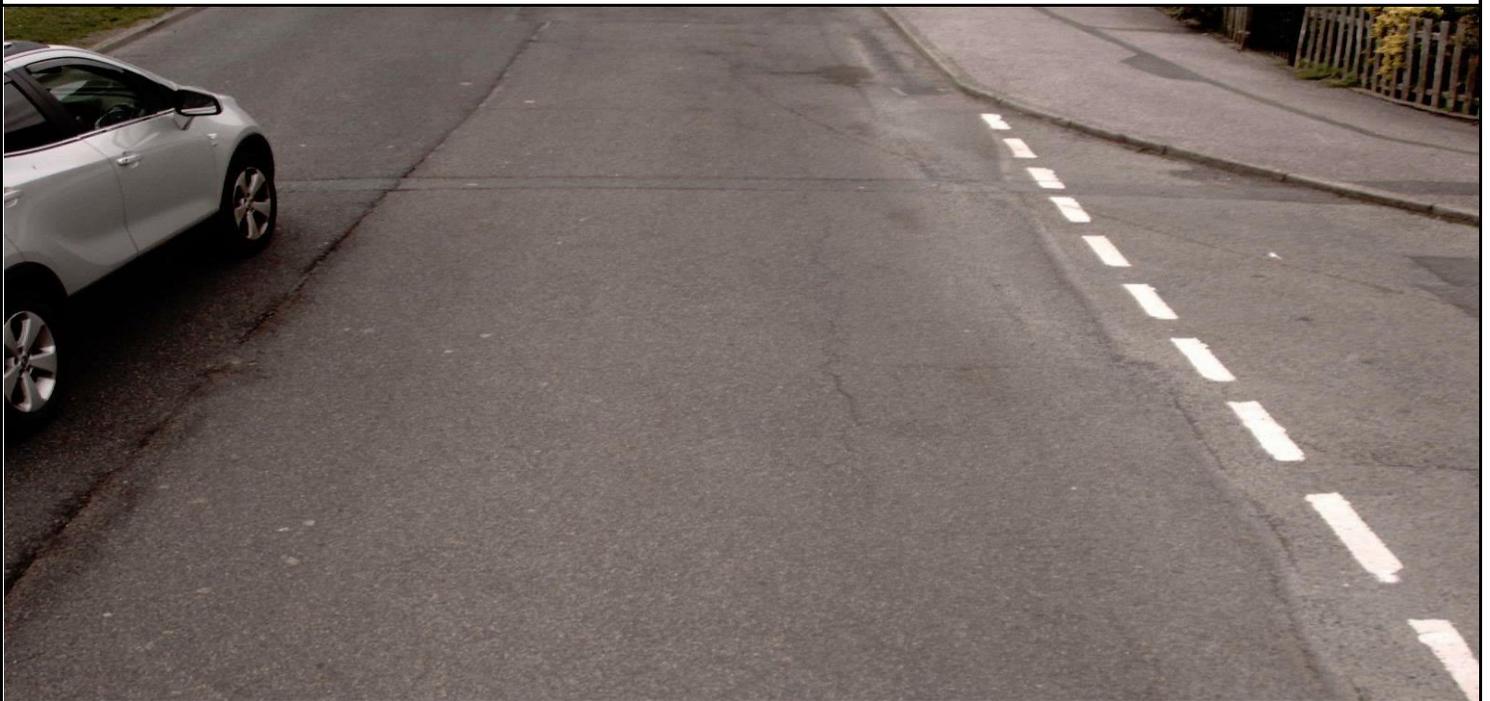
Photo Ref : 26	Section : Parkside Road
Chainage : 182m	Feature / Defect : Major Cracking

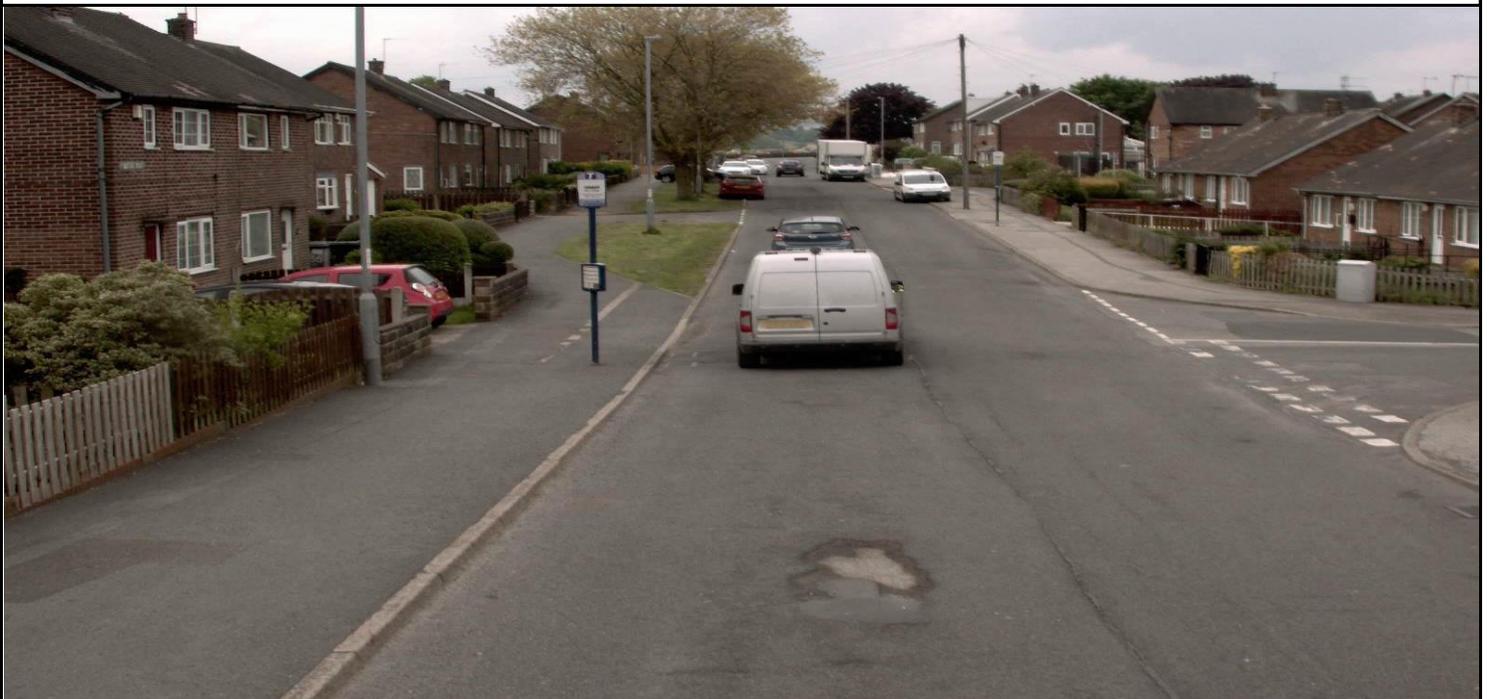
Feature / Defect : Major Surface Defectiveness

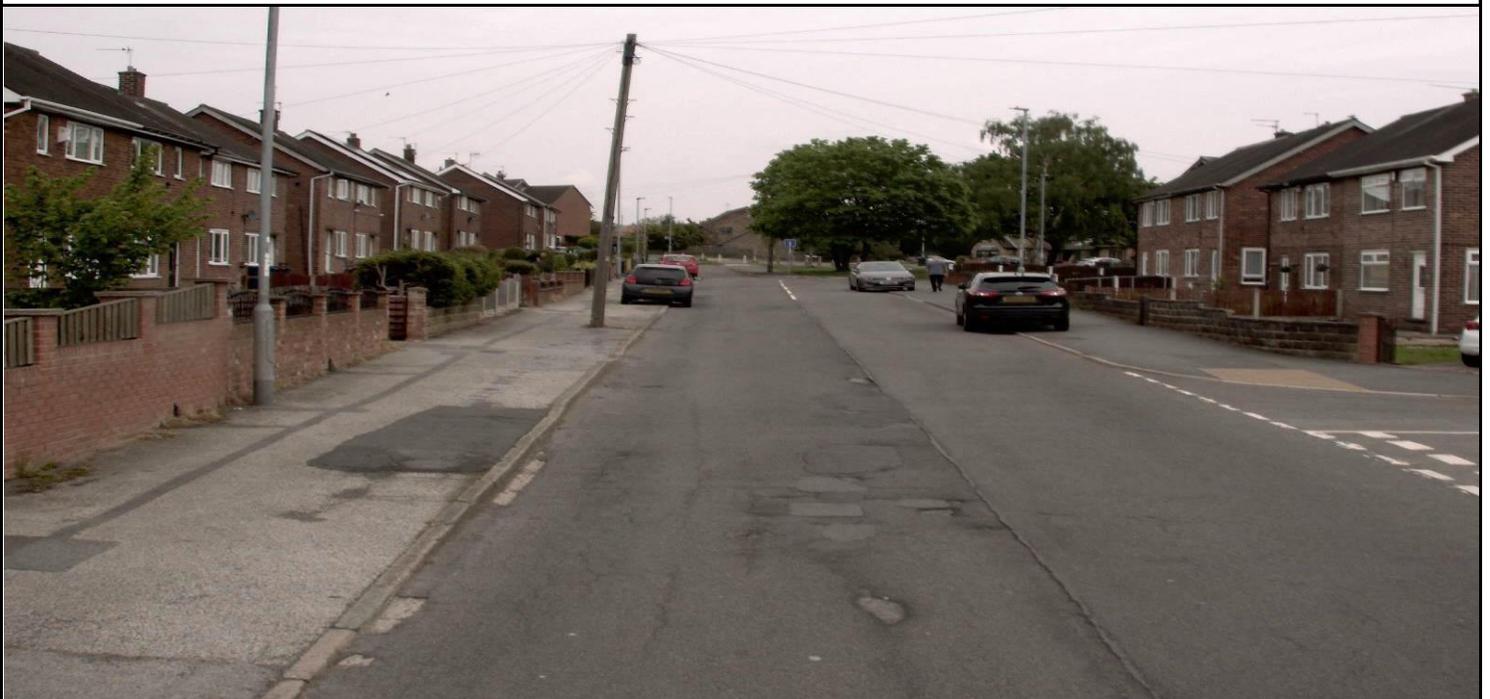
Feature / Defect : Major Surface Defectiveness, Minor Cracking

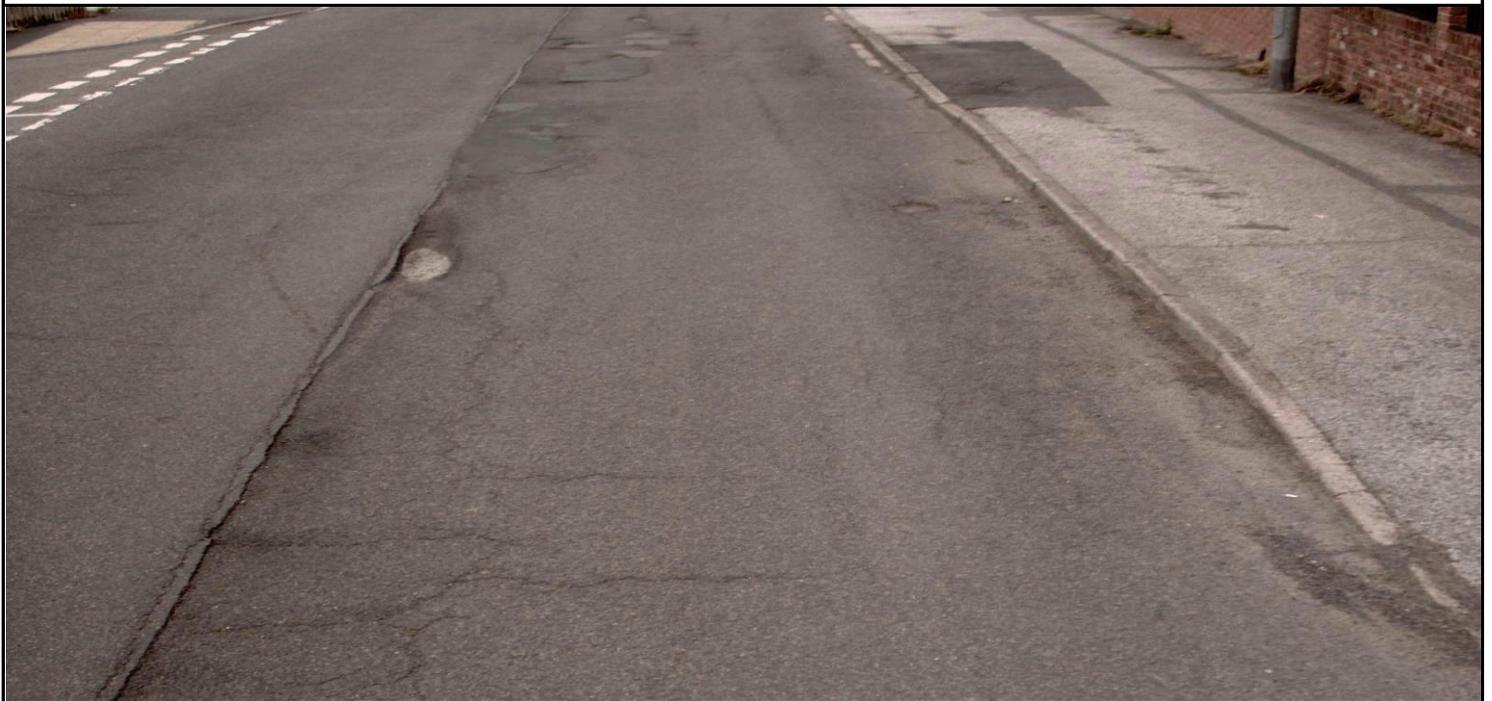
Photo Ref : 32	Section : Parkside Road
Chainage : 224m	Feature / Defect : Major Surface Defectiveness, Major Cracking

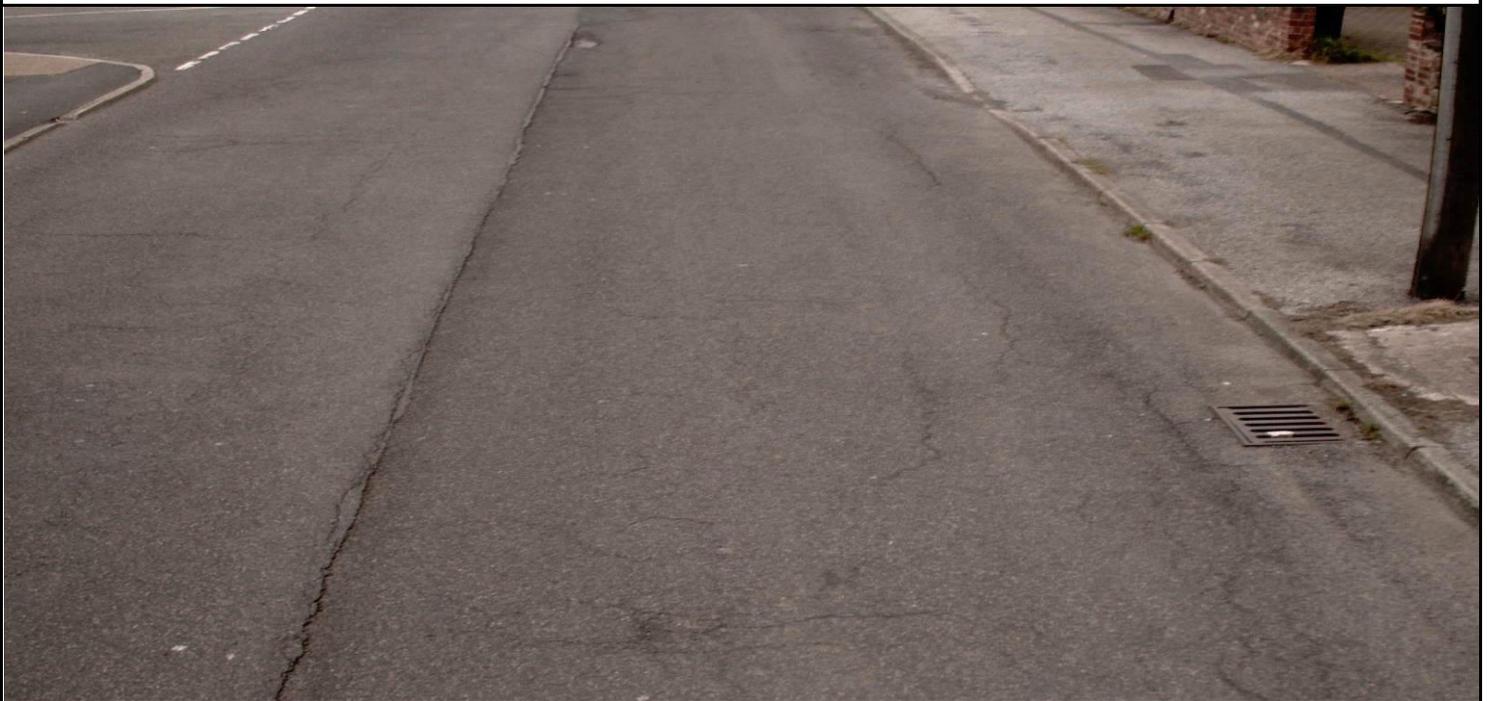
Feature / Defect : Minor Cracking

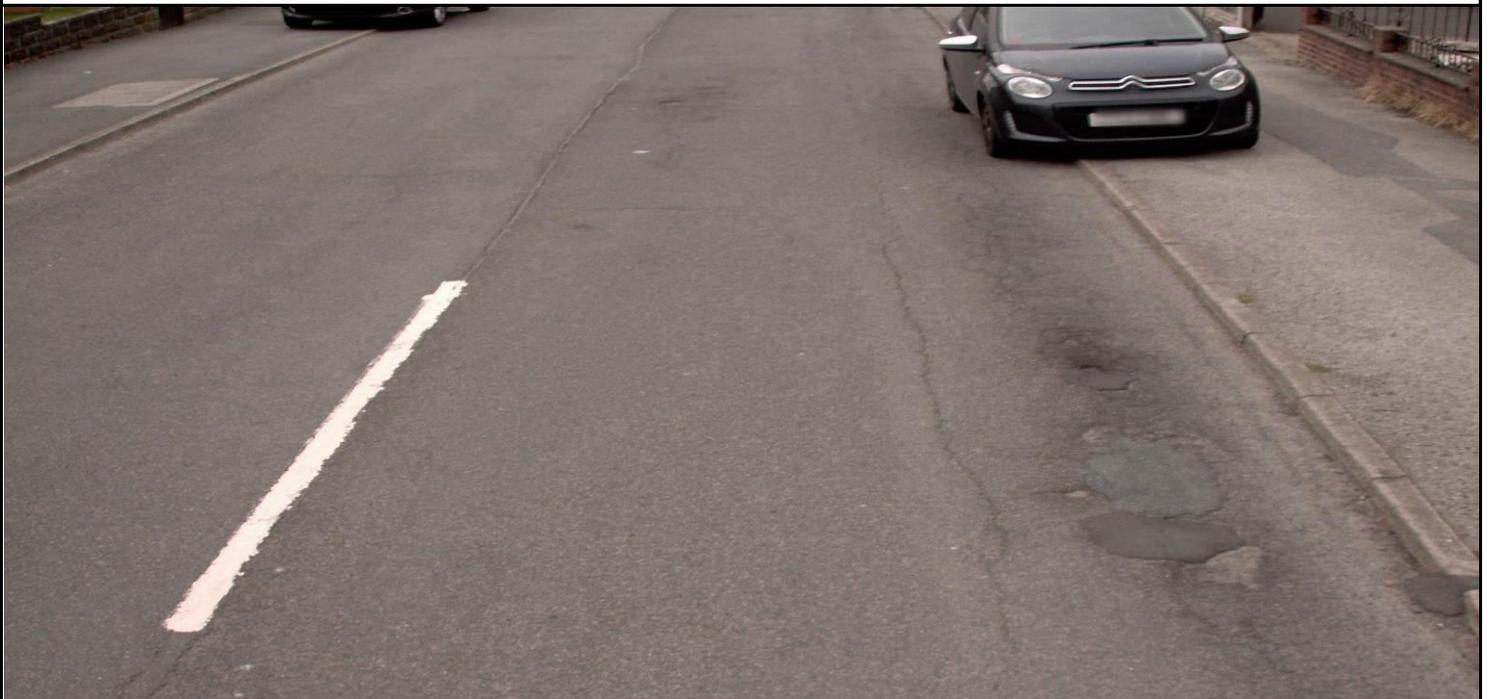
Feature / Defect : Major Cracking, Major Surface Defectiveness

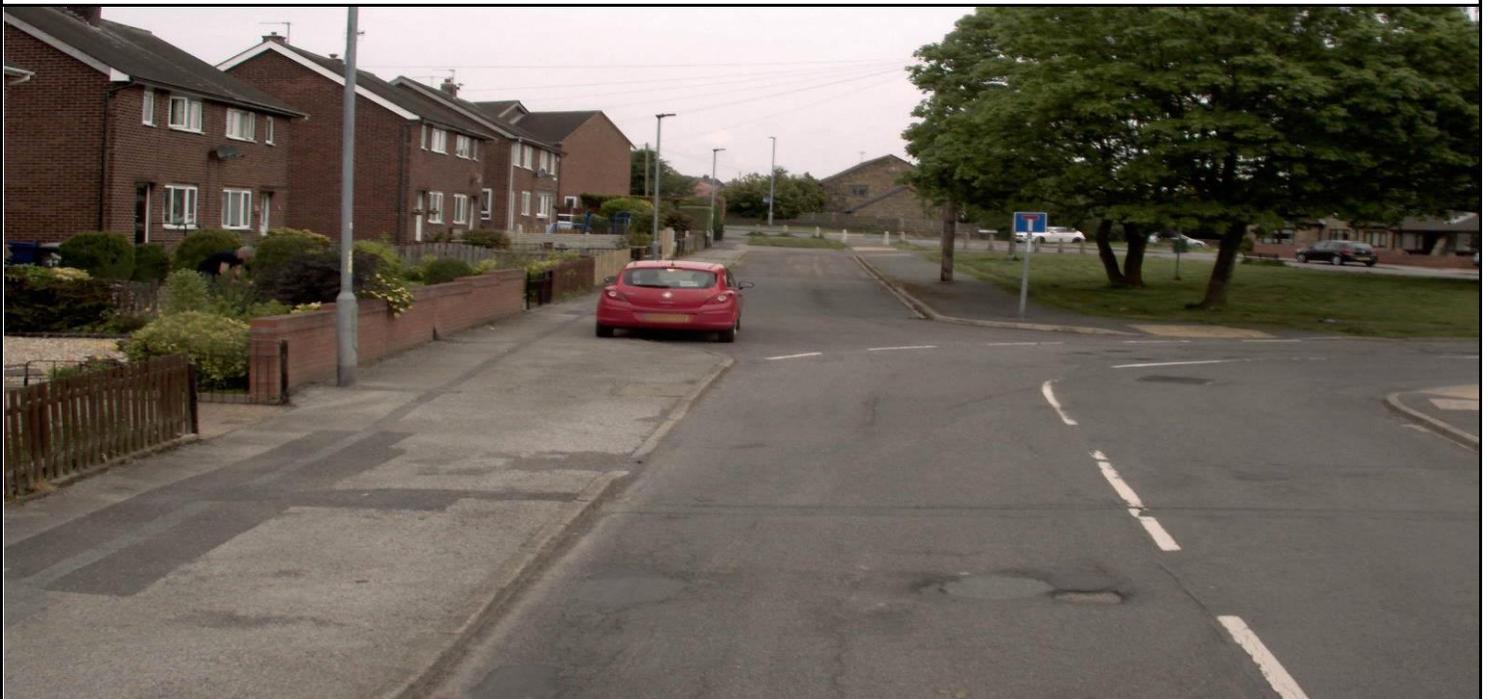
Feature / Defect : Major Surface Defectiveness

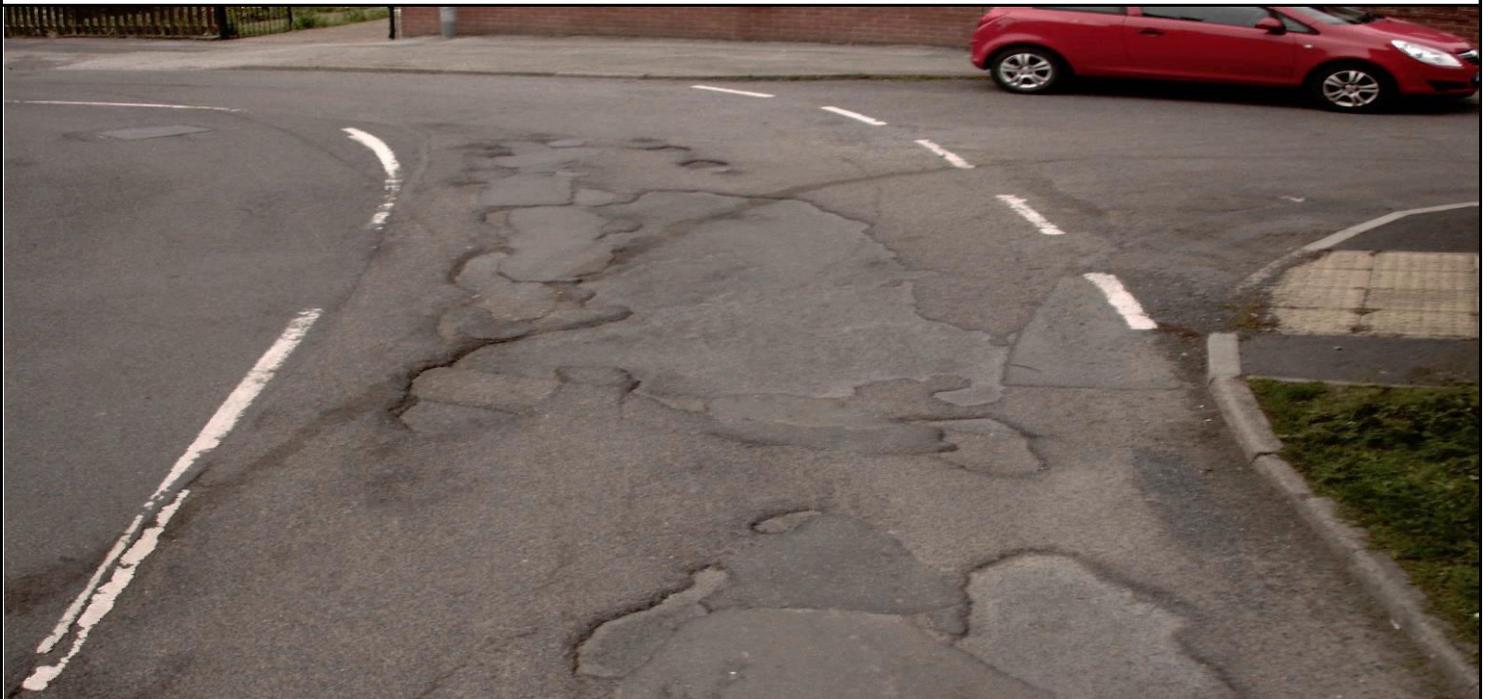
Feature / Defect : Major Surface Defectiveness

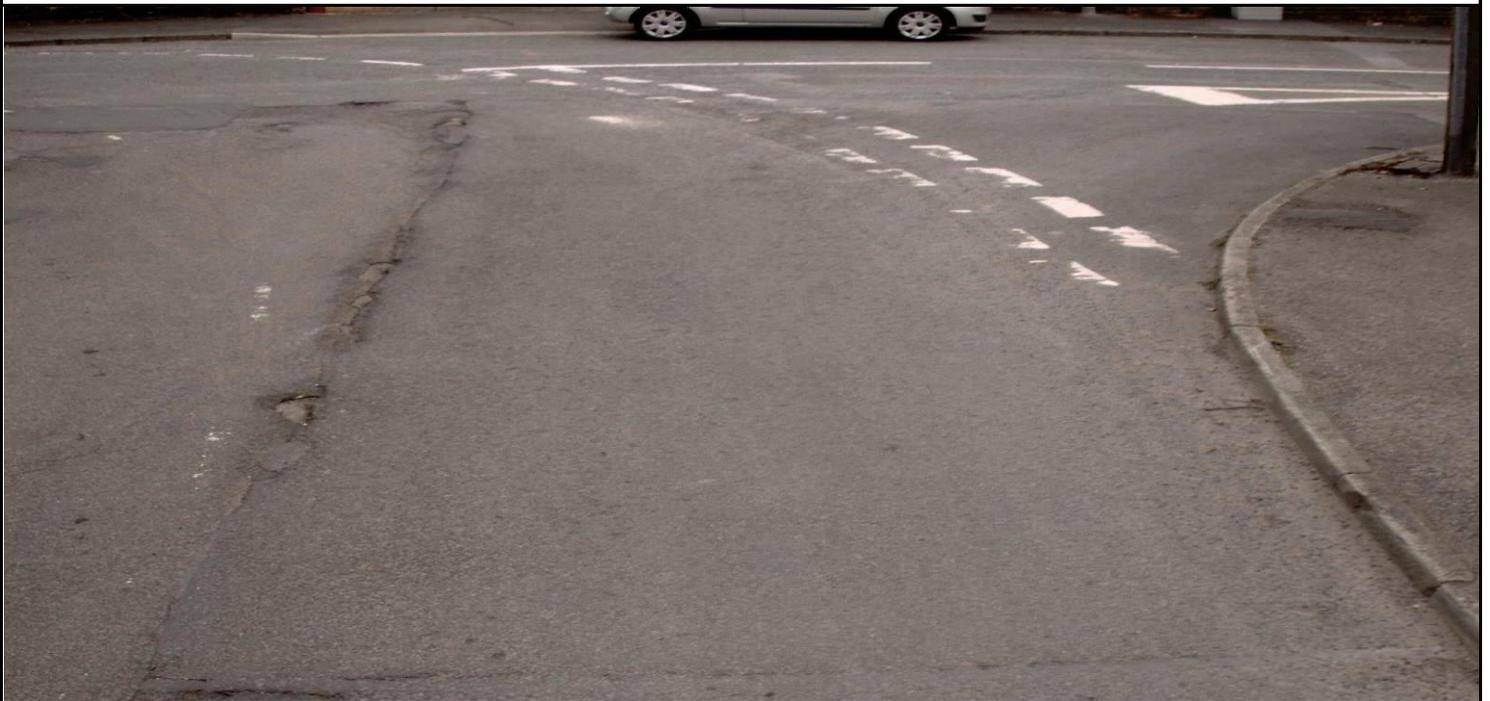
Feature / Defect : Major Surface Defectiveness

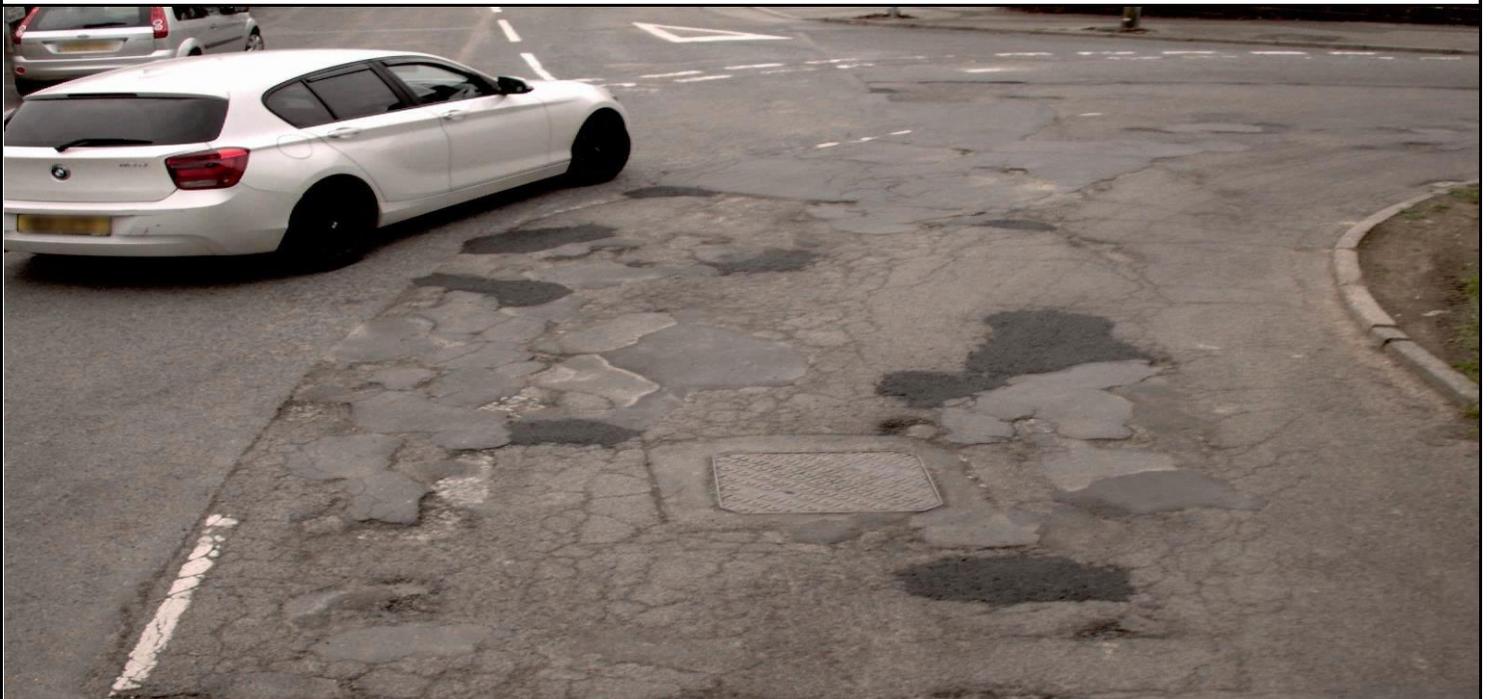
Feature / Defect : Major Surface Defectiveness, Major Cracking

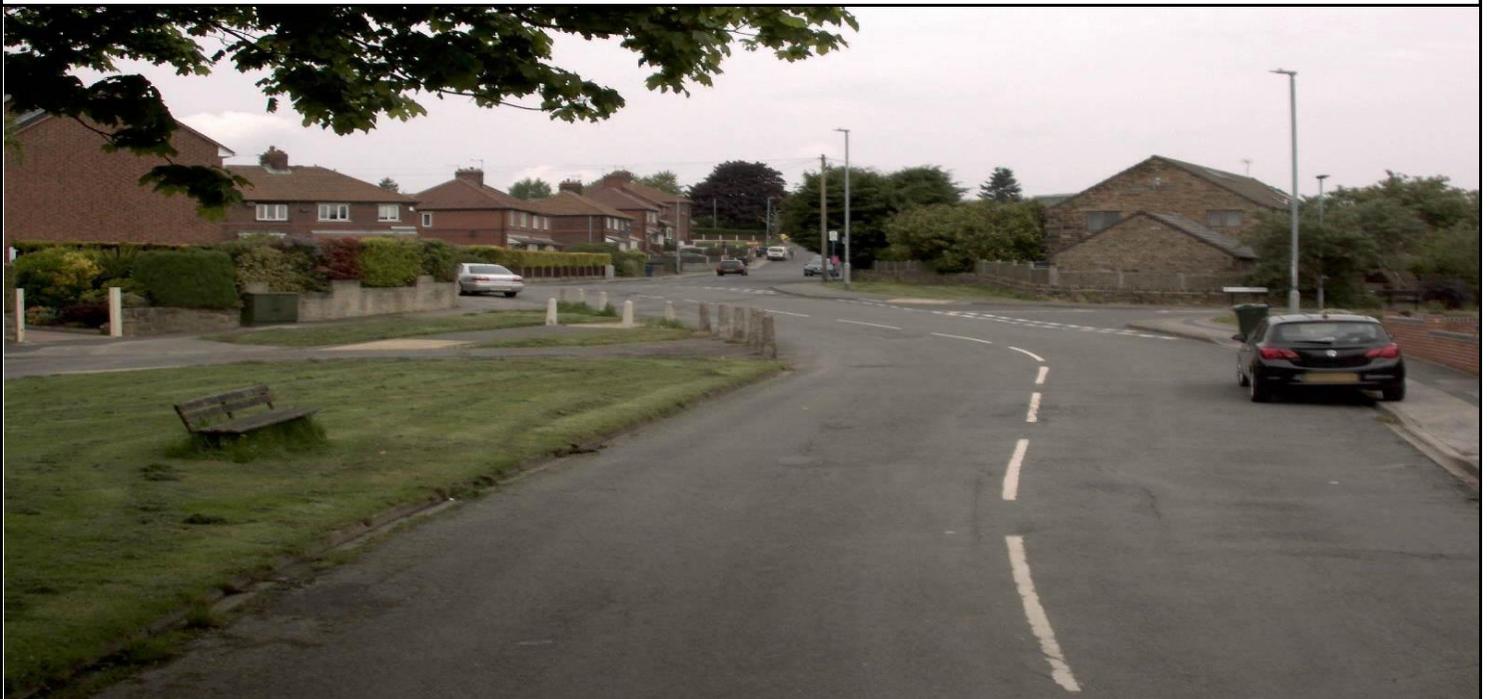
Feature / Defect : Minor Surface Defectiveness
