VCS Report

Project: Hoyland, Barnsley

Job No: PTS21335-01

This report describes the Visual Condition Survey of the Hoyland, Barnsley scheme. This can be identified on the site plan within Appendix A. The survey was undertaken in June 2021 in the daytime using a HD resolution video survey.

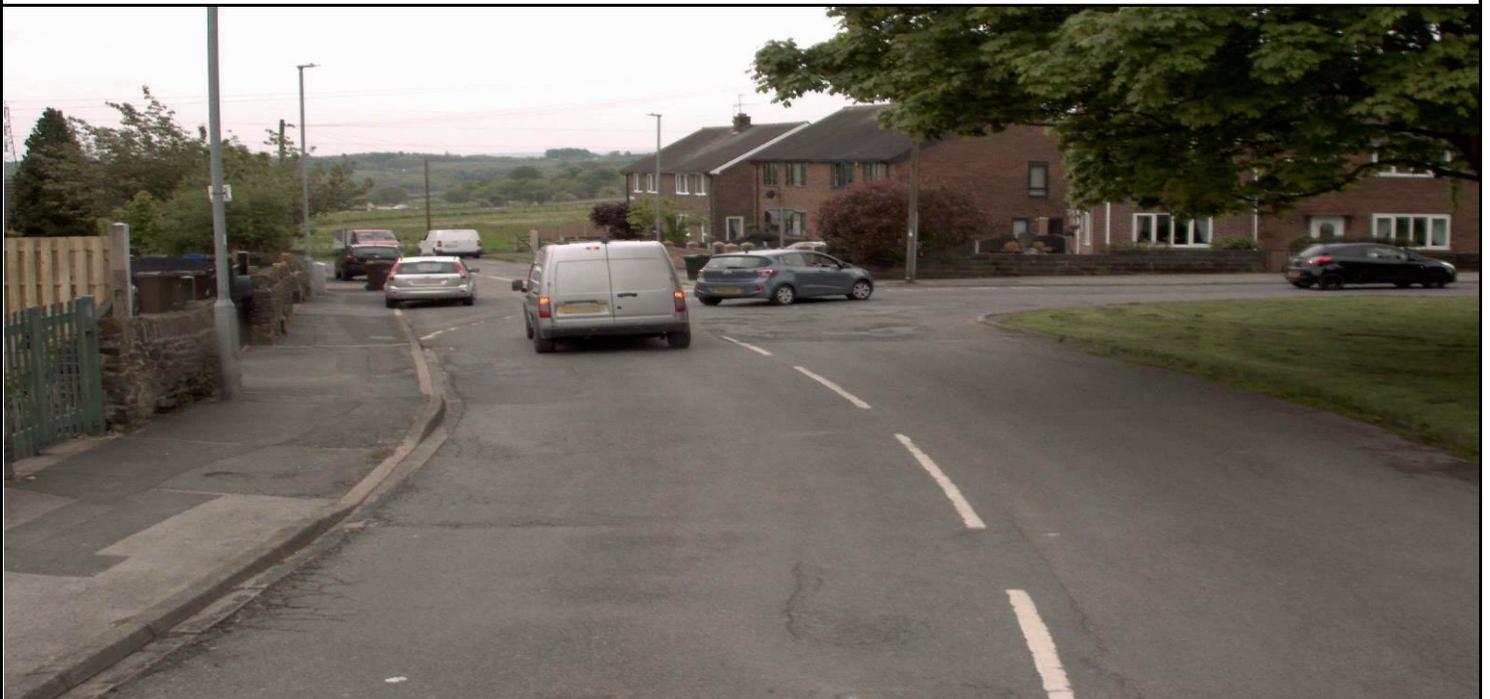
Feature / Defect : Major Surface Defectiveness

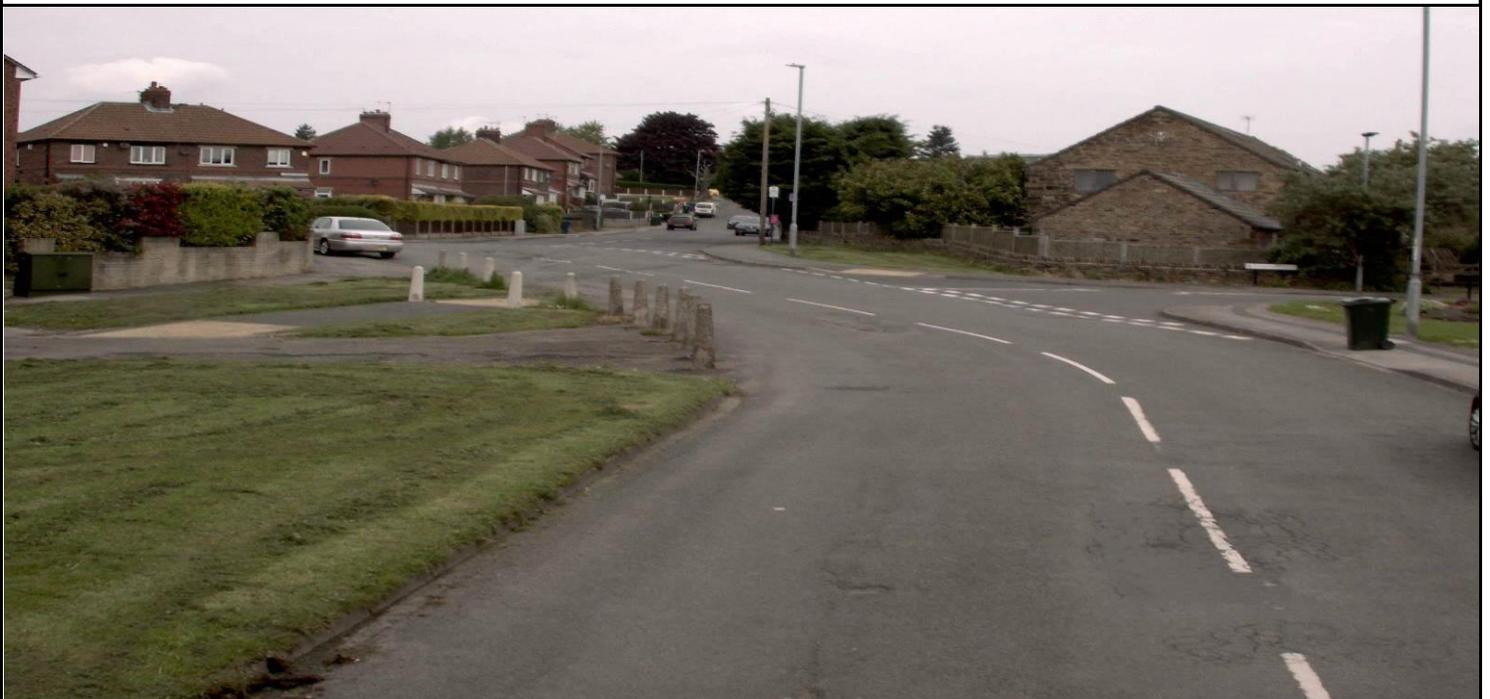
Feature / Defect : Major Cracking, Major Surface Defectiveness

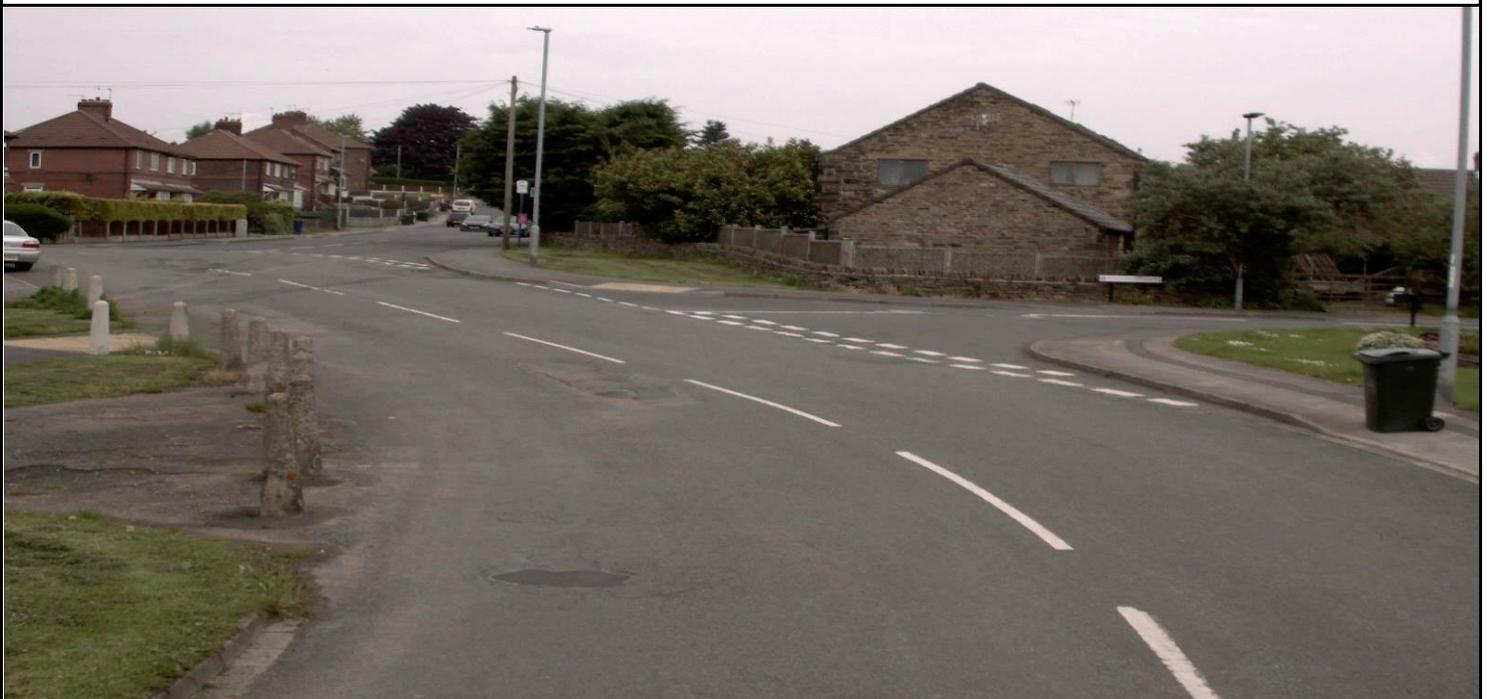
Feature / Defect : Major Cracking

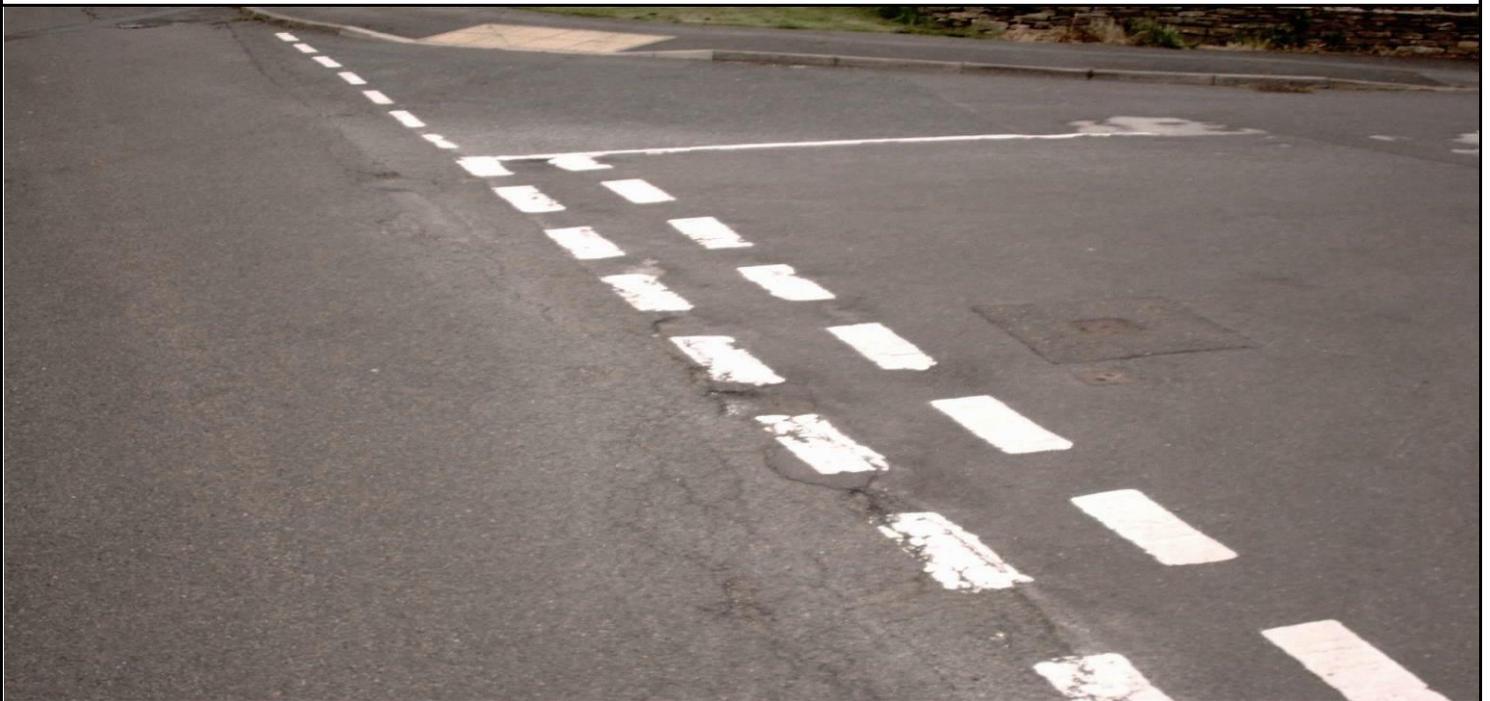
Feature / Defect : Minor Cracking

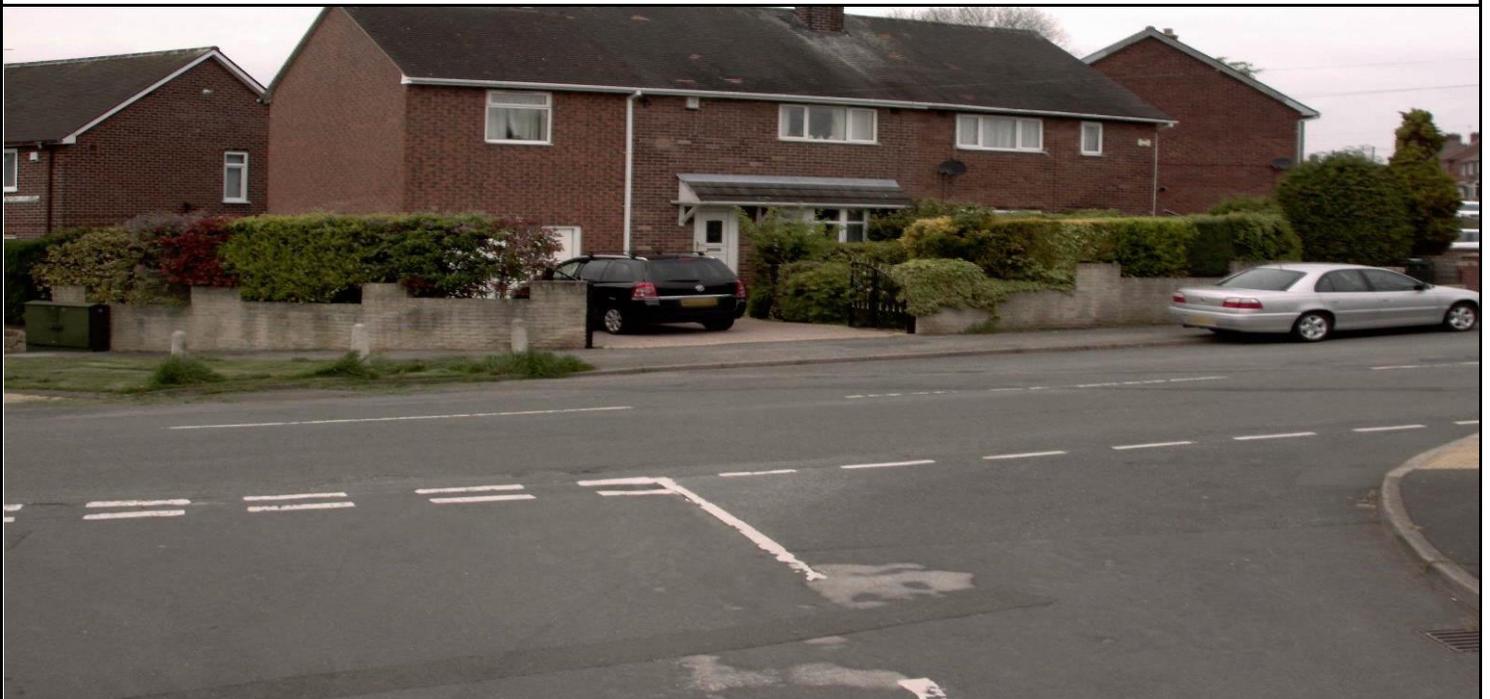
Feature / Defect : Major Surface Defectiveness

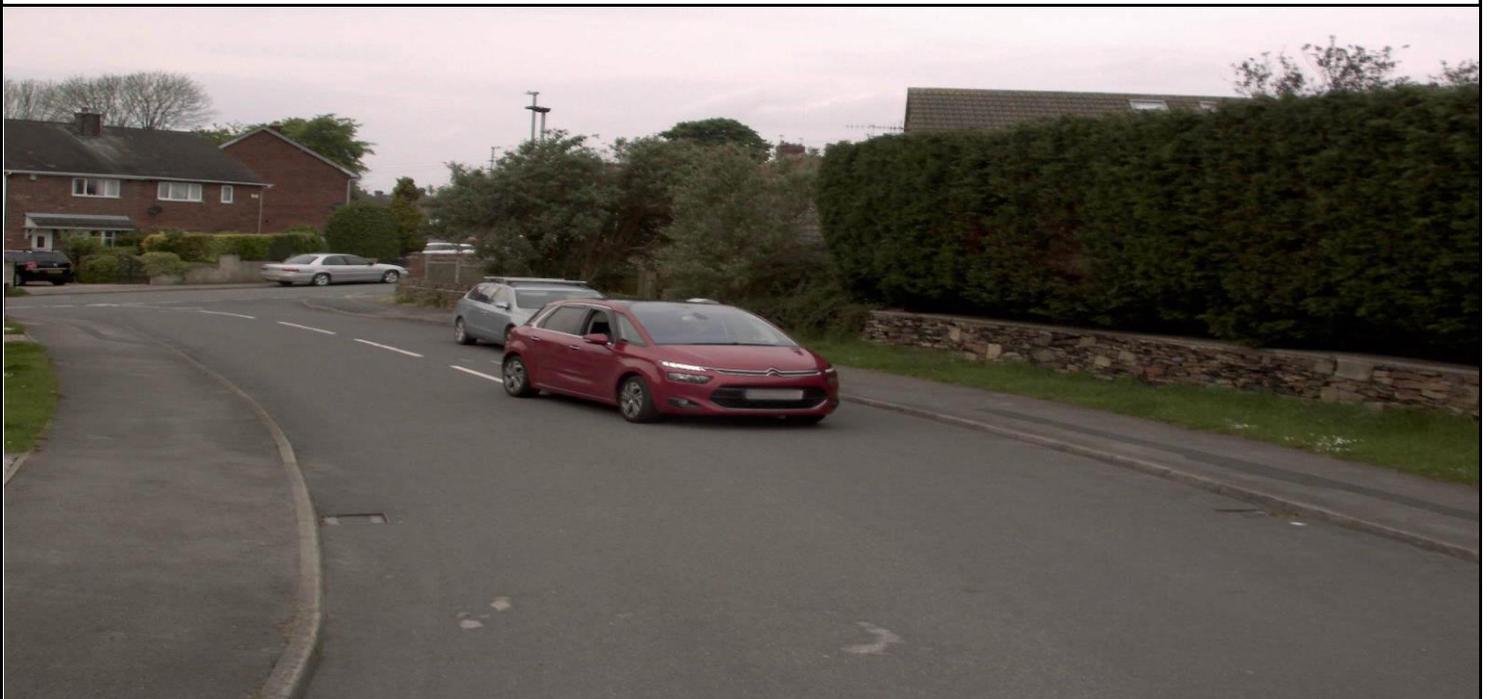
Photo Ref : 60	Section : Pendlebury Grove
Chainage : 35m	Feature / Defect : Major Surface Defectiveness

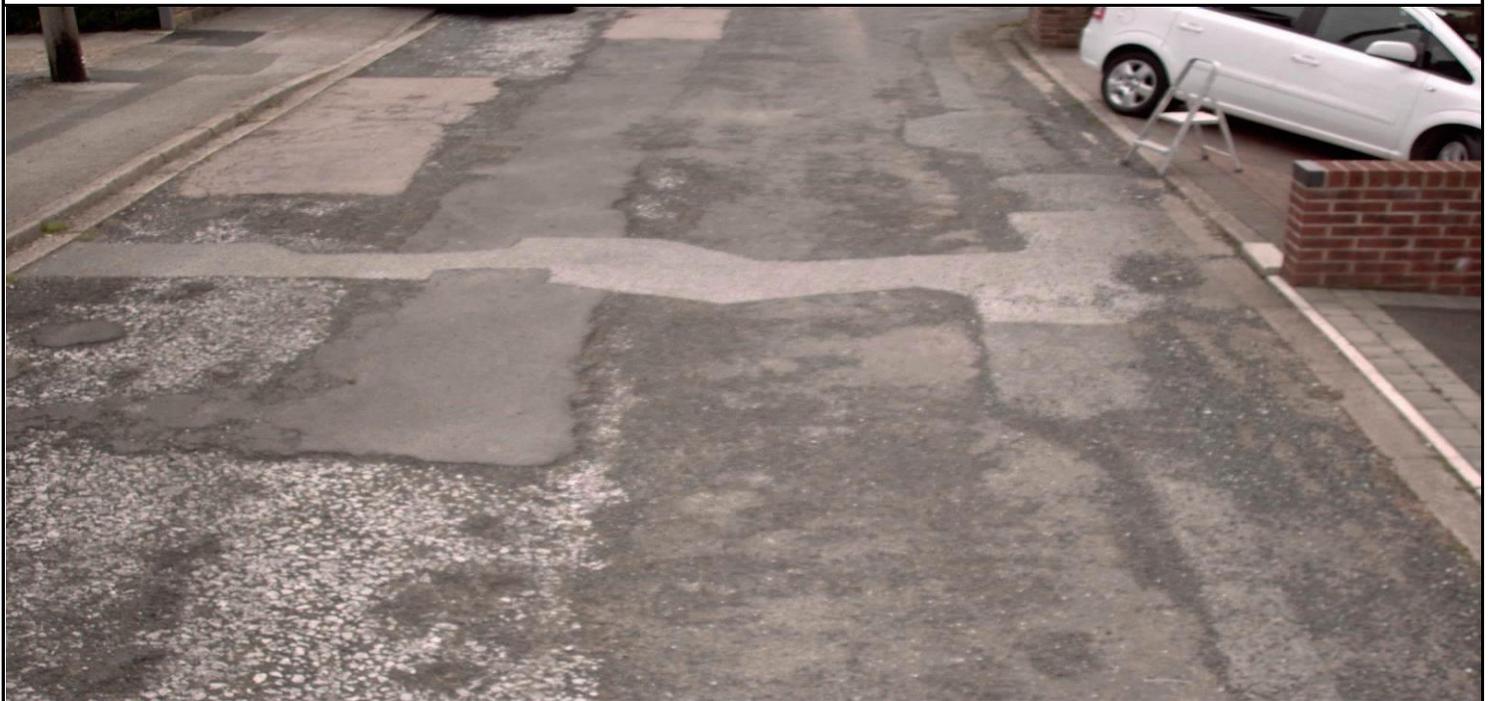
Feature / Defect : Minor Surface Defectiveness

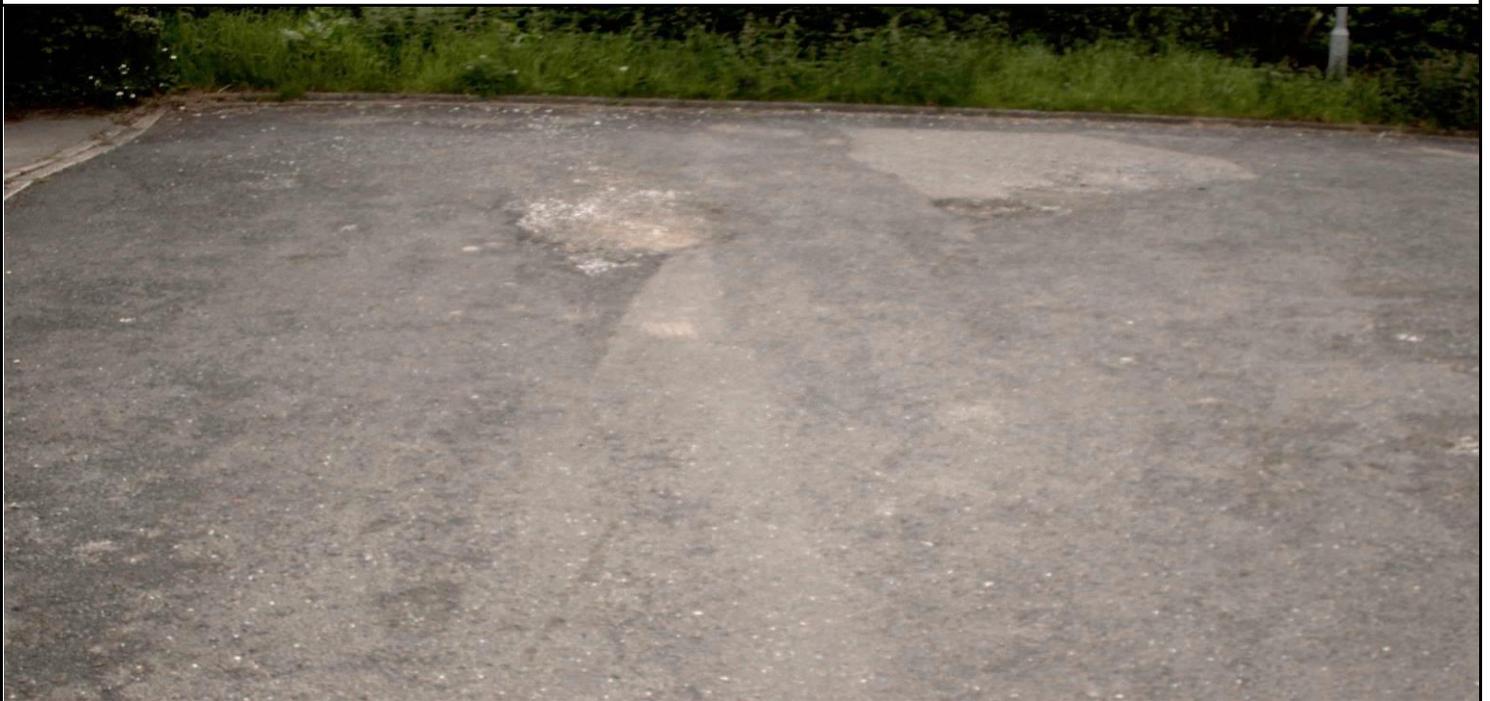
Feature / Defect : Major Surface Defectiveness

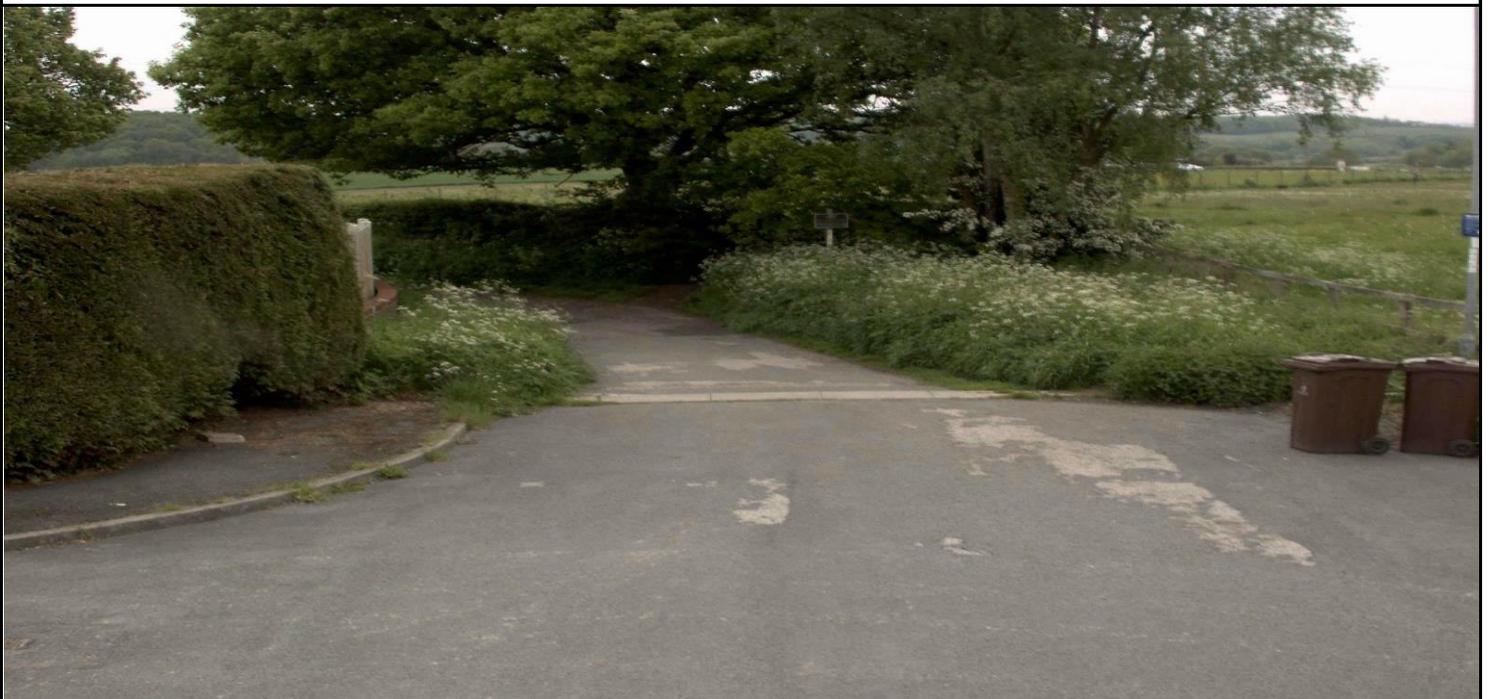
Feature / Defect : Major Surface Defectiveness

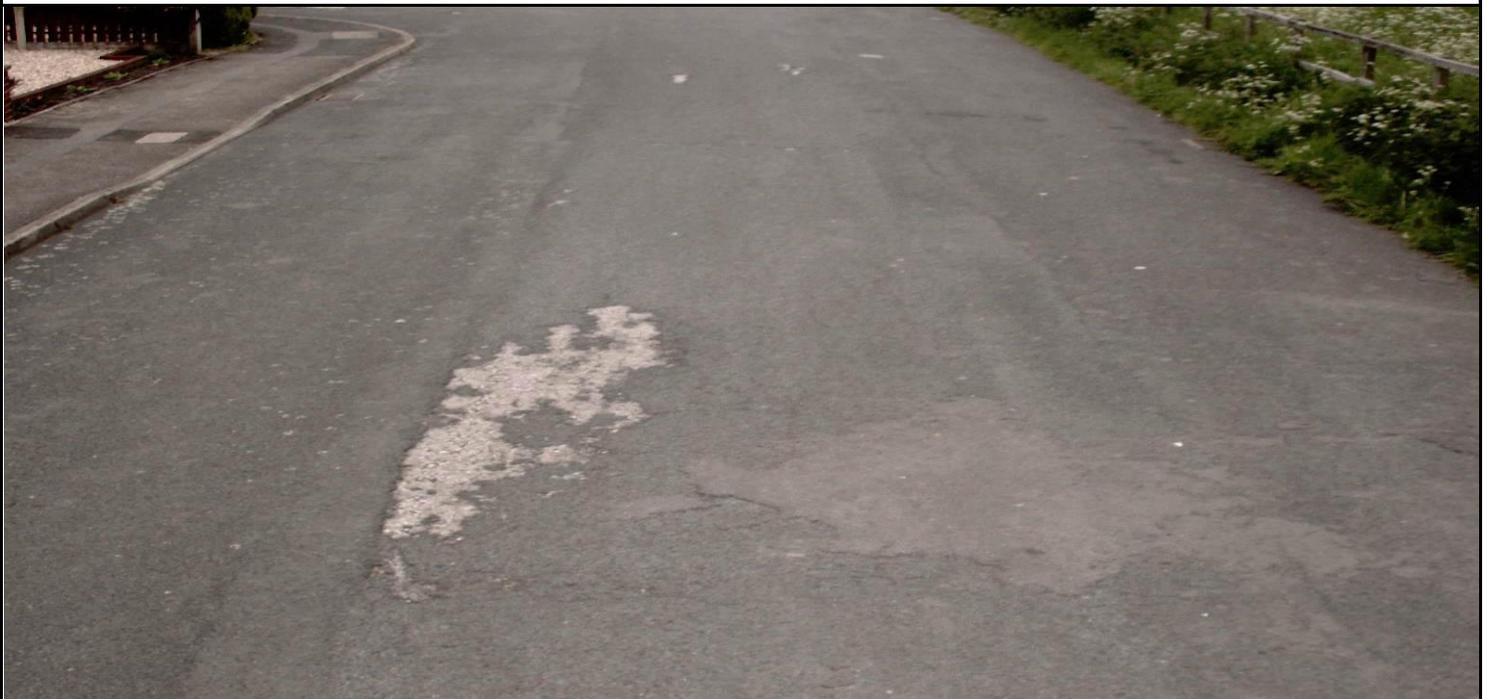
Photo Ref : 74	Section : Stead Lane
Chainage : 40m	Feature / Defect : Major Fatting

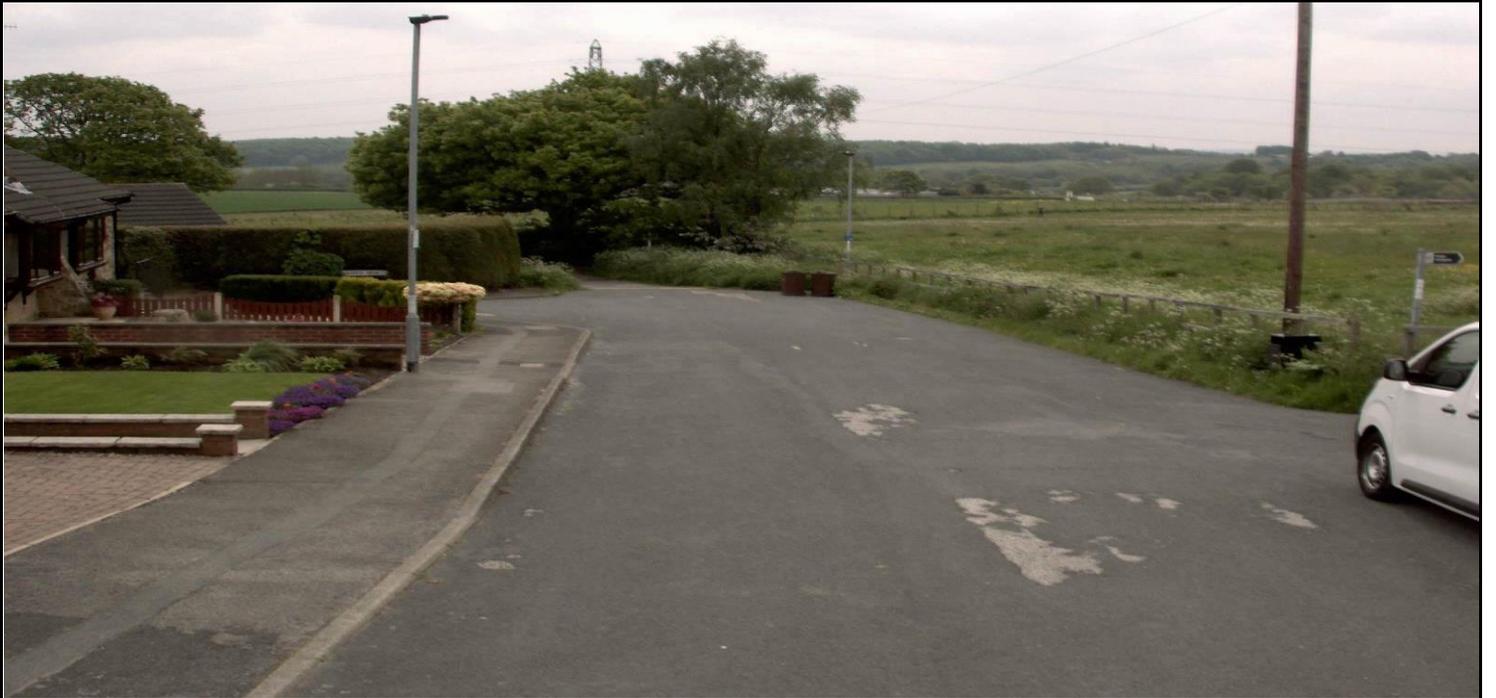
Photo Ref : 75	Section : Stead Lane
Chainage : 47m	Feature / Defect : Major Surface Defectiveness, Minor Surface Defectiveness

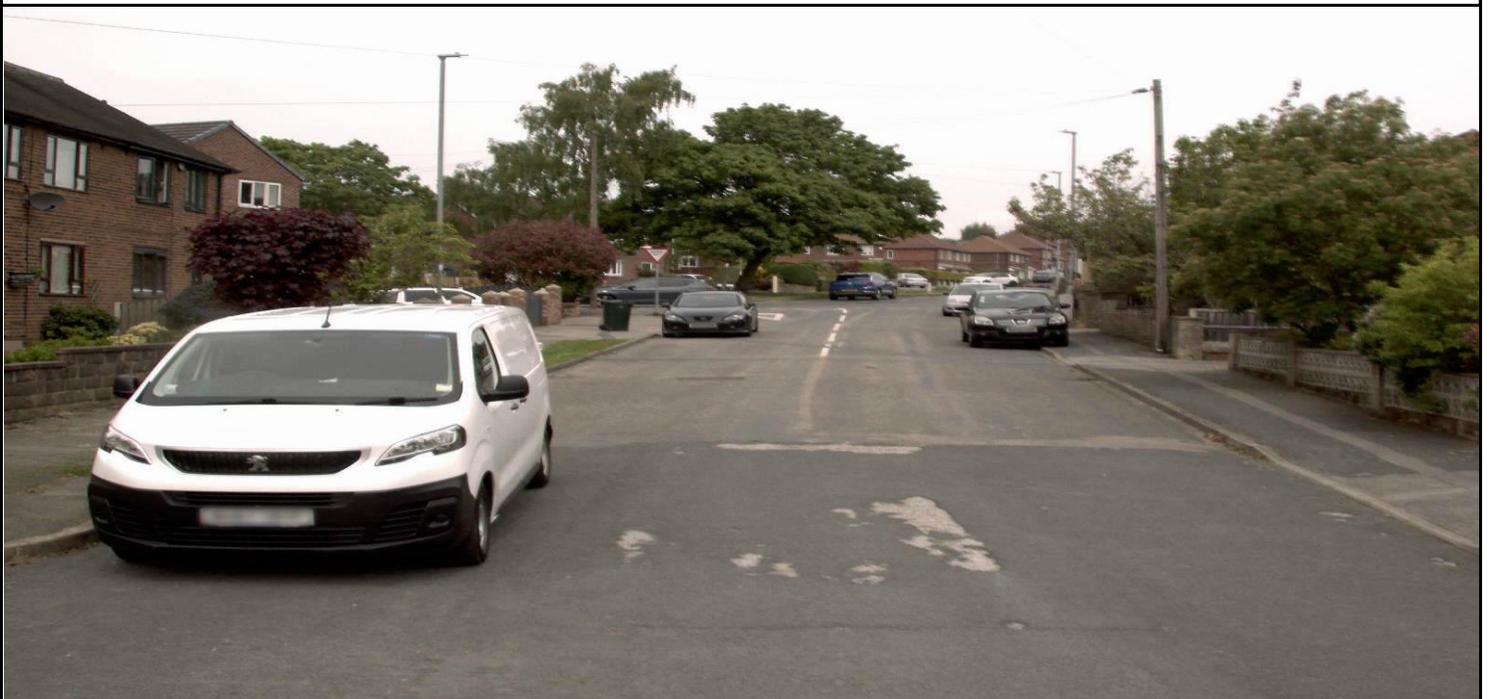
Photo Ref : 76	Section : Stead Lane
Chainage : 47m	Feature / Defect : Major Surface Defectiveness

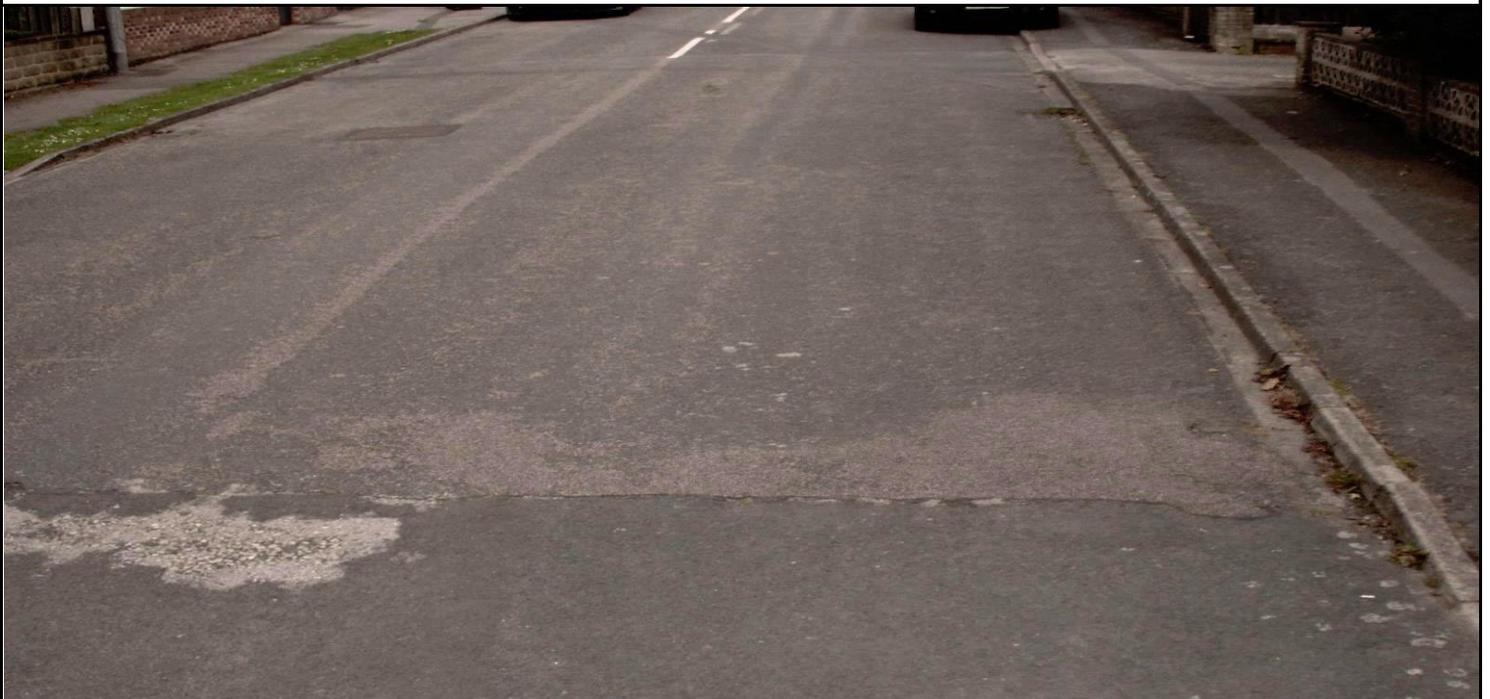
Feature / Defect : Major Surface Defectiveness

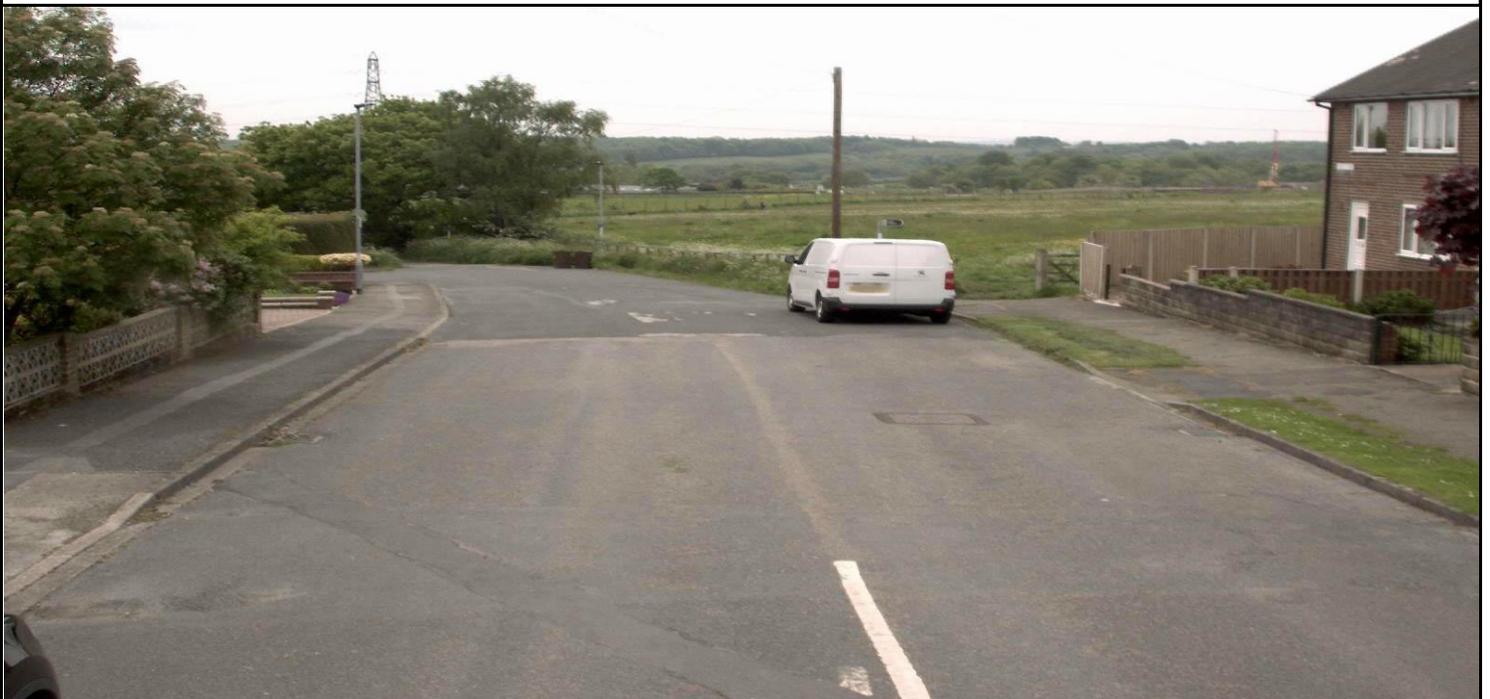
Feature / Defect : Major Surface Defectiveness

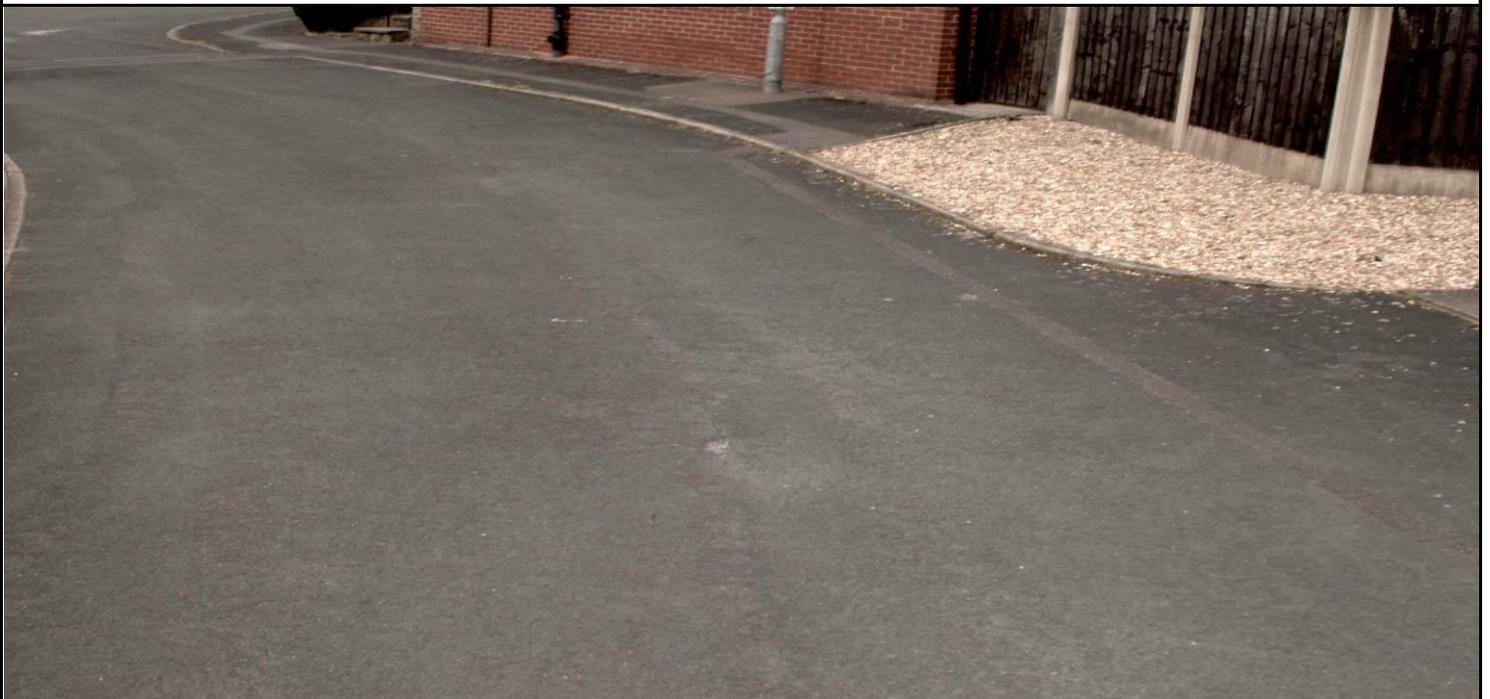
Feature / Defect : Major Surface Defectiveness

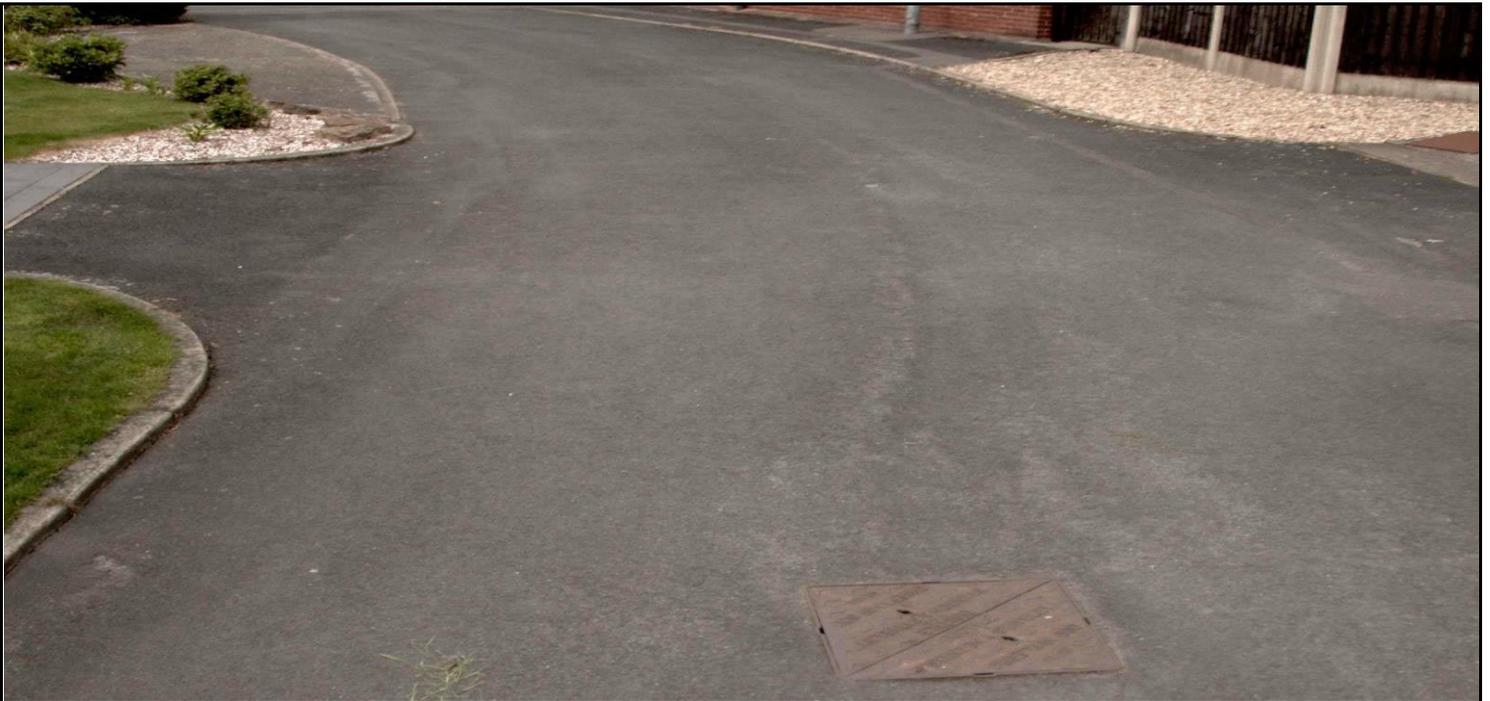
Feature / Defect : Minor Surface Defectiveness

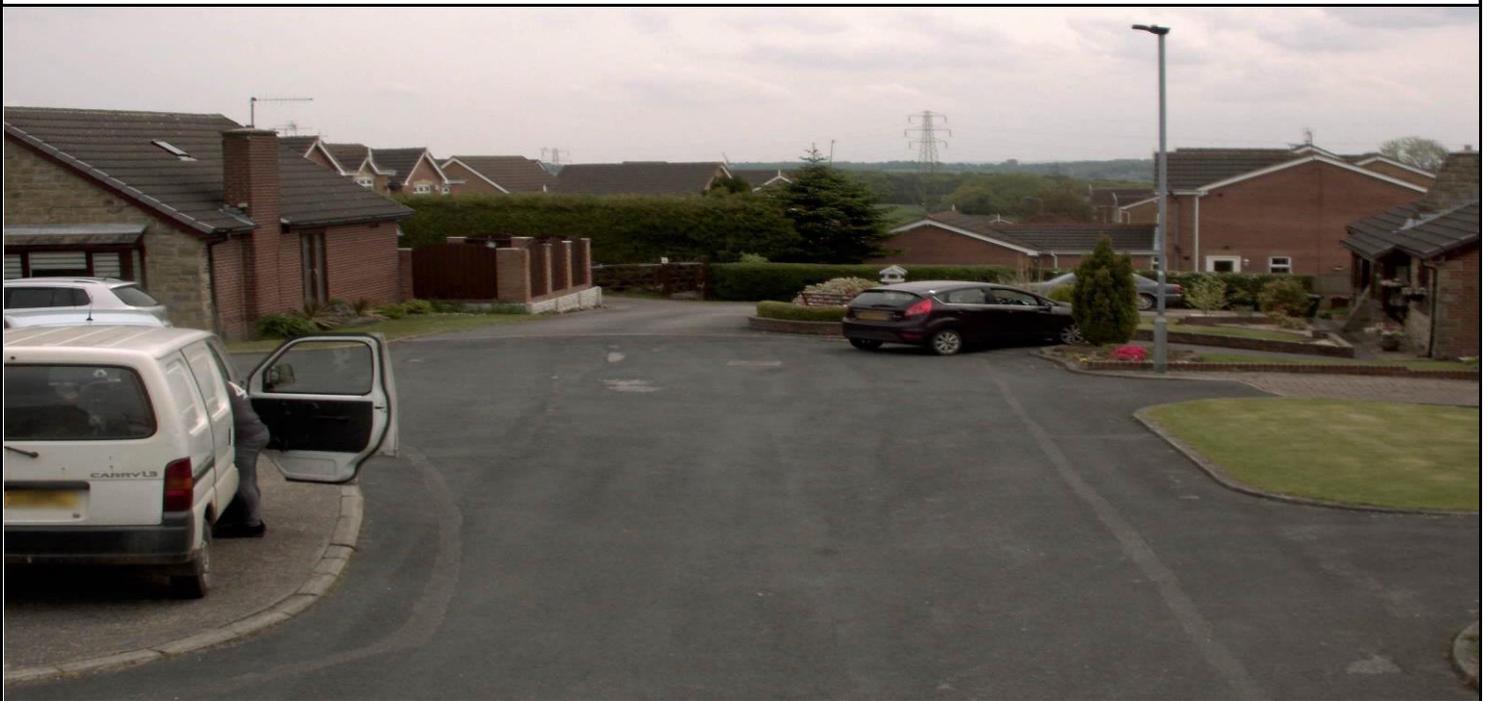
Photo Ref : 86

Feature / Defect : Major Surface Defectiveness

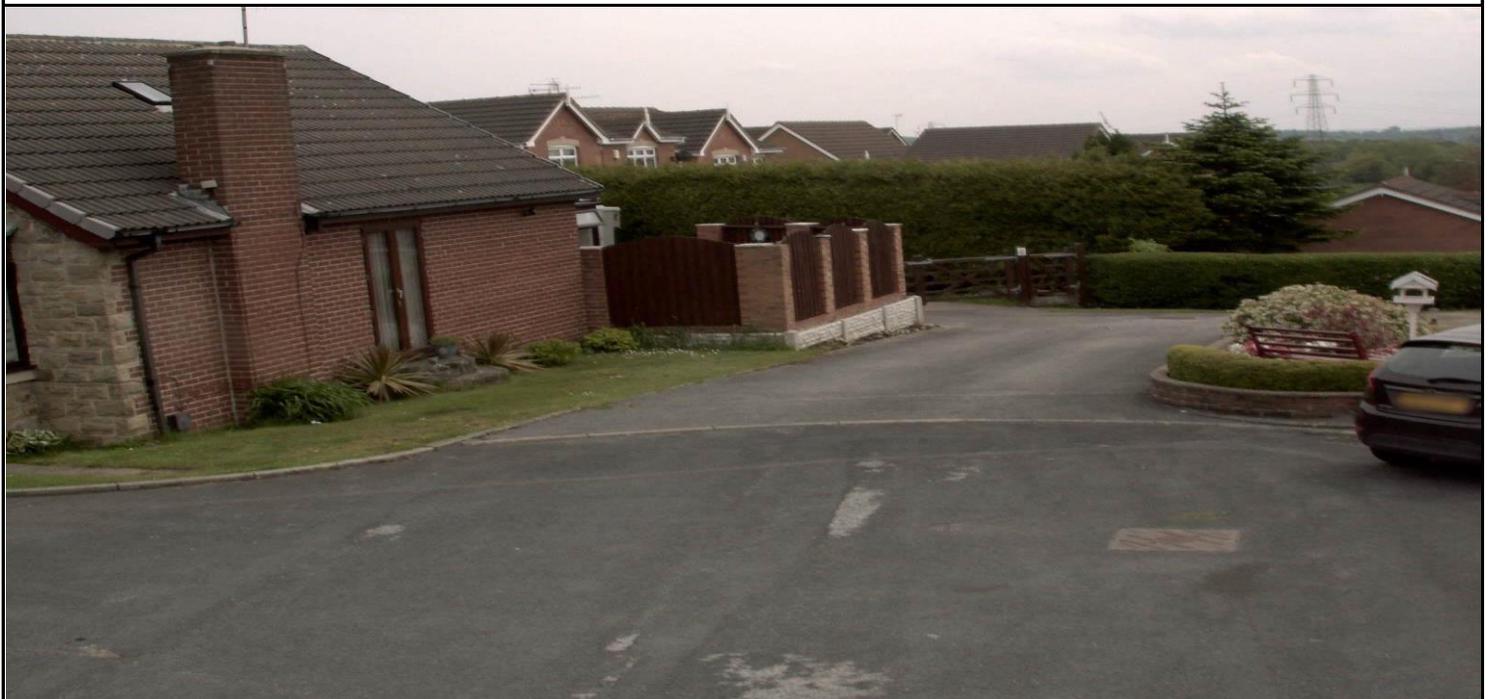
Photo Ref : 88	Section : Warren View
Chainage : 49m	Feature / Defect : Major Surface Defectiveness

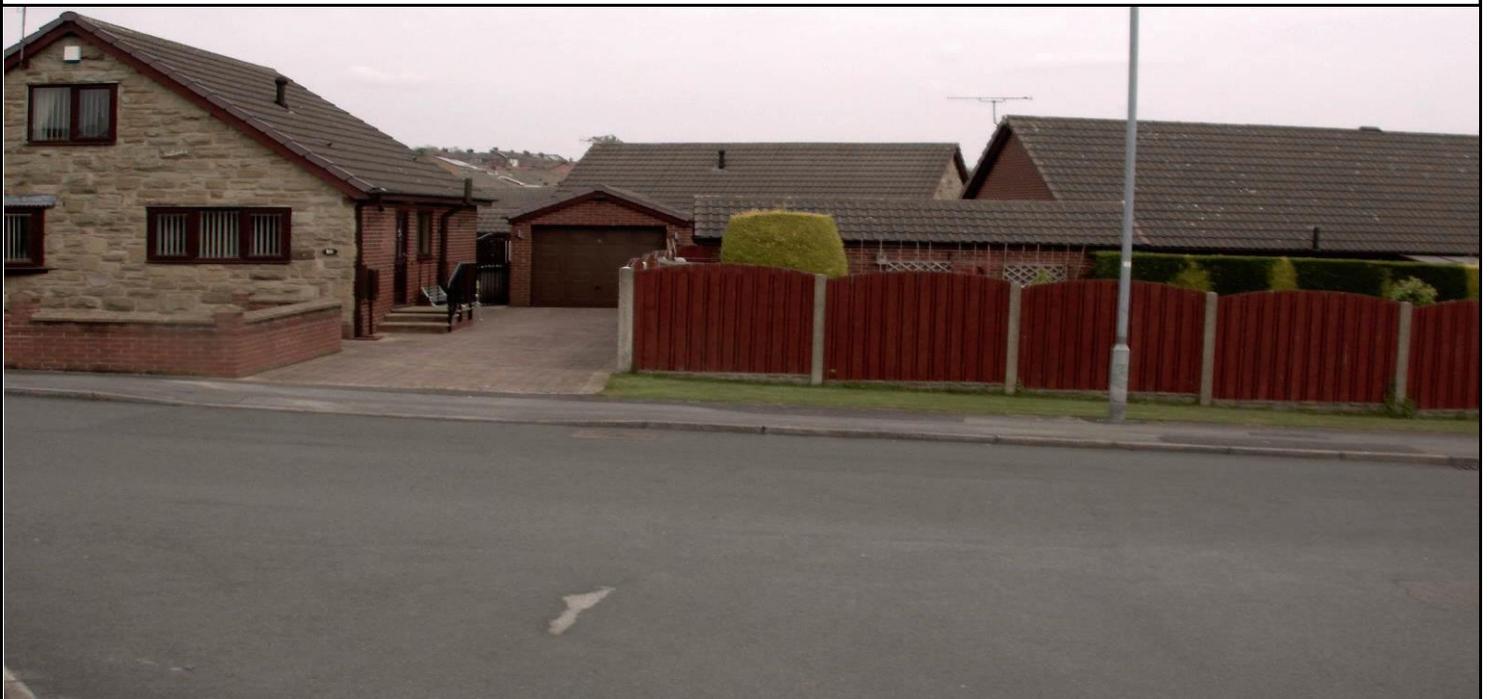
Feature / Defect : Major Surface Defectiveness

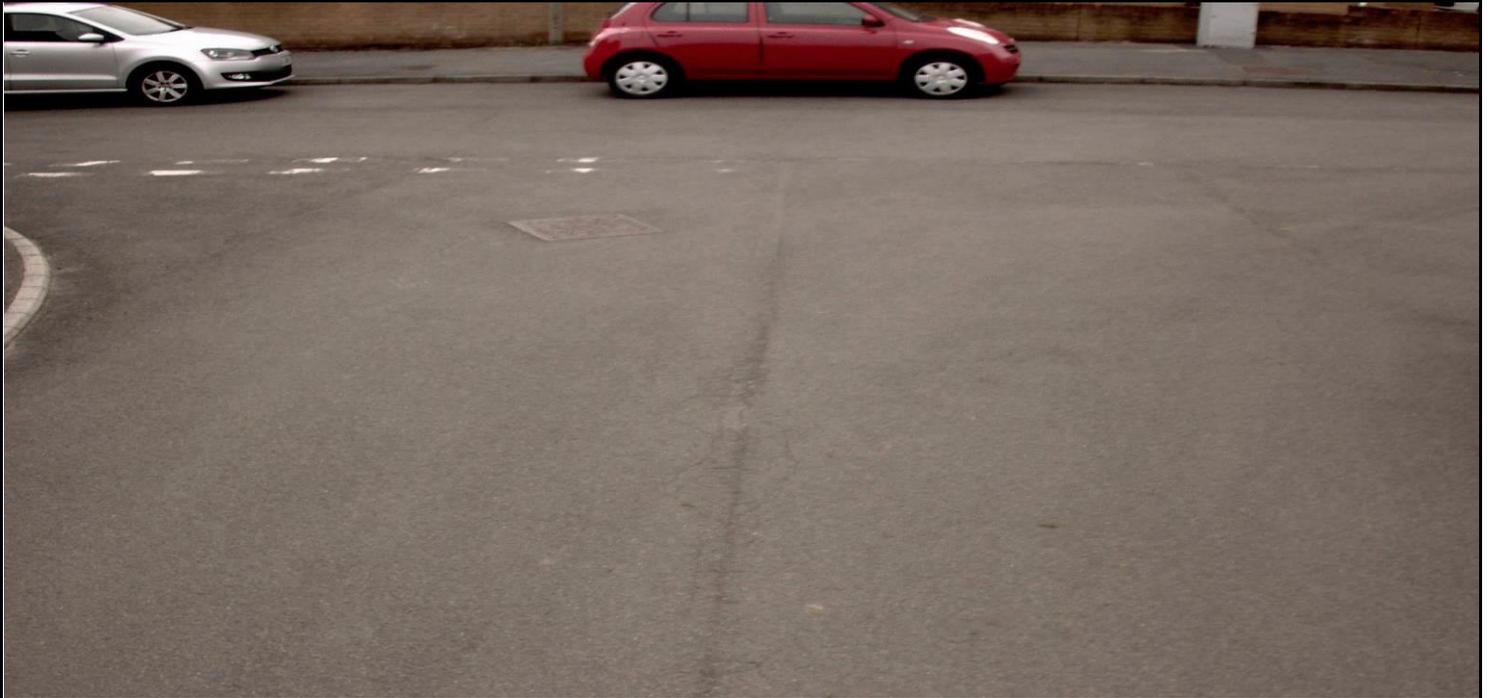
Feature / Defect : Minor Cracking

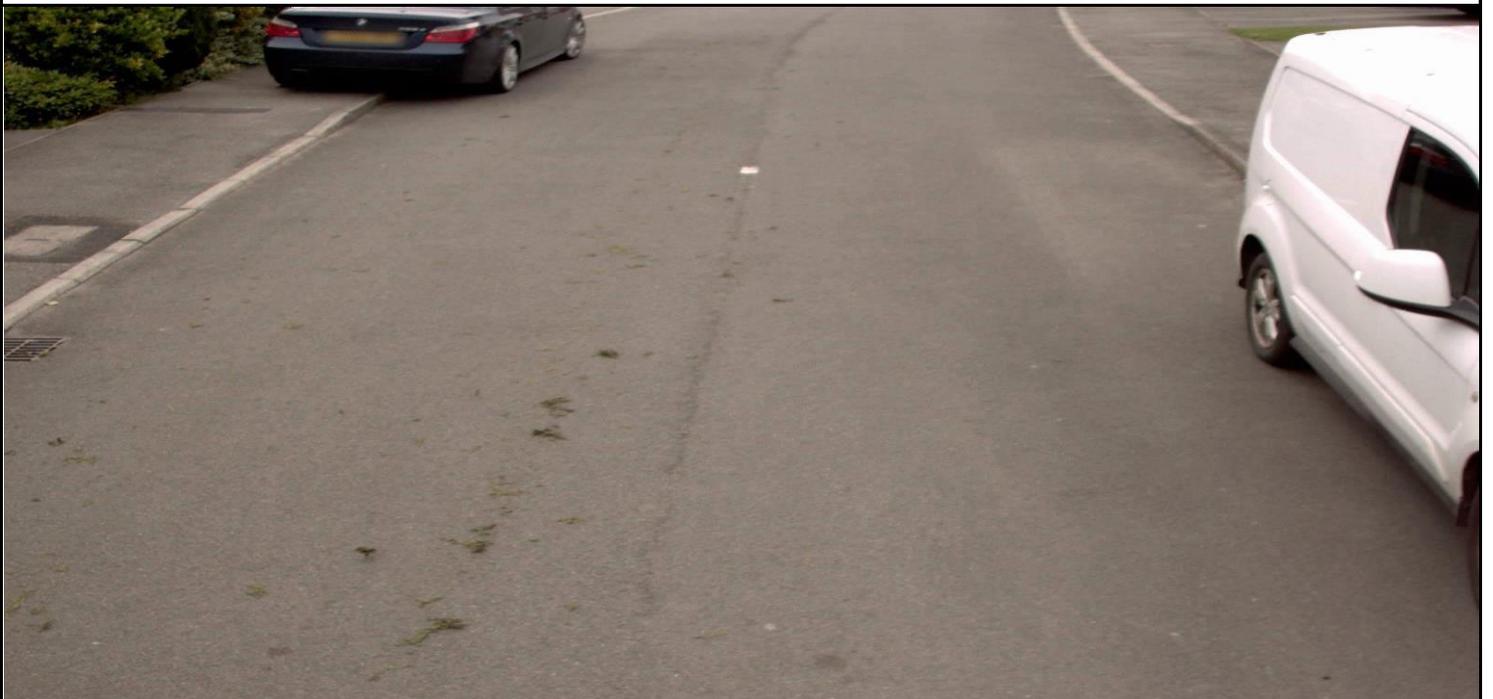
Photo Ref : 94

Feature / Defect : Minor Cracking

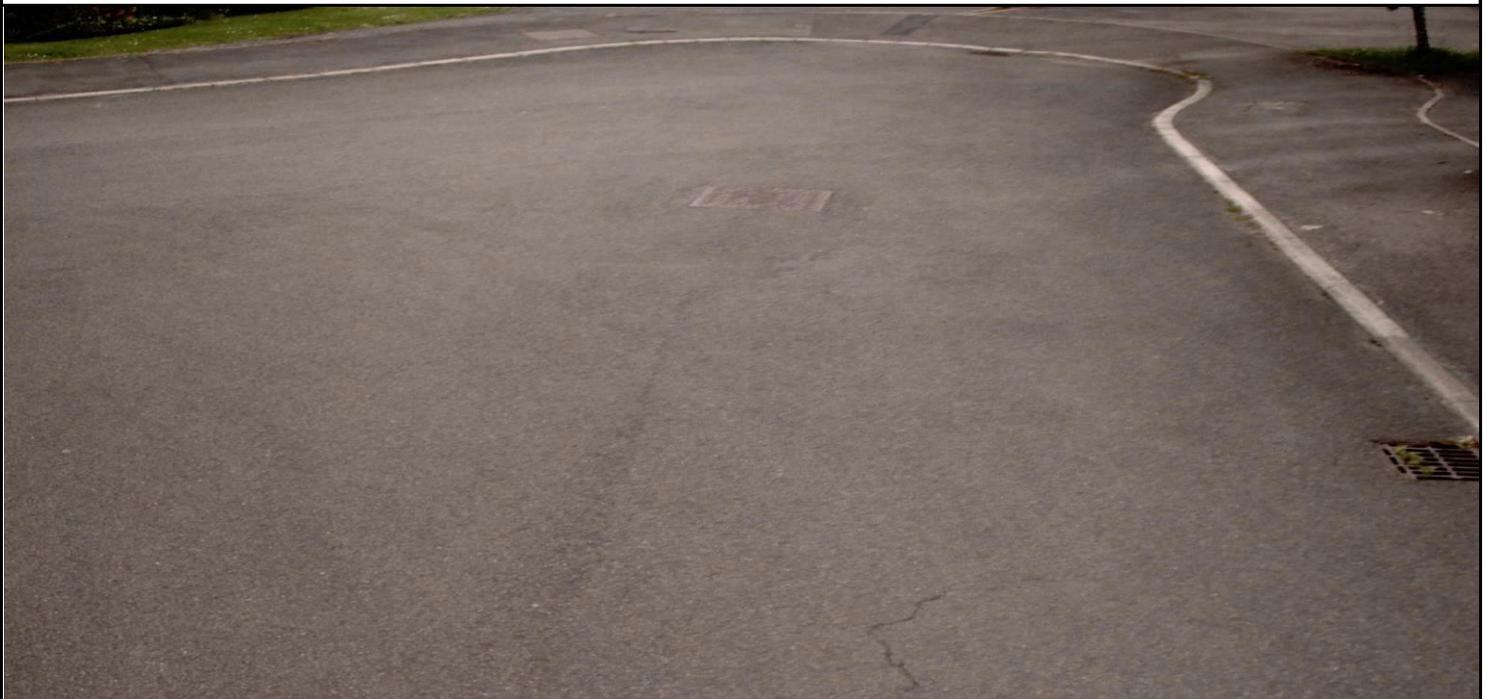
Feature / Defect : Major Cracking
