VCS Report

Project: Hoyland, Barnsley

Job No: PTS21335-01

This report describes the Visual Condition Survey of the Hoyland, Barnsley scheme. This can be identified on the site plan within Appendix A. The survey was undertaken in June 2021 in the daytime using a HD resolution video survey.

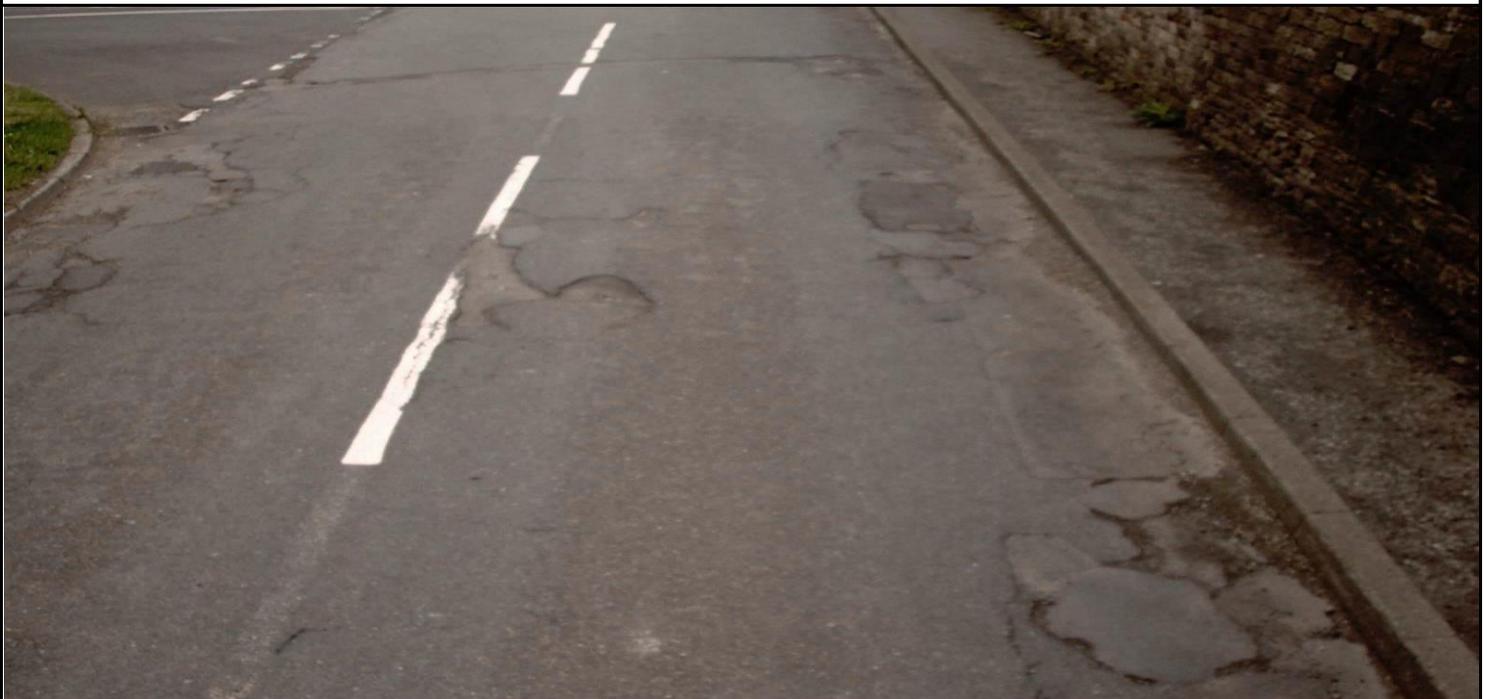
Feature / Defect : Major Surface Defectiveness

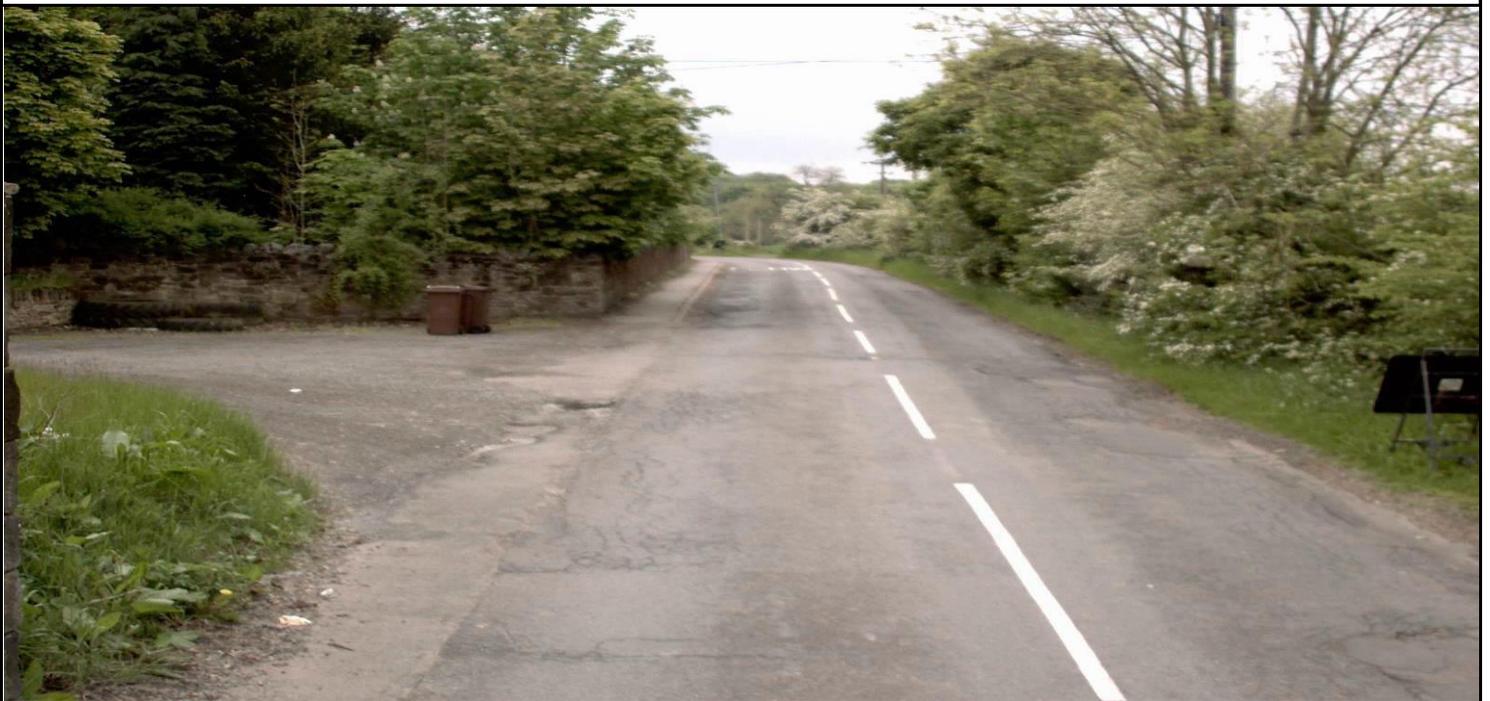
Photo Ref : 104	Section : Tankersley Lane
Chainage : 15m	Feature / Defect : Major Transverse Cracking

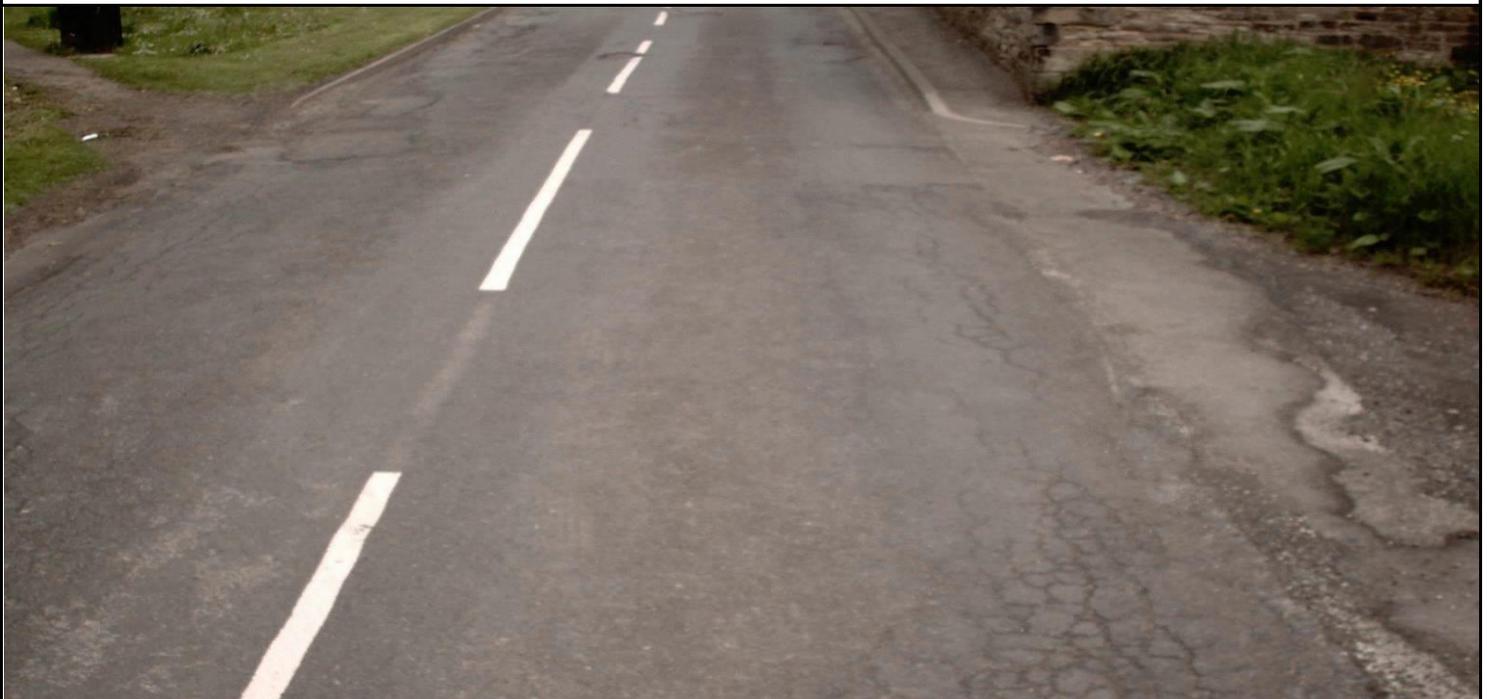
Feature / Defect : Major Cracking

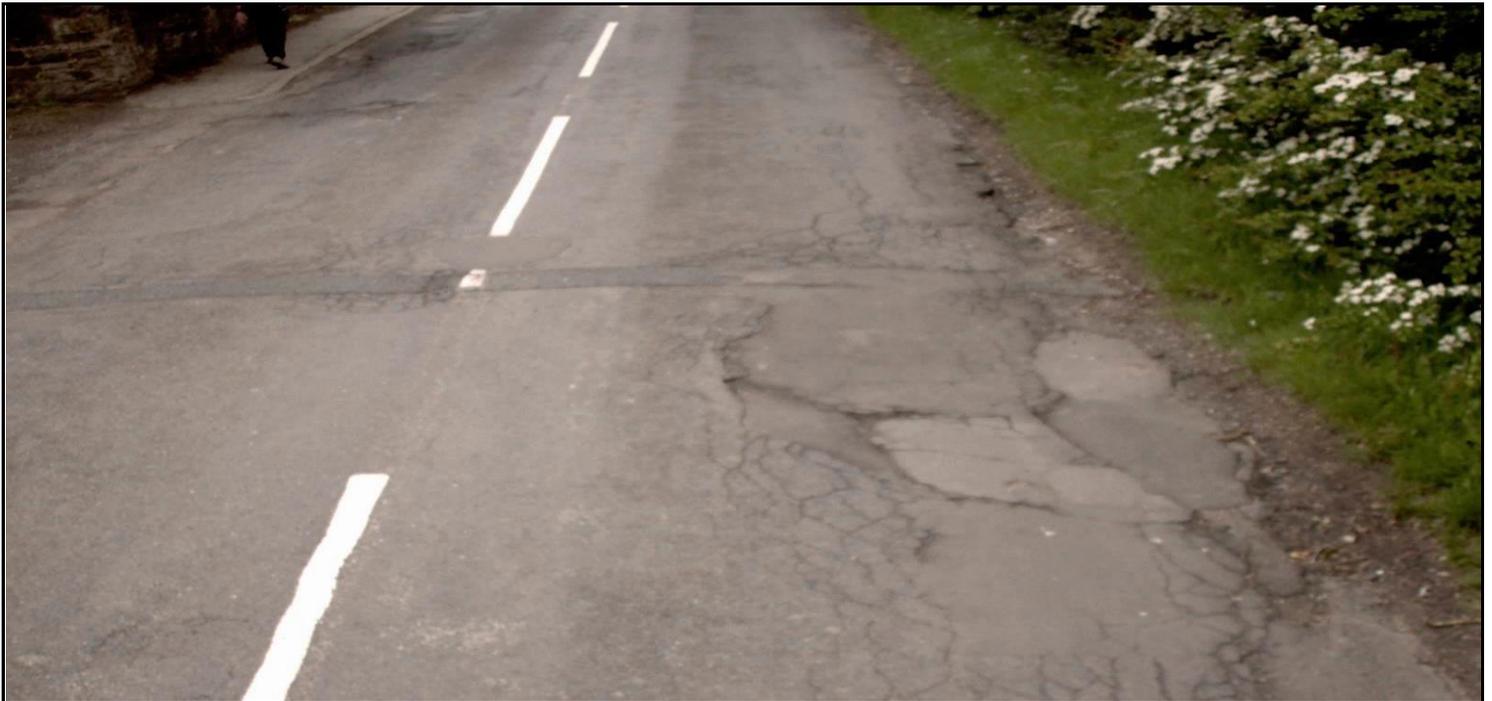
Feature / Defect : Major Cracking

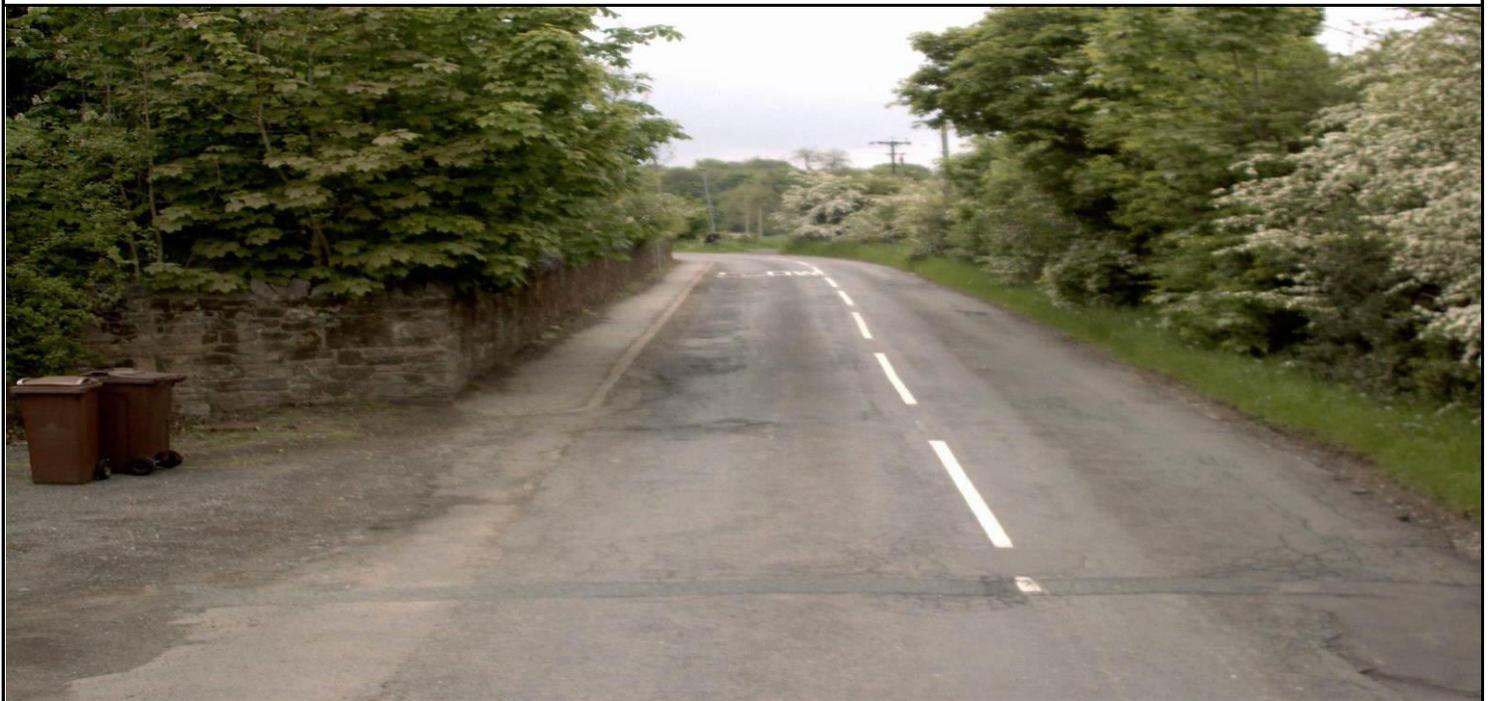
Photo Ref : 108

Feature / Defect : Major Cracking

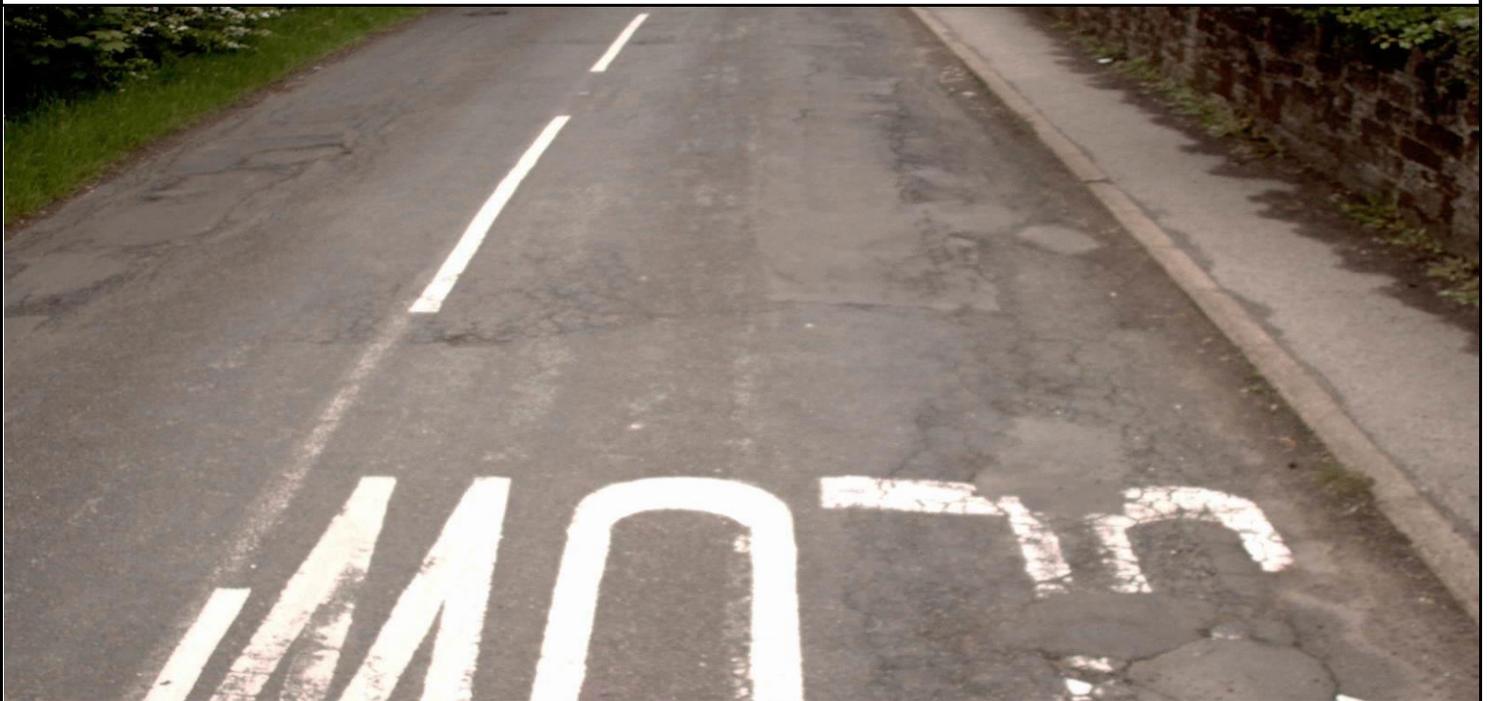
Feature / Defect : Major Surface Defectiveness

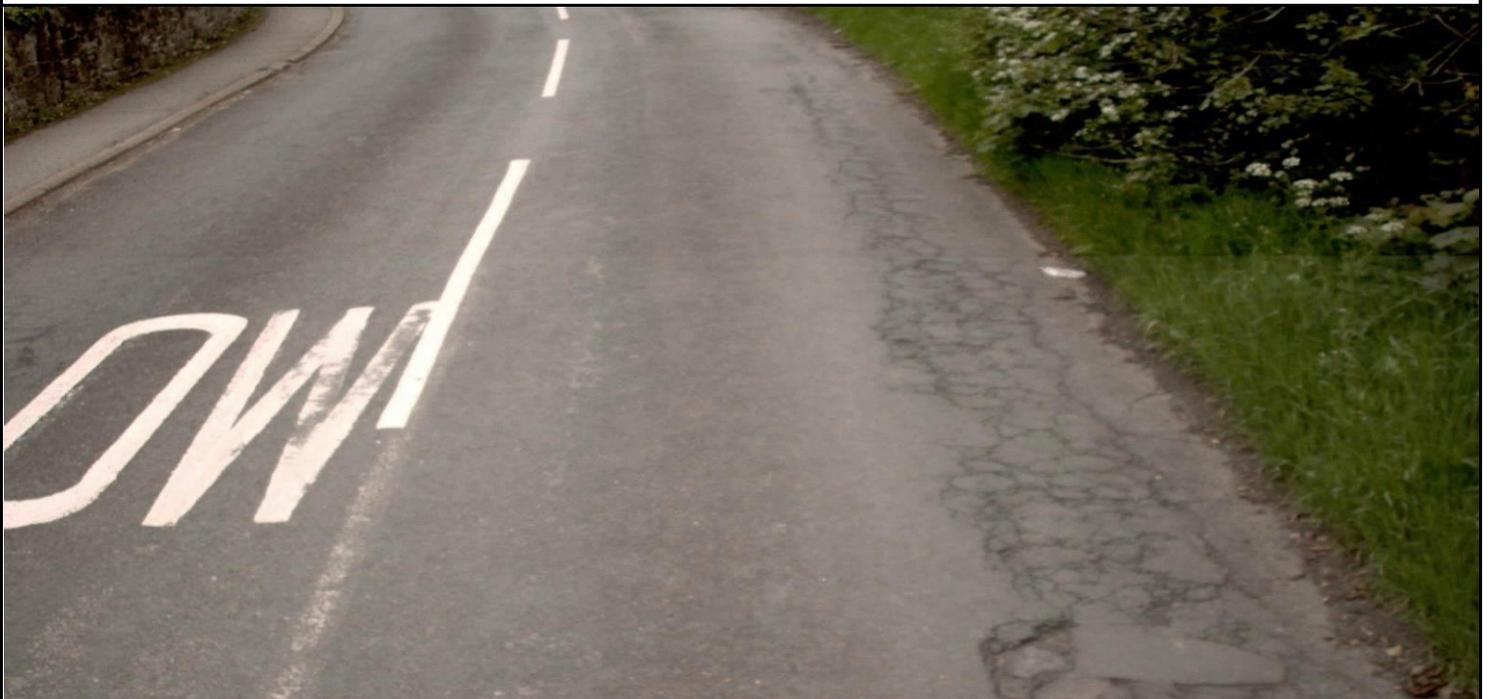
Feature / Defect : Major Cracking

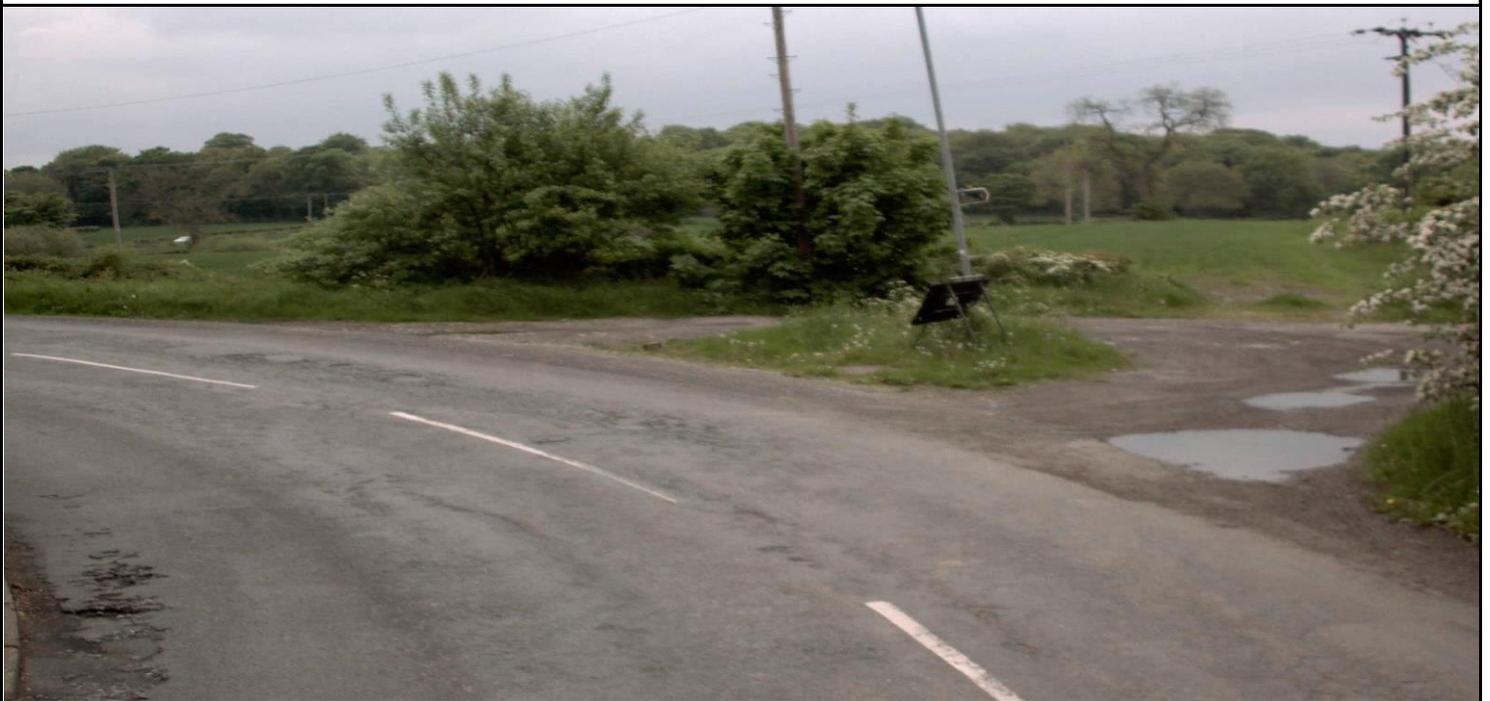
Feature / Defect : Major Surface Defectiveness

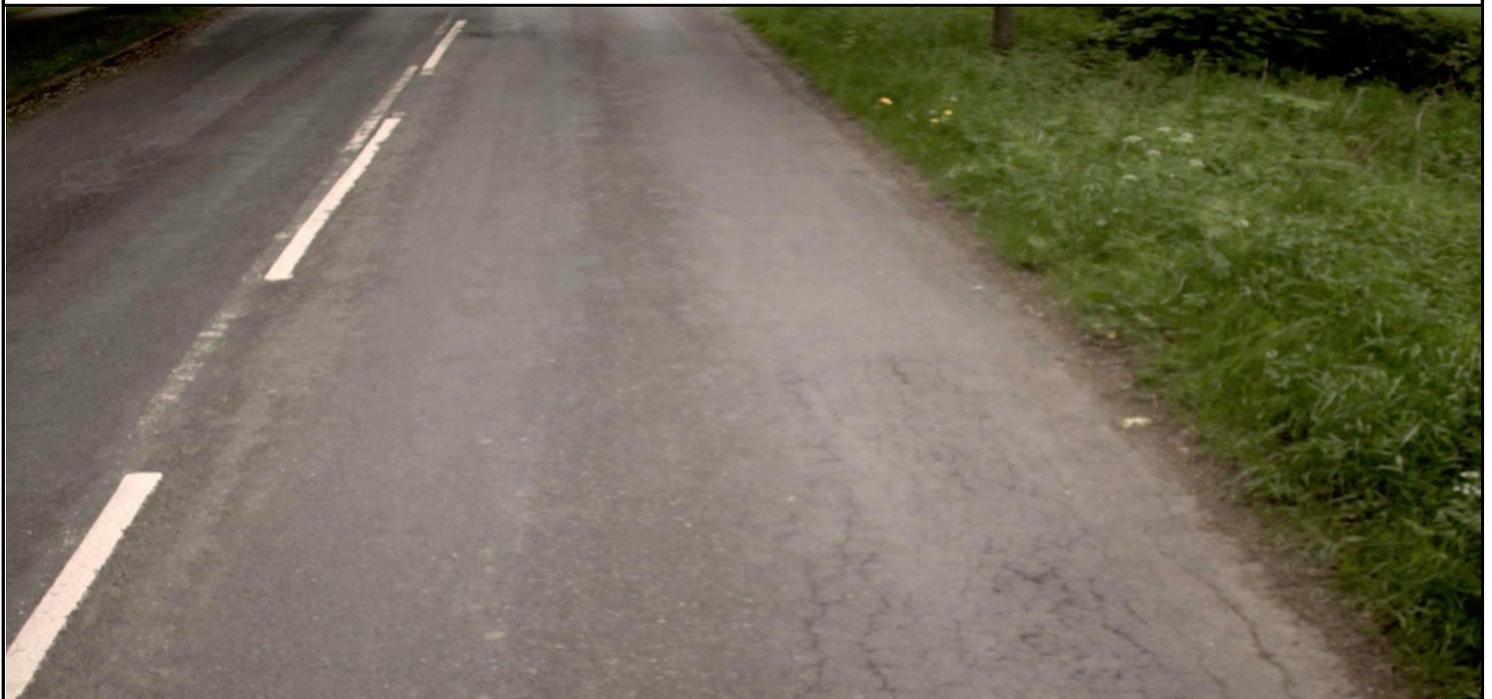
Photo Ref : 118	Section : Tankersley Lane
Chainage : 145m	Feature / Defect : Minor Cracking

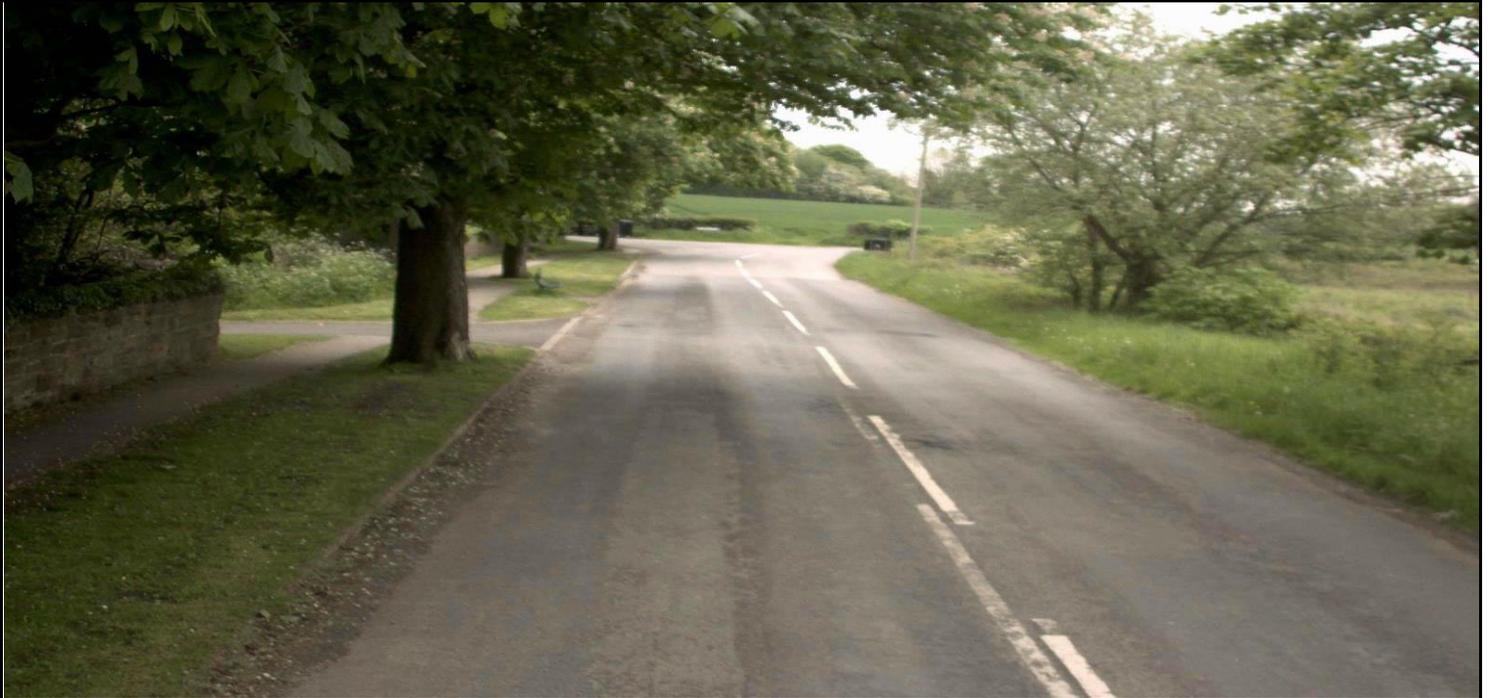
Feature / Defect : Minor Surface Defectiveness

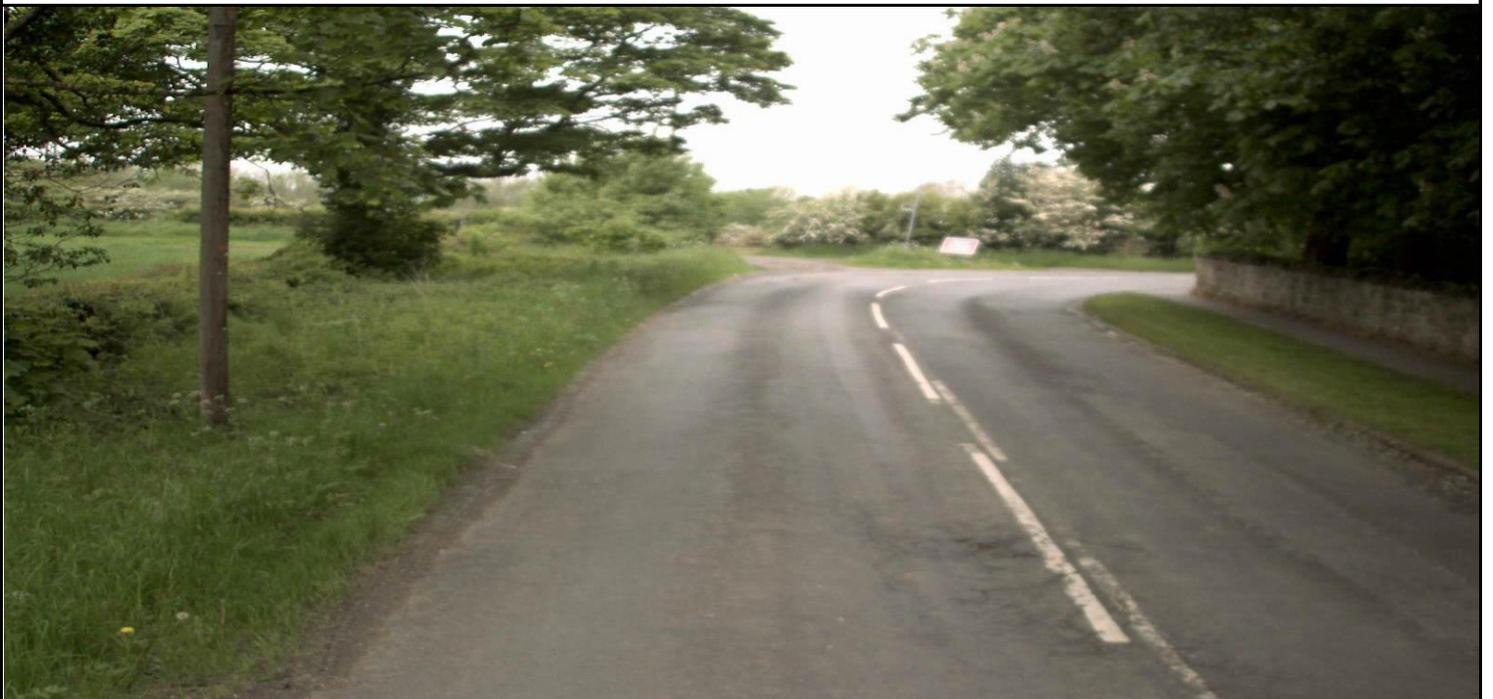
Photo Ref : 120

Feature / Defect : Major Cracking

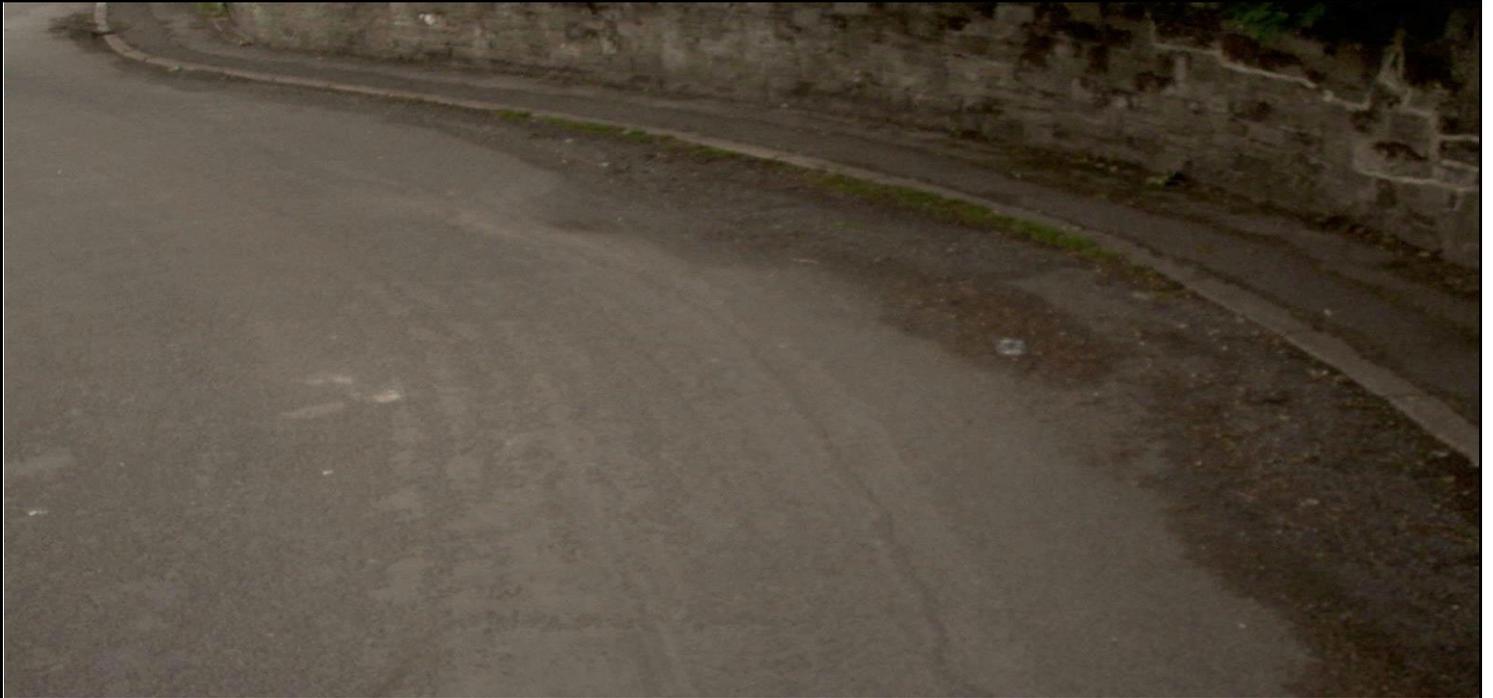
Feature / Defect : Minor Surface Defectiveness

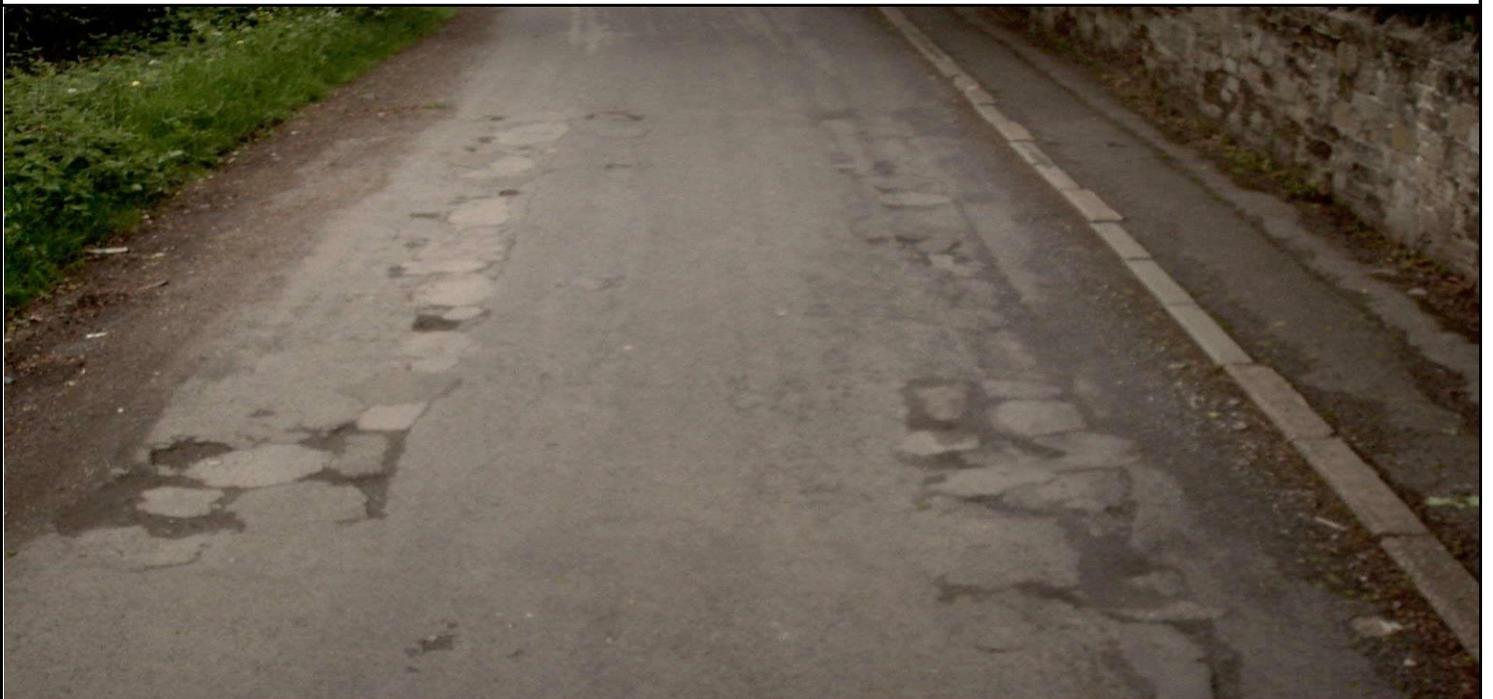
Photo Ref : 132

Feature / Defect : Major Surface Defectiveness

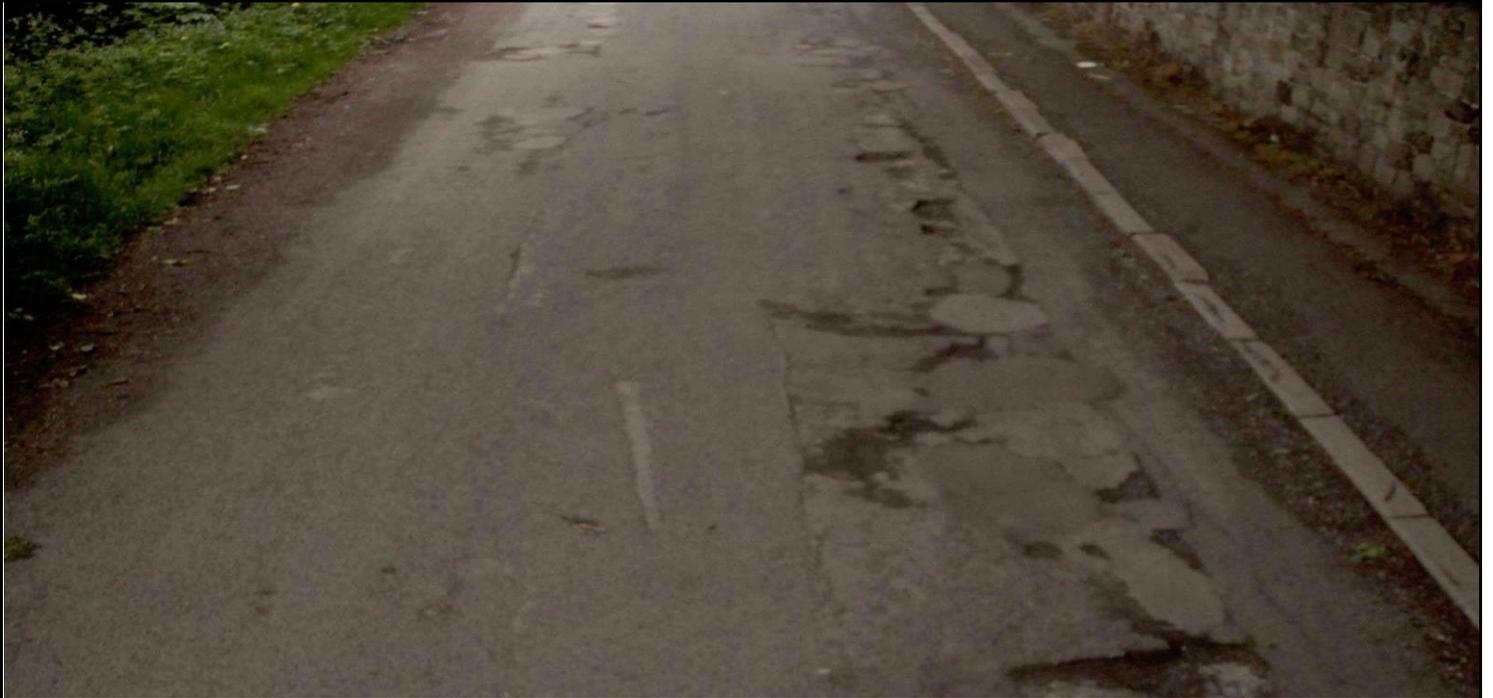
Feature / Defect : Major Surface Defectiveness

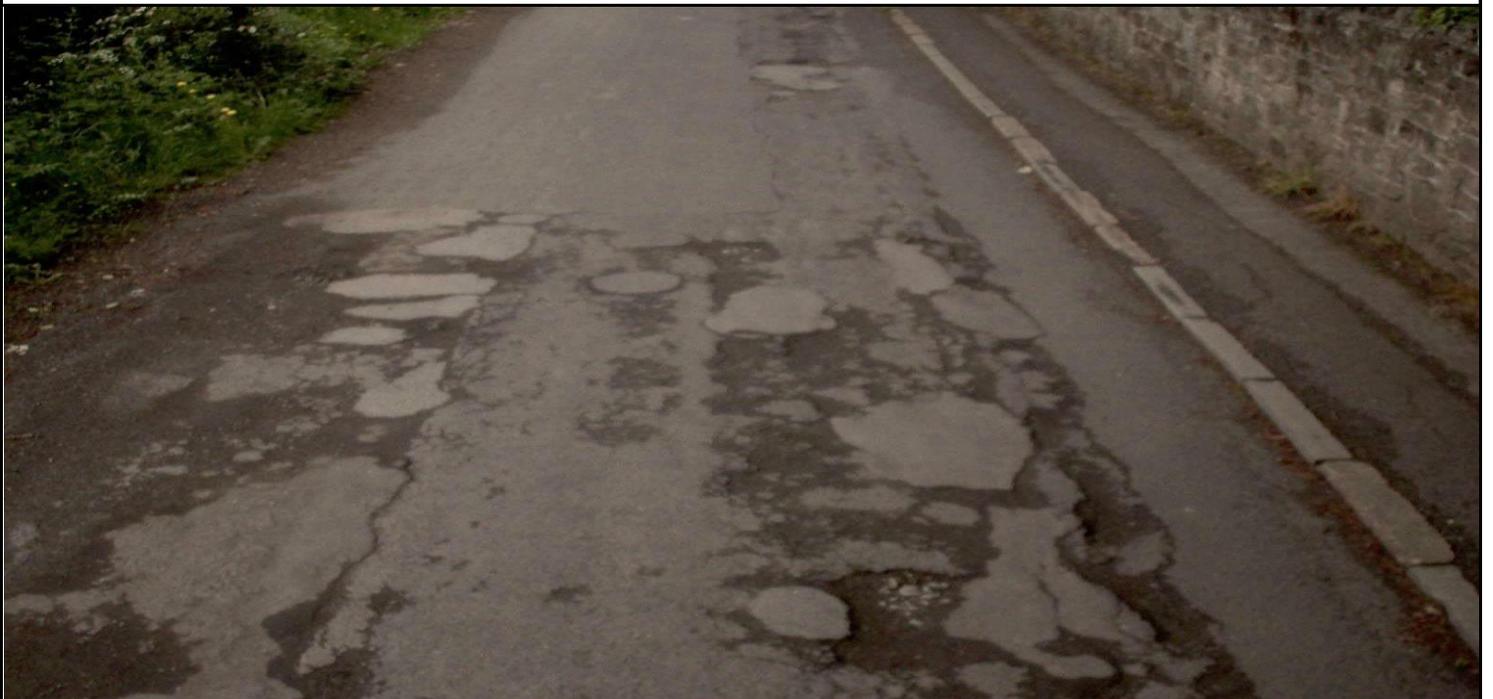
Photo Ref : 134

Feature / Defect : Major Surface Defectiveness

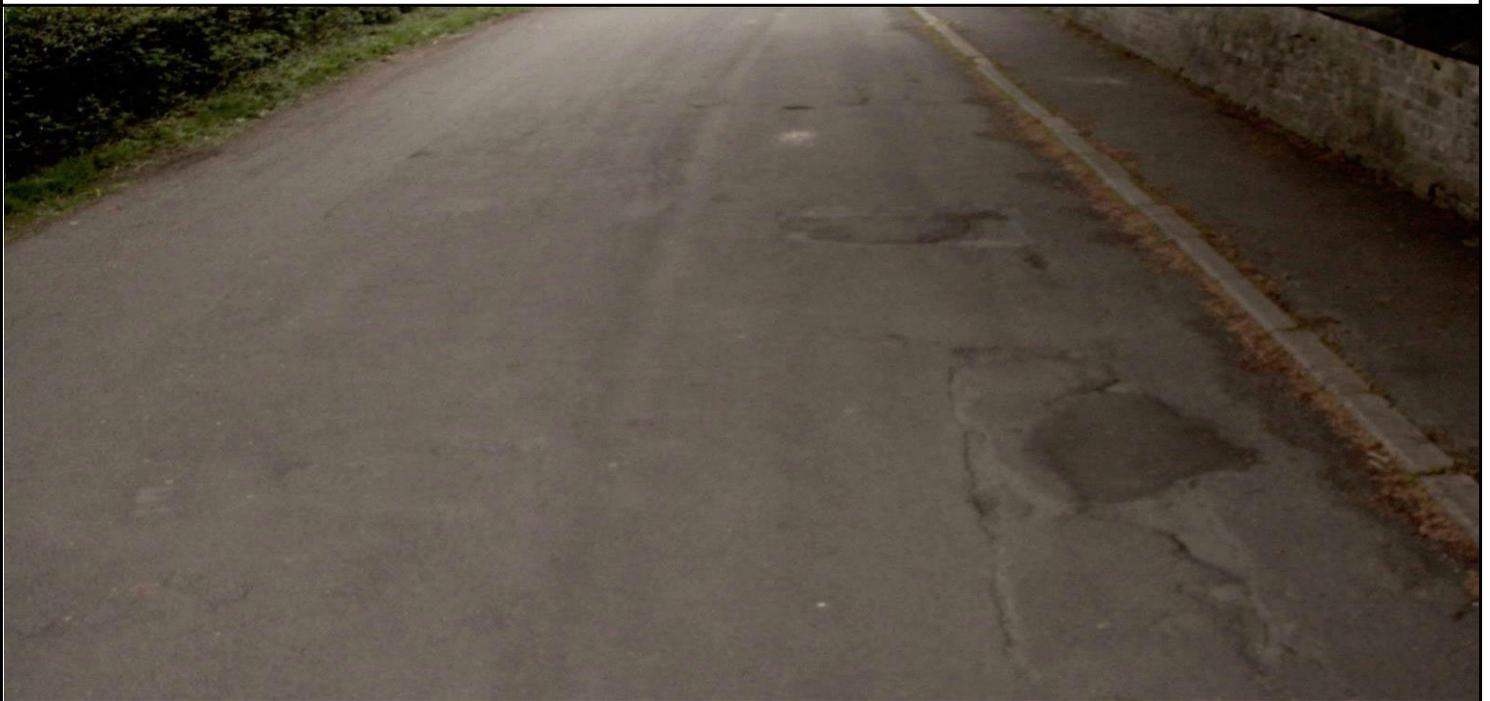
Photo Ref : 138	Section : Black Lane
Chainage : 127m	Feature / Defect : Patch Failure

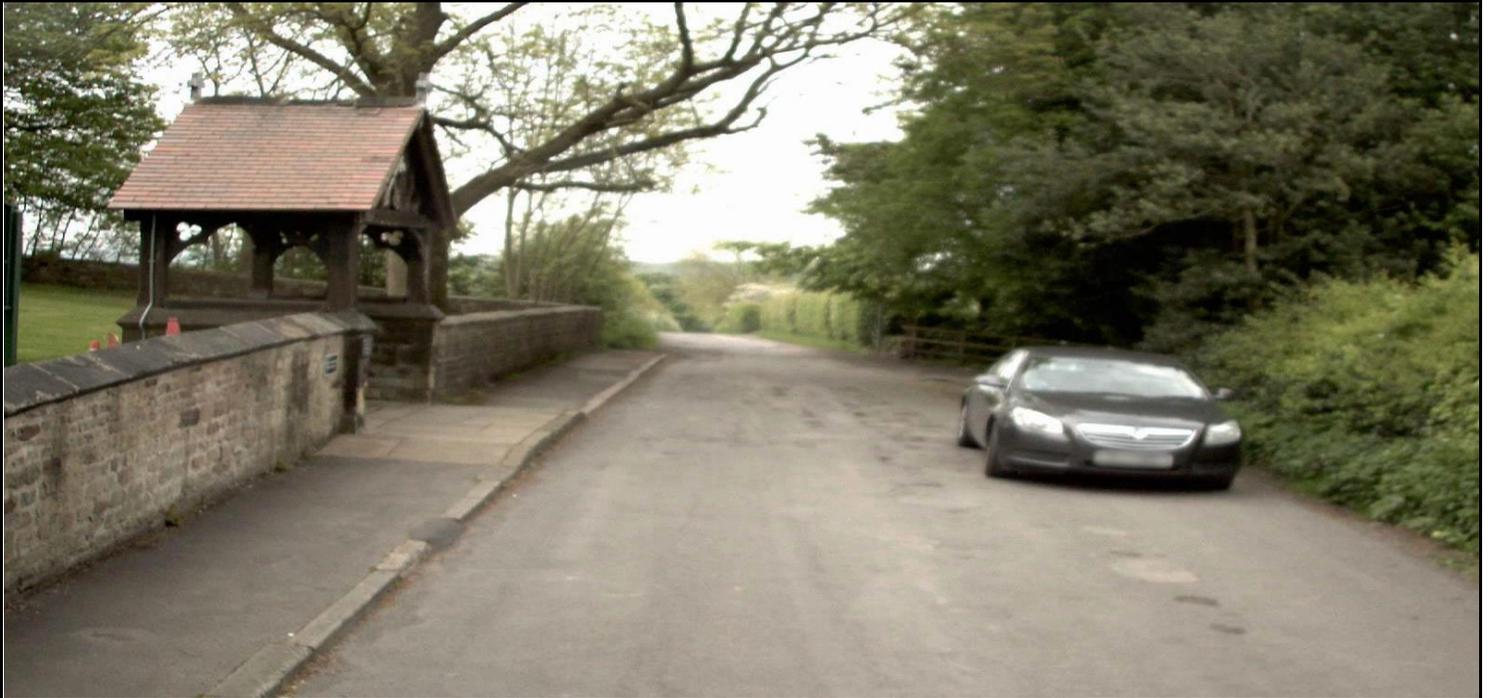
Feature / Defect : Major Surface Defectiveness

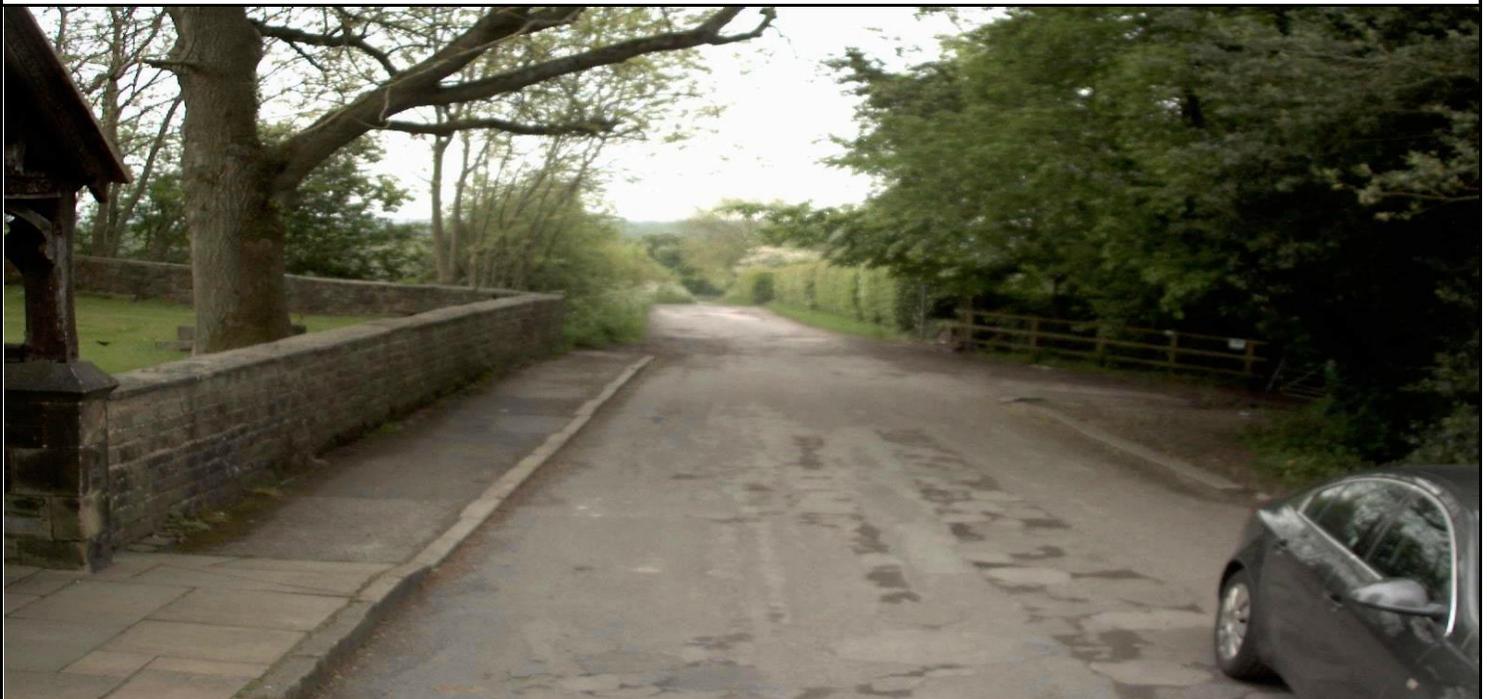
Photo Ref : 140

Feature / Defect : Major Surface Defectiveness
