ARBORICULTURAL REPORT

& Impact Assessment

Land at
Shaw Lane,
Carlton,
Barnsley,
S71 3HG

Reference: *AWA6359*

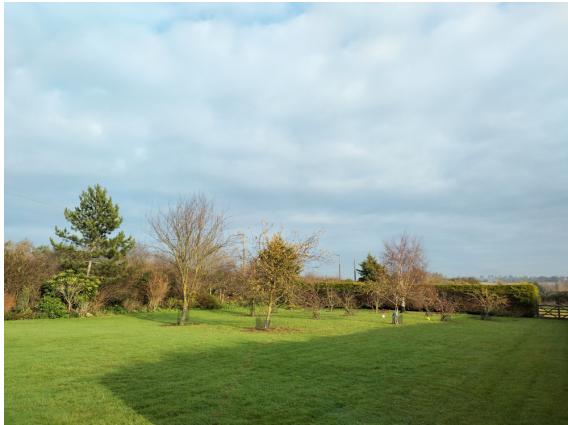
- 3.2.7 Trees T3, T4, T5, T6, T7, T9, T10, T11, T12, T13, T14, T16, T17, and T18 form the significant tree cover within the garden of the site. All are semi-mature with only T9 being early-mature. These trees are all planted specimens, most being fruit trees forming a small orchard within the site. These trees provide the site with some tree cover, however individually most feature defects likely to limit their long-term prospects. As such these trees are retention category 'C'.

Photo 1: G2, T4-T7, G8, and T9-T14 looking north east

4.2.6 Trees T3, T4, T5, T6, T7, T9, T10, T11, T12, T13, T14, T16, T17, and T18 are lower value semi-mature trees with defects that limit their value and prospects, or they are of insignificant stature.

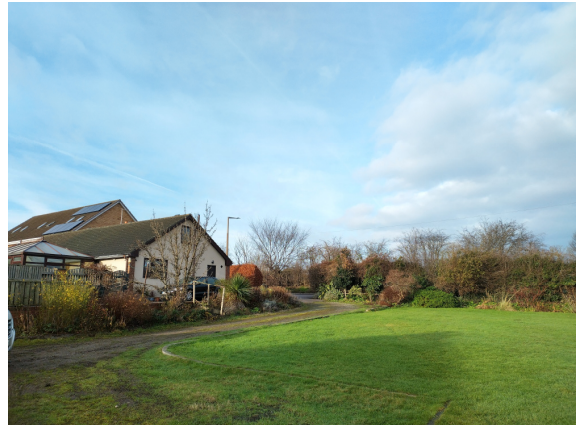
- 3.2.6 Hedges G1, G2, G8, and G15 are all semi-mature and managed, providing some screening value. Hedges G1 and G2 provide a moderate amenity value as they provide an effective screen from Shaw Lane. Tree group G19 is an adjacent group of mature Elder at the north eastern boundary of the site. All have reduced vitality featuring dieback, deadwood, or decay, limiting their long-term prospects. As such these hedges and tree groups are retention category 'C'.

Photo 2: G1, G2, T3, and T16 looking north west

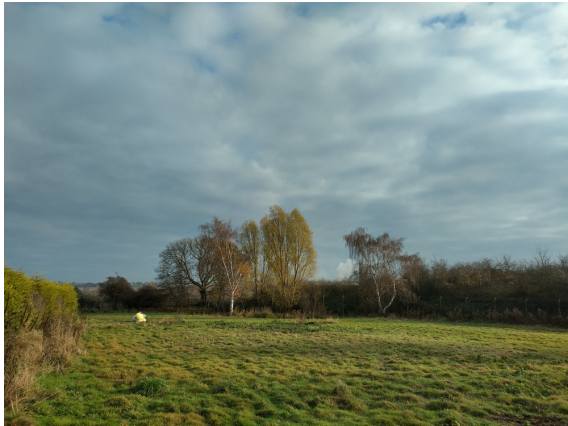
- 3.2.8 Trees T20, T21, T23, T25, T26, T27, and T28 form the significant tree cover within the south eastern corner of the site, surrounding an existing pond. These trees are prominent within the site but provide only a limited amenity value. They are predominantly early-mature Willows and Birch, with the occasional semi-mature Beech, and feature weak unions, poor form, or wounds which limit their long-term prospects. As such they are retention

Photo 3: G15 and T20-T28 looking east

4.2.7 Trees T23, T25, T26, T27, and T28 provide some landscape value, however they feature weak unions, poor form and wounds which limit their long-term prospects. Due to the low value of the trees to be removed, the removals will have only a negligible negative arboricultural impact.

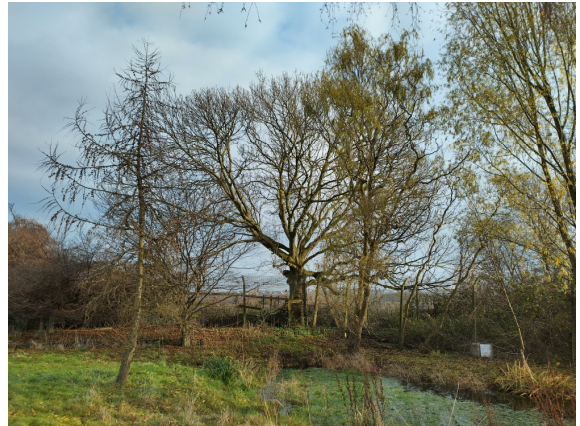
- 3.2.5 The sites most significant tree is T24, an adjacent mature Ash. The tree is situated at the south eastern corner of the site. This tree is prominent throughout the entire site and surrounding area and provides a moderate level of amenity value. Whilst the tree does not currently suffer from Ash Dieback Disease, its long-term prospects are likely limited as a result. As such the tree is retention category 'C'.

Photo 4: T21, T22, T24, T25, and T26 looking east

T22	Larch	<i>Larix decidua</i>	Dead	9.5	1	140	No	1	1.5	1.5	1.5	1.5	No visual defects	Single stemmed. Vertical. Old pruning wounds. Stubs	Major dieback. All dead / absent. Major deadwood	Recently dead Larch to north of pond	Dead	Dead	n/a	Dead	U	No works required to facilitate development
T23	Birch	<i>Betula pendula</i>	Early-mature	17	1	320	No	5	4	2.5	4	1	No visual defects	Single stemmed. Slight lean. Old pruning wounds. Stubs. Bark damage. Minor cavity	Minor deadwood. Old pruning wounds	Leaning slightly south east. Pond 1m to south. Crown lifted to 6m leaving several stubs and flush cut old pruning wounds. Minor cavity to north west of stem at 1.5m. Southern limb with major tearout wound. Good vitality in crown	Good	Fair	20 to 40 yrs	Moderate	C	Removal required to facilitate development

- 3.2.12 T22 is dead and requires felling regardless of any new development at the site (as detailed in Appendix 4).
- 3.2.13 Some trees were covered in dense ivy or were inaccessible (as detailed in Appendix 4). In such cases measurements were estimated and the condition values are indicative only.

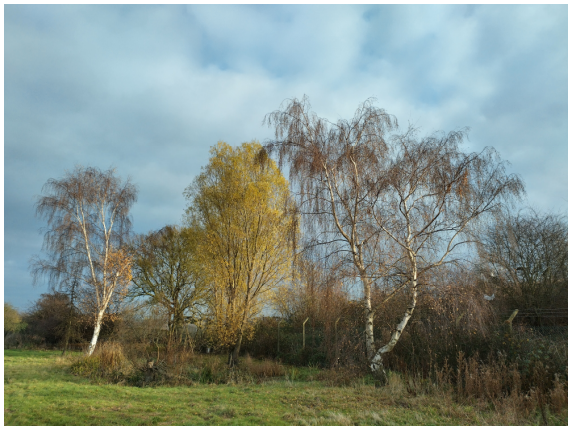
Photo 5: T20 to T28 looking east

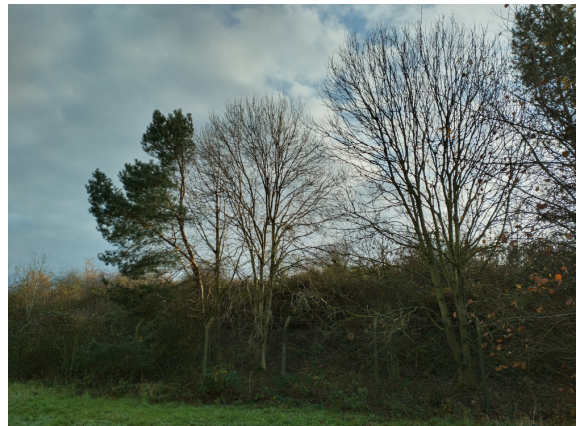
- 3.2.9 Tree groups G29 and G30 are situated at the southern boundary of the site. G29 is an adjacent shelter-belt screening group predominantly composed of semi-mature and early-mature Pine and Ash. The group provides a moderate amenity value due to its position in the landscape and screening value, however, individually the trees are of little arboricultural significance. Tree group G30 is an insignificant semi-mature group of self-set Willows. As such these trees are retention category 'C'.

Photo 6: G29 looking south east

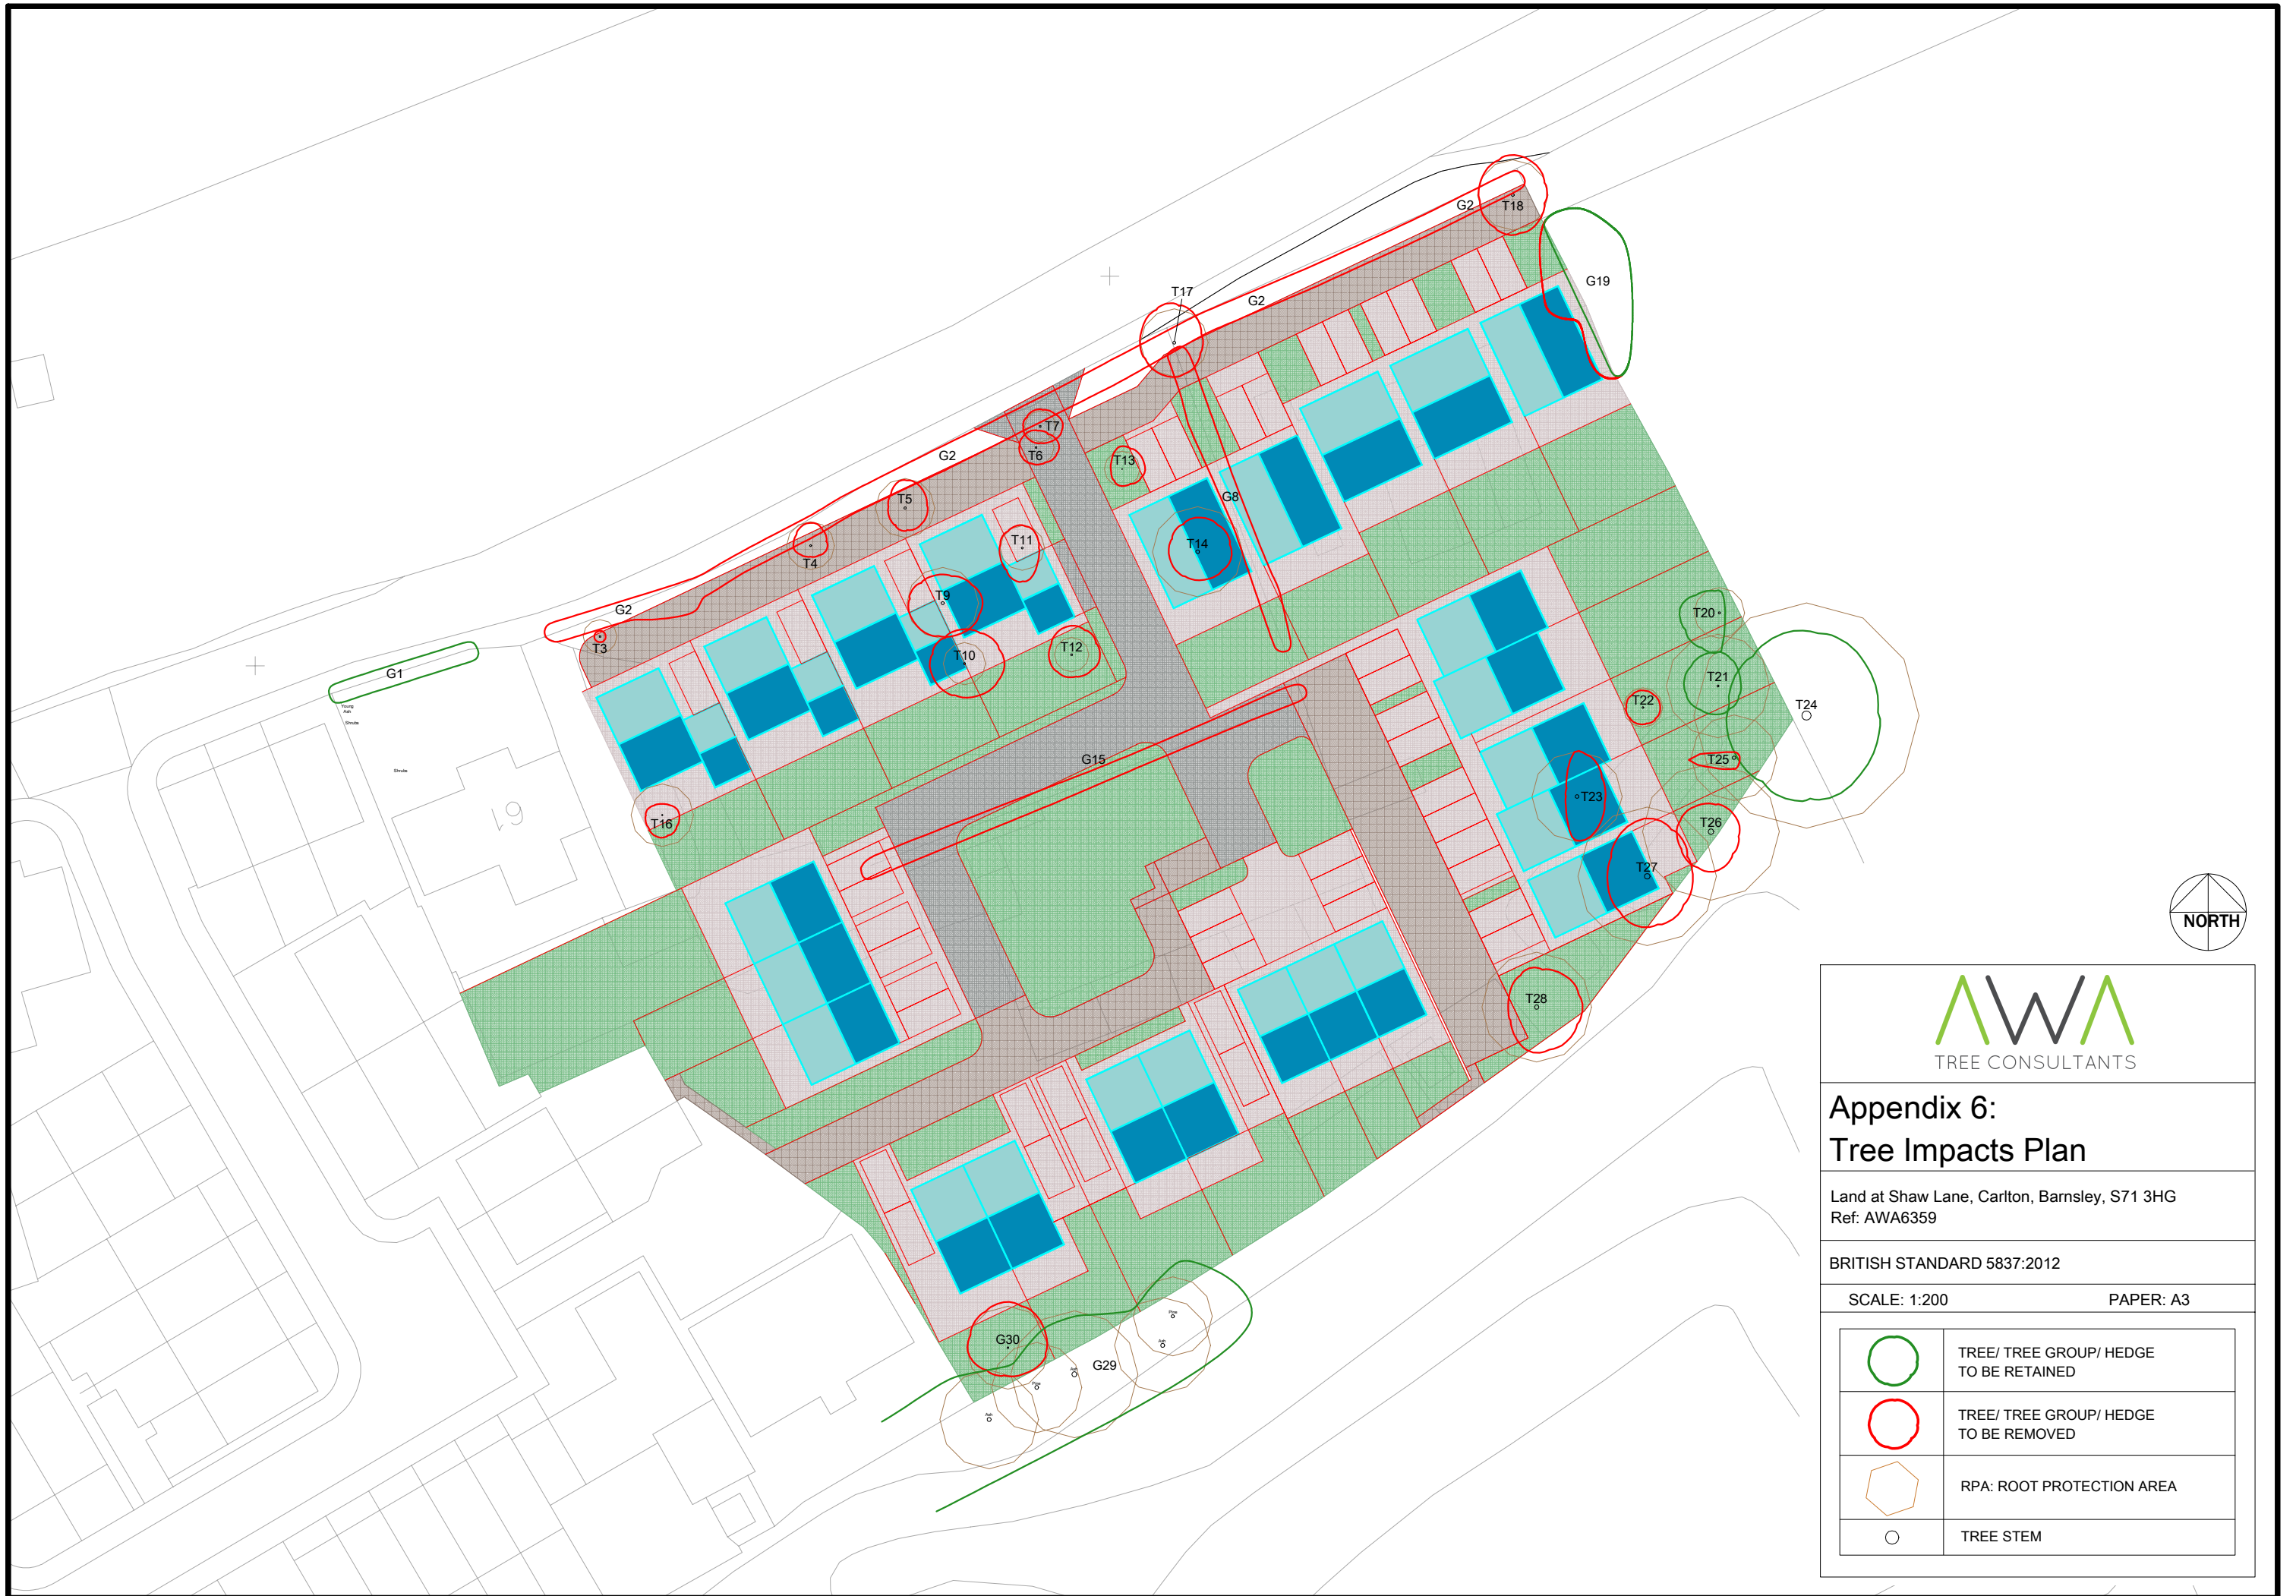
Appendix 6: Tree Impacts Plan

4.2.1 From assessing the new development proposals, 19 trees, 1 tree group and 3 hedges will require removal to facilitate the development as they are situated in the footprint of the development or their retention and protection throughout the development is not suitable.

- 4.3.2 Potentially damaging activities are proposed in the vicinity of retained trees. New boundary fences encroach close to and into the RPAs of T20, T21, T24, and G19. Construction within the RPA, can have negative impacts on tree roots. However, the encroachment into the trees' RPAs should not significantly adversely impact on the health or future condition of the trees, provided posts and panels type footings are used as opposed to strip footings, with the holes for the posts dug by hand, avoiding significant tree roots where possible. The retained trees should remain largely unaffected by the works, provided care is taken during construction.

- 4.5.1 The retained trees will require protection by fencing in accordance with BS 5837: 2012, during the development phase.
- 4.5.2 If required by the Local Planning Authority, an associated Arboricultural Method Statement, detailing protective fencing specifications and construction methods close to the retained trees can be provided.
