## Anchor Farm, Silkstone, Barnsley, S75 4LD Structural appraisal of agricultural building

**Job Number: MP8344**

### STRUCTURAL CONDITION REPORT

Name of Project	Anchor Farm, Silkstone
Name of Structure	Barn
Structure Ref No	S01

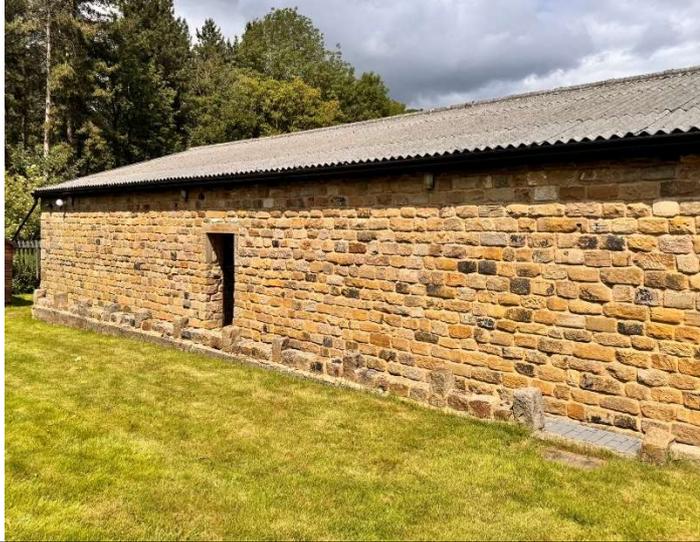
The masonry walls are substantial and in very good order. Concrete cavity infilled natural sandstone masonry walls are plumb, in line and free from defect. Structural capacity is way in excess of the load applied.

**Photo 1:** View on external walling, coursed stone outer

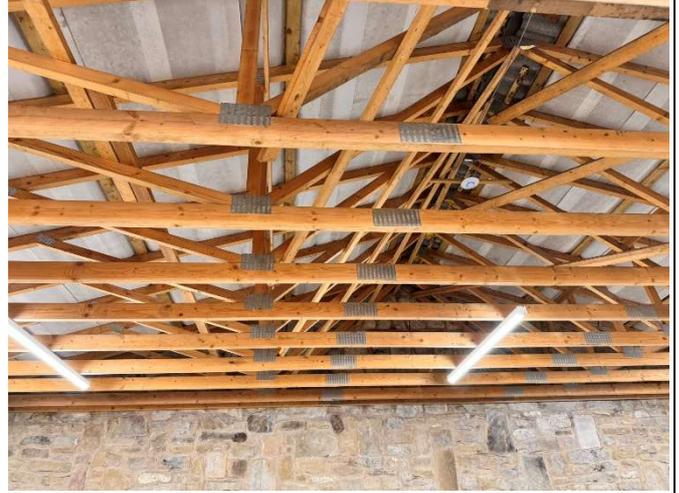
Roof structure – Prefabricated timber trussed spanning 11m between wall plates. Trusses in good order, prefabricated from a local supplier. A measure of structural members and brief check of 2D analysis confirms the trusses are suitable for the span and loading applied. Indeed the trusses are likely to have additional capacity should roof covering be changed or PV panels added to the structure.

**Photo 2:** View on prefabricated trussed roof structure

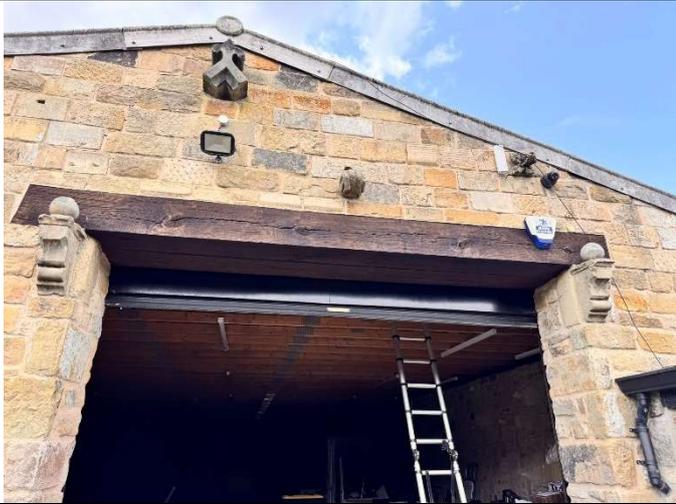
Support over openings is provided by natural stone heads or timber beams. The timbers are substantial in size, brief checks confirm they would confirm to design checks as part of any structural checks as the building is repurposed.

**Photo 3:** Large opening to front elevation, oak beams inner and outer leaf

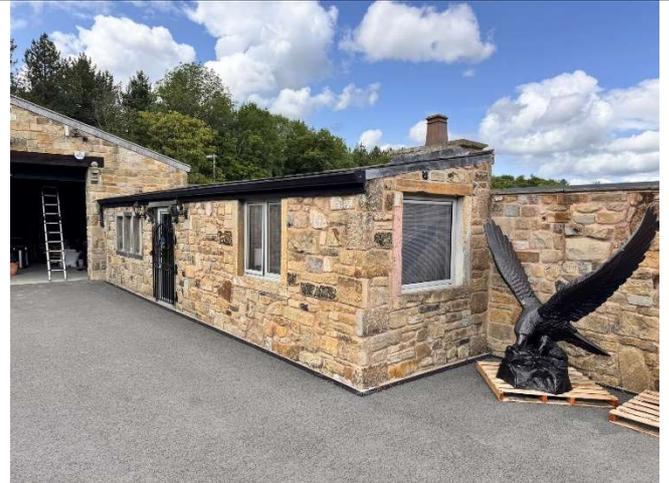
**Photo 4:** Mono-pitch roof building adjoining main structure
