1<sup>st</sup> April 2019

Ref C331/02/GS

**Ref: Shallow Mining Investigation on land at 35 Intake Road, Gawber, Barnsley**

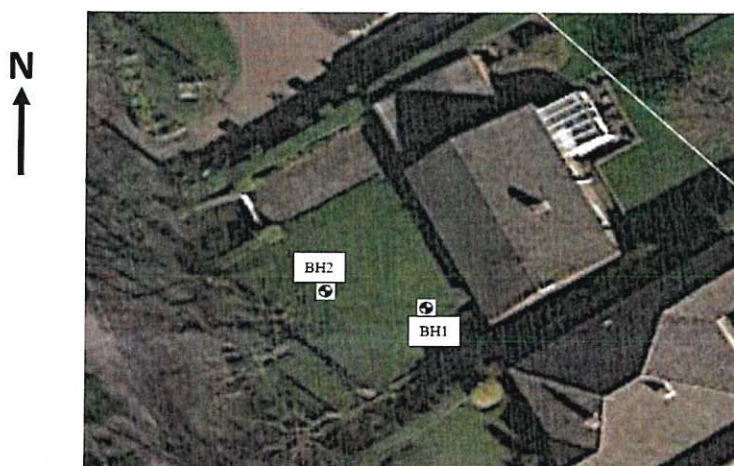
The locations of the boreholes are shown below.

Topsoil up to 0.3 m thick overlays subsoils comprising 'clay orange grey with flakes of coal dust' (driller's description) which was recorded in both boreholes BH1 and BH2 to depths of 2.4 m and 2.7 m bgl respectively. The subsoil was immediately underlain by bedrock. Mudstone was proved to a depth of 9.8 m and 10.2 in BH1 and BH2 respectively overlying sandstone, which was proved to a depth of 18.5 m and 18.0 m respectively. In BH1 coal was proved below the sandstone and in BH2 a void was encountered with associated loss of flush. The depth to the coal / void is summarised below.

| BH No | Depth (m) | Depth to Top of Bed (m bgl) | Thickness (mm) | Probable Seam / Comments |
|---|---|---|---|---|
| 1 | 23 | 18.5 | 2900 | Barnsley Coal |
| 2 | 19 | 18.0 | 1000 | Void, obstruction met at 19.0 m |

In BH1 sandstone was proved below the coal to completion depth. In BH2 an obstruction was encountered which was thought to be metal.
