## GeoEnvironmental Investigation

Barber Street

Hoyland

**Report Ref: A1331/16**

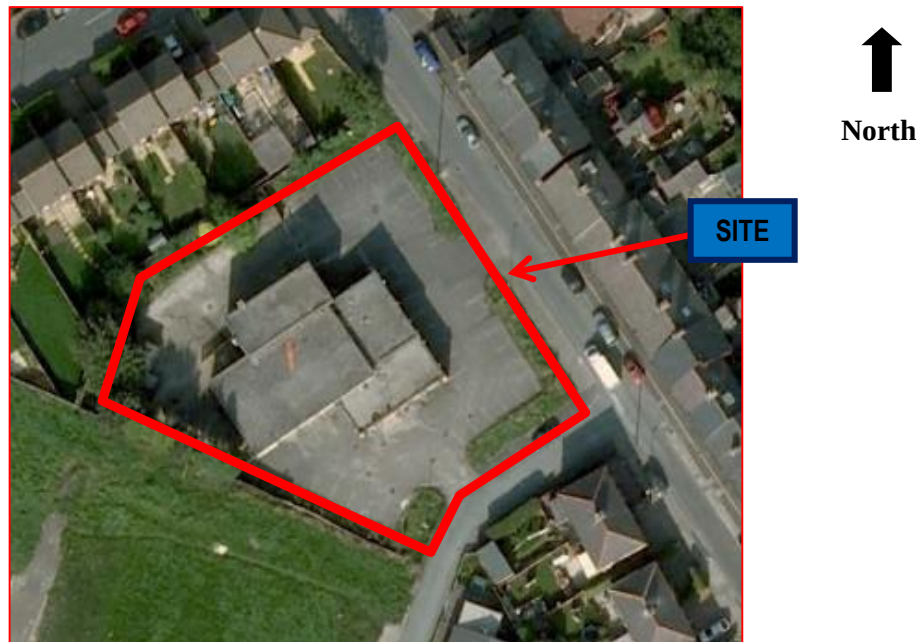
**Figure 2: Former Layout**

The site was previously occupied by the Welcome Inn public house.

At the time of the investigation, the site was partially covered with hardstanding from historical land uses. The majority of the site was covered with demolition rubble with a stockpile of demolition rubble in the eastern corner of the site and along the side adjacent to Barber Street, approximately 1.5m high, 10m wide and 30m long.

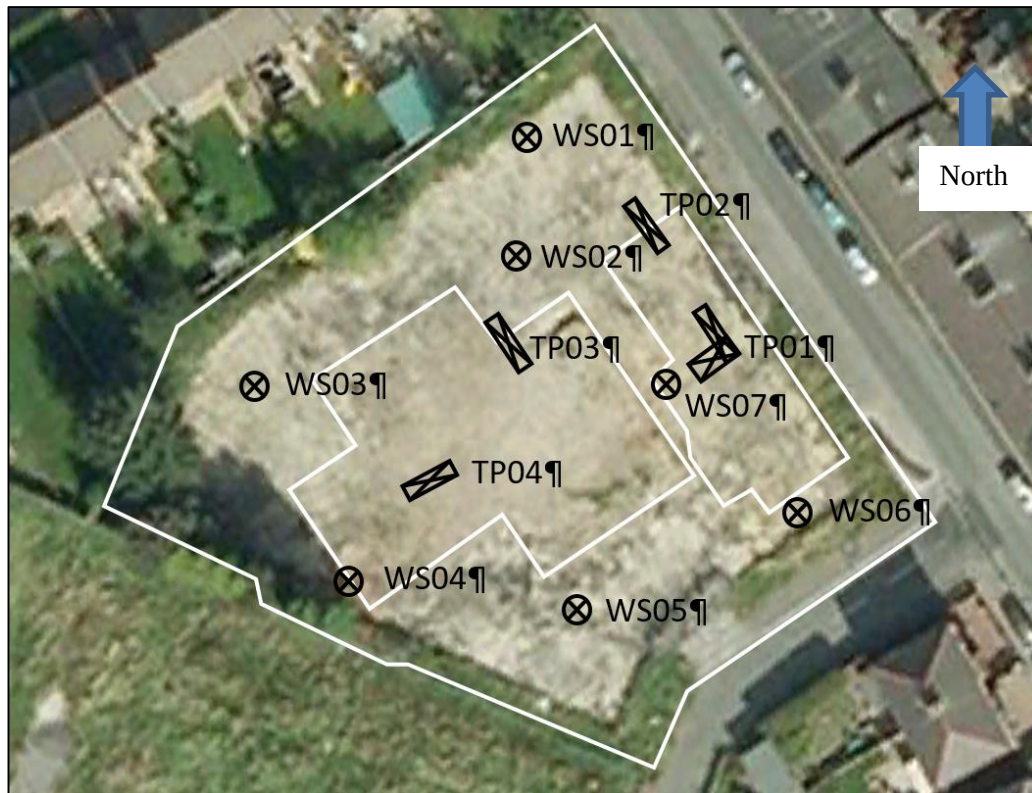
**Figure 8: Sampling Location Plan**

The exploratory holes (WS01 to WS07 and TP02 to TP04) revealed made ground overlying sandy clay or sand. Superficial materials were underlain by weak and weathered coal, sandstone, siltstone or mudstone at depths from 0.5 to 3.4m bgl.

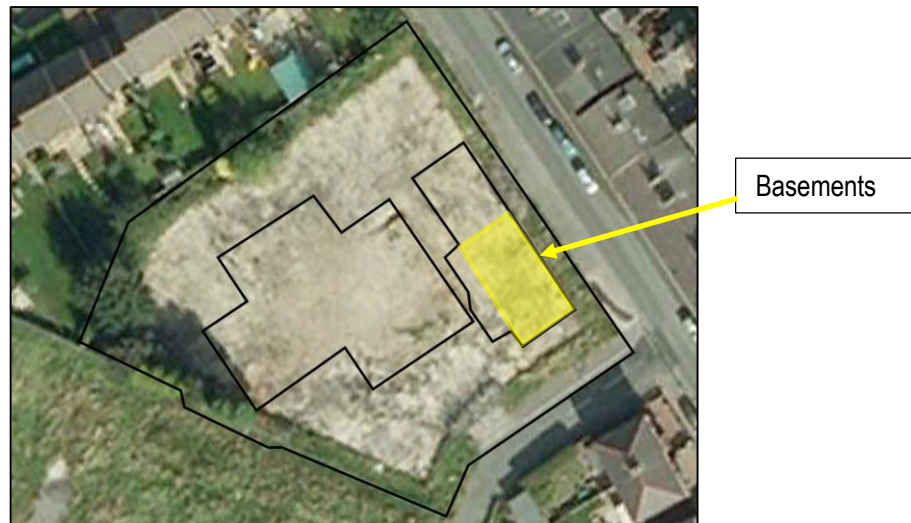
**Figure 9: Estimated Extent of Basements**

Trial pit TP01 found basements extending to 2.9m below ground filled with mixed demolition rubble, fragments of fibre reinforced cement materials (potential asbestos containing materials) were found in some horizons. At the lower levels the demolition rubble appeared to be loose and blackened, indicative of a significant fire.

Figure 9, overleaf, provides an estimate of the potential extent of the basements under the the former British Legion Club.

Ground conditions across the site are variable with the presence of deep made ground in the area of the basements below the former British Legion Club.

Materials in the infilled basements contain elevated concentrations of lead, PAH's (Poly-Aromatic Hydrocarbons) and also fragments and fibres of asbestos. These were found in the blackened and ashy fill materials in the lower part of the basement and appear likely to be a mixture of broken historical building products and by-products of combustion. Materials removed from the basement as waste are potentially likely to be classified as Hazardous Waste. These materials should be segregated from all other waste materials and will need to be classified for suitable waste disposal.

Foundations for the units in the location of the basement below the Former British Legion Club should be supported by piles or some form of ground improvement, such as vibro-stone columns. This appears most likely to affect Units 4, 5, 6 and 7 but may not affect all of these units.

Foundations constructed in the location of the basements of the former British Legion Club should be designed as Design Sulphate Class DS-3 and ACEC class AC-2, in accordance with BRE Special Digest 1.
