PR/AJK/47055/004

18 July 2022

**Former Wombwell High School, Gypsy Lane, Wombwell**  
**Report on Soakaway Testing**

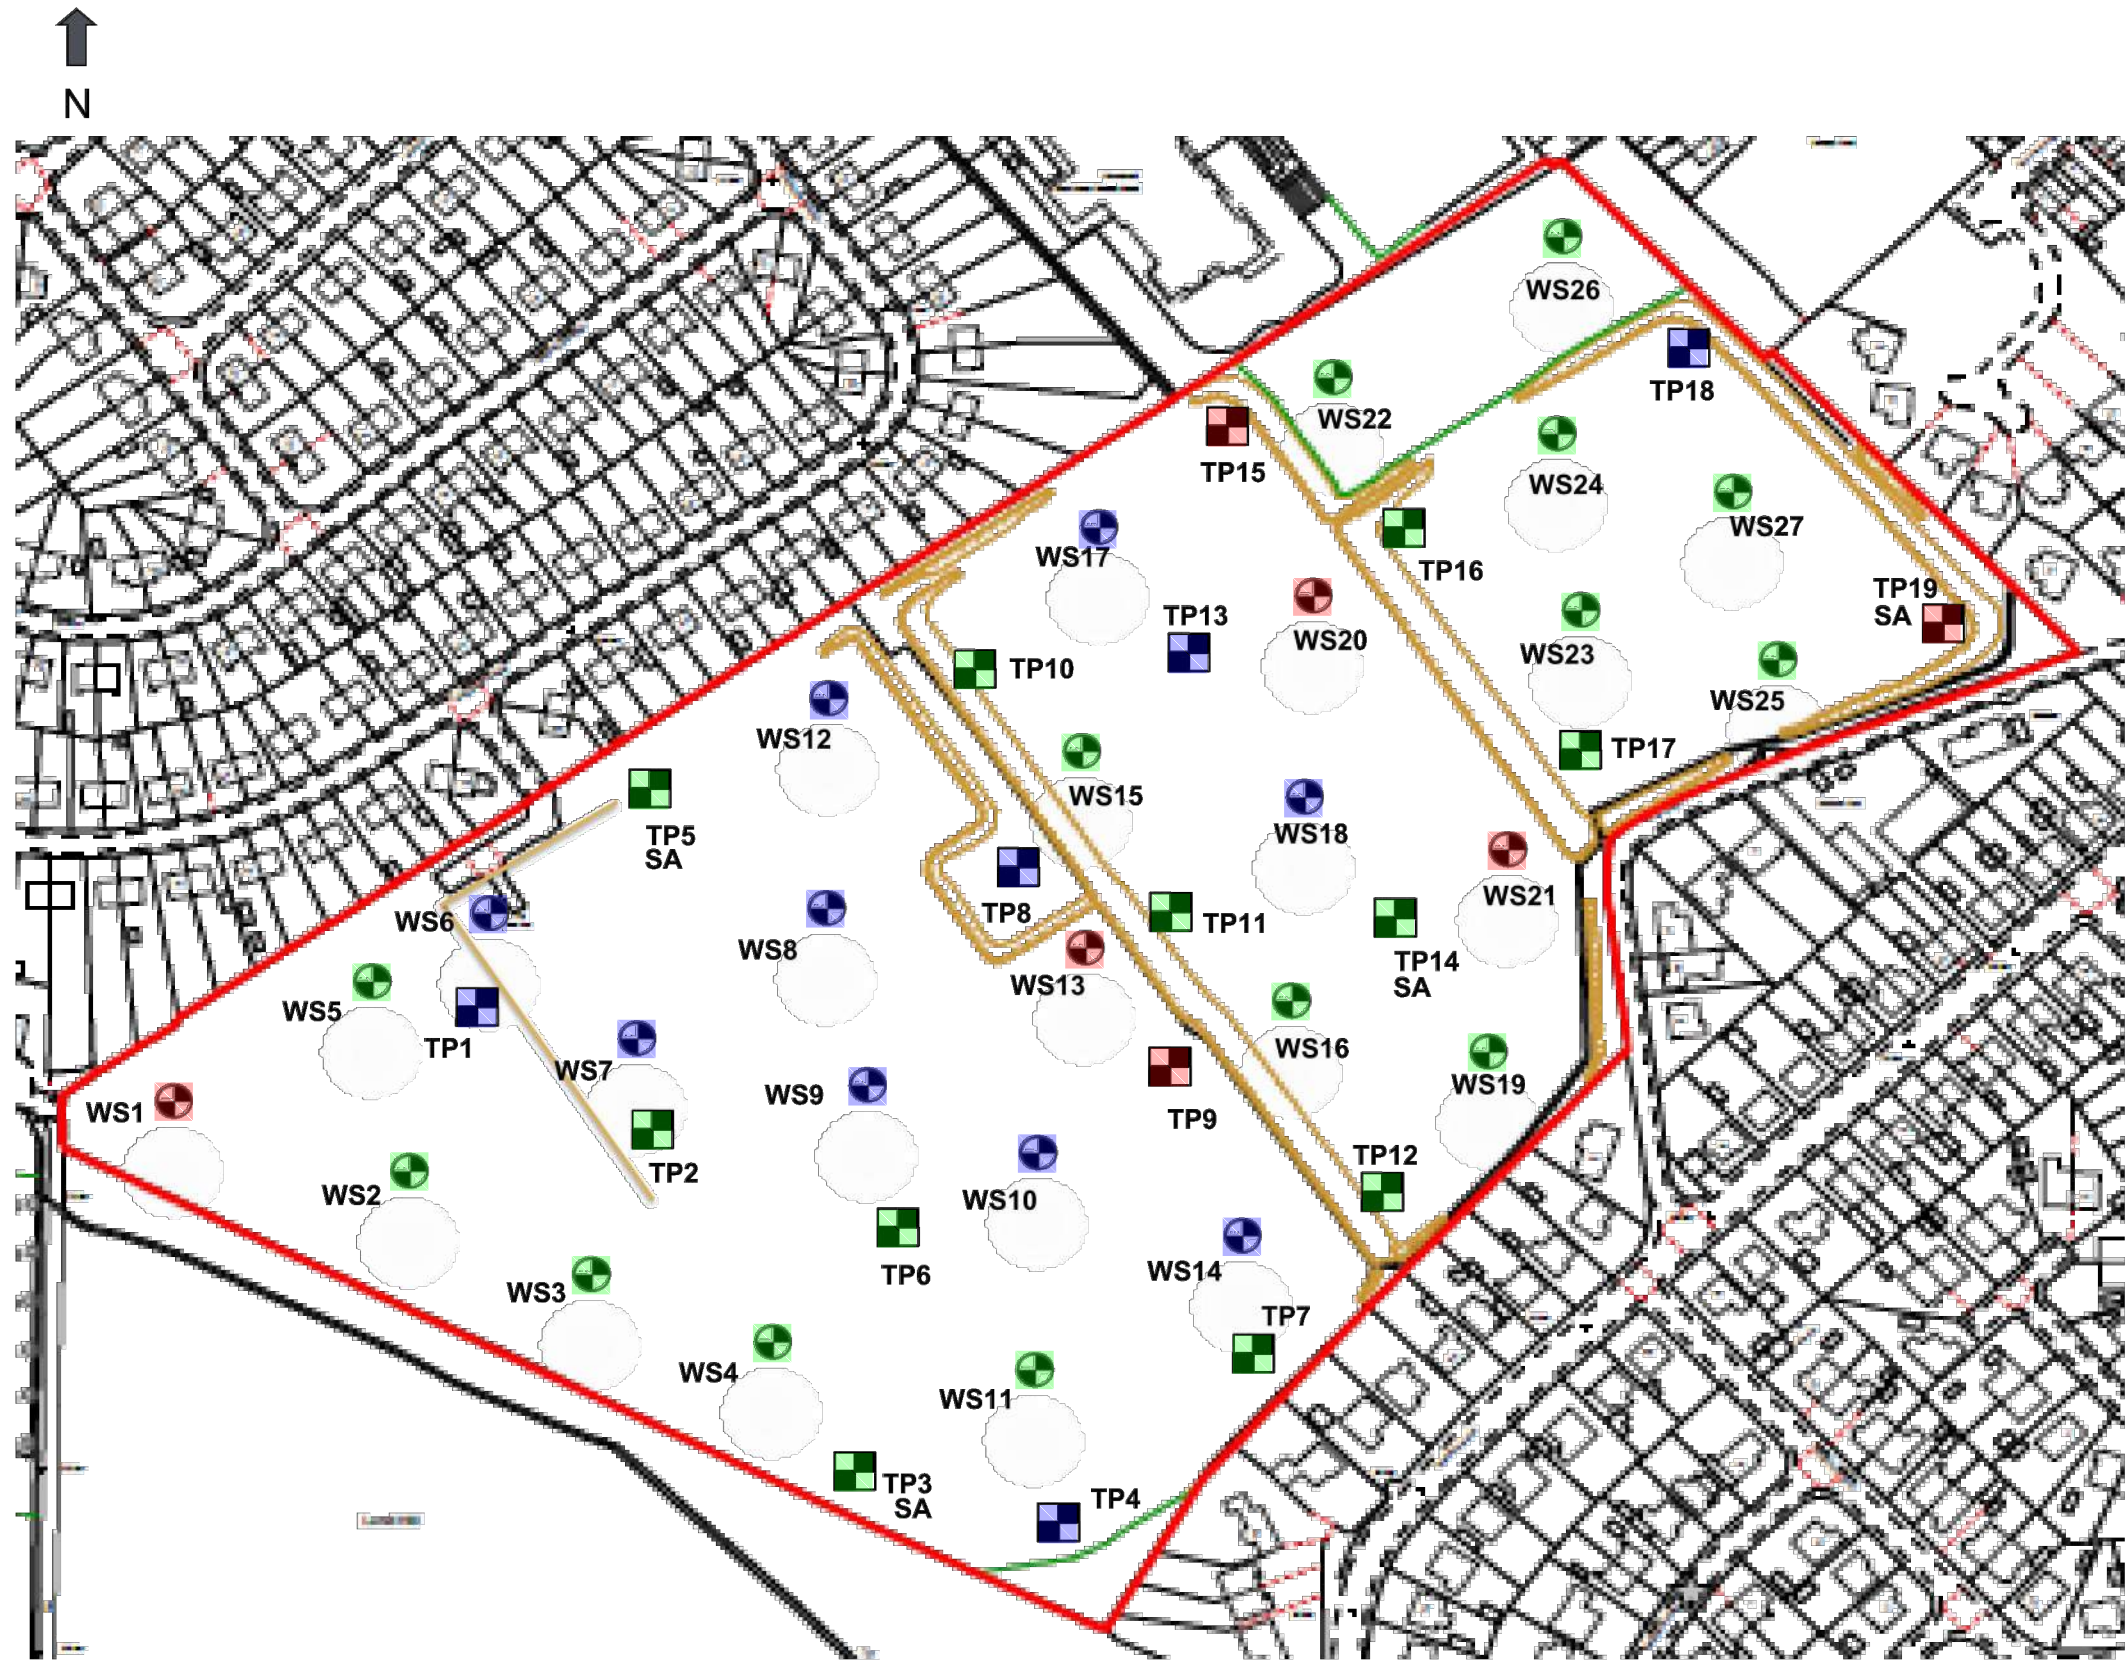
| DRAWING NUMBER<br>HBS-DR-G-(00)-002 | | REV CODE<br>P 1 |

The initial site investigation for the site was prepared by Hamson Barron Smith (HBS) in May 2018, report reference 23-24-18-1-6003/GIR1. The report was prepared for the original site vendor, Barnsley Metropolitan Borough Council and included soakaway testing in four locations across the site. Tests were undertaken in trial pits TP3, TP5, TP14 and TP16, which were widely spaced across the site in the west, north, south and east respectively.

The results of the testing were variable. TP3 encountered a “weathered siltstone” bedrock. Only one test was completed in this location, which recorded an infiltration rate of  $6 \times 10^{-6}$  m/sec. TP5 also recorded a low infiltration rate of  $6.1 \times 10^{-6}$  m/sec in the single test which was undertaken, with the bedrock being described as a very sandy, clayey gravel of sandstone with occasional clay horizons. Both tests recorded good initial flows out of the test pit for the first part of the tests, before slowing significantly in the later stages, indicating a potential silting of the water pathways through the surrounding bedrock.

TP16 encountered sandstone bedrock, recovered a tabular gravel and cobbles. Two tests were completed in this pit, the first giving an infiltration rate of  $17 \times 10^{-6}$  m/sec, and the second giving a slightly improved infiltration rate of  $26 \times 10^{-6}$  m/sec.

TP14 encountered made ground (reworked sandstone gravel) overlying sandstone bedrock, recovered as coarse gravel and cobbles. This pit performed the best, with three tests being completed, providing infiltration rates of  $300 \times 10^{-6}$  m/sec,  $140 \times 10^{-6}$  m/sec and  $96 \times 10^{-6}$  m/sec respectively. Some silting up of the strata is indicated to have occurred, with the successively slower rates. However, the majority of the water within each test was within the granular made ground, and therefore is likely to have accelerated the test due to the increased permeability of the fill.

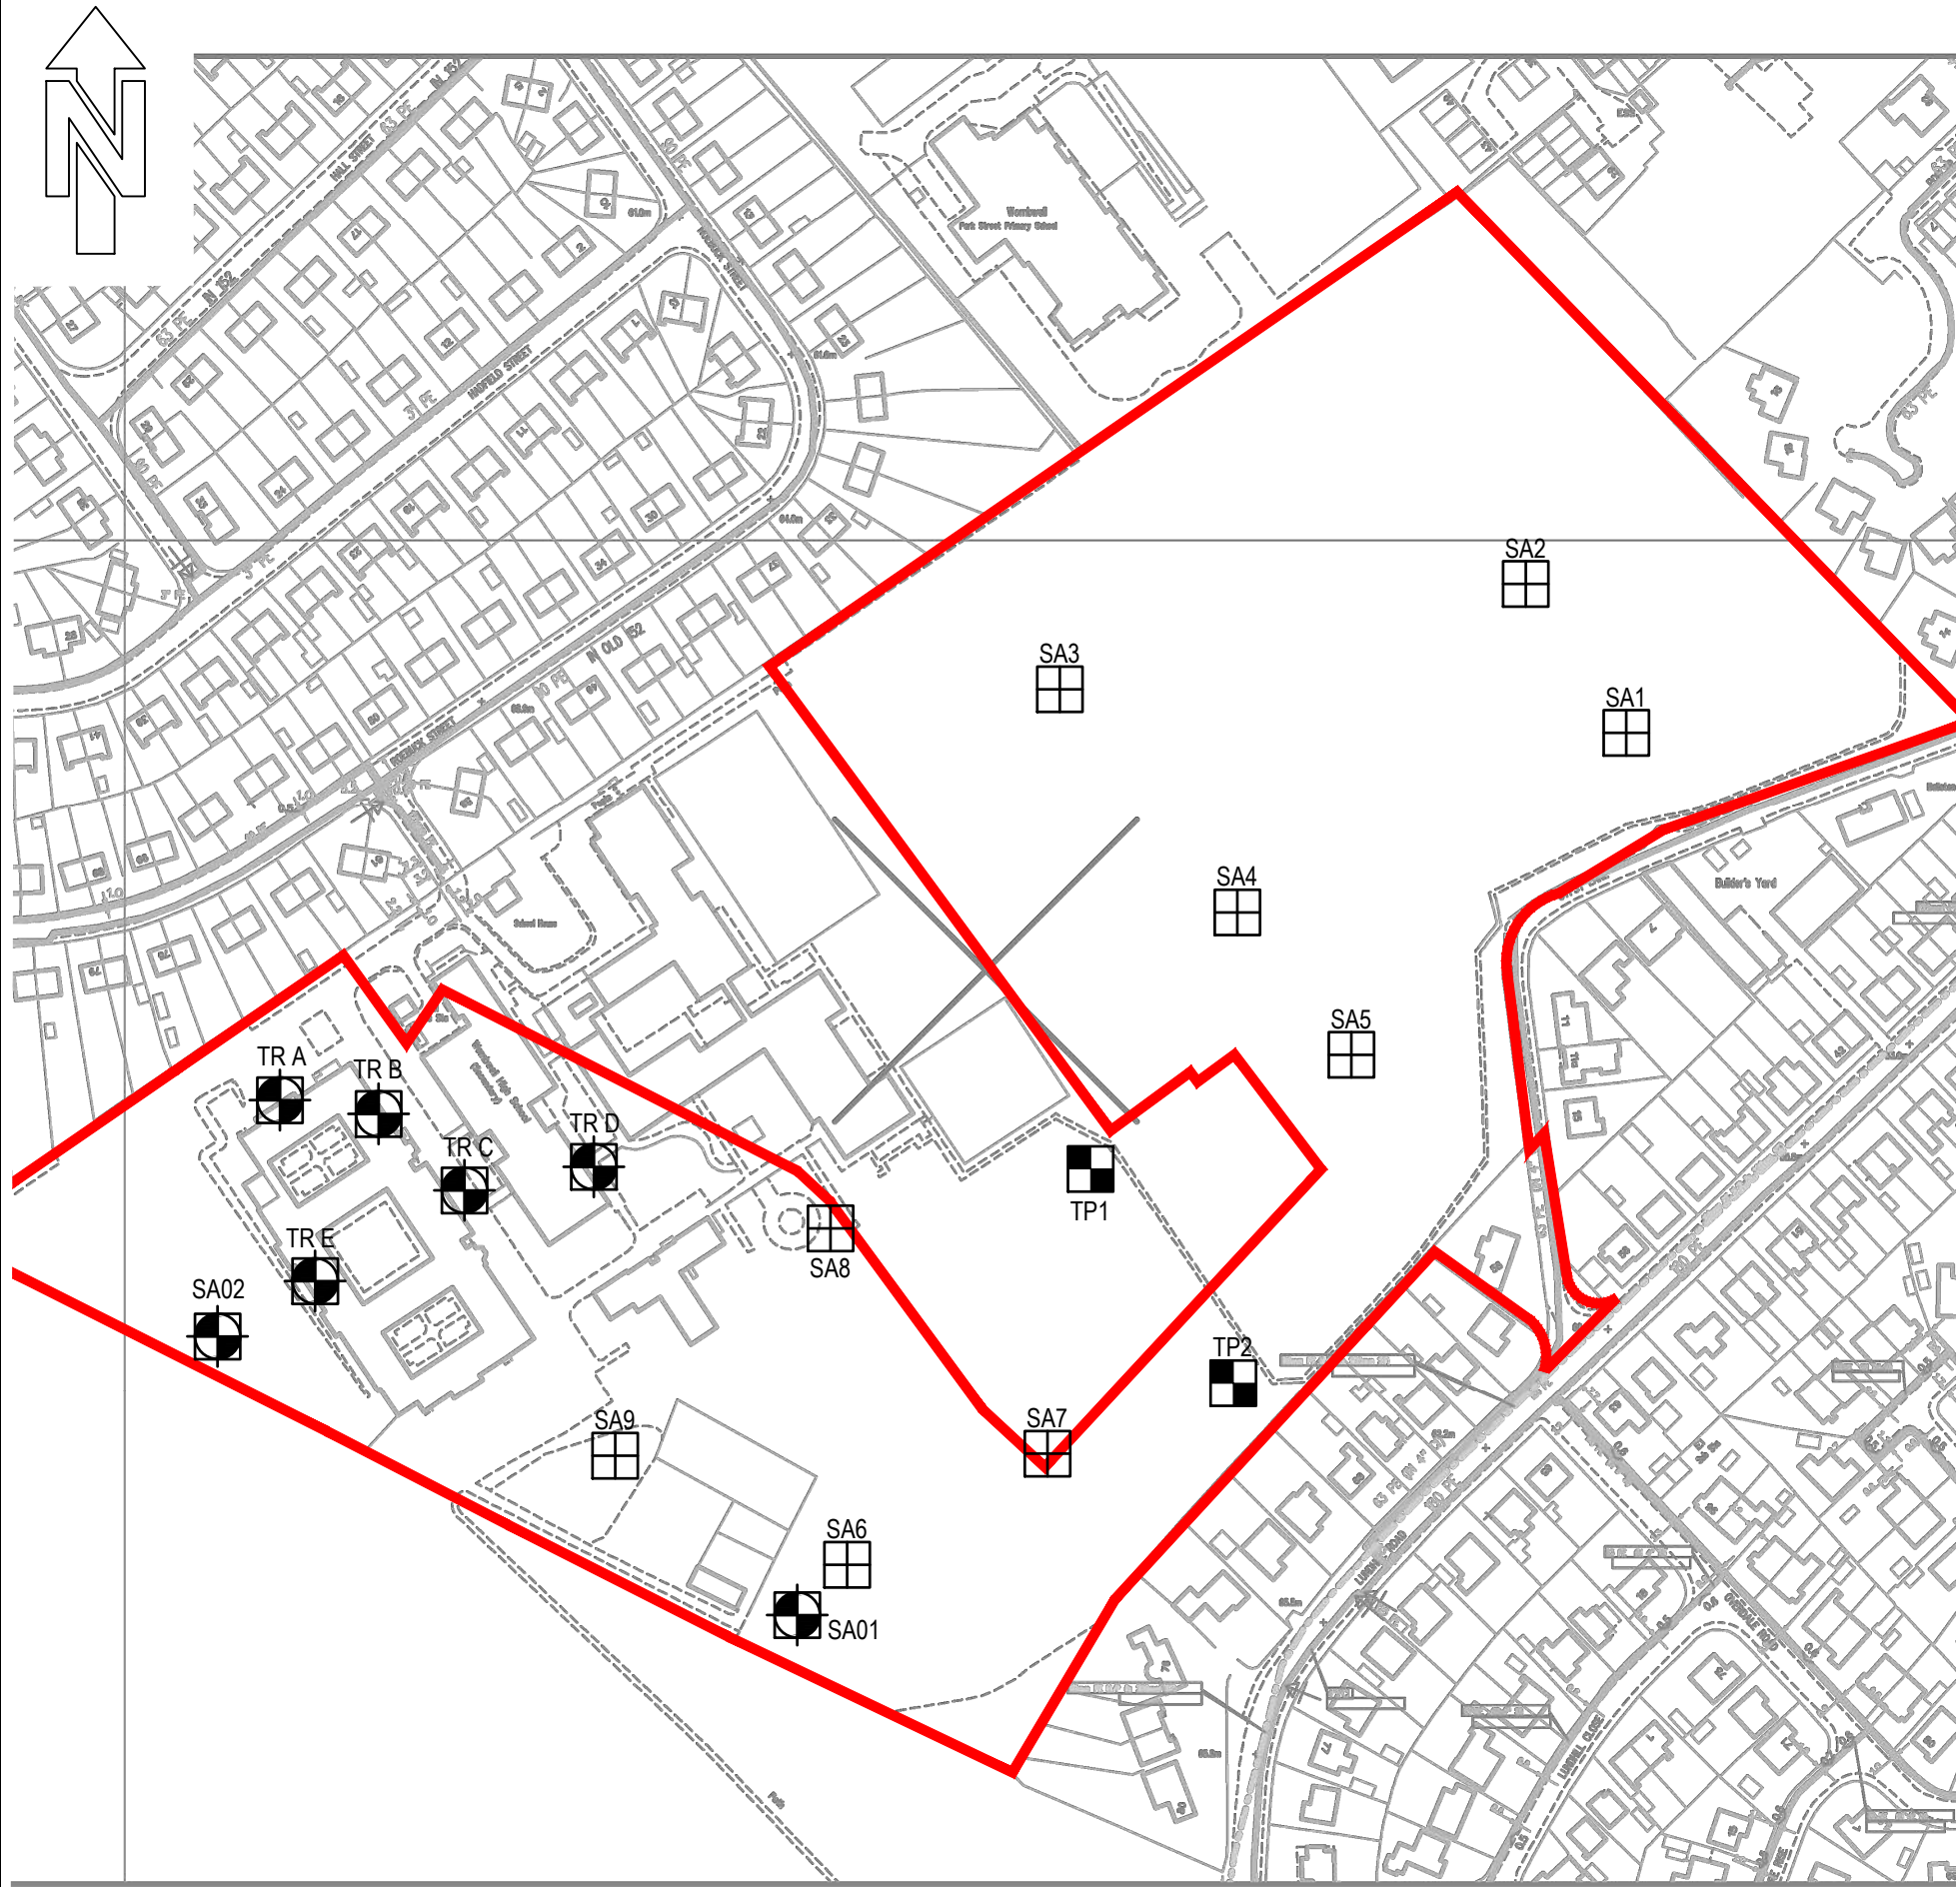
| DRAWN<br>AT | CHECKED<br>AK | DATE<br>17.05.2022 | DRAWING NUMBER<br>47055/001 | REV<br>A |

Eastwood & Partners (now trading as Eastwood Consulting Engineers) undertook further infiltration testing on the site in December 2018. Nine further pits were excavated across the site, four on the upper western plateau, three on the central plateau, and two on the lowest, eastern plateau. The findings were presented in Letter Report reference PR/AJK/SAE/43497-001.

Most locations showed a reduction in the infiltration rate during the second and third tests, where completed. The exception to this was SA1, where the rates in the second and third tests were higher than during the first. This pit was located in the east of the site in the lowest plateau. It is also to be noted that SA2, also located in this area, but to the north of SA1, recorded an infiltration rate of zero. SA2 recorded hard sandstone at the base of the test pit, whereas SA1 had more weathered material.

ECE attended site in April 2022 on behalf of Miller Homes. Two additional soakaway pits were undertaken in the west of the site. One of these, SA01 towards the southern corner of the site, encountered a mudstone/shale material below 1.8 m of made ground. The test in this location was undertaken within the shale strata, and this failed to drain by any significant amount. A

BRE365 infiltration rate could not be calculated, but an average infiltration rate of  $0.72 \times 10^{-6}$  m/sec was determined for the test.

SA02 was undertaken further toward the north of the site, and encountered weathered sandstone bedrock, recovered from the ground as a sandy gravel. Two tests were completed in this pit, with infiltration rates (in accordance with BRE 365) of  $56 \times 10^{-6}$  m/sec and  $40 \times 10^{-6}$  m/sec being calculated respectively. A reduction in infiltration rate was again noted during the second test, most likely due to silt ingress into the various water pathways through the sandstone.

Therefore, based in the above and due to the significant variability of the infiltration rates offered by the natural ground on the site, it is recommended that piped drainage is utilised for the development. Significant amounts of on-site attenuation will be required, and it is likely that the regulators will restrict any discharge to greenfield run off rates, given the lack of previous development of much of the land and the time which has now elapsed since demolition of the school buildings.
