STRUCTURAL INSPECTION

BARN BUILDINGS

CLIFF HOUSE FARM

MR D DAWSON

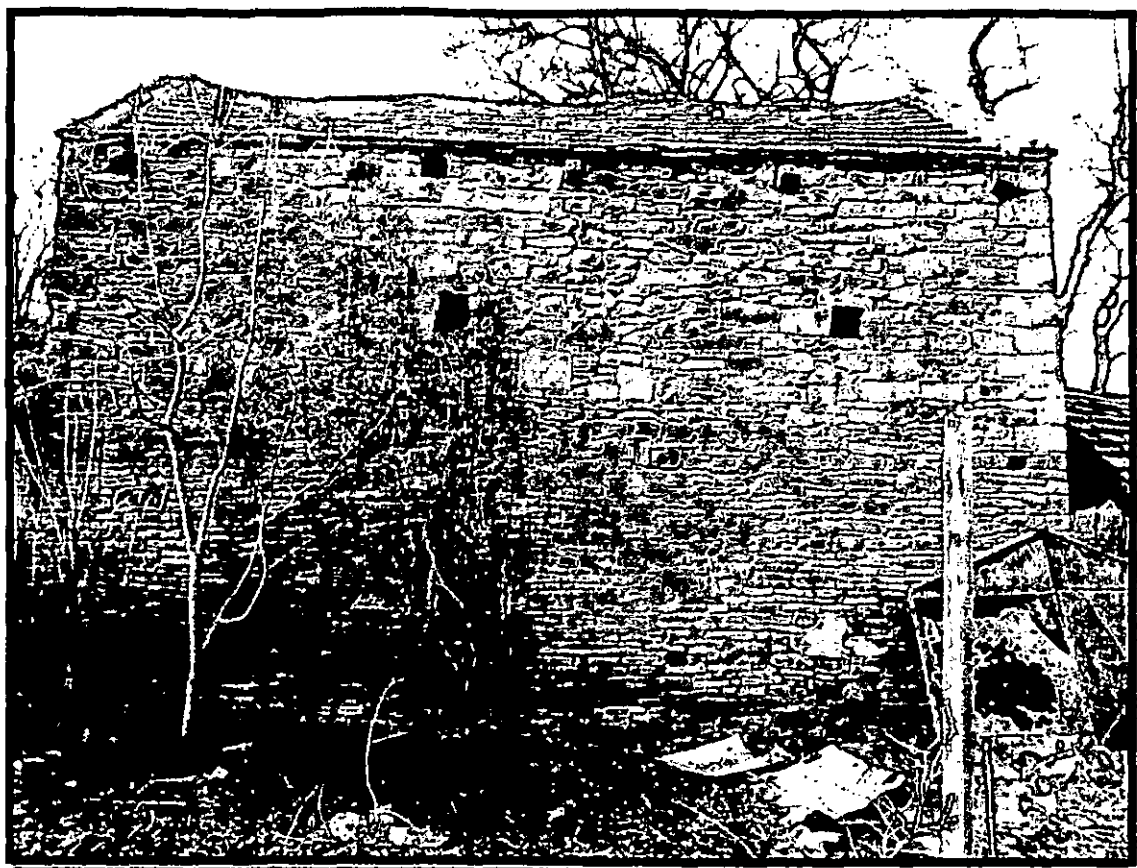
Photograph 49 – View of East Elevation

- 5.1.2.1 This wall is constructed in random stone masonry approximately 350mm thick. The elevation is generally in good condition with no cracking or movement noted. There are remains of ivy growing over a small part of the elevation. **(Photograph 49)**

- 5.1.6.1 The roof is a duo pitch with gables on the North and South elevations.
- 5.1.6.2 The roof is covered in stone slate tiles and ridges. The stone slates are in good condition and intact over most of the roof area. **(Photograph 49 & 52)**

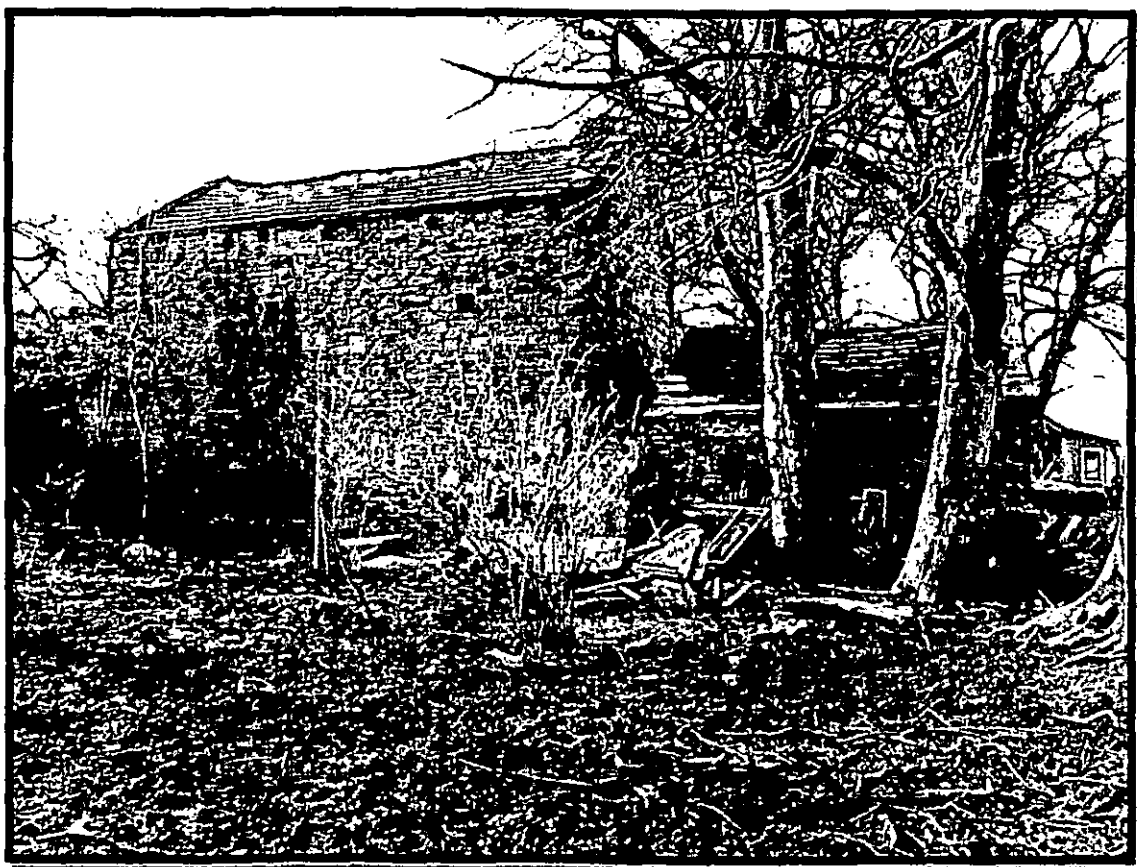
Photograph 50 – View of East Elevation showing trees

- 5.1.2.5 There are two small trees located within 1.0 metre of this elevation. **(Figure 5) (Photograph 50)**
- 4.1.2.7 A trial pit was excavated on this elevation. The pit extended 400mm below ground level which was also the underside of the foundation. A 100mm widening of the wall was noted 100mm below ground level and was 300mm deep. The ground encountered in the trial pit was 200mm of topsoil on yellow gravelly weathered Sandstone with some clay content. Many small tree roots were present in the trial pit. **(Photograph 51)**

- 5.3.8 The three existing trees located within 5.0 metres of the Annex should be pollarded. The trees located within 2.0 metres from the Annex should be cut back such that no branches extend over the barn for safety reasons. Removal of these trees is also considered an option. Advice should be sort from an arboriculturist on how to remove the trees to prevent distress and damage to the existing structures. The two small trees adjacent to the East elevation of the Tractor Shed should be removed.

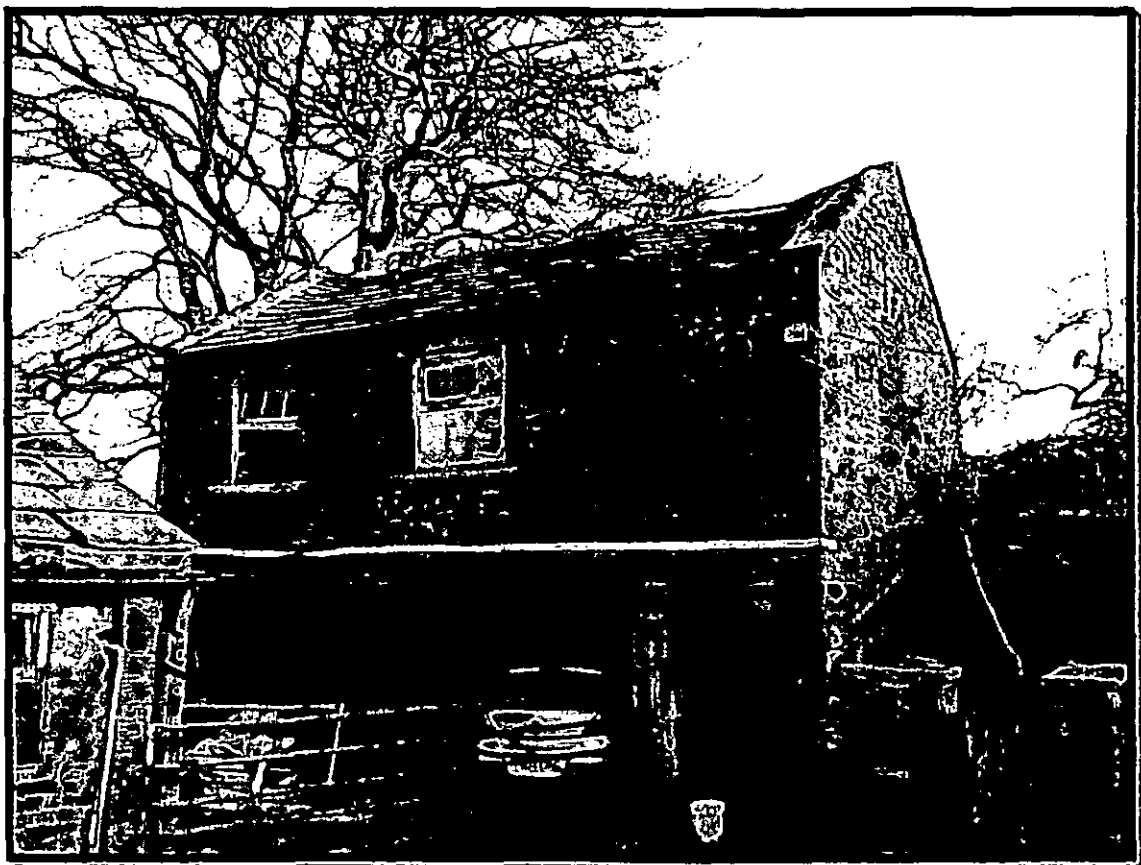
- 5.1.3.1 This elevation is constructed in random stone masonry at first floor level which is supported by a timber beam. In turn the timber beam is supported on the North and South elevations and two internal columns. The two columns are constructed in coursed masonry and are approximately 350mm x 350mm with a wider capping stone. There are three openings at ground floor level two large spans and a single shorter span. All the stonework in this elevation is in generally good condition. **(Photograph 52)**

- 5.1.6.3 The ridge line is undulating along the whole length
- 5.1.6.4 The roof slopes also exhibit sagging or undulations and in one location at the South end of the West facing slope the roof has partially collapsed. **(Photograph 51 & 52)**

**Photograph 52 – View of West Elevation**

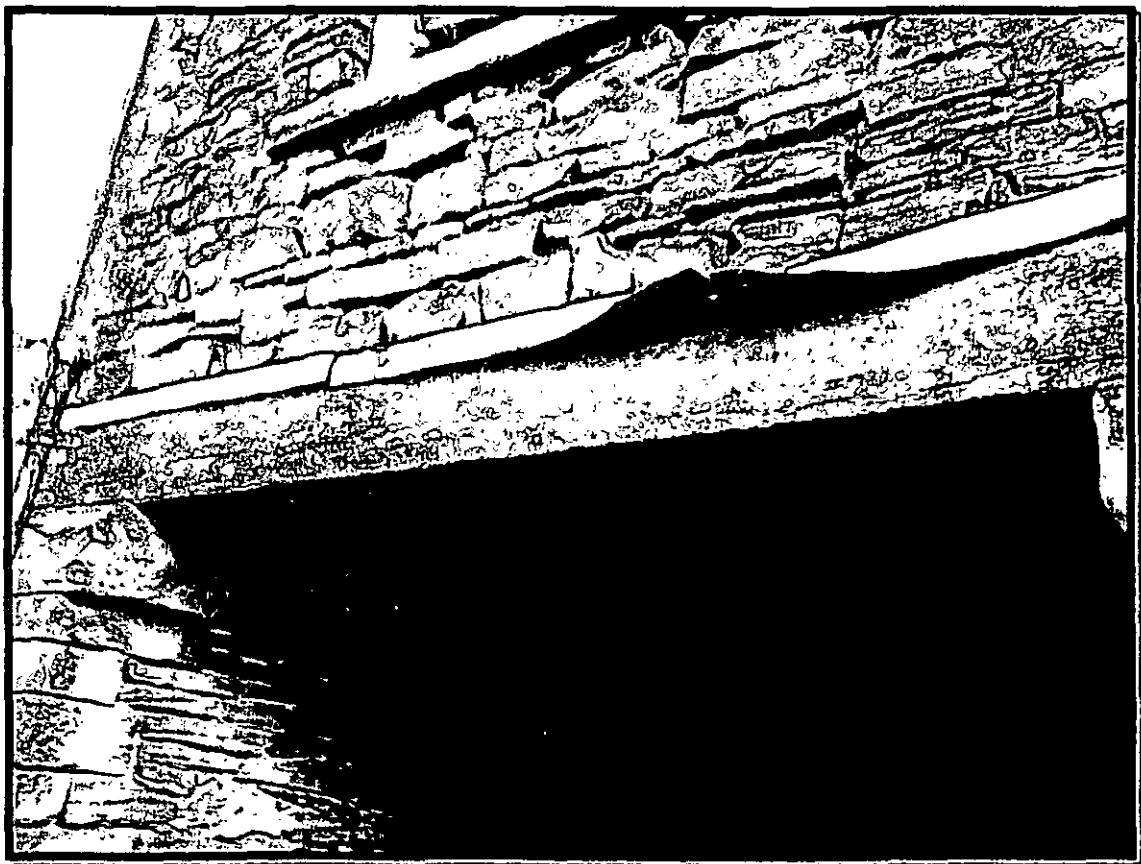
- 5.1.3.2 The timber beam supporting the first floor is a single 350 x 350 section timber. There is a lead flashing between the wall above and the timber beam. Over the right hand long opening the top of the timber beam has suffered wet rot caused by water leaking through the lead flashing. The wall above has settled and a small section of masonry has loosened. Generally the timber beams are in good condition and do not exhibit any permanent deflections. **(Photograph 53 & 54)**

Photograph 54 – View of timber beam tom West Elevation

- Carry out repairs to the timber beam to the West elevation of Tractor Shed where beam has suffered roof and reinstate masonry wall above. Check load carrying capacity of beam and strengthen if necessary.

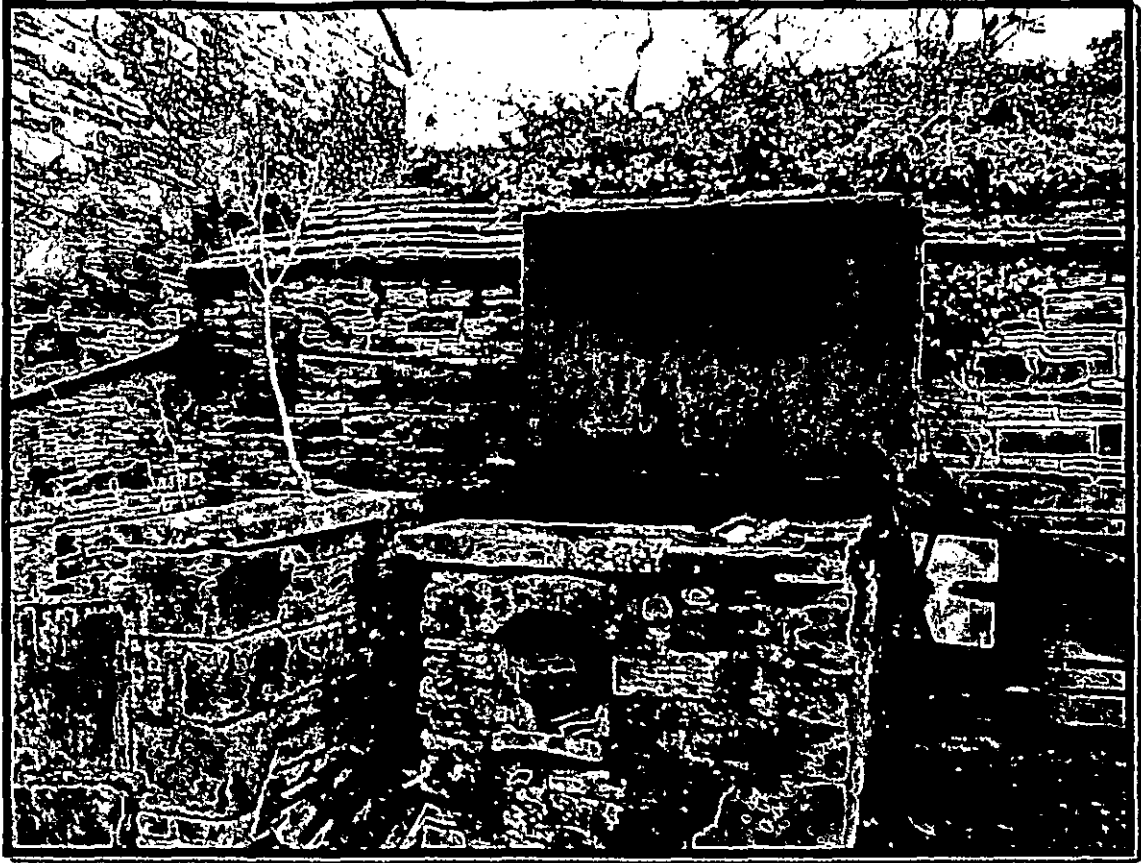
- 5.1.3.3 The pointing to this wall is in fair condition with some localised deep mortar loss from the joints.
- 5.1.3.4 No bulging or movement was noted in this elevation.
- 5.1.3.5 The gutter and rainwater downpipes to this elevation intact and in fair condition.
- 5.1.3.6 At the Southern end of this elevation the wall is connected to an adjacent building. The client informed The Epoc Group that this building was a pig sty. This structure is constructed in random course stone masonry and in good condition. **(Photograph 55)**

Photograph 55 – View of structure adjacent to the Tractor Shed

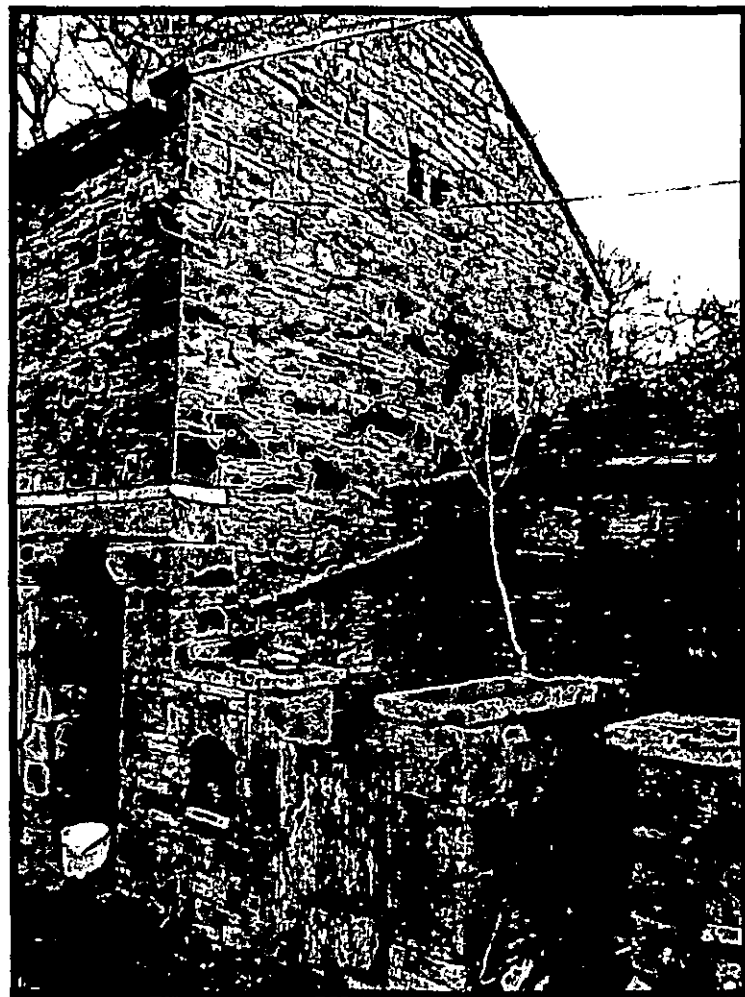
Photograph 56 – View of South Elevation

- 5.1.4.1 The South elevation is a gable wall and is constructed in random coursed masonry. This wall is in good condition with no signs of cracking and settlement. **(Photograph 56)**
- 5.1.4.2 This elevation is partly obscured by an adjacent structure.
- 5.1.4.3 Some minor bulging of the wall was noted to this elevation.
- 5.1.4.4 The pointing to this wall is in fair condition with mortar loss from some of the joints
- 5.1.4.5 The wall is topped with copings stones that remain intact and in good condition.

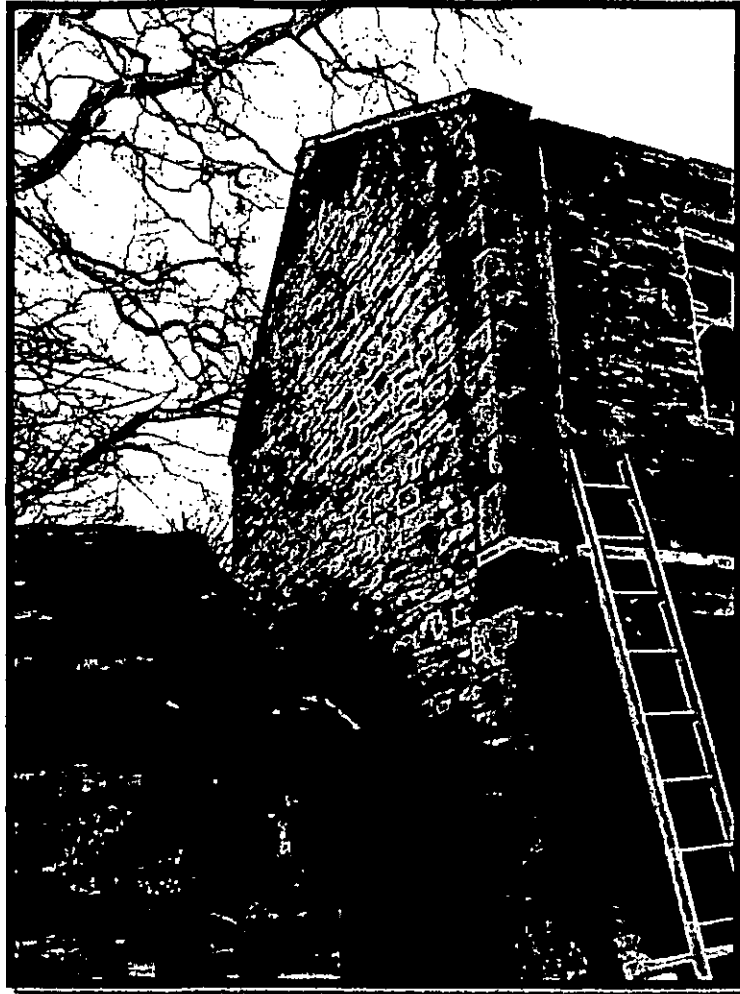
Photograph 57 – View of North Elevation

- 5.1.5.1 The North elevation is a gable wall and is constructed in random coursed masonry. This wall is in good condition and showed no signs of cracking, settlement or bulging. **(Photograph 57)**
- 5.1.5.2 The pointing to this wall is in fair condition with mortar loss from some of the joints
- 5.1.5.3 The wall is topped with copings stones that remain intact and in good condition.

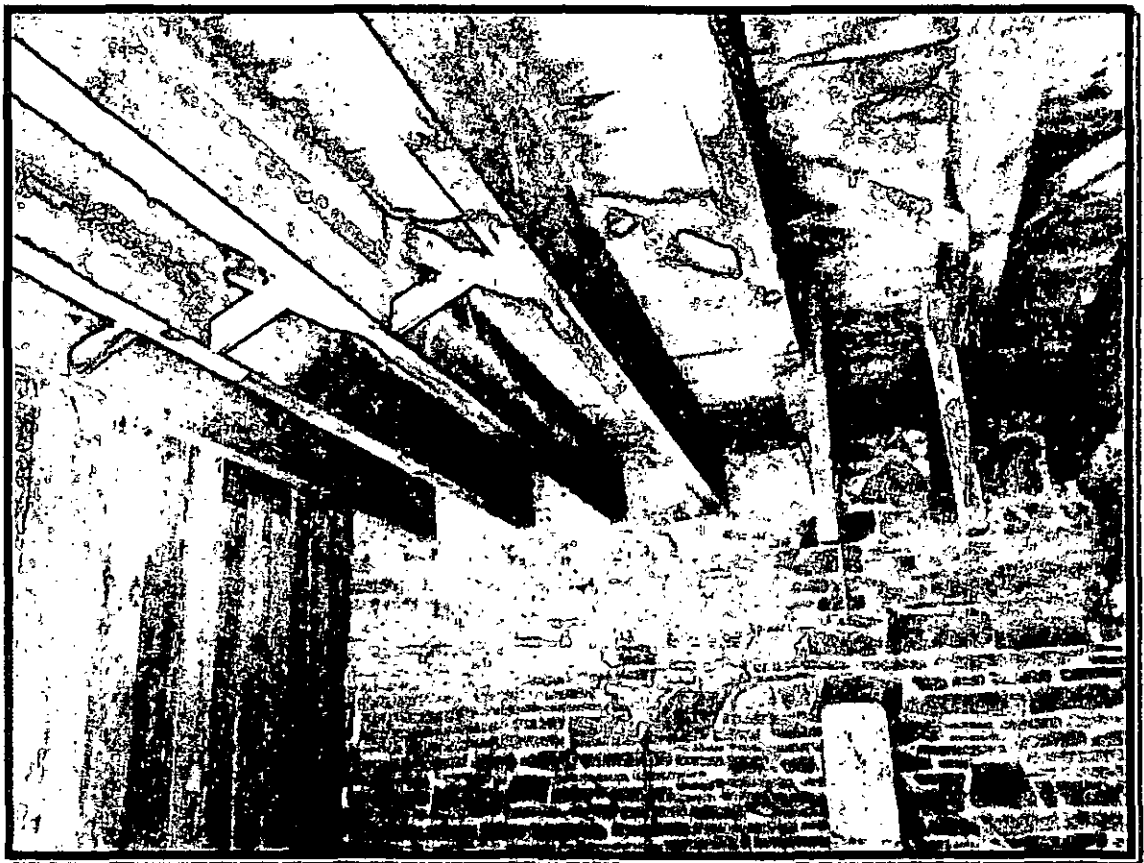
- 5.1.7.2 The walls internally are constructed in random coursed stone masonry. Where visible they are in good condition and showed no signs of cracking or movement. **(Photograph 60)**

Photograph 60 – View Internal wall construction

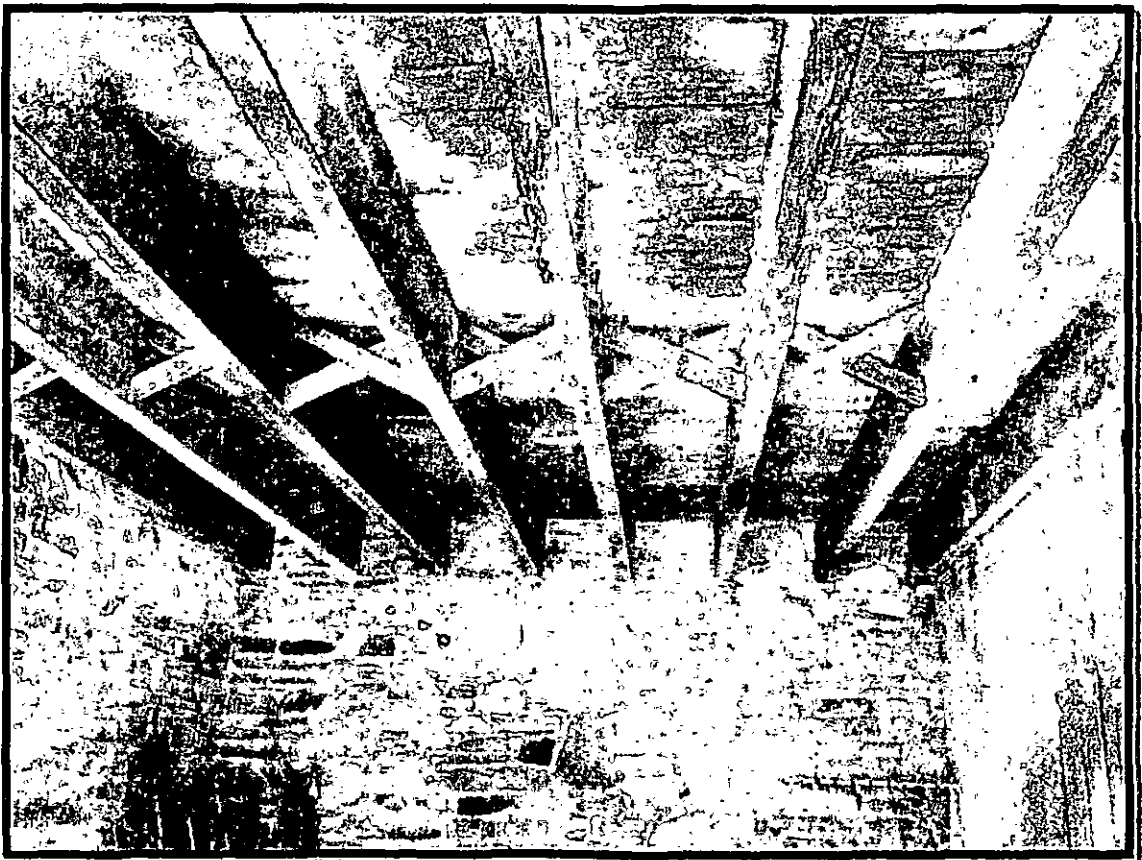
- 5.1.7.4 The timber joists support timber floorboards. From first floor level it was difficult to assess the condition due to the amount of debris. Although, the floor did not deflect excessively the floorboards felt very springy. From the underside holes in the floorboards could be observed. **(Photograph 62)**

Photograph 62 – View of first floor construction

- 5.3.5 The existing first floor should be assessed to determine its suitability to carry the new loads. The floor boarding requires replacement as it is unserviceable. The first floor will require lowering to increase headroom to the underside of the kingpost truss ties at first floor which currently is only 1700mm.

- Check the structural capacity of the existing first floor timbers and reuse if possible. Lower the floor to give sufficient headroom at first floor level.

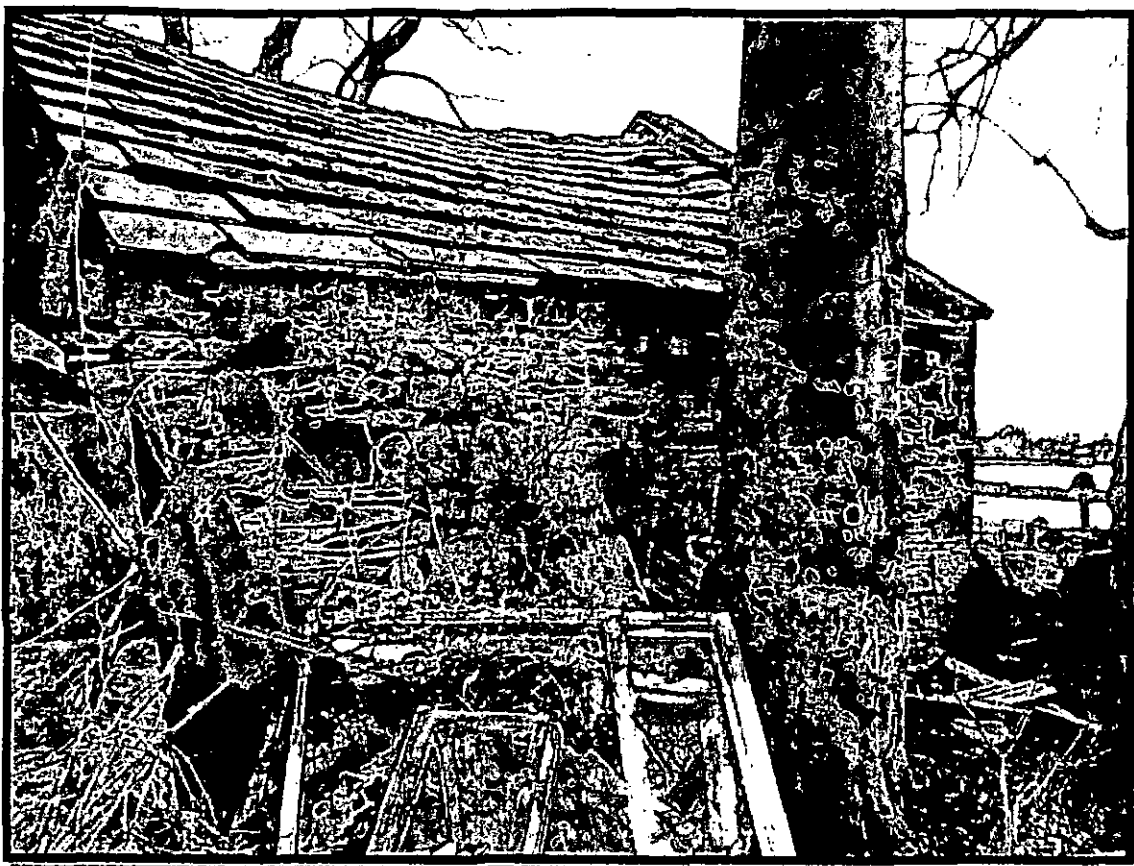
**Photograph 63 – View of Annex East Elevation**

- 5.1.8.1 This elevation is constructed in random stone masonry and is in fair condition. There are some large blocks of stone within the wall and some brickwork patch repairs at eaves level. **(Photograph 63)**
- 5.1.8.2 At eaves level outward bowing of the wall was observed.
- 5.1.8.3 The pointing to this elevation is in poor condition with open and eroded joints.
- 5.1.8.4 Guttering and rainwater downpipes were completely missing to this elevation.
- 5.1.8.5 Three large trees are growing within 5.0 metres of this elevation two of which are 2.0 metres and 1.50 metres away. **(Photograph 63)**

- 5.1.11.1 The roof is covered in stone slate tiles which are intact over the whole roof area. The tiles are in good condition albeit covered in moss. **(Photograph 63 & 66)**
- 5.1.11.2 Sagging and spreading of the ridge line and roof slopes was observed.
- 5.1.11.3 The timber structure comprised of timber purlins at mid slope and a ridge board span between the North and South elevations. In turn rafters span between the ridgeboard, purlins and East and West elevations. **(Photograph 68)**
- 5.1.11.4 Permanent sagging and bowing of the timber purlins was observed.

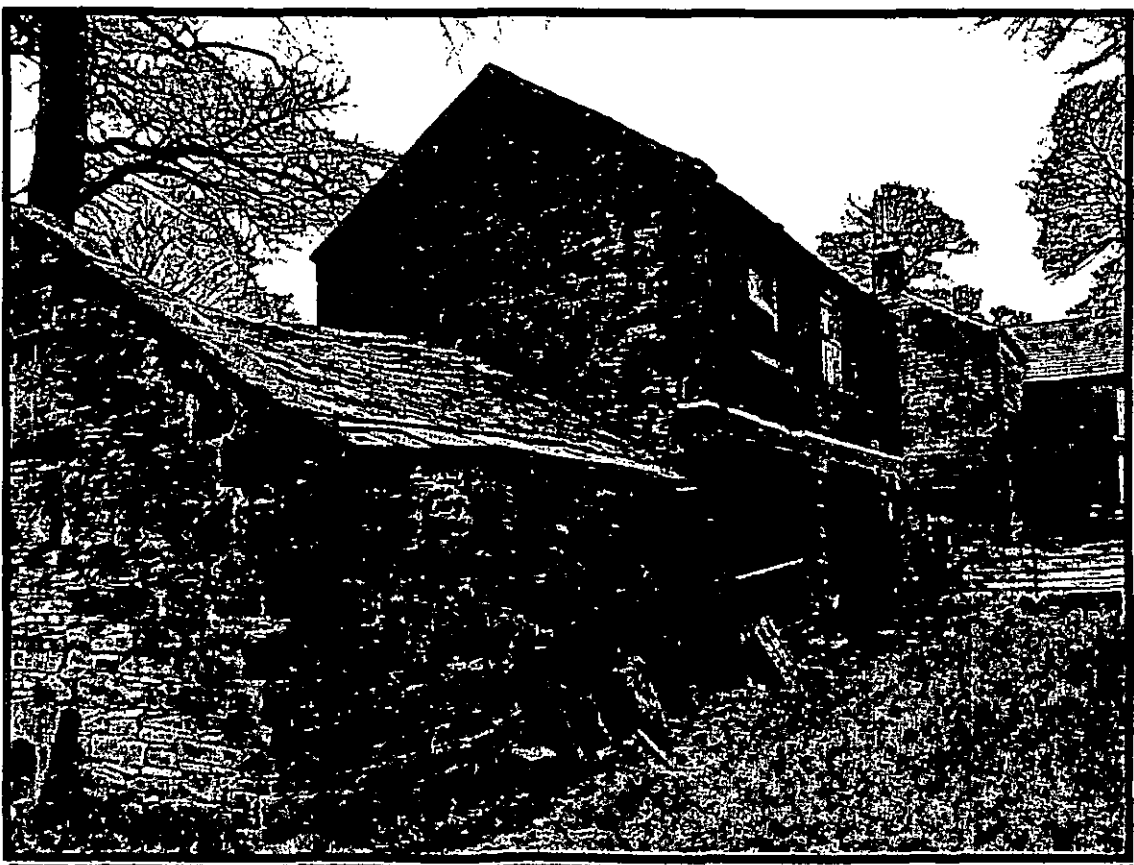
**Photograph 64 – View of Annex West Elevation**

- 5.1.9.1 This elevation is constructed in random stone masonry and is in fair condition with no signs of cracking or settlement. There are some large blocks of stone within the wall and some patch repairs at eaves level. **(Photograph 64)**
- 5.1.9.2 At eaves level outward bowing of the wall was observed.
- 5.1.9.3 The pointing to this elevation is in poor condition with open and eroded joints.
- 5.1.9.4 Guttering and rainwater downpipes were completely missing to this elevation.

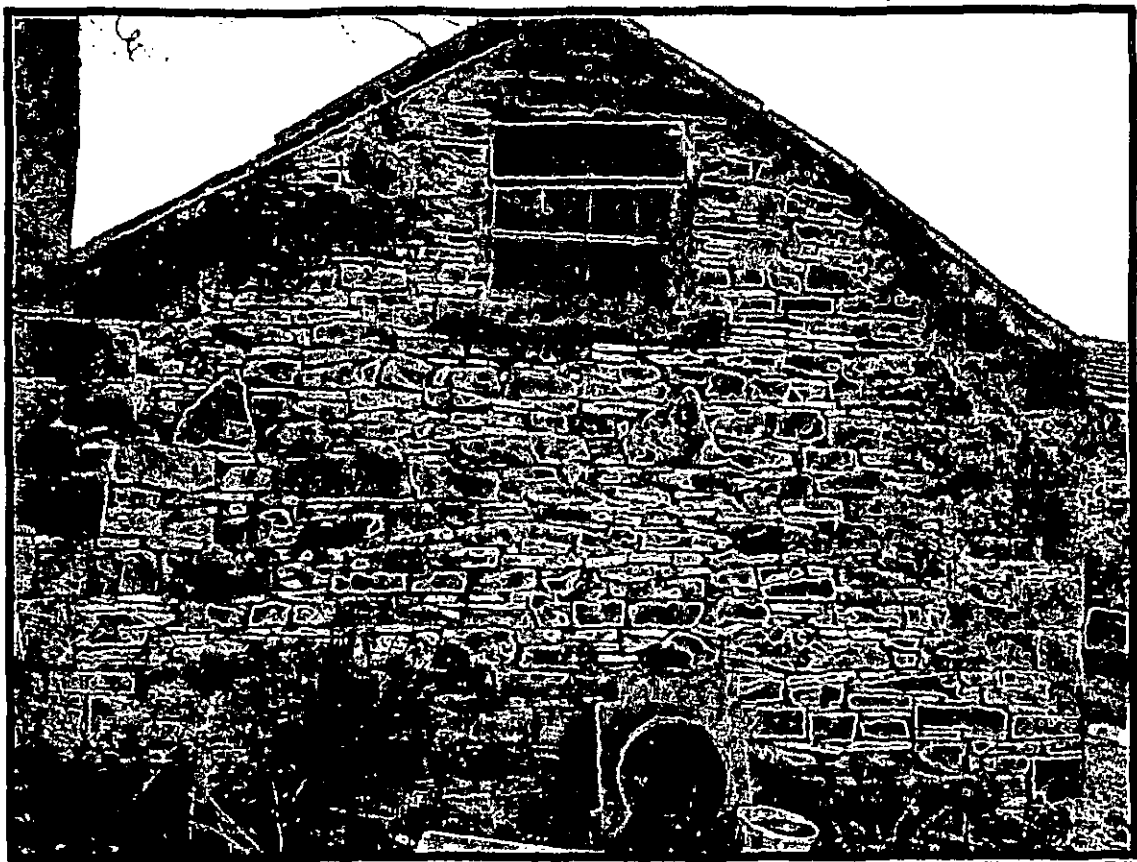
Photograph 65 – View of Annex North Elevation

- 5.1.10.1 This is a gable elevation and is constructed in random stone masonry and is in fair condition with no signs of cracking or settlement. **(Photograph 65)**
- 5.1.10.2 The slopes of the gable are capped with stone copings that are in good condition and intact to both slopes. **(Photograph 66)**
- 5.1.10.3 The pointing to this elevation is in poor condition with many open and eroded joints.
- 5.1.10.4 There is a window opening to this elevation with a stone masonry lintel and cill. Both are in good condition. The timber window frame is intact but in poor condition.
