ARBORICULTURAL REPORT  
RELATING TO PROPOSED DEVELOPMENT AT  
BURTON ROAD, MONK BRETTON, BARNSELY

YORKSHIRE HOUSING  
c/o WSM ACANTHUS ARCHITECTS

| Title | <b>Tree Survey</b> | DATE COMPLETED | <b>01/11/2010</b> |
| AUTHOR | <b>Ian Barnes</b> | OUR REF. | <b>BA3310</b> |

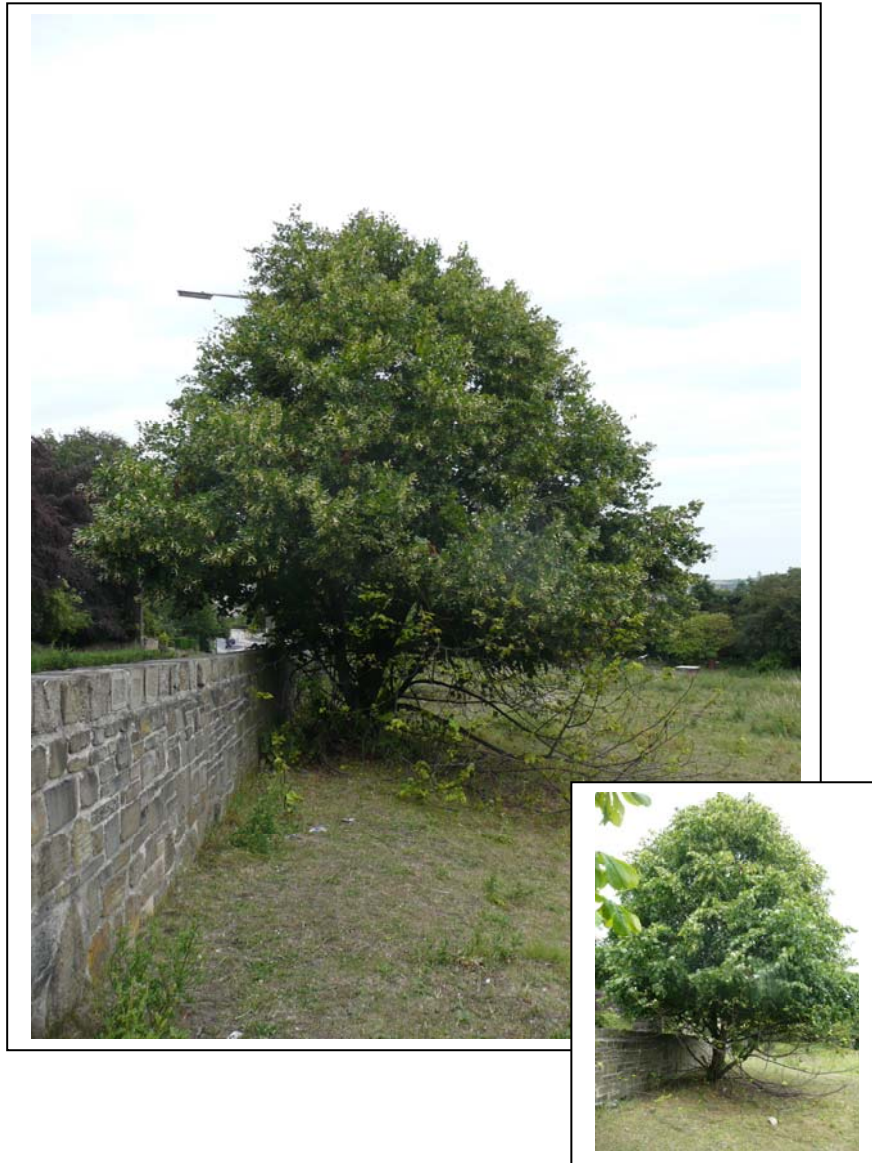
- 10.4. The majority of the trees on the western boundary have been affected by grazing damage to the lower sections of the canopy as shown in photograph 1 in Appendix 3, with both bark damage and defoliation being seen. To avoid future inherent problems with the lower branches these limbs should be crown lifted.

**Photograph 1** – Typical example of the Limes on the western boundary.

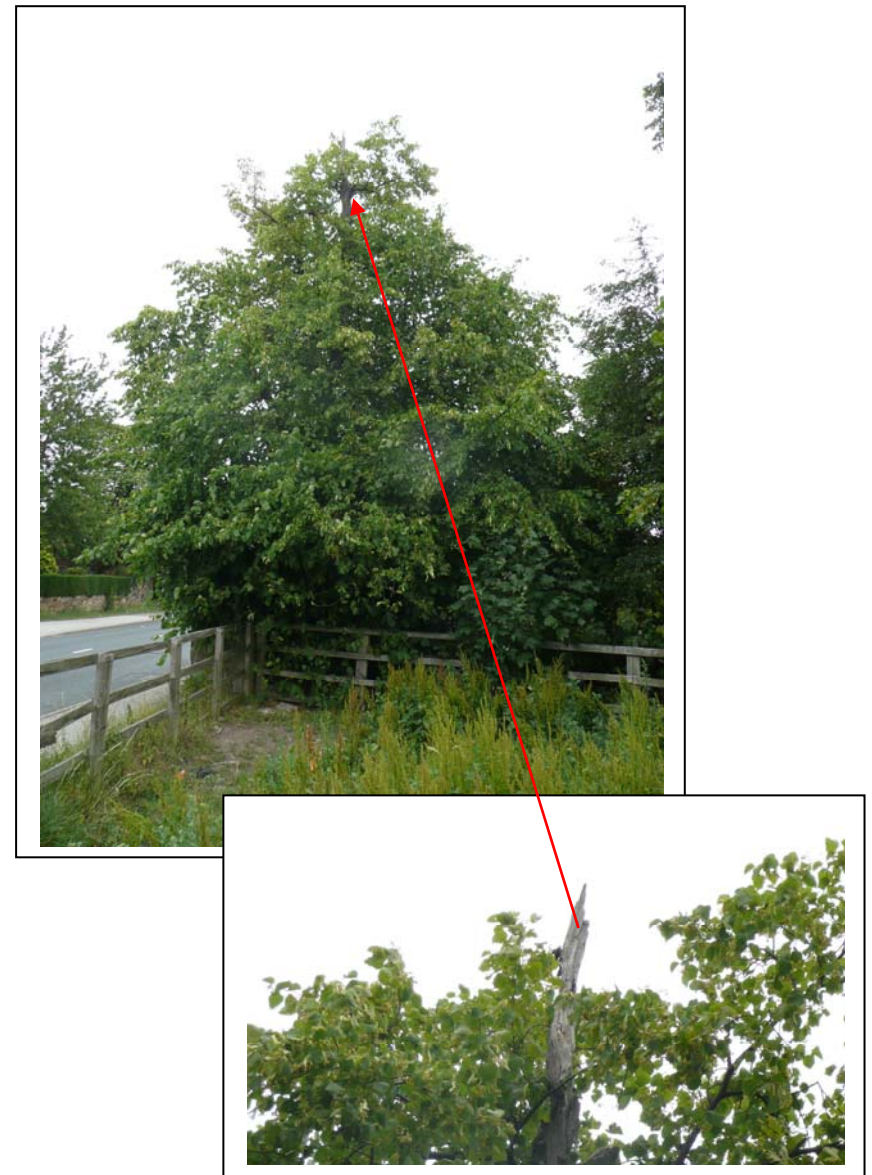
- 10.5. The Lime T2535 located close to the western boundary has a large section of dead wood in the upper canopy as shown in photograph 2 in Appendix 3, this dead section poses a risk to highway users and should ideally be removed as soon as possible.

**Photograph 2** – The Large Dead section within the upper canopy of T2535.

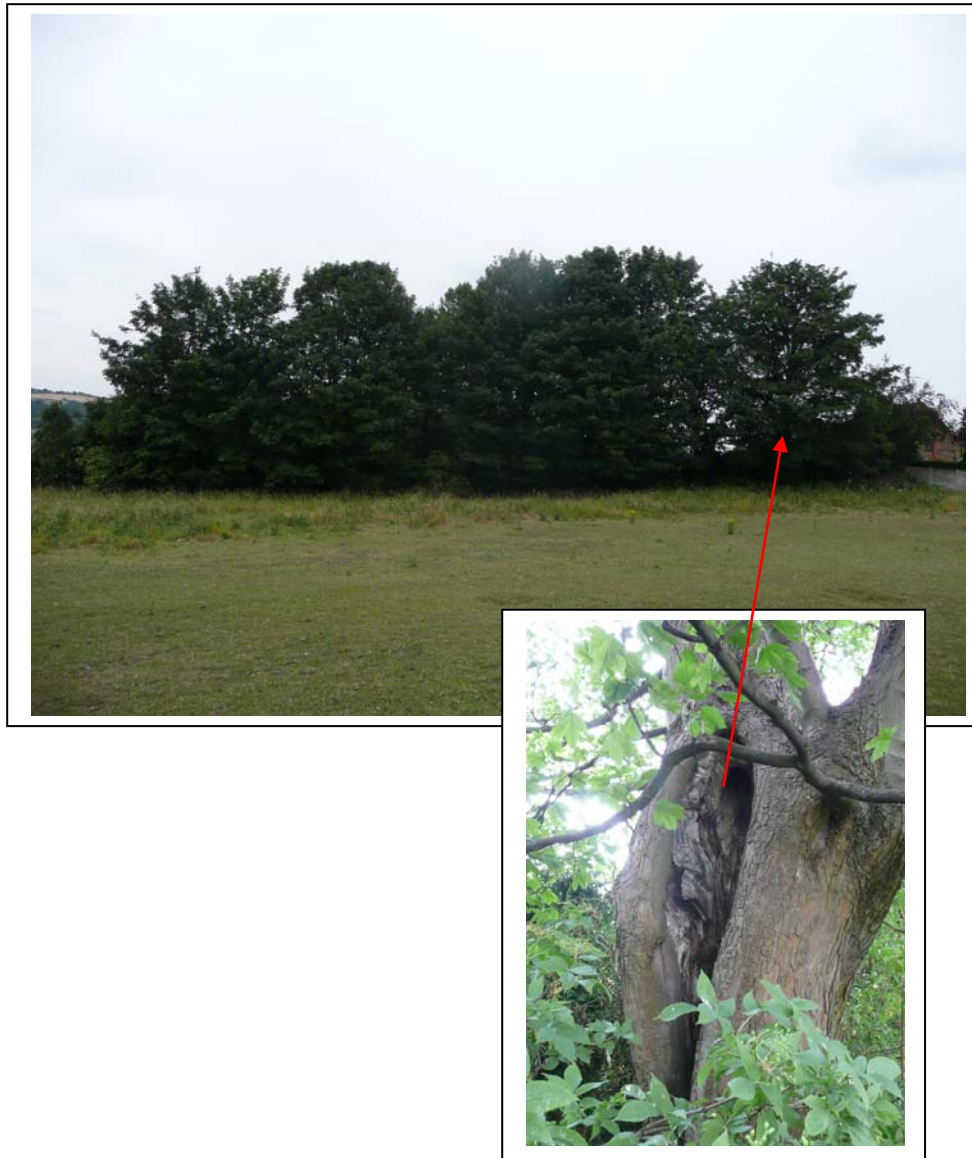
- 10.7. The western most Sycamore in the Group T2546 has a significant cavity / wounding as shown in photograph 3 in Appendix 3, which is thought to be affecting the trees stability. In these cases, the recorded defects should be further assessed to detail the extent of decay versus the retained supportive wood. Ideally, this should be undertaken using a combination of sonic tomography to assess wood density, electronic impedance tomography to identify high / low water / ion content and Thermal imaging to assess various in temperature distribution. I will be happy to forwards further details and an outline of costs upon request.

| TAG No. | Species | Age | Height | Canopy Height | North Canopy | South Canopy | East Canopy | West Canopy | Vitality | Safe Life | Category | Diameter @ 1.5m (mm) | Observations / Comments | Recommendations | Minimum RPA (Radius) (m) | Minimum RPA (Area) (m <sup>2</sup> ) |
|---|---|---|---|---|---|---|---|---|---|---|---|---|---|---|---|---|
| 2546 | Sycamore Group x 12 | M | 13 | 1 | 7.5 | 7.5 | 7.5 | 7.5 | Fair | 20-40 | B2 | upto 850 m | Multiple stemmed close to ground level, tri-forked below the canopy with tight unions.<br>Growing on neighbouring land.<br>Growing close to fence.<br>A line of trees which follows a collapsed stone wall.<br>Good examples of the species.<br>Western most tree has lost a large leader which has caused a large cavity. | The extent of the cavity should be assessed to provide an insight into the retained sound wood and enable comments upon the trees stability to be made.<br>Ideally this should be undertaken using a none injurious system such as Tomography. | 8.5 | 227 |

**Photograph 3** – The Group of Sycamore T3546 with the cavity inserted.

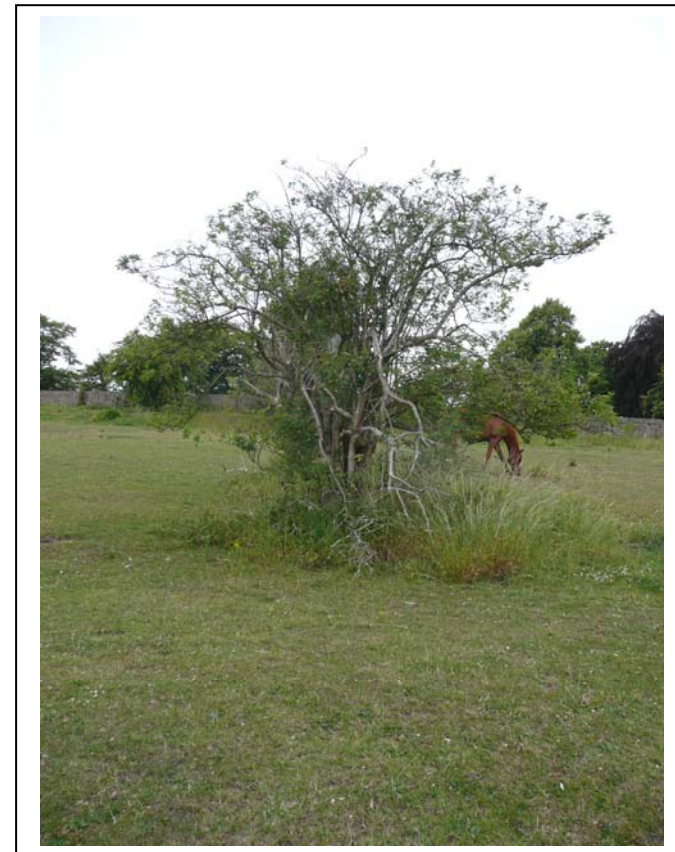
- 10.11. Within the site several maturing Elders can be seen, these are in a poor state and are mainly in decline with a number being defoliated as shown in photograph 4 in Appendix 3 these trees are not expected to be sustainable.

| TAG No. | Species | Age | Height | Canopy Height | North Canopy | South Canopy | East Canopy | West Canopy | Vitality | Safe Life | Category | Diameter @ 1.5m (mm) | Observations / Comments | Recommendations | Minimum RPA (Radius) (m) | Minimum RPA (Area) (m <sup>2</sup> ) |
|---|---|---|---|---|---|---|---|---|---|---|---|---|---|---|---|---|
| 2549 | Elder | O<br>M | 4.5 | 2 | 2.5 | 2.5 | 2.5 | 2.5 | Very Poor | <5 | R | 430 m | Tri-forked close to ground level.<br>50% of the leaves within the canopy are missing.<br>A poorly developing tree. | | 4.3 | 58.1 |

**Photograph 4** – Typical grazed central Elder tree T2549.
