# THE READING ROOM DARFIELD

## A PROPOSAL FOR REPAIR AND ALTERATION

August 2008

Prepared By  
Linda Lockett Chartered Architect  
7 Acaster Lane,  
Bishopthorpe,  
York YO24 2SA  
01904 708879  
lindalockett.uk@btinternet.com

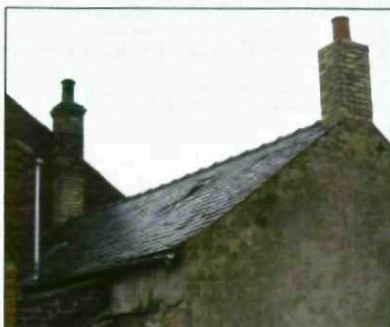
The East roof slope

The roof slates are starting to laminate and are suffering from nail fatigue, there are many slipped and broken slates and there are a number of holes in the roof. The roof structure is holding up well, considering the amount of water that must be getting into the building, but there are some rotting timbers. The timber roof members are undersized by today's standards.

The roof will need to be stripped of tiles. The existing structure will require repair and upgrading to present standards. The roof should then be re-clad in new Blue Welsh slate, it is hoped that the original blue clay ridge tiles can be reused. New metal framed double glazed roof lights should be reinstated in the positions of the originals.

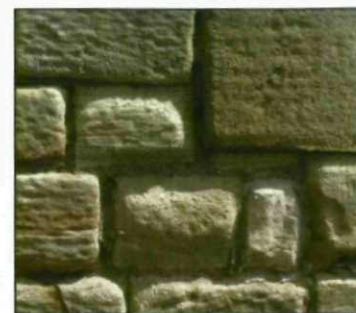
The external walls of the Reading Room are constructed of a soft dressed sandstone, rendered on the South side. The West and North elevations form party walls with adjacent properties. The later toilet extension is of solid smooth red brickwork with a concrete roof.

The stonework of the East elevation is soft and much of the facing stone has eroded particularly at low level where it has been splashed with saline water from the road. Most of the joints are open and require repointing. The South wall has been rendered, but the stone under the rendering is starting to decay. On the exposed areas of the West wall there is considerable erosion of the rubble facing and patching with breeze blocks and brick is visible below.

All the stonework to the East elevation requires repointing in a lime based mortar, approximately 12 of the ashlar stones should be replaced with new stone. Masonry repairs are required on the dressed stone around the windows. The South elevation should be

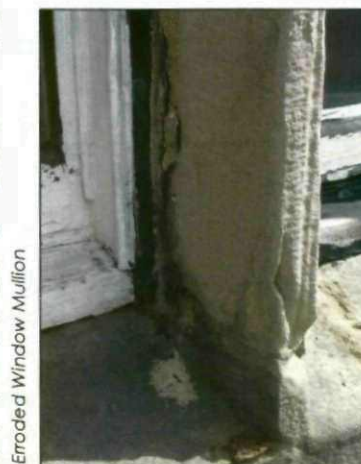
Eroded Window Mullion

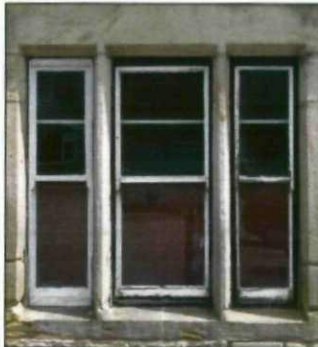
*The North West Window*

The windows on the South elevation are the original Victorian sash windows. Some of the original glass remains in place. The sills are rotten and all will require some degree of repair before they can be re-weighted and re-hung.

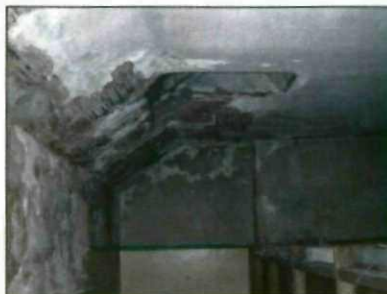
*The Interior Ceiling*

has a mezzanine floor and the other a suspended ceiling. There are remains of the original plaster ceiling at high level. This has been badly damaged by water ingress. The walls were originally plastered on the hard-board. In most areas the plaster has been damaged by water ingress at the East side this has been caused by saturation of the wall from the leaking valley gutter above, on the East side the damp-

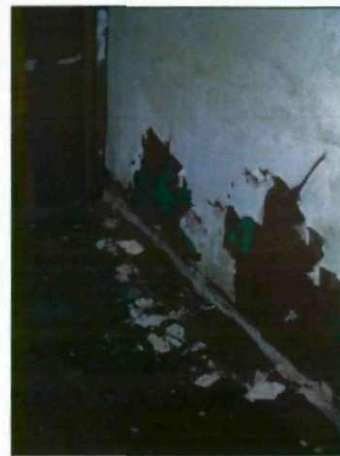
*Dampness on the East Wall*

Dampness is due to splashing from the road, water from leaking gutters and rising damp; the floor level is below that of the road particularly at the South end.

The proposals are to strip out the Reading Room and return it to a single cell. The walls will need to be stripped of plaster and allowed to dry out before dry lining the walls to provide adequate insulation.

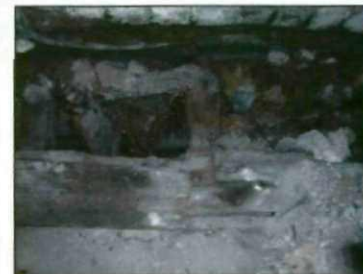
The floor is a timber suspended floor. Much of the structure in contact with the walls is damp and rotten. The proposals are to remove the wooden floor and form a new solid floor.

*The Rotten Floor joists*
