**Elsecar Rail Station**

Outline Geotechnical  
Desk Study Report

February 2010

**Ove Arup & Partners Ltd**

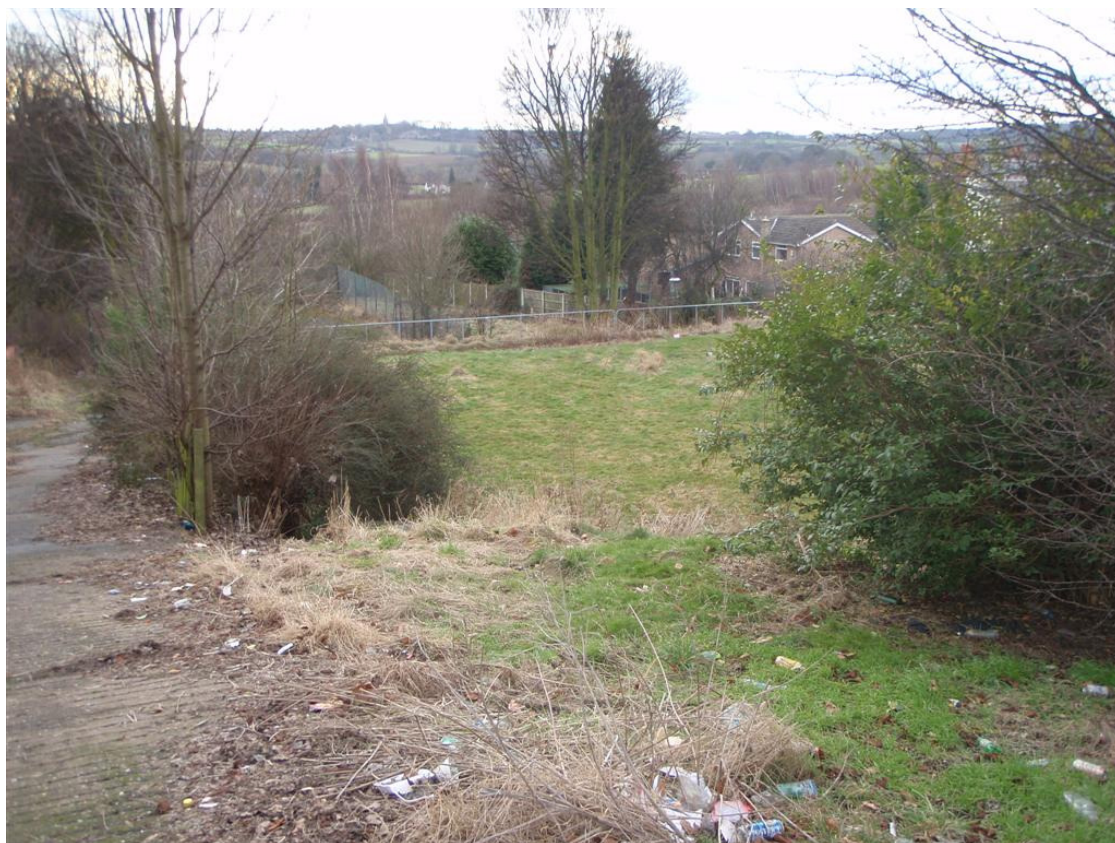
**Photograph 1 Level ground (see figure 3)**

It was noted on the site walkover that the bowling green and tennis court were both on very level ground which did not reflect the natural slope of the site. The bowling green had a three tier retaining wall (see photograph 2) up to Millhouses Street, to the north, and a relatively steep embankment to the south, down to the tennis courts. It is assumed that a cut and fill exercise was carried out here to form the level areas. The fill is likely to mostly comprise the cut material, waste material from part of the works prior to 1930 to construct the school or the spoil material described in section 3 (1903).

Photograph 1 was taken from the north access path looking down to the bowling green and tennis court.

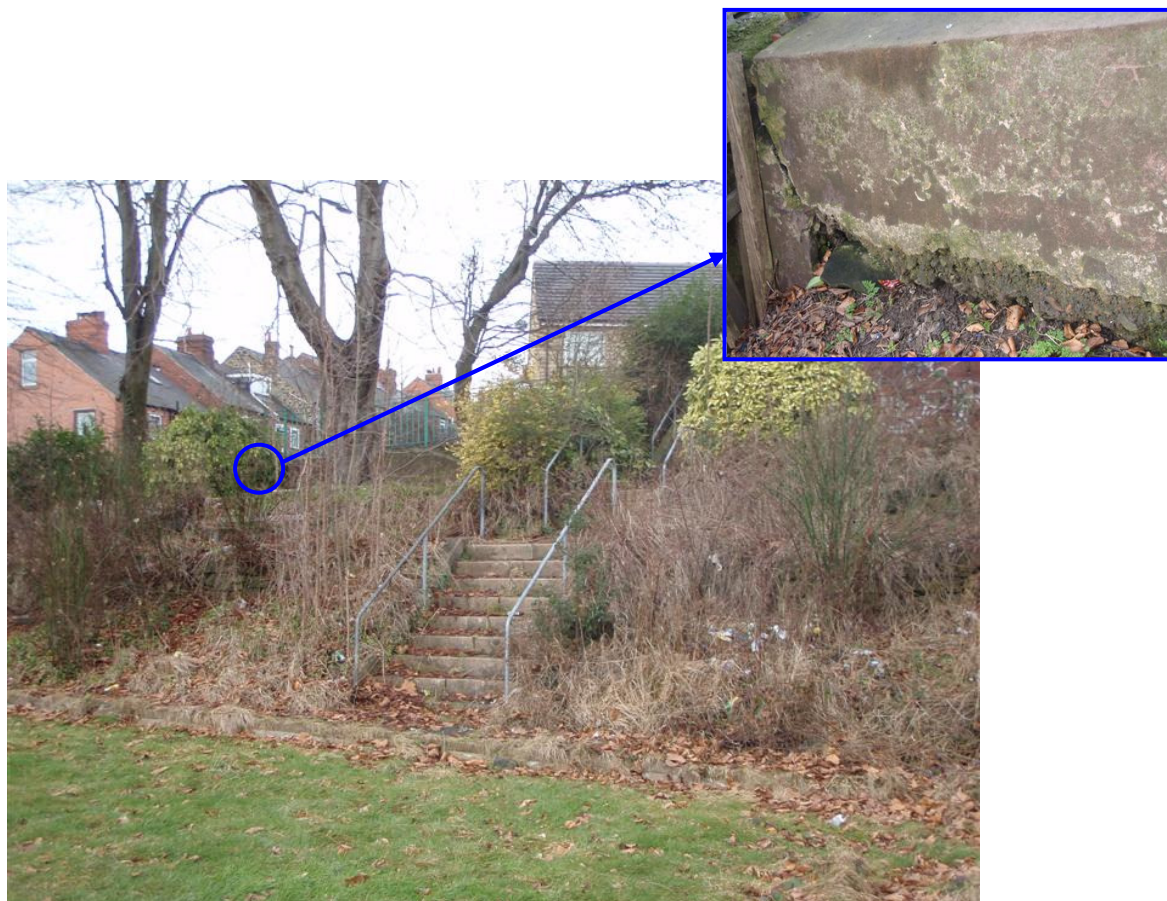
**Photograph 2 Three tier retaining structure - with detail of cracking in concrete (see figure 3)**

Most of the brick and concrete used in the retaining structures showed signs of poor maintenance, particularly, the concrete retaining wall at the top of the bowling green. The two lower walls of the retaining structure were noted to have no significant signs of leaning or cracking. However, the top wall had several large cracks throughout its length, some of which had been filled with fresh concrete, indicating a deterioration in the condition of this structure.

Although there were significant signs of deterioration in some of the retaining structures, there did not appear to be any signs of overall failures.

There is a three tier retaining structure between the bowling green and Millhouses Road. The upper wall of this structure was noted to have significant cracking and deterioration of the condition of the wall. However, this did not appear to be due to soil movement and no signs of overall failure were observed. It is more likely that the damage has arisen from a combination of: old structures coming to the end of their design life, the mature trees' extensive root networks and a general lack of maintenance.

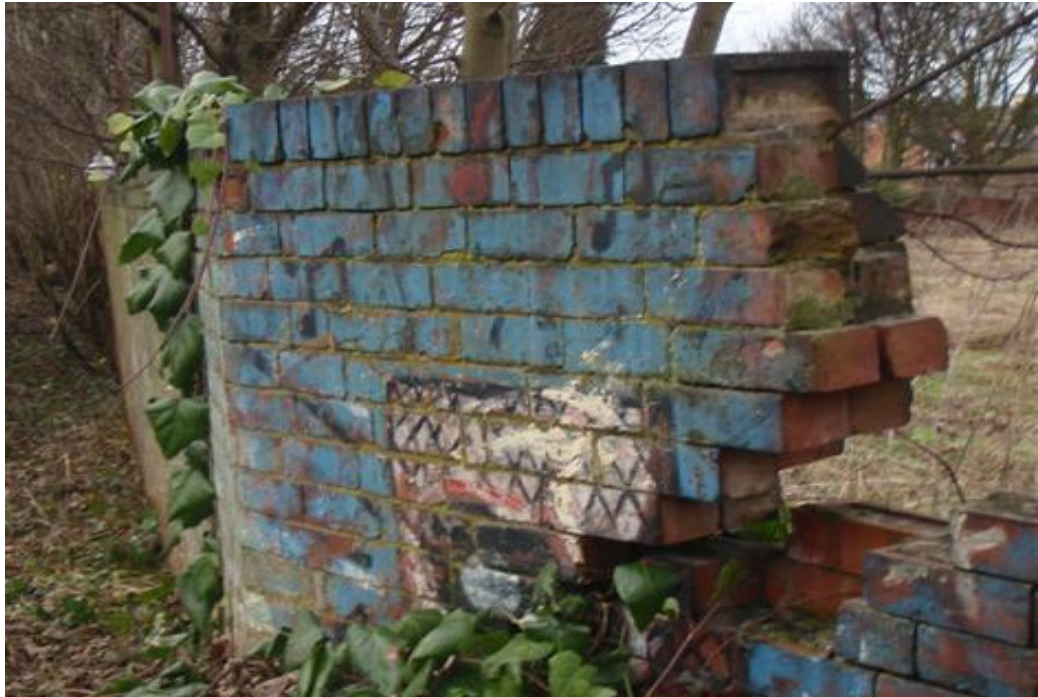
**Photograph 3 Buckled free standing wall – middle and southern section (see figure 3)**

The free-standing wall which extends to the south and east of the pre-existing school showed the most significant signs of disrepair. The northern section of the wall was heavily vegetated and some of the length of this section could not be seen, however, no signs of cracking or leaning were noted. The middle and southern section of the wall have buckled and broken apart (see photograph 3), with large vertical cracks visible along its length.

The free standing wall to the south of the site has been described as showing signs of undergoing significant movement, causing the wall to buckle and break apart. The movement appears to be vertical in direction, with either the southern section sinking, the middle section rising or a combination of both actions. As the wall is close to the railway, it is likely that it was founded on fill material, therefore, the vertical action may have been caused by the associated issues described above. However, this type of damage could also be due to several other unrelated reasons: poor foundations, damaged sustained during the demolition of the school or an old structure at the end of its design life.

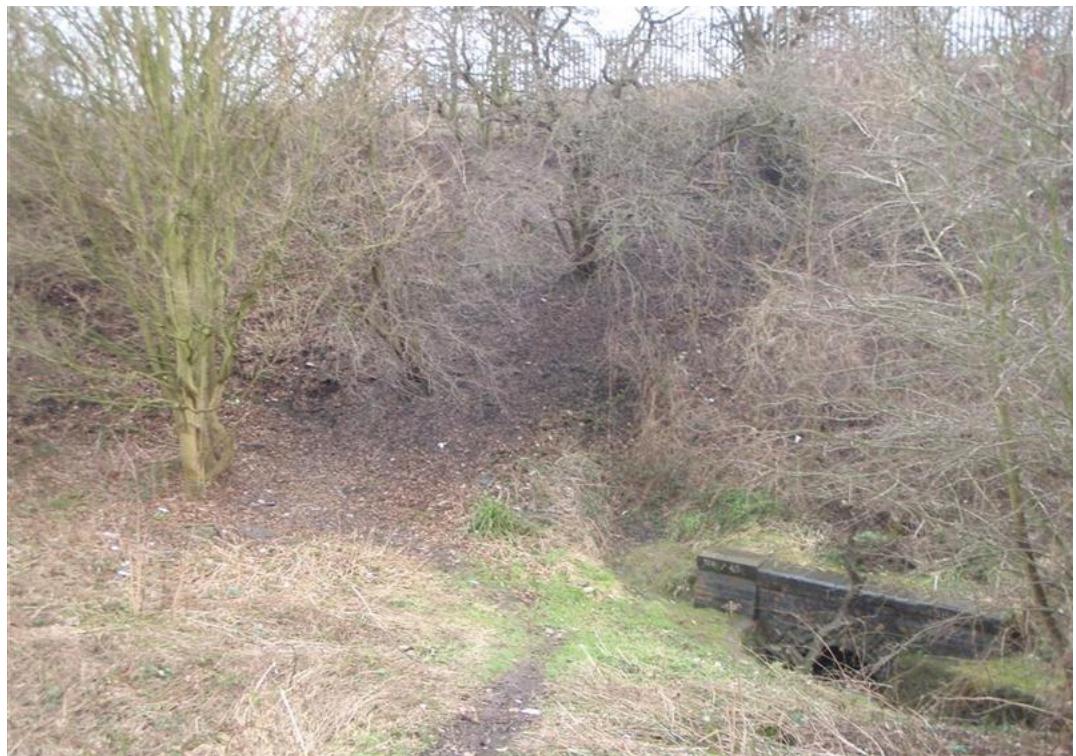
**Photograph 4 Man made valley (see figure 3)**

Photograph 3 is taken from the bottom of the valley on the western boundary. The valley is shallow, approximately 10m deep, and has steep sides,  $>25^\circ$ . No signs of slope instability were noted on valley sides. The photograph also shows the small watercourse and the culvert under the railway embankment. The watercourse also runs into a culvert immediately to the right hand side of the picture (westwards), under the recreational grounds. It was also noted on the site walkover that the recreational grounds were very level, indicating that some major earthworks have been carried out on the western side of the valley.

The man made valley and corresponding level land to the west of the site is shown as Made Ground on the BGS geological map and in the historical maps this area is shown to be spoil. The spoil is assumed to be connected to, either, the activity in the Iron Works (1855), to the west of the site, or the Iron Foundry (1892 – present) to the south of the site. It is likely that some of this spoil was used in the fill exercises carried out during the embankment construction.

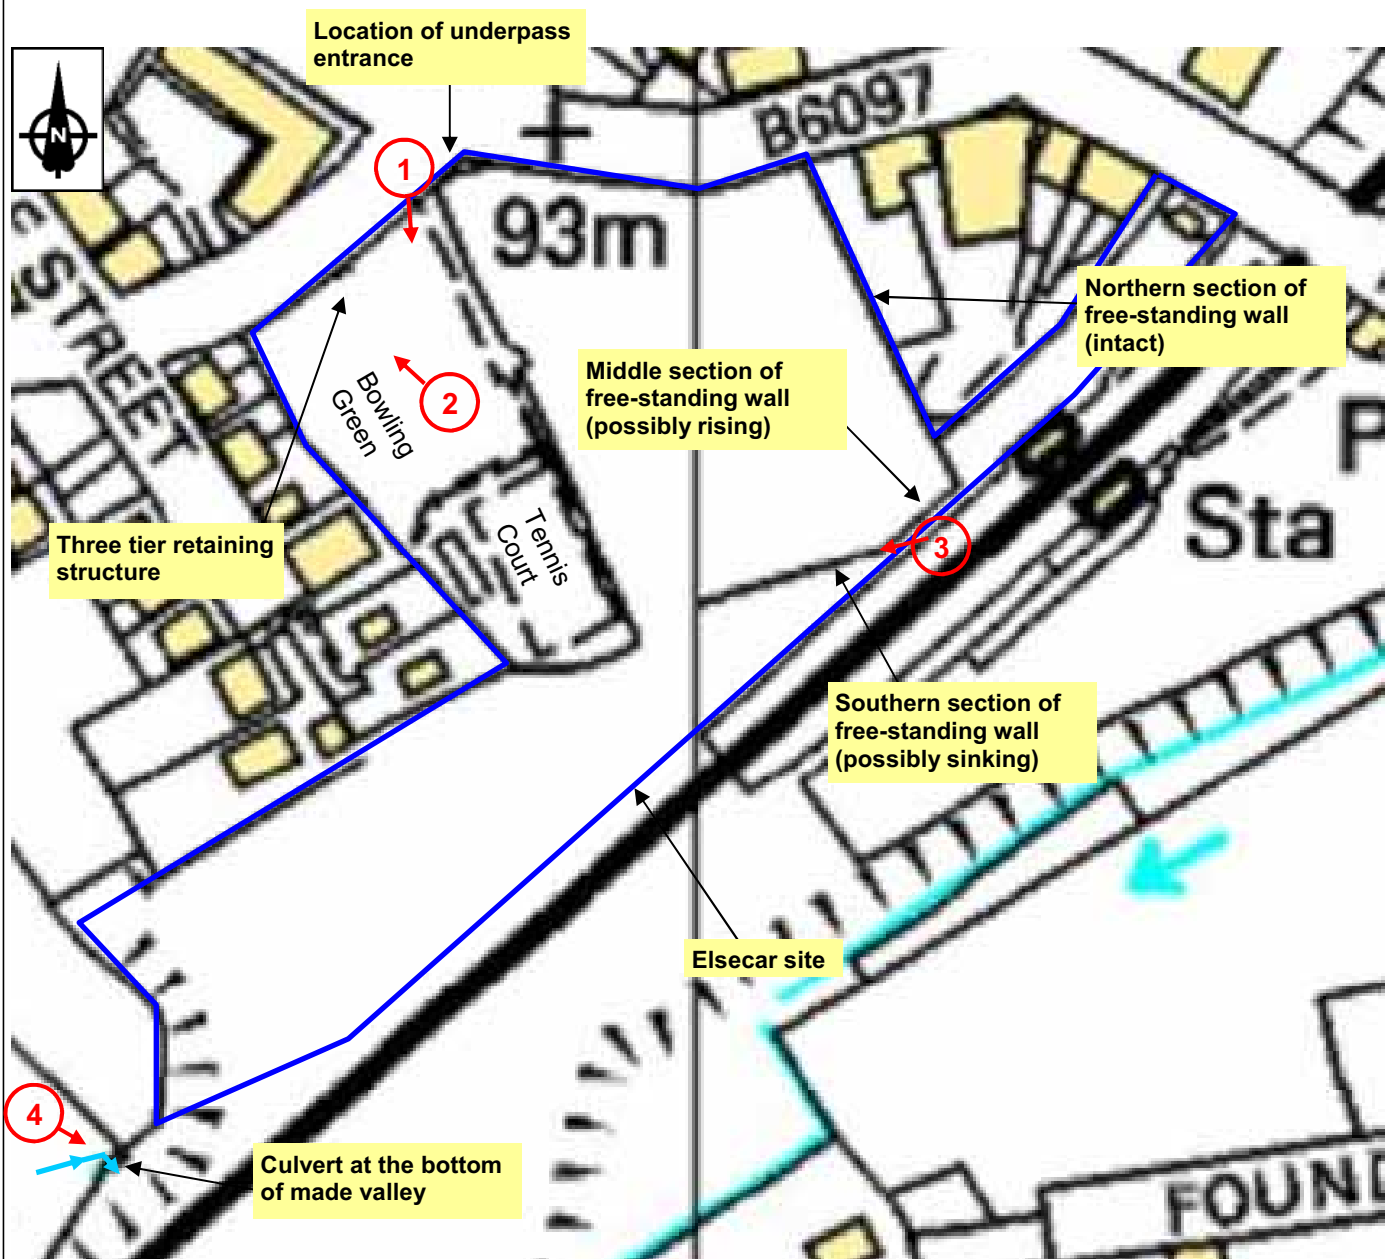
Figure 3

To the north of the free standing wall (marked on figure 3) the site has a gradual gradient sloping high to low from north to south. However, the ground has been landscaped to provide level platforms for the bowling green and tennis court, creating a two tier effect. To the south and south-west of the free standing wall the ground is relatively flat. The lowest point on the site is approximately 80mAOD, beside the railway, sloping up to the north to a height of 92mAOD. There is a small, steep valley on the western boundary sloping down to below 70mAOD, where a small watercourse is shown flowing into a culvert under the railway in a north-west to south-easterly direction.

Field studies to date include a walkover survey and a topographical study (undertaken by others and not reported here). A walkover survey was undertaken on 2<sup>nd</sup> February 2010 to establish any geotechnical issues that could be interpreted from a visual inspection of the site (see figure 3 for walkover notes and position of photographs)
