## **Report on an Inspection of an existing building at Hill Top Farm, Hood Green**

| <p>PETER THOMPSON</p> <p>HILL TOP FARM – BARN BUILDING SURVEY PHOTOGRAPHS</p> | |

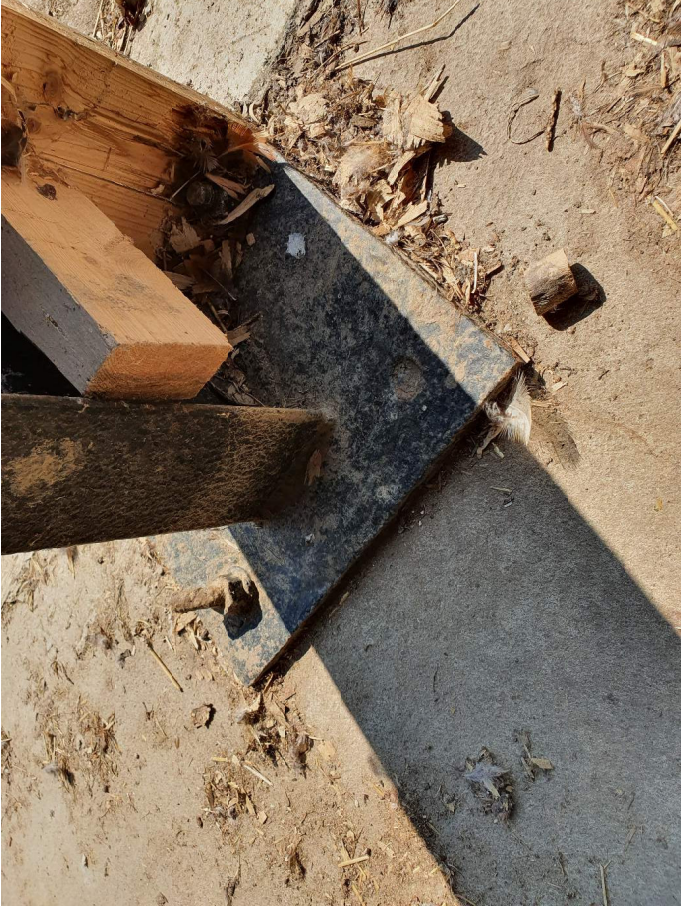
The steel portal frames generally appeared to be in good condition. There was evidence of mild rusting in localised areas where the protective paint finish had chipped or worn away, but this wasn't considered to be significant. There were two instances where holding down bolts were missing from the base plates to two of the columns on the southern elevation, but there was no evidence that this has impaired the performance of the structure.

Bolt missing from column baseplate

- Replace the missing bolts to the column baseplates
- Repair any damaged blockwork by repointing the mortar joints and replacing cracked/fractured blocks
- Repair/replace the existing guttering systems and install new downpipes, ensuring that surface water run-off from the building is properly managed
- Repaint or touch-up any rusted sections of steelwork
- Remove silt, debris and vegetation from the roof

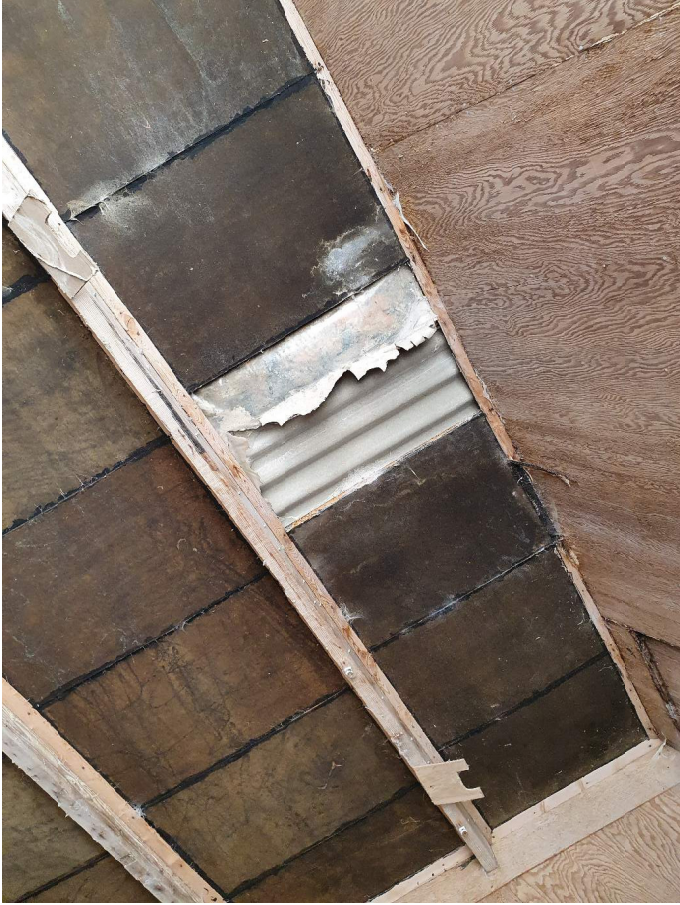
The inner roof fabric was damaged and deteriorated in places. There were some soffit boards missing and the membrane was torn in places, revealing the underside of the corrugated roof panels above.

Missing soffit panel and damaged membrane

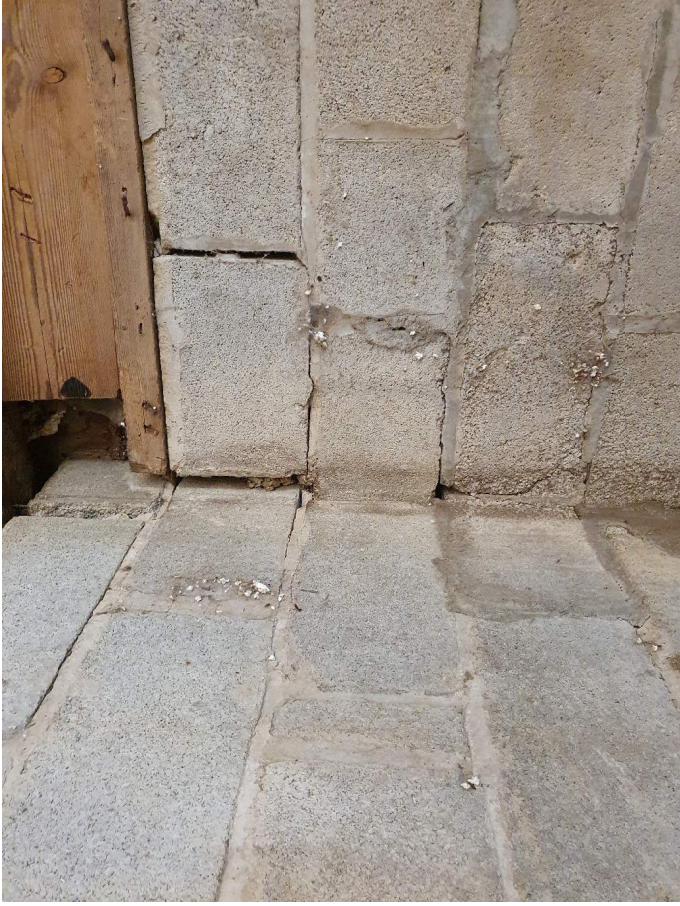
There was also some damage to the bottom courses of blockwork in the north east corner of the building. Here the lowermost block right in the corner was fractured, leaving a large cavity in the block. The cause of this is unknown, but it may be related to some external drainage issues in that area of the building discussed later in this report. There was some cracking to the blockwork above and around the fractured block, but this was not considered to be significant.

Cracked/displaced blocks in northeast corner

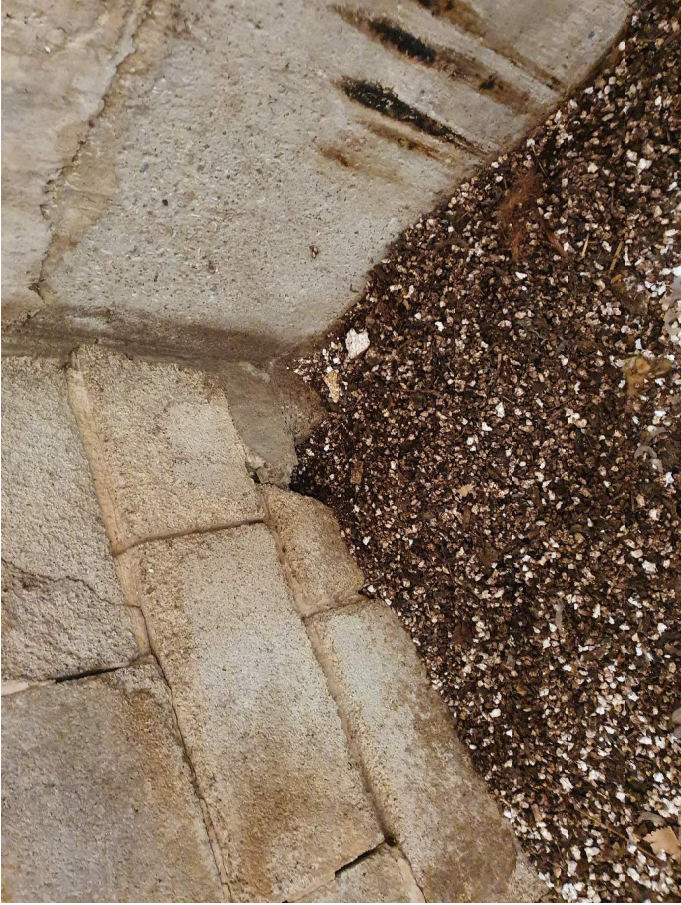
Fractured blockwork in northeast corner

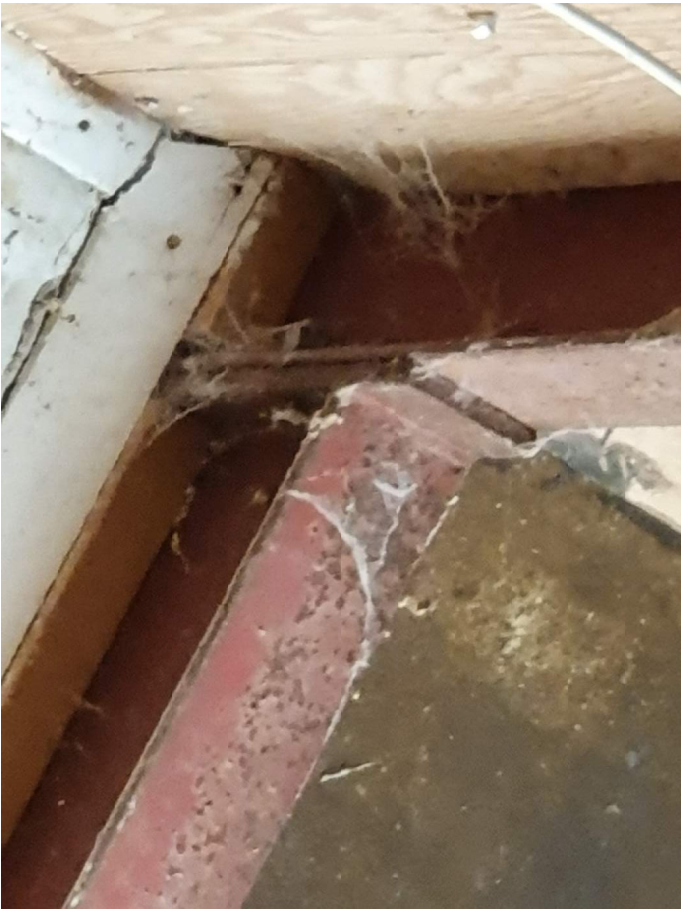
Mild rusting/pitting to steelwork

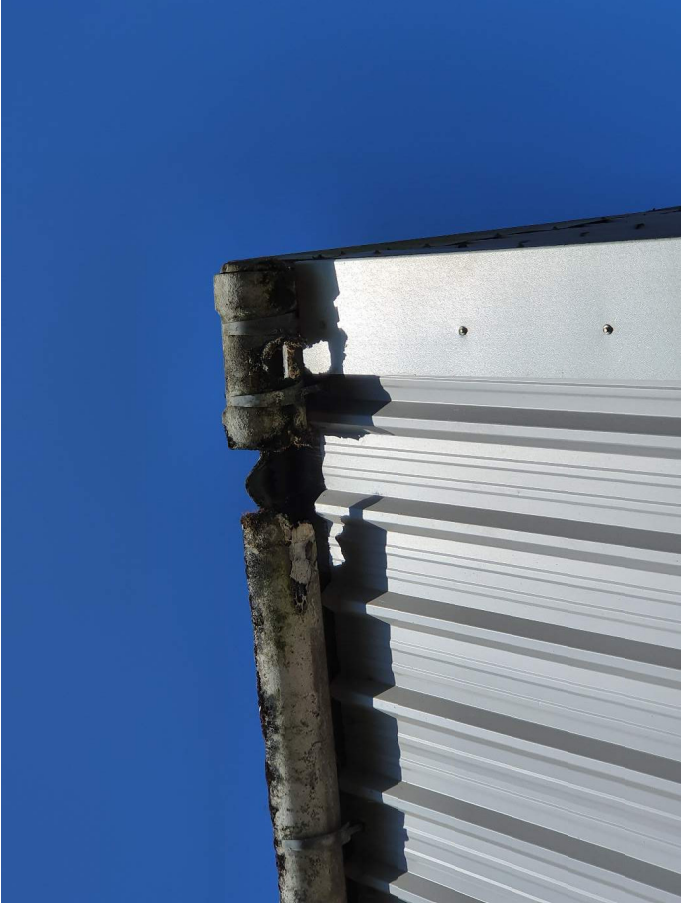
There was evidence of some drainage issues at both the northeast and southeast corners of the building. It is suspected that this is due to the rainwater downpipes being removed in these areas, leading to the water from the gutters being misdirected. The worst affected area was at the north east corner of the building. Here, there was evidence of a long-term issue with water running down the walls. The blockwork was severely water stained and a large area of moss had developed on the surface. There was a similar issue at the south eastern corner, but to a lesser extent. It would appear that a drainage channel has been formed in the external yard slab to direct the water away from the building.

Downpipes 'missing' and damaged gutter

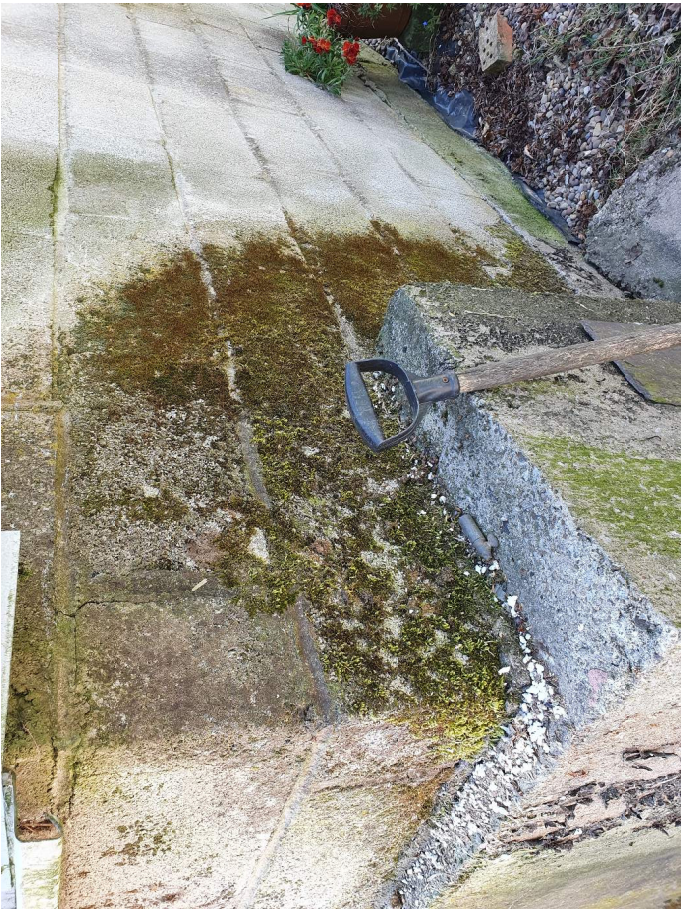
Evidence of long-term drainage issues

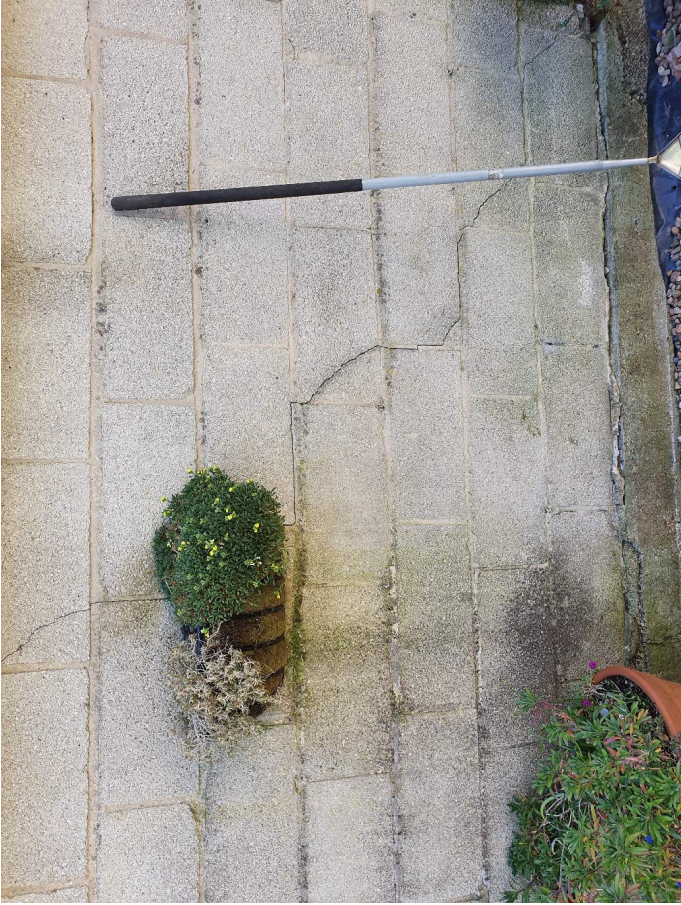
There was a vertical crack in the external masonry in the gable elevation extending up the wall from external ground level up to the bottom of the cladding. There was some further cracking to the external masonry in the northern elevation. Here, staggered diagonal cracks were observed extending from ground level through the full height of the blockwork. In all instances, the cracking was not considered significant, and is likely due to thermal shrinkage.

Cracked blockwork in north elevation

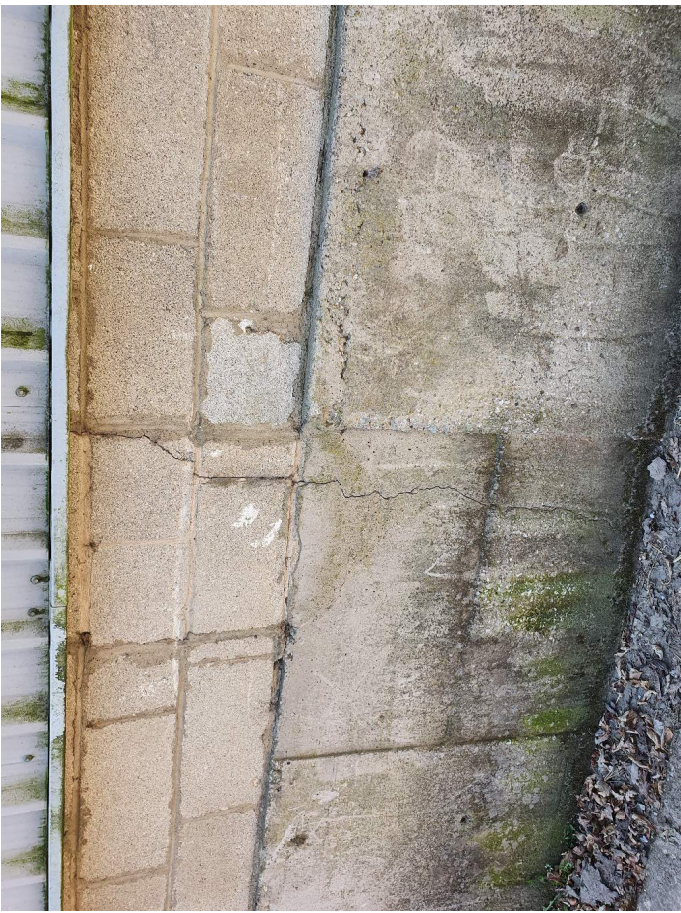
Cracked blockwork in east elevation
