# STRUCTURAL REPORT

Bank House Farm, A628  
Silkstone, Barnsley  
S75 4FZ

NE5559

**STRUCTURAL REPORT ON** Bank House Farm, A628, Silkstone, Barnsley, S75 4FZ

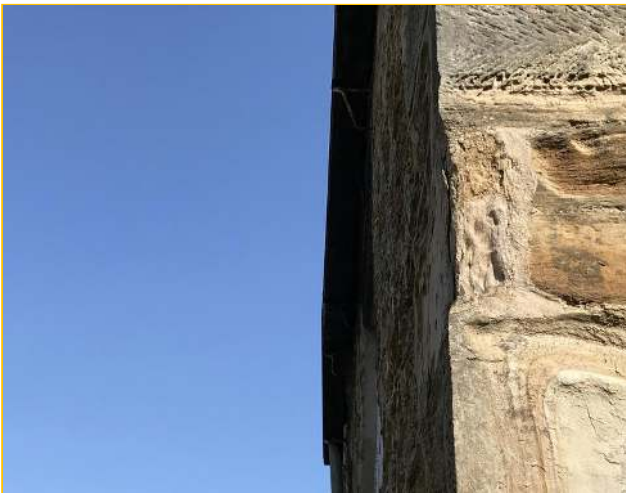
Observations along the right hand eaves line of the right hand extension identified a degree of lateral movement, typically associated with roof spread. An internal inspection of this roof structure identified that timber ties have been installed to resist this lateral movement.

Photograph - 9 - Rear eaves line

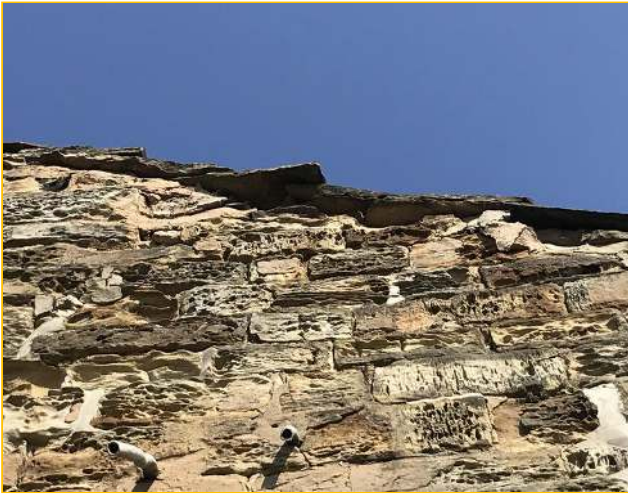
The gable edges are highly weathered, particularly to the left hand extension.

Photograph - 10 - Roof verge

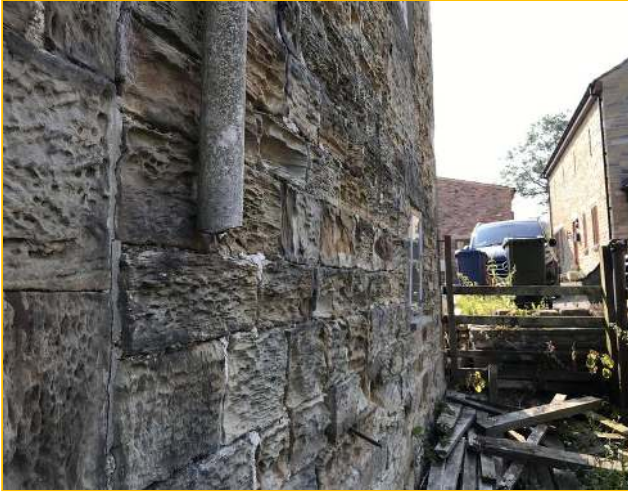
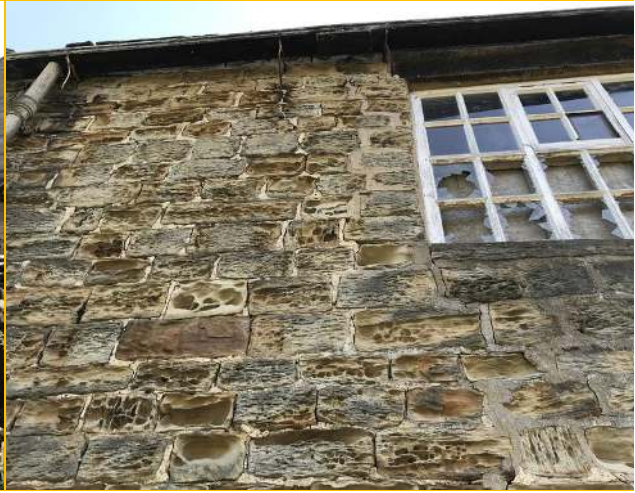
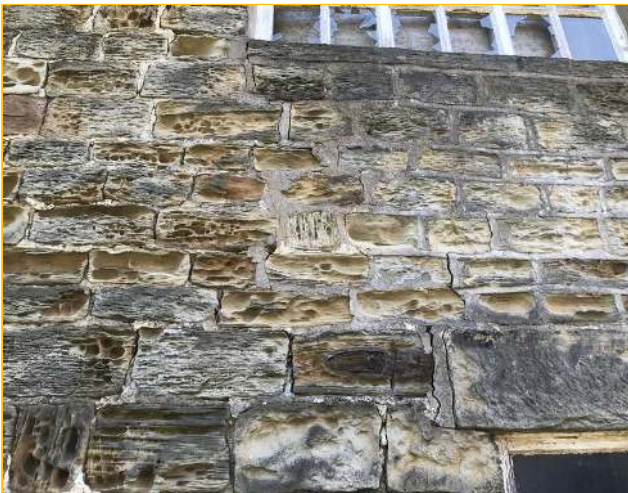
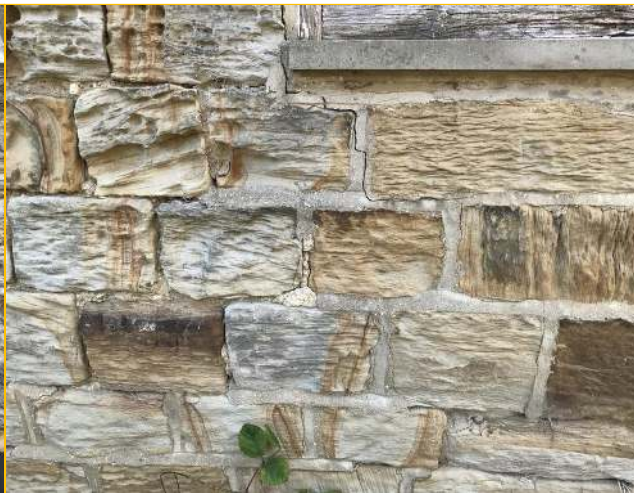
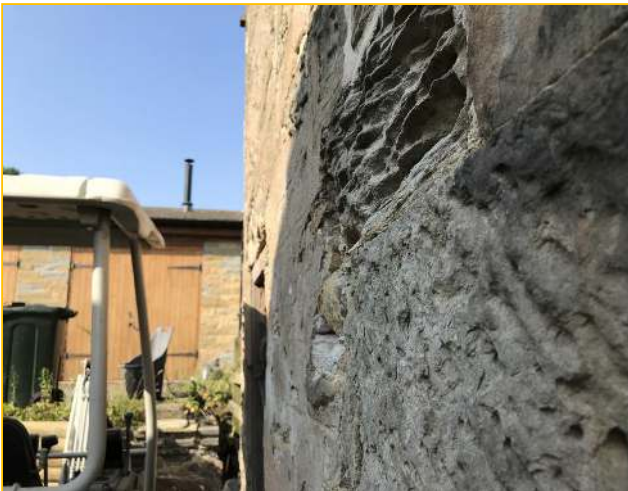
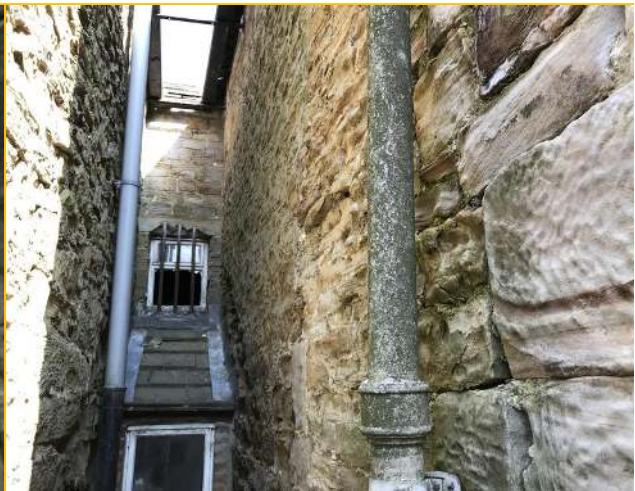
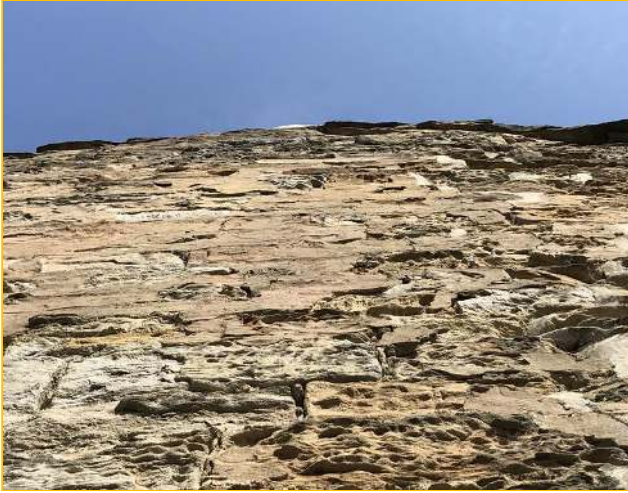
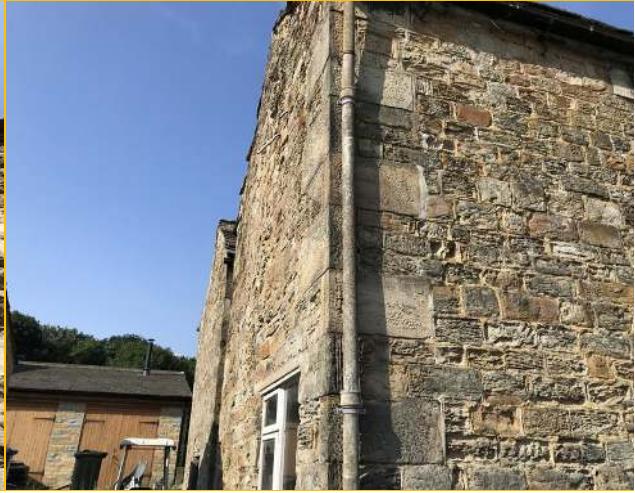
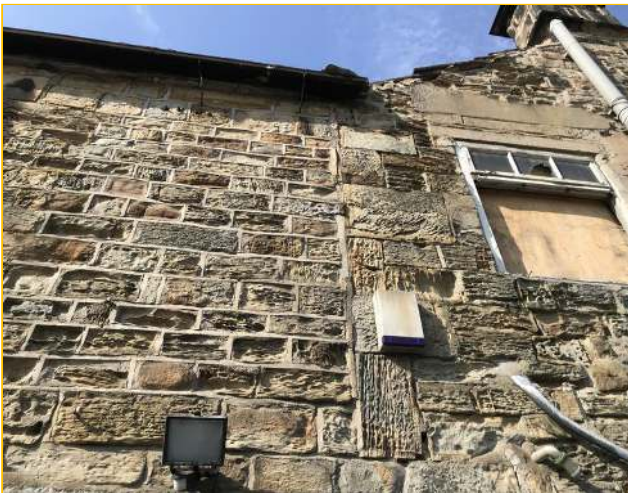
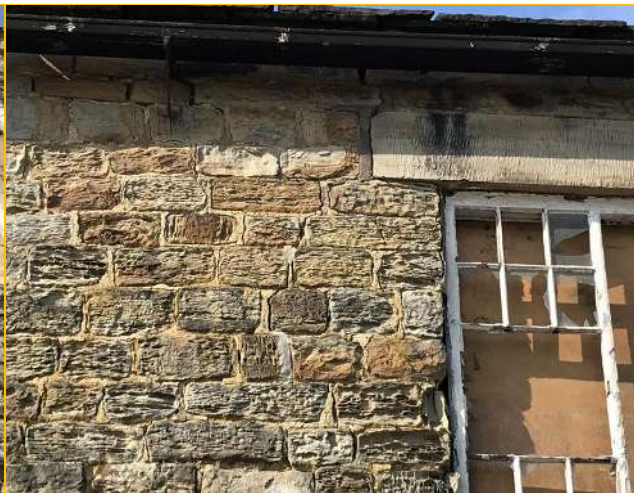
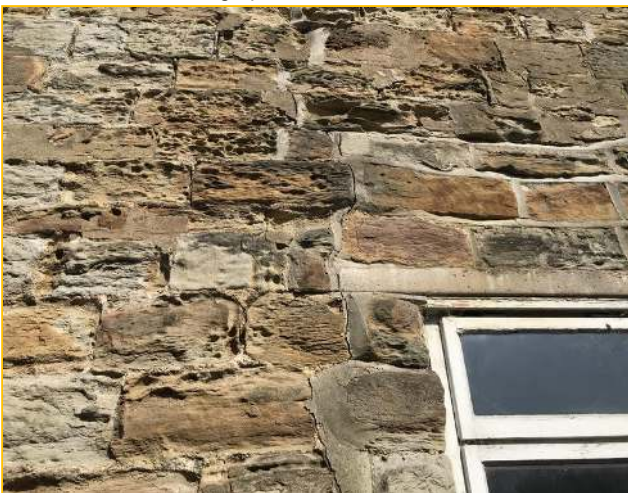
There is evidence of leaf separation in this property as shown by distortions to the walls in general.

This has caused a general weakness in the external stonework leaves resulting in fractures extending down from the roof eaves, between openings and at poorly bonded construction interfaces.

B. It is recommended that the extensions are carefully taken down and the materials recovered, sorted and stock piled for reuse. Rebuild the extensions on new suitable foundations. Allow for importing any additional local materials to replace the highly weathered masonry units / defective materials.

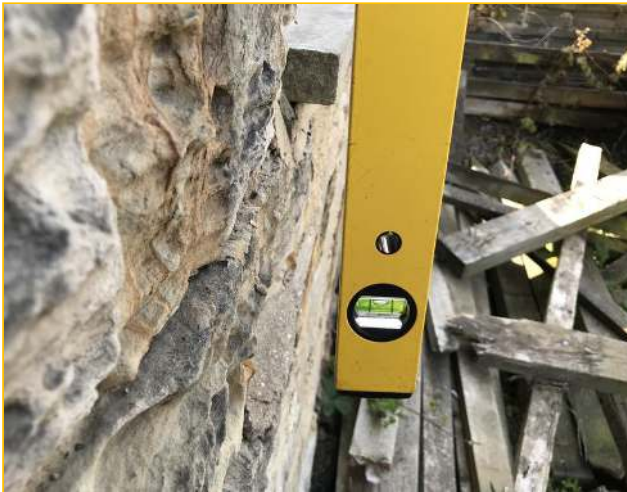
In this instance, the measured tilt is 1:20.

Photograph - 28 - Extent of tilt

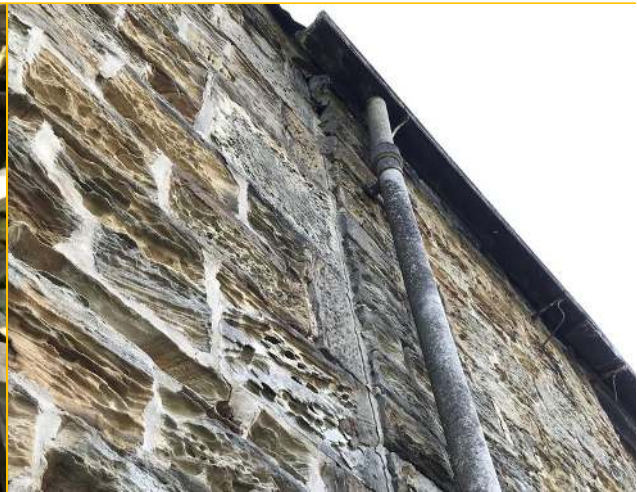
Photograph - 29 - Lateral distortions

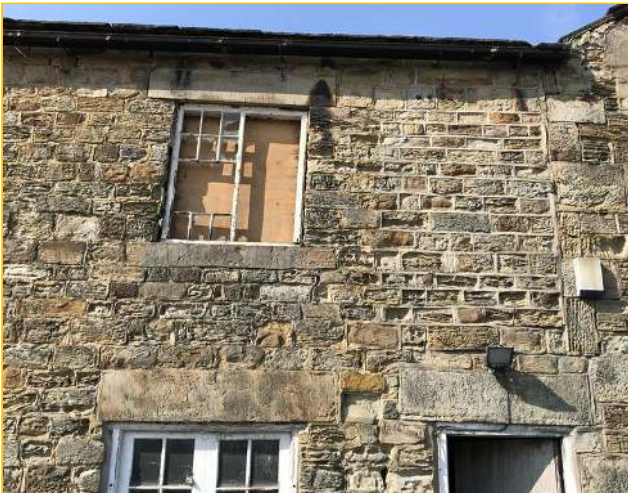
On the left hand wall of the left hand extension, the door and window openings are generally out of square with sloping sills and lintels. This is indicative of some historic

structural foundation movement. This movement appears historic, however there residual distortions remain. Such distortions will affect future door and window replacements.

Photograph - 30 - Distortions

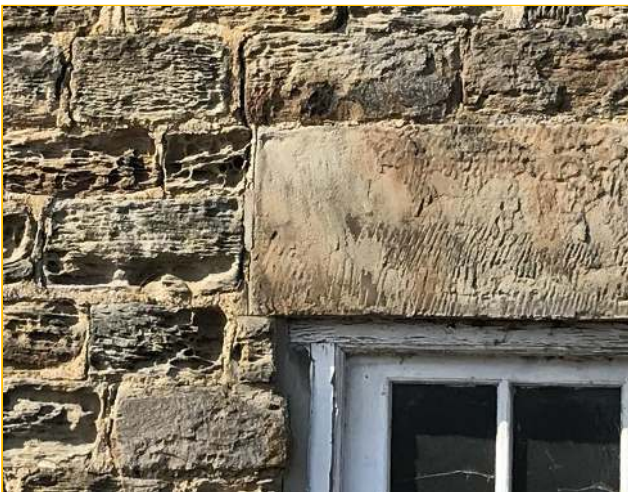
It was noted that the lintel to the ground floor window opening, in the left hand wall of the left hand extension, has limited bearing. A minimum of 150mm is recommended.

Photograph - 31 - Limited bearing

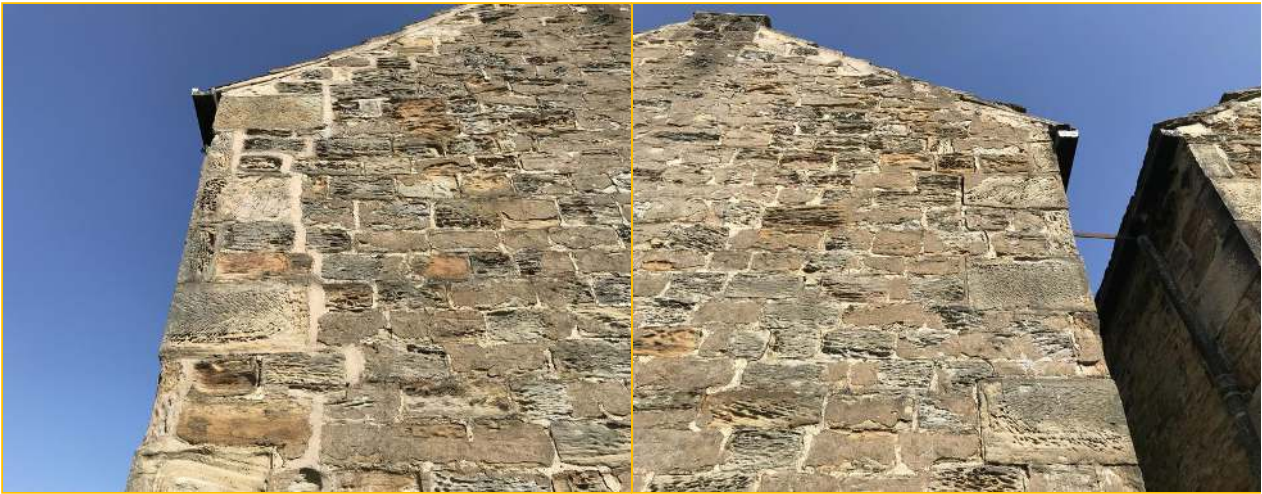
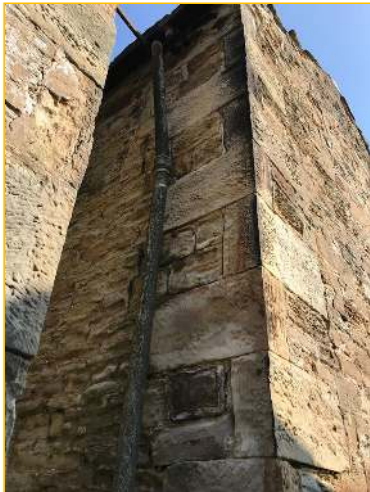
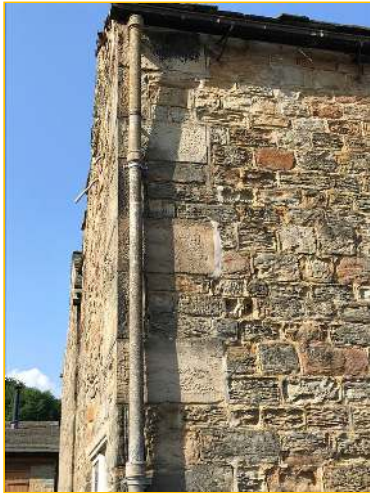
On the rear wall corners of the two extensions there is evidence of past and more recent movement (shown by reopened repairs), between the wall panels and the corner quoin stones. The recent movement is not significant at this time but will progress with age.

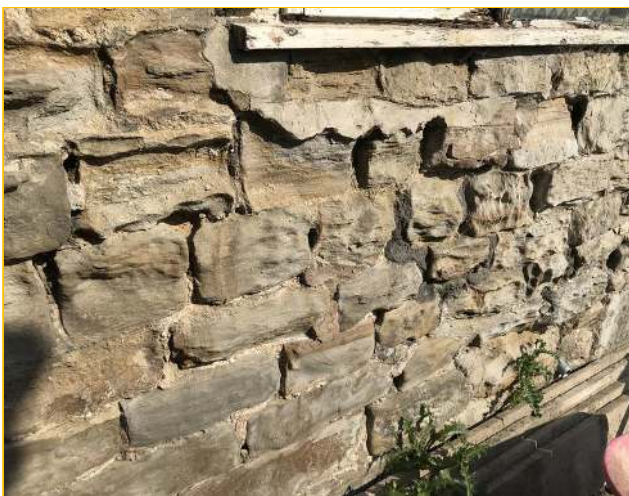
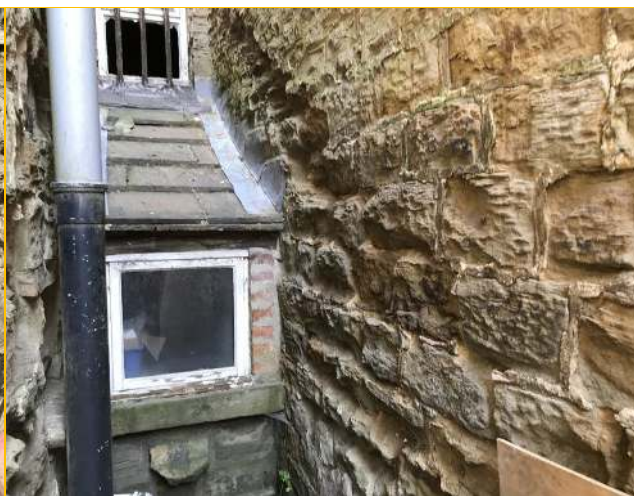
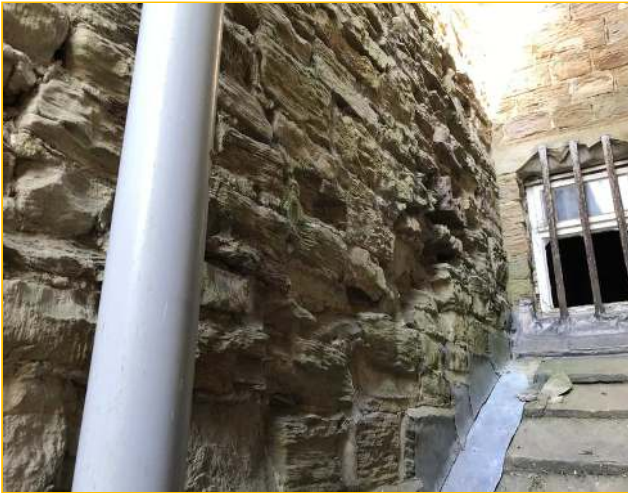
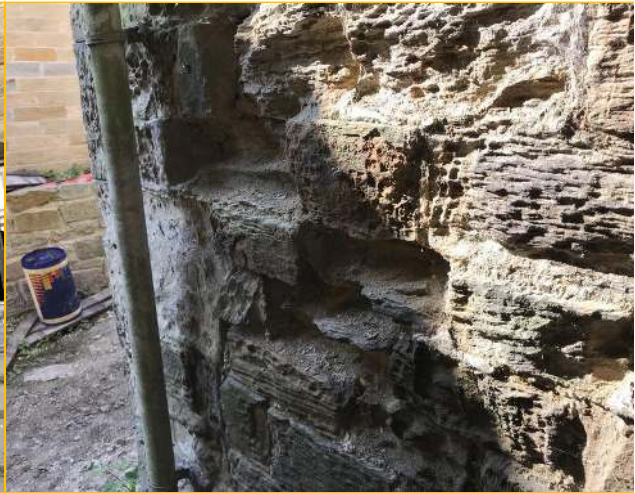
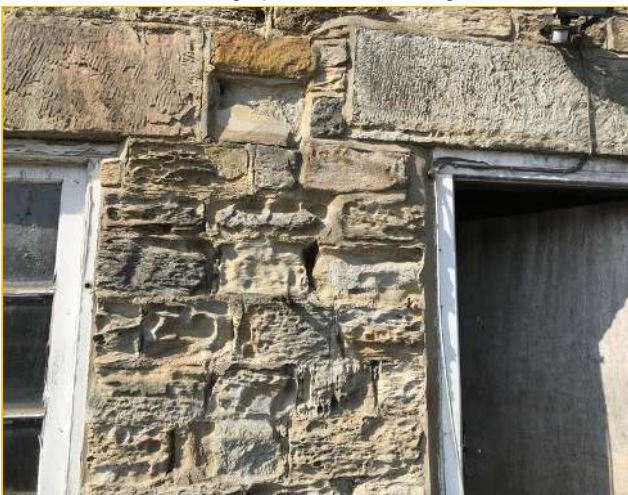
The mortar pointing to all elevations is noted to be badly weathered. This has adversely affected the long term durability of the bed joints and perpend joints on the wall. The mortar has two functions. Firstly to bond the masonry together for strength purposes and secondly to provide a weather tight wall. As the joints weather, they will become susceptible to rainwater ingress, which may result in internal dampness and accelerate the overall deterioration of the wall.

The external masonry of the extension walls is highly weathered in areas with areas of past and non sensitive mortar render repairs. The stonework is generally friable to the surface where weathered.

Photograph - 37 - Weathered masonry

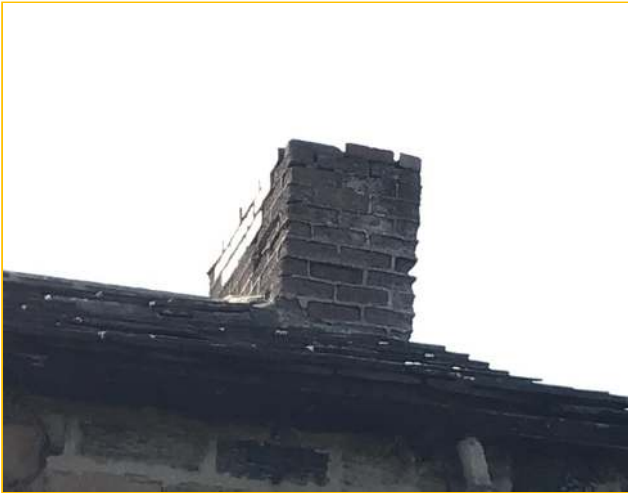
Although beyond the scope of this specific defect inspection report, we would draw your attention to the poor condition of the brickwork masonry stack along the right hand gable wall of the original building. This stack is highly weathered with areas of loose material and significant distortions. We would recommend that you consider taking down and rebuilding this stack.

Photograph - 42 - Brickwork stack

A. Due to extensive weathering, loose masonry and distortions to the brickwork chimney stack of the main building, we would recommend that future refurbishment of the property allows for taking down and rebuilding the stack.

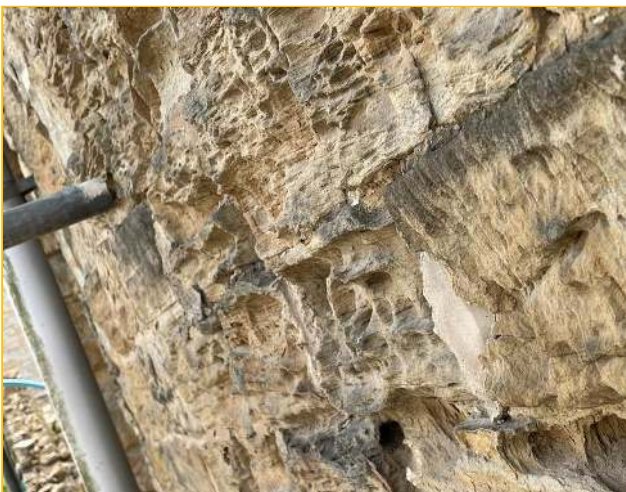
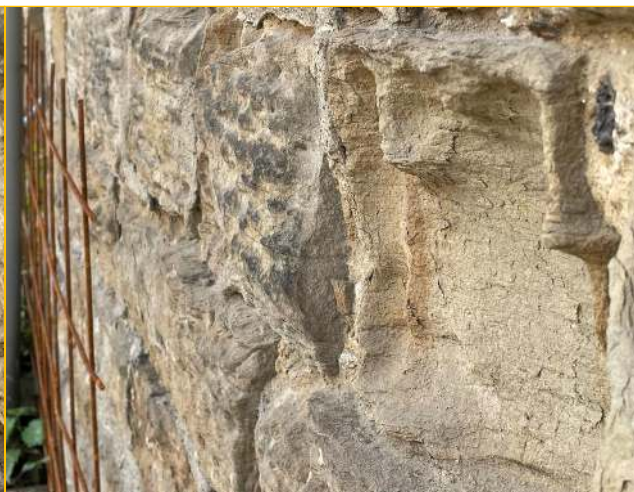
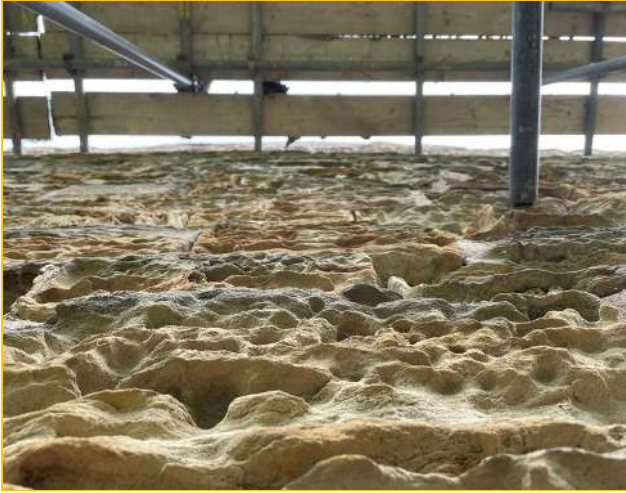
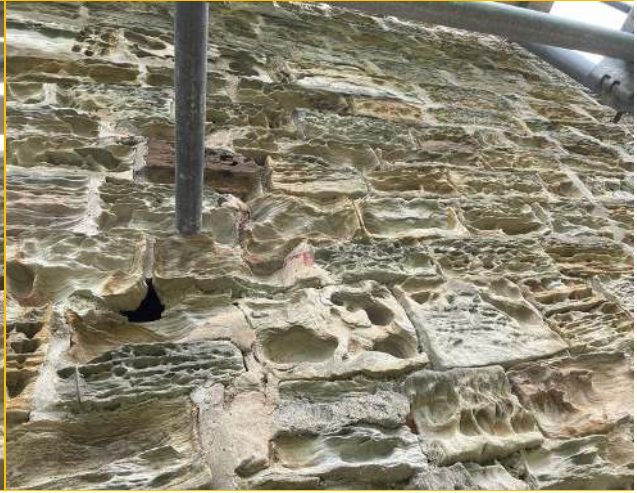
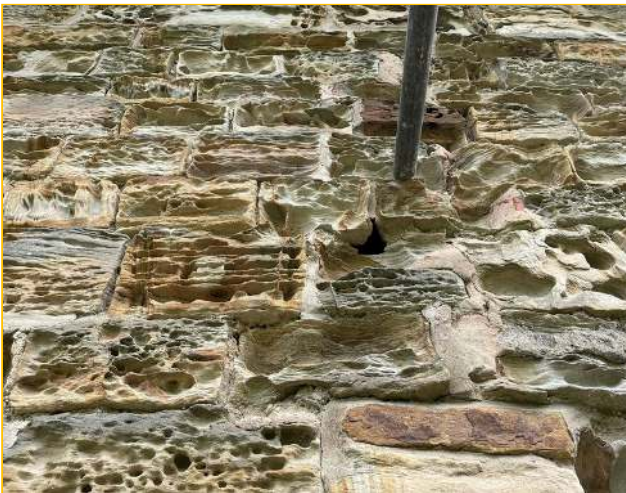
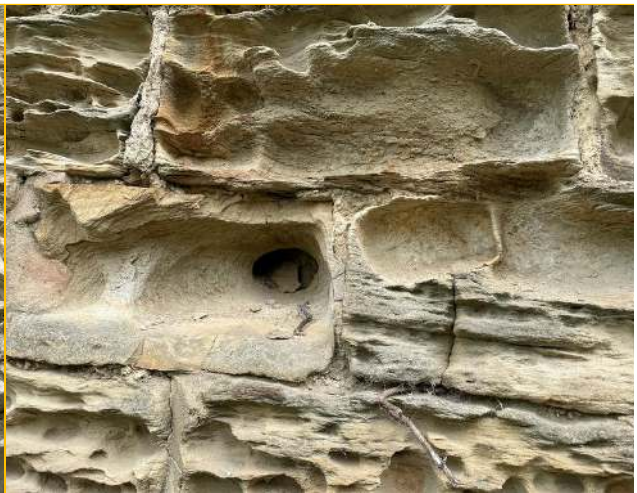
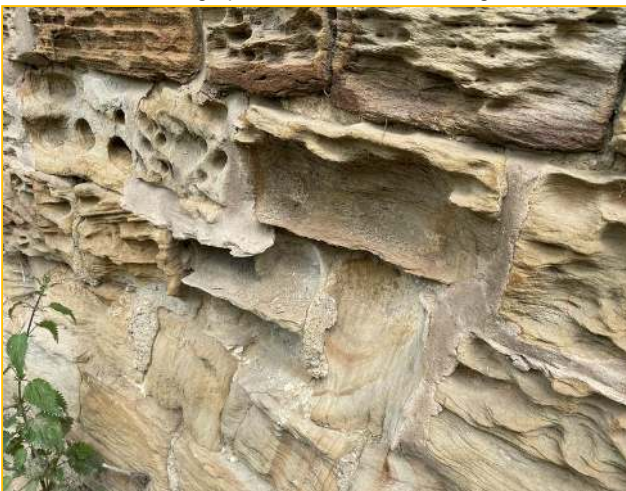
From review of the photographs it is clear that the external stone masonry was highly weathered and voided in areas with significant section losses. Mortar pointing appears very limited in areas.

Photograph - 43 - Severe weathering

Rev A - This should include the severely weathered gable walls of the main building where voiding is present and stability cannot be guaranteed.

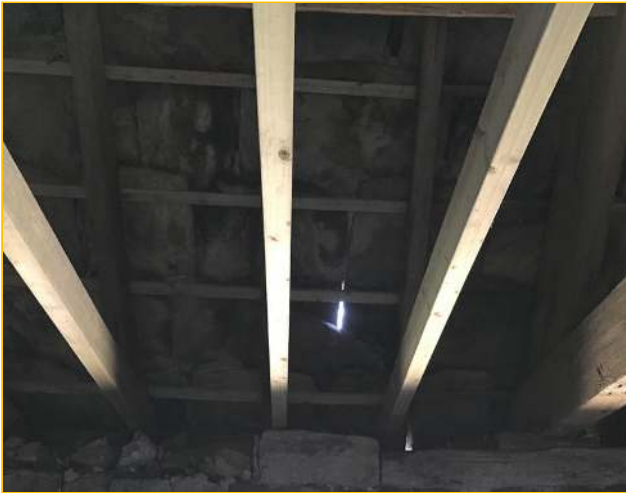
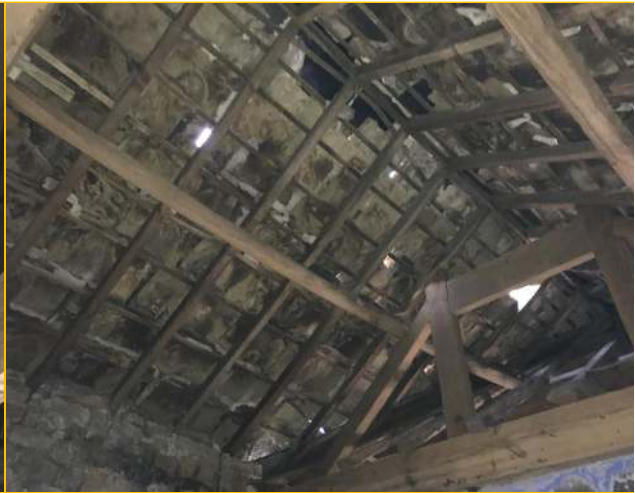
There are several areas where day light can be seen through the tiled roof covering. This will allow the ingress of rainwater and pose a risk of decay to the timber roof structure. Remedial action is required as part of any future property refurbishment.

Photograph - 52 - Areas of daylight

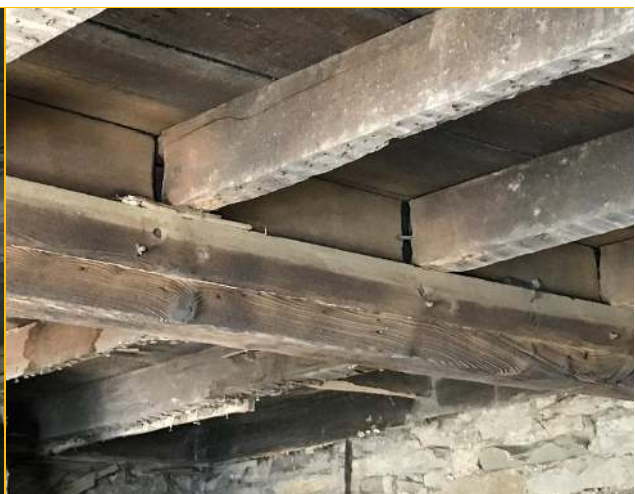
Several joists in the left hand extension were provided with insufficient bearing due to historic movements within the property.

Photograph - 55 - Limited bearing

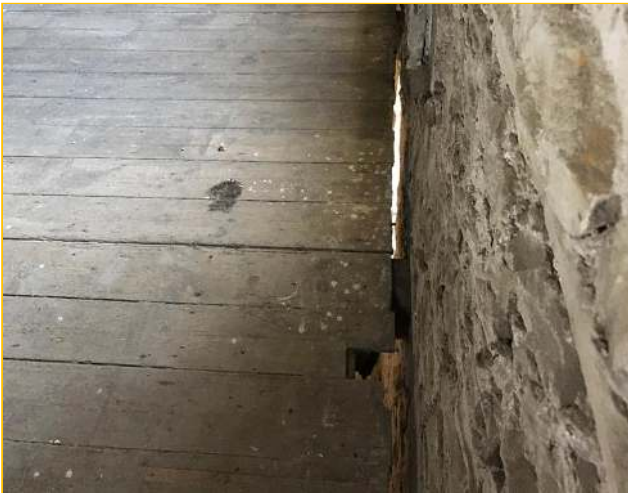
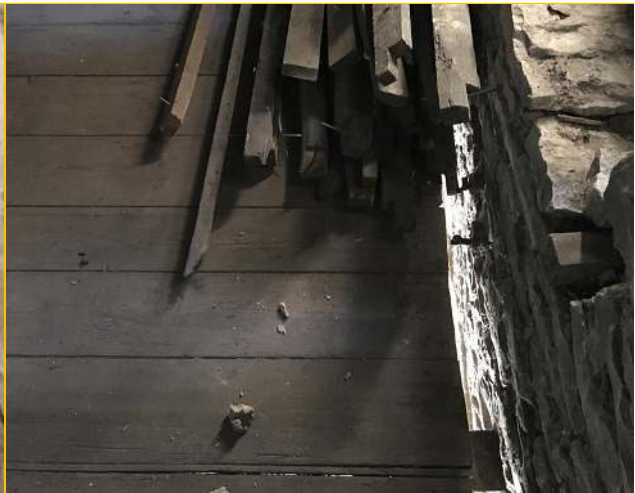
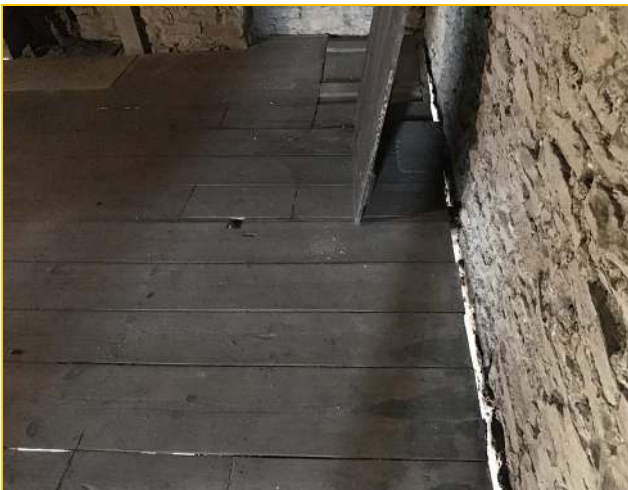
The internal walls within the rear extensions have been stripped of the internal finishes. Observations around the first floor room perimeters identified evidence of lateral movement of the external walls. This was shown by separation between the walls and the floor boards.

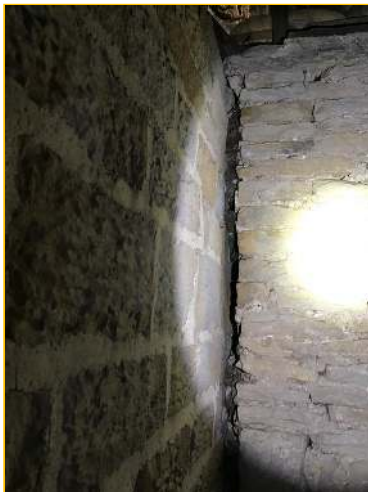
At the construction interface, between the main original rear elevation wall and the flank walls of the extensions, identified separation fractures, up to 50mm in width. No structural bonding was apparent at the interfaces.

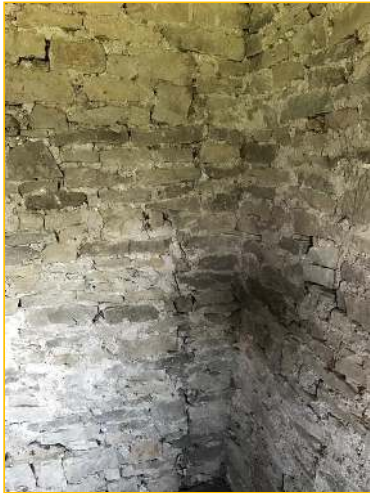
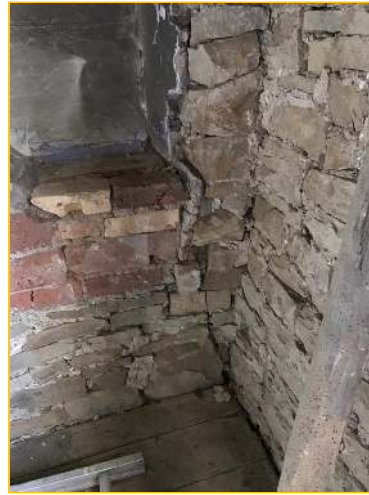
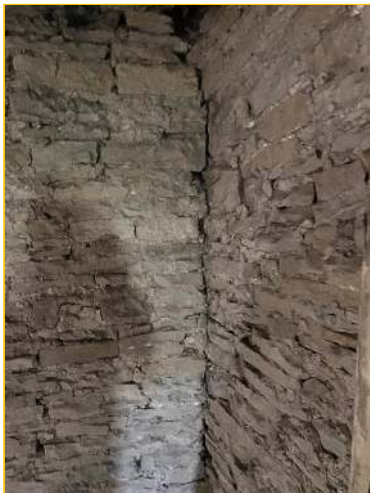
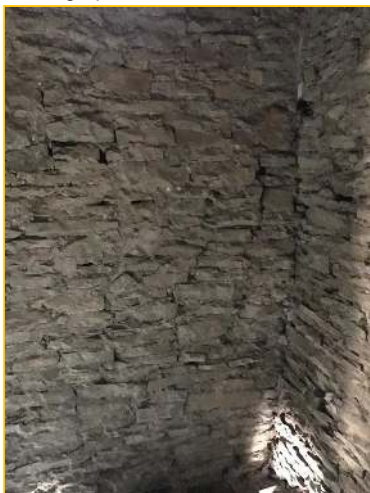
At the rear wall corners there is a degree of vertical fractures that generally trend to reflect those noted externally at the quoin to wall panel interfaces. This shows full depth fractures.

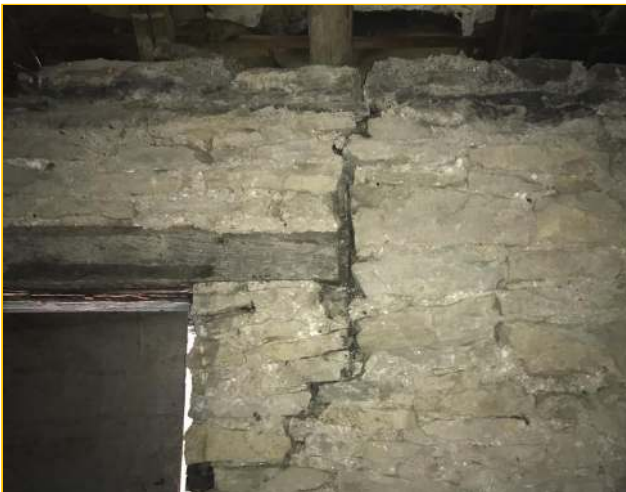
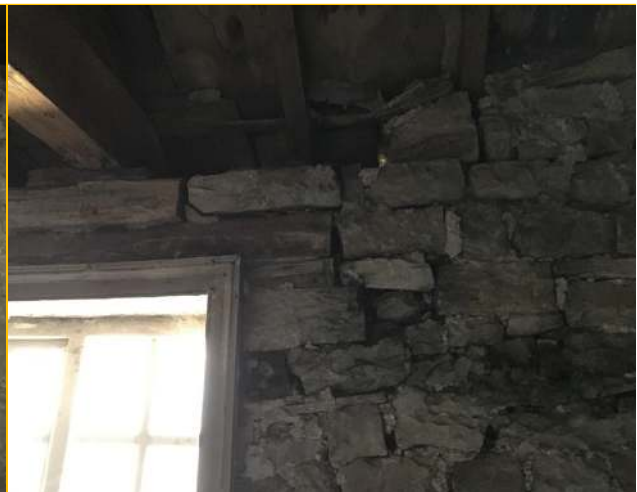
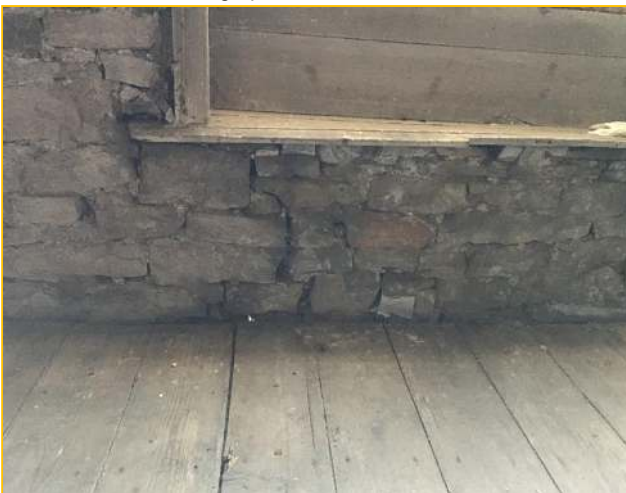
Looking throughout the first floor areas of the extensions there are fractures and separations to the internal stonework, general extending from the various openings. Some areas of the masonry are loose locally.

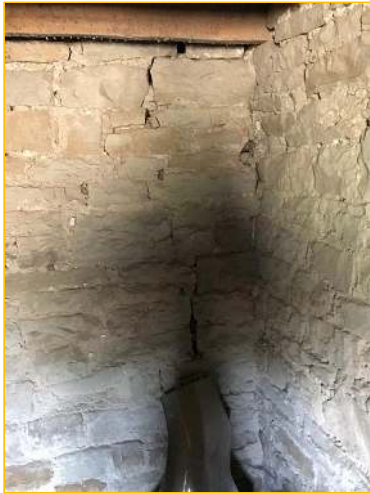
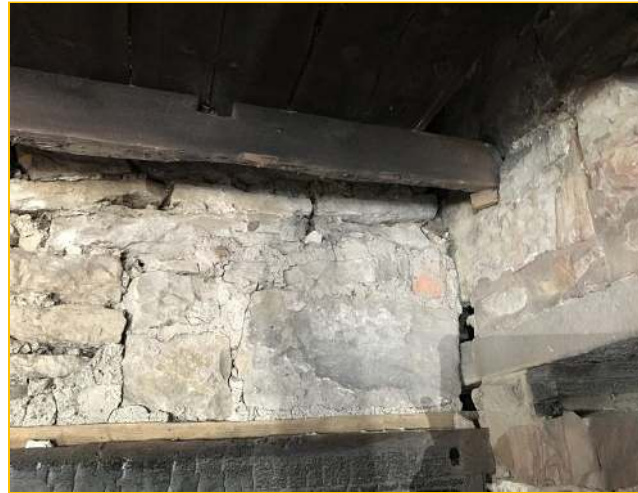
Similarly at ground floor level fractures are evident to the internal faces of the external walls that trend to reflect the fractures noted externally.

Photograph - 71 - Reflected fracture

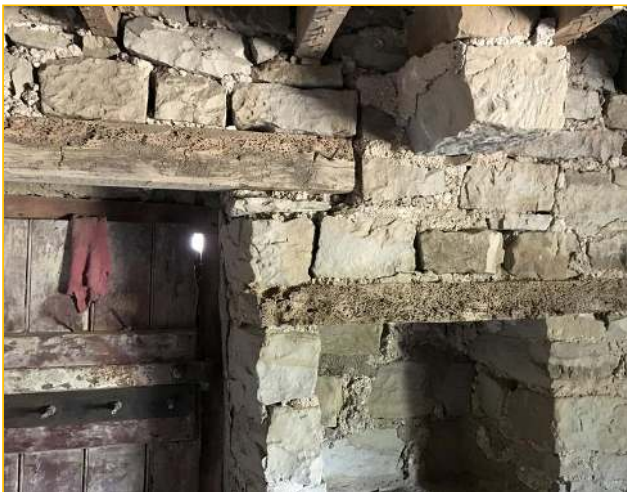
The timber lintels that spanned the external window openings were generally noted to display evidence of wood destroying insect damage and areas of historic decay. Allowances should be made for replacement or treatment of the timbers as part of any future property refurbishment works.

Photograph - 73 - Wood destroying insect damage

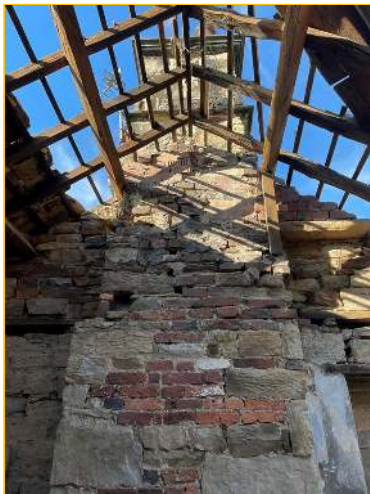
From review of the photographs it is clear that the internal stone masonry was highly weathered and voided in areas with significant section losses. This had necessitated the use of brickwork infill repairs in several areas, including to the internal chimney breasts which rose up the gable walls. Mortar pointing appears very limited in areas.

Photograph - 74 - Voiding to chimney breast

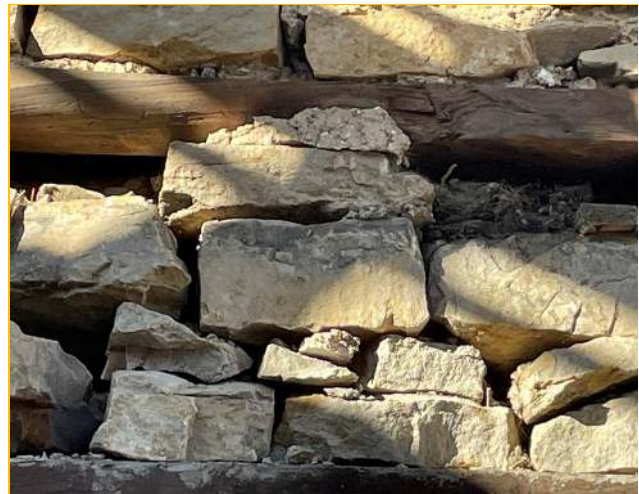
Photograph - 75 - Loss of mortar
