## **Tree Survey**

| <b>Survey for trees at site:</b> | Westfield House, 47 Victoria Road, Barnsley, S70 2BU |
| <b>Reference</b> | TreeSurvey <b>0155 (Revision C)</b> |
| <b>Survey date(s)</b> | 19/04/2018<br>Revision made on 26/07/2019 |

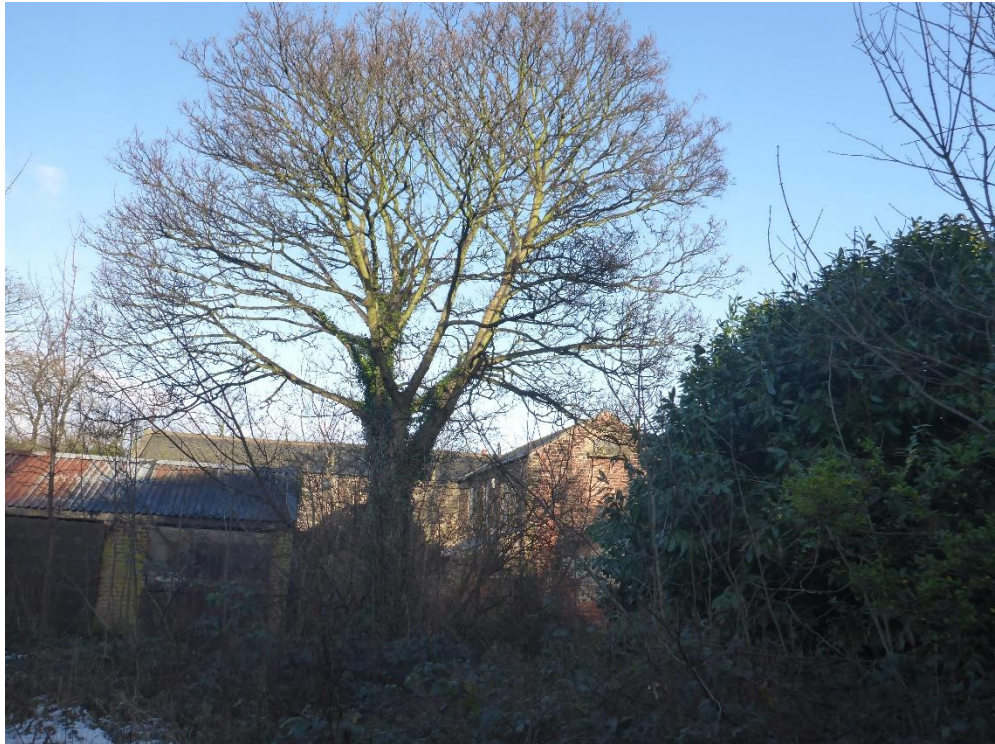
*Photo 1: T1- Sycamore and surrounding understory vegetation.*

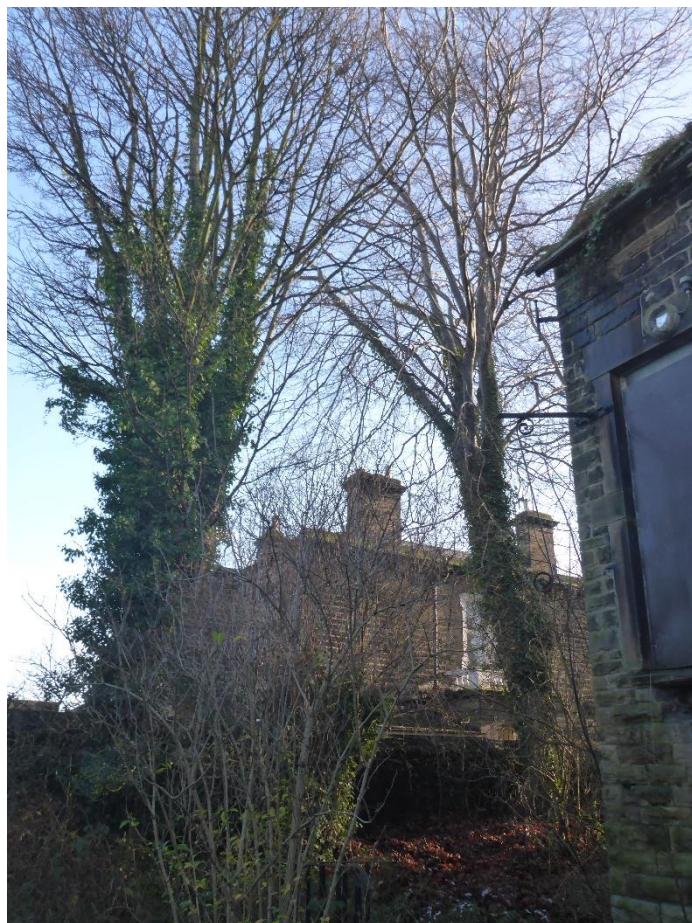
*Photo 2: T2 and T3 (left to right) situated close to the existing building.*

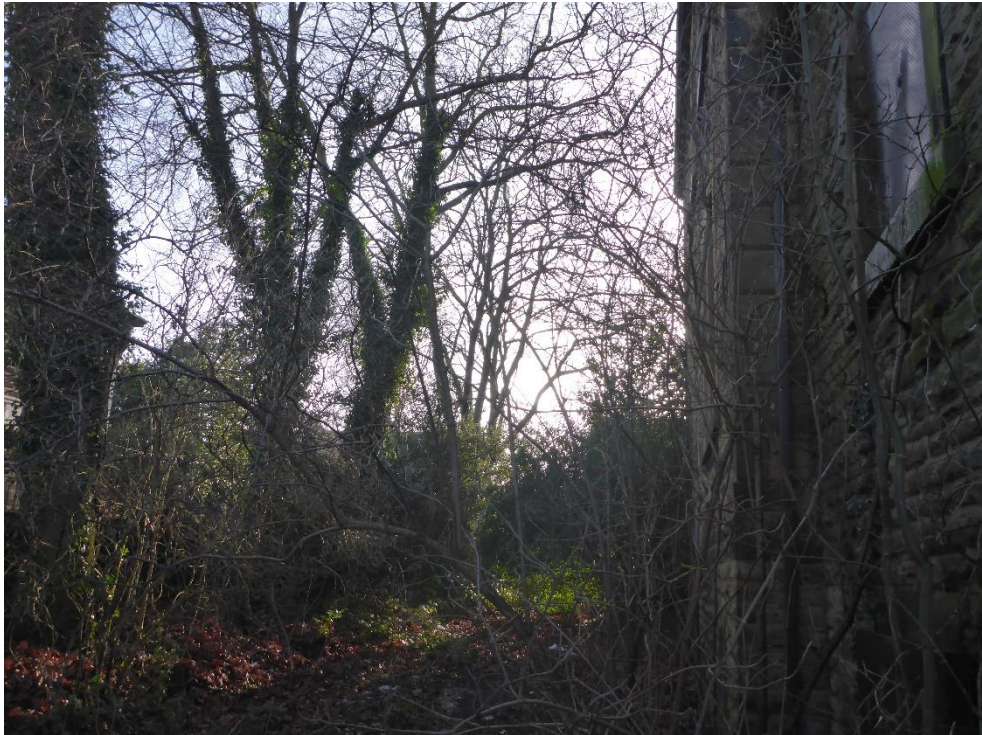
*Photo 3: Trees T3, T4, T5, T6 situated in a line running along the east border, with the existing building to the right.*

the proposed driveway areas has therefore been recommended (See appendix 3 Tree Works Schedule). T3, T4, T5 and T6 also have branches which reach to and over the existing two storey building, so tip reduction pruning of the west branches has been recommended to manage the trees during the proposed refurbishment of the building.(See appendix 3 Tree Works Schedule). Any tree work should conform to British Standard BS3998:2010 ‘Tree work-Recommendations’ and should conform to arboricultural best practice. All tree works are to be undertaken by professional arboricultural contractors who have appropriate insurance and experience.

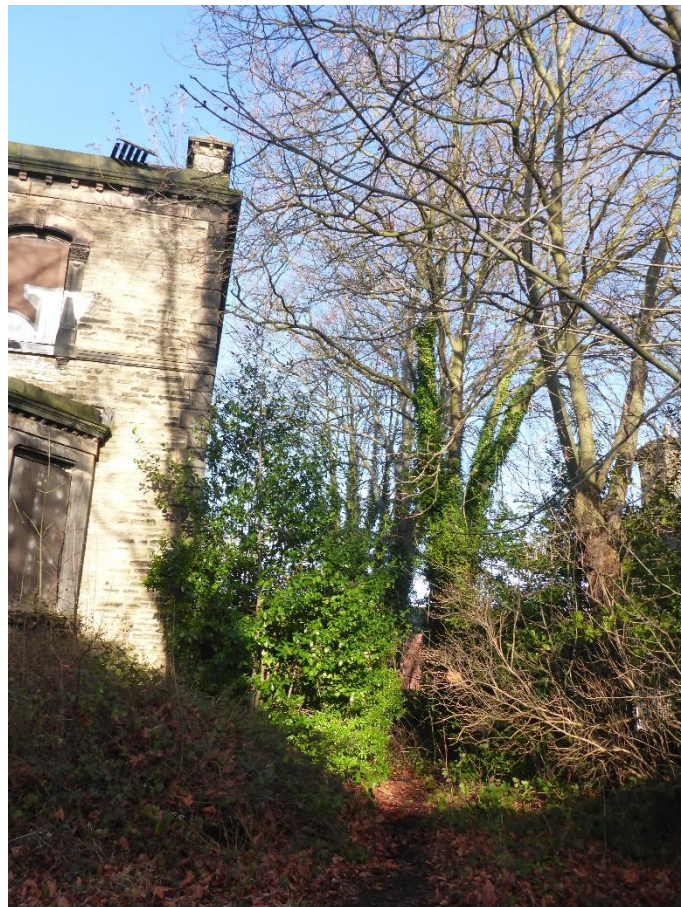
*Photo 4: T5 and T6 on the east boundary situated close to the existing building. The proposed driveway is to run between the existing building and these trees.*

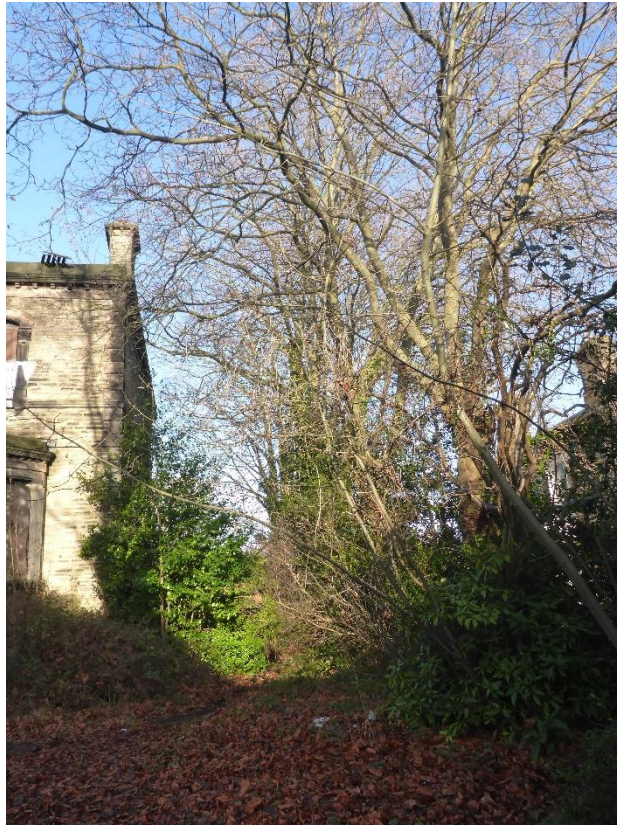
*Photo 5: Trees on east border (right) and existing building. The proposed driveway is to run in between.*

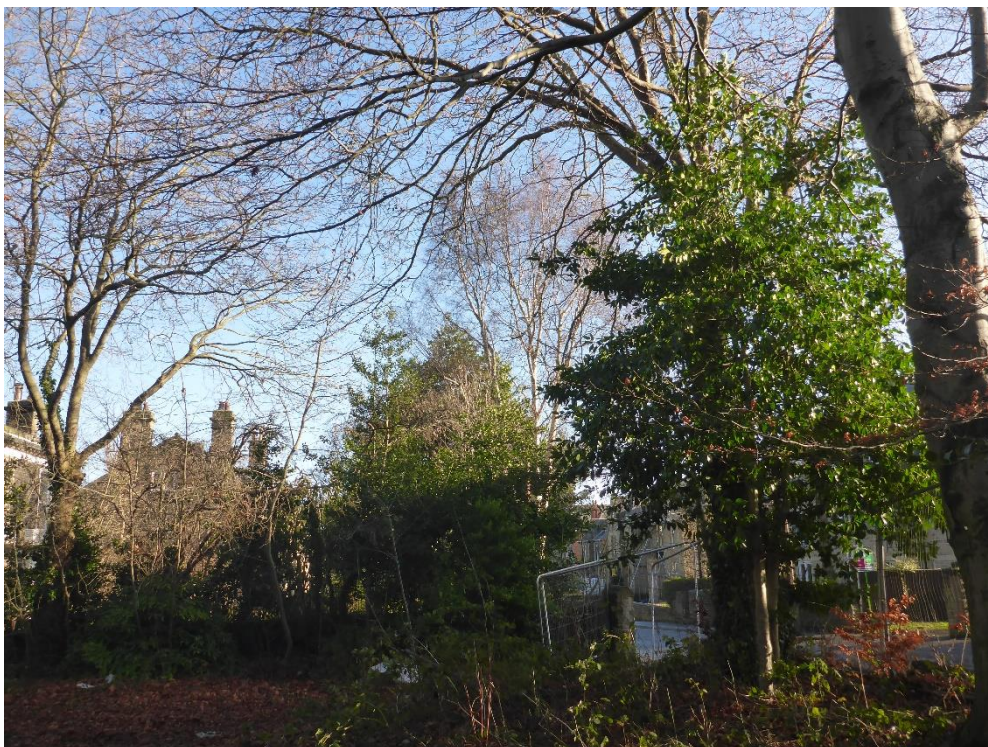
*Photo 6: T8 (situated right of middle) close to current site access from Victoria Road. Branches of T8 overhang access driveway. Understory shrubs also present.*

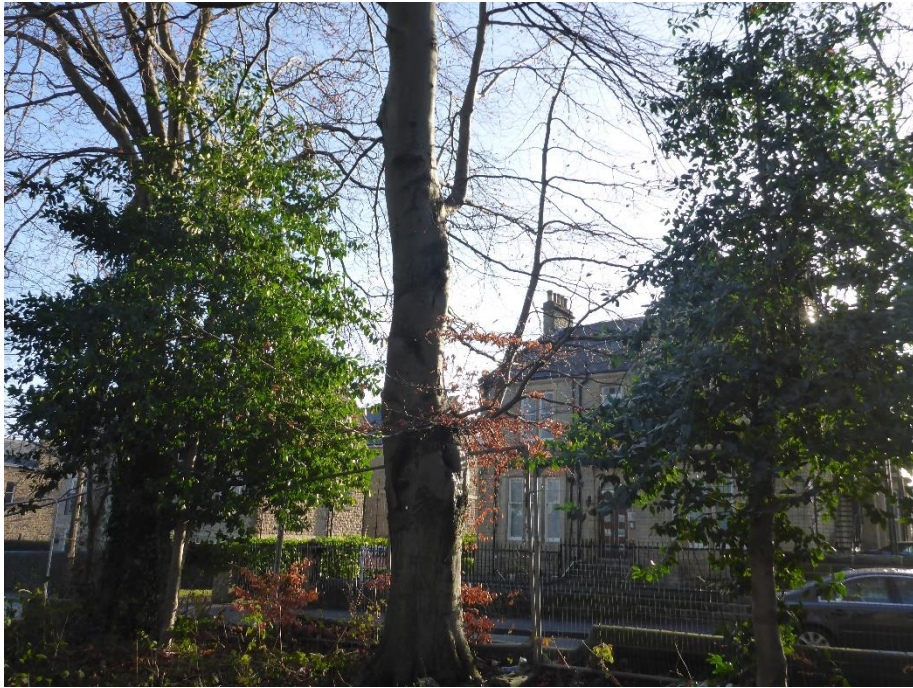
*Photo 6: T9 (centre) situated on south border, bordering Victoria Road.*

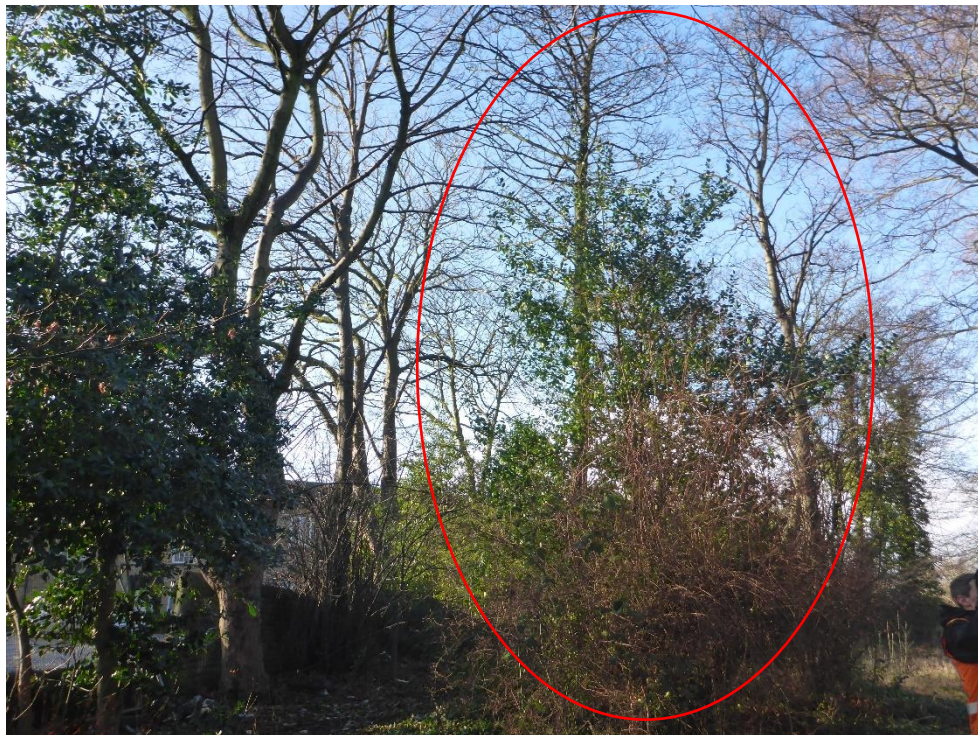
*Photo 7: Trees lining south border (left), and T12, T13, and T31 (centre, circled).*

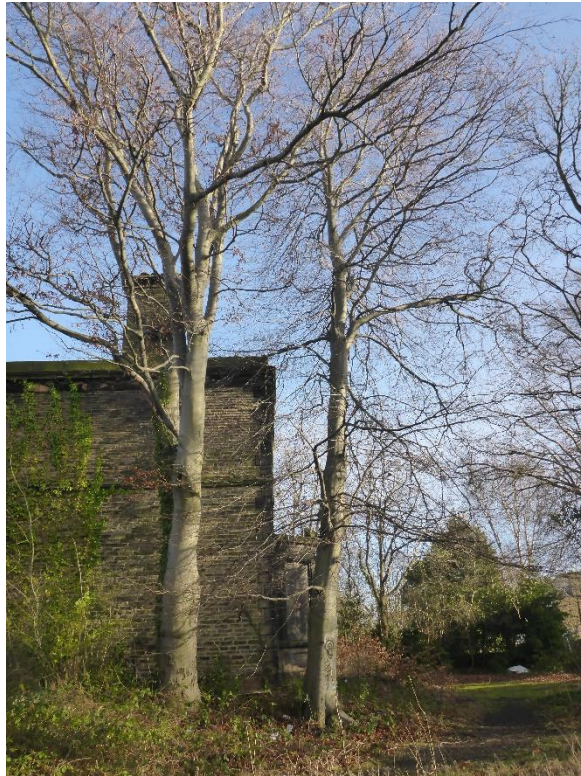
- 6.7 As detailed in the tree condition survey (Appendix 1), trees T14 and T15 are situated in very close proximity to the existing building. These trees are unlikely to be suitable for long term retention in such close proximity to a property, therefore their removal is considered acceptable. T15 in particular was observed to have a significant structural defect, with a V- shaped union which could potentially fail in the future, therefore limiting its overall potential contribution. T11 has a cavity on its main stem and therefore does not have a long term future. Therefore this tree has been indicated for removal. T10 also has a cavity on its main stem, therefore it may also not have a long term future therefore its removal is considered acceptable.

*Photo 8: T14 (right) and T15 (left), situated in very close proximity to the existing building.*

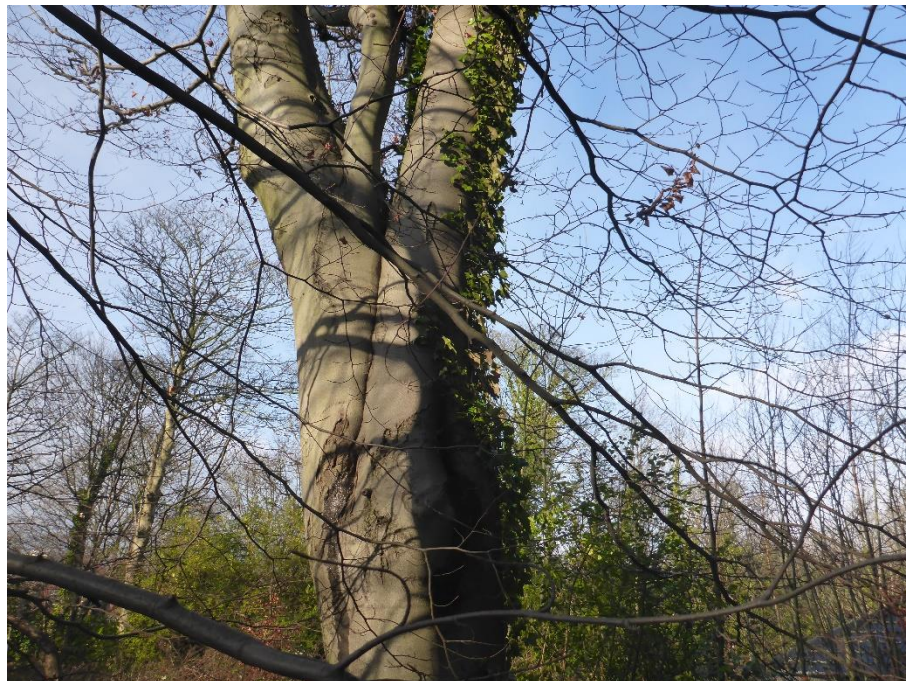
*Photo 9: T15 with significant V-shaped union and merged stems.*

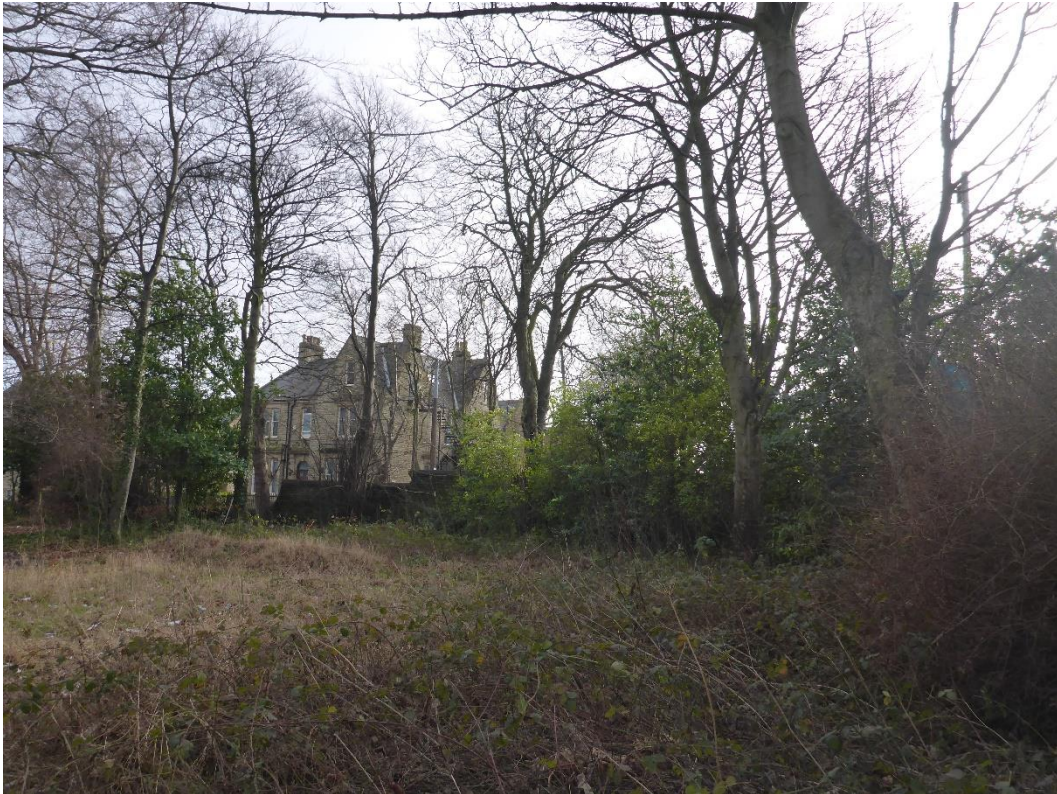
*Photo 10: Trees bordering the south of the site (centre) and trees bordering the SW of the site, bordering Sackville Street (right).*

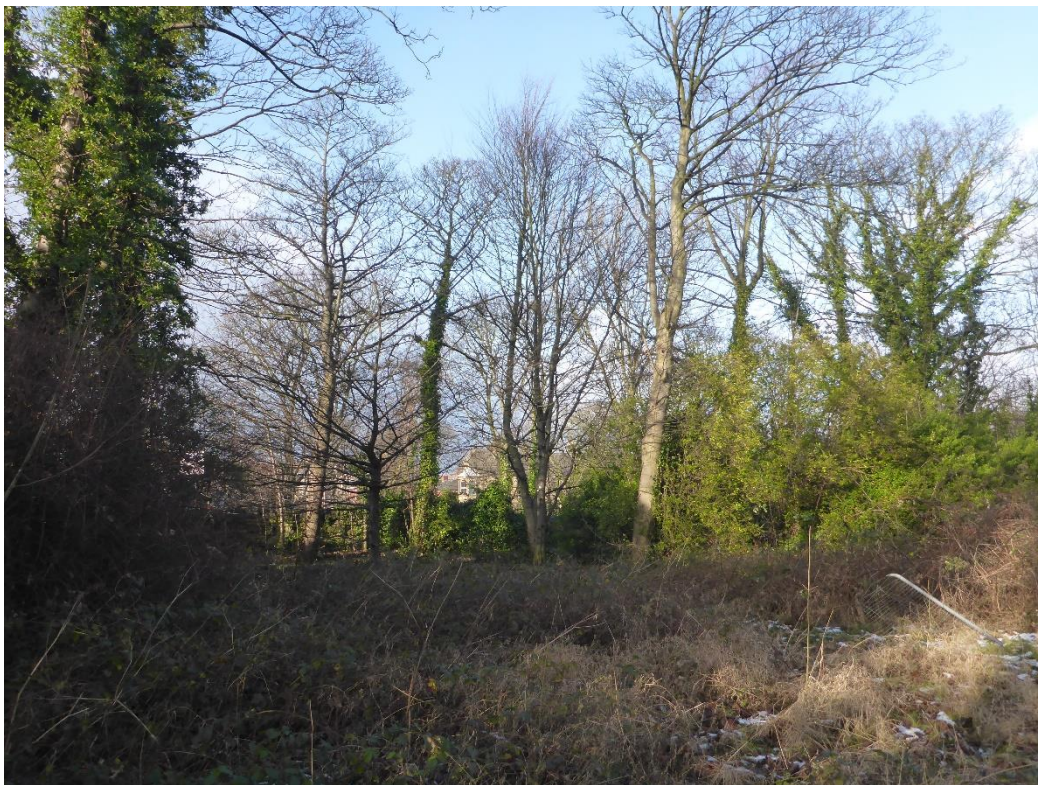
*Photo 11: Trees T22 to T27 along the North West border.*

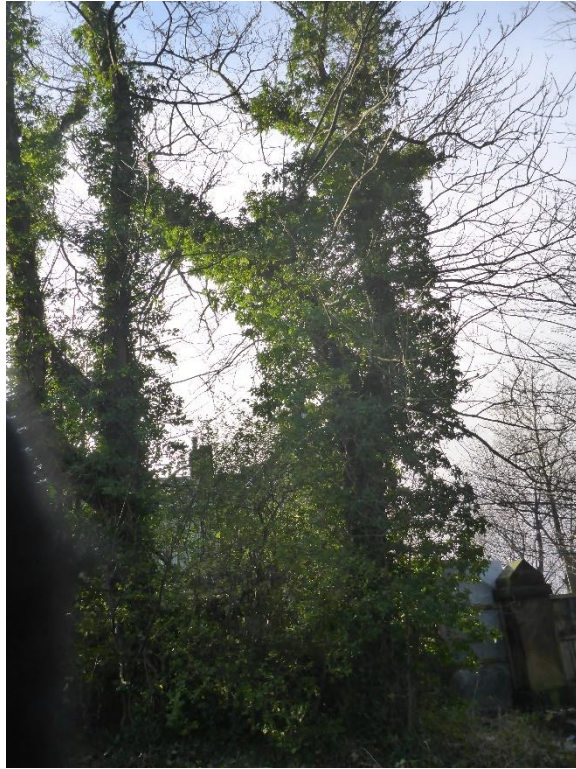
*Photo 12: T20 and T21 (left to right), and the new proposed driveway entrance from Sackville Street, right*

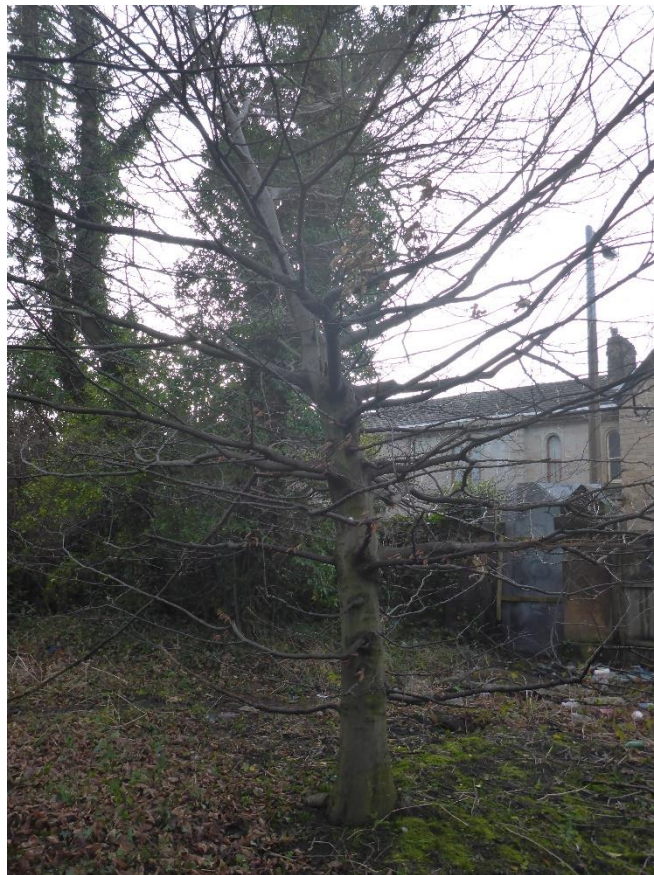
*Photo 13: T29, and new proposed access driveway from Sackville Street, right*

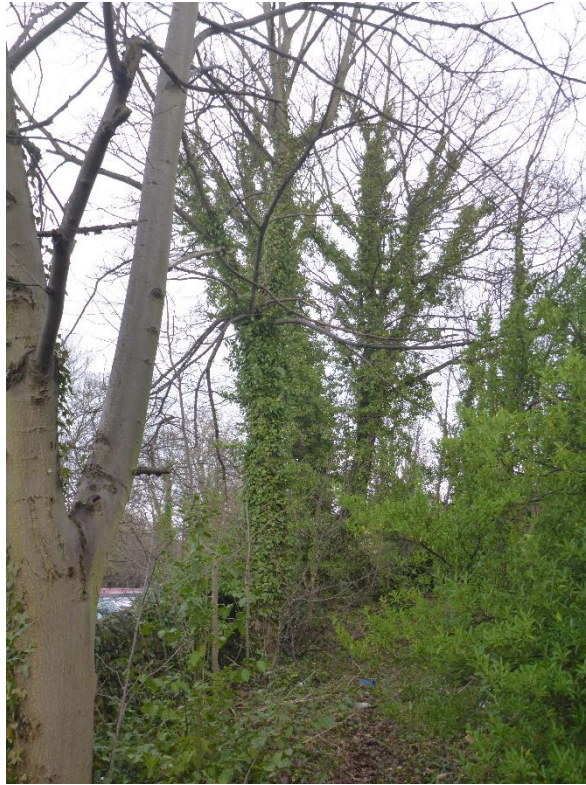
*Photo 14: Trees lining NW border*

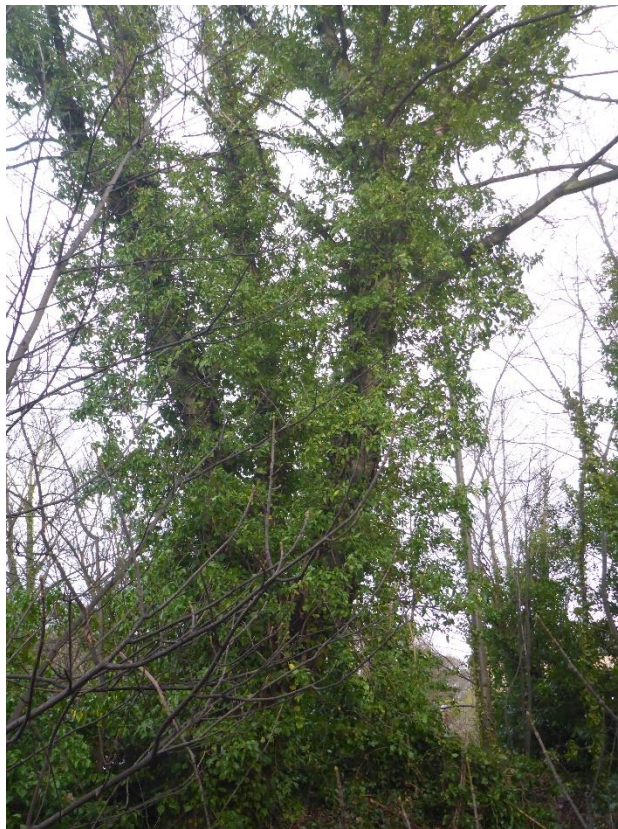
*Photo 15: T26, covered in ivy*

- 4.3 Tree work removals and pruning work shall be carried out following consent. The works recommended are shown in Appendix 3 Tree Works Schedule Plan, with some recommendations deemed necessary whether the site is developed or not, especially the removal of poor trees with suspect structural conditions. Some trees on the site are covered in ivy and the ivy will be cut and removed from such trees.

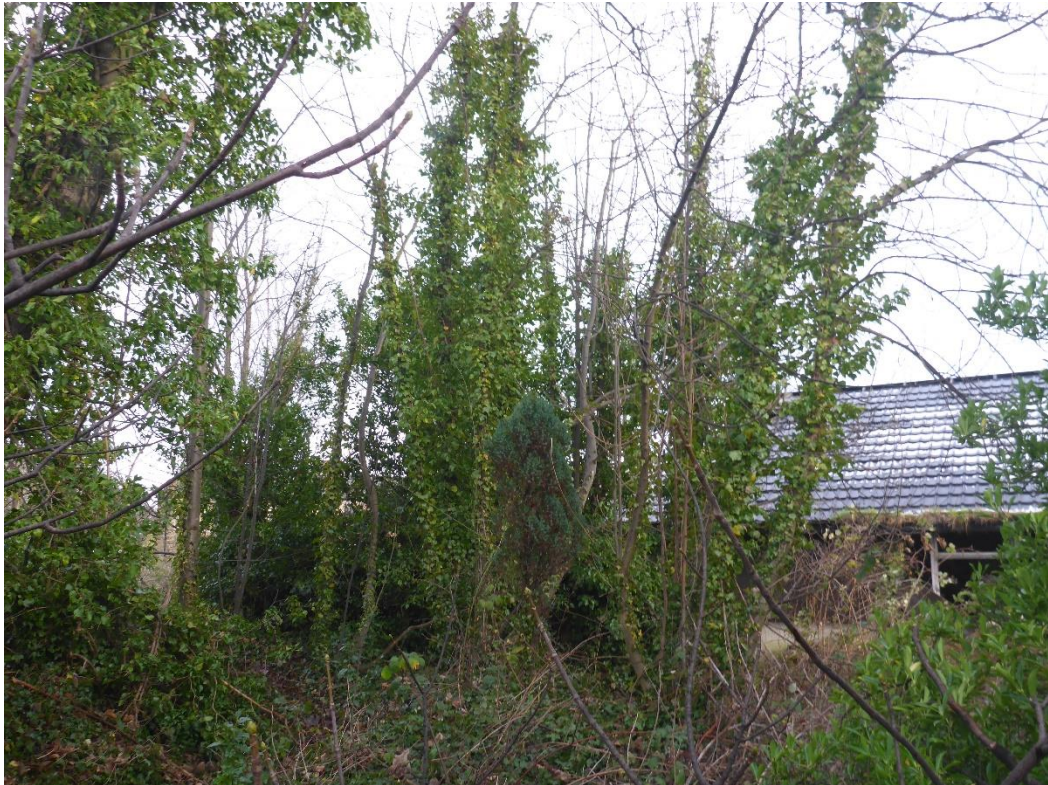
*Photo 16: Clump of understory self-set shrub undergrowth, marked as T30.*

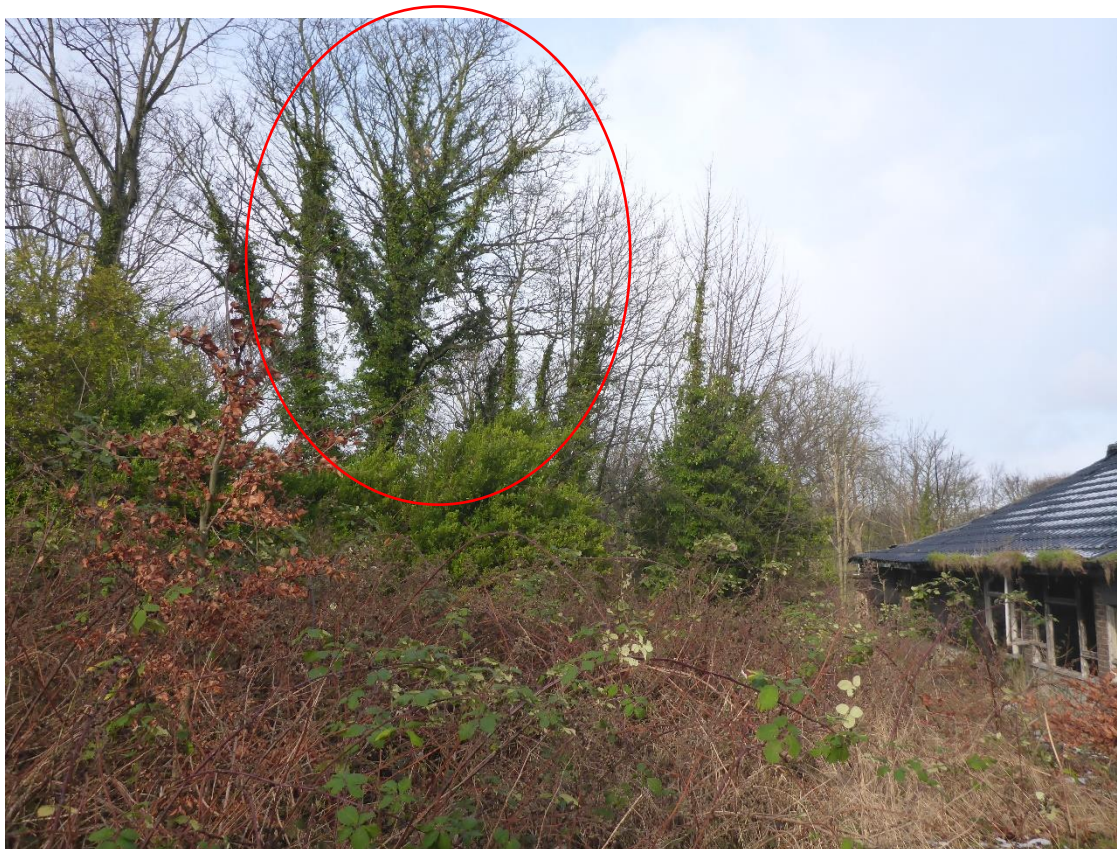
*Photo 17: T26, circled, and understory clump of shrubs and vegetation. Single storey building to right*
