# SUSTAINABLE DRAINAGE STRATEGY & FLOOD RISK ASSESSMENT REPORT

PROJECT: BARNSELY ACTIVITY PARK

CLIENT: BARNSELY METROPOLITAN BC

REPORT REFERENCE: BAP-HLE-XX-XX- RP-C-00001

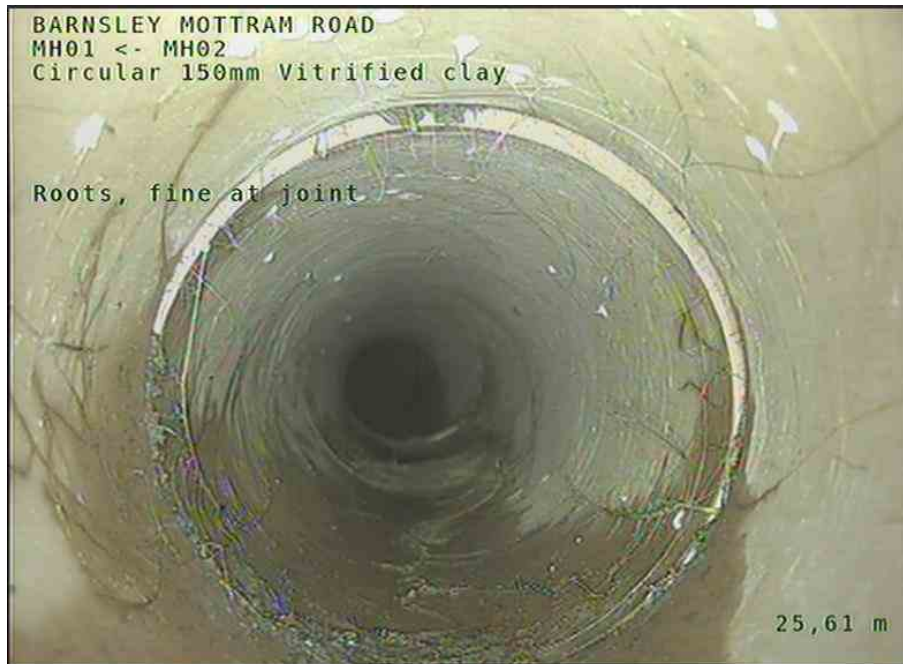
1, 00:02:51, 25.61 m  
Roots, fine at joint, CIP PATCH REQ

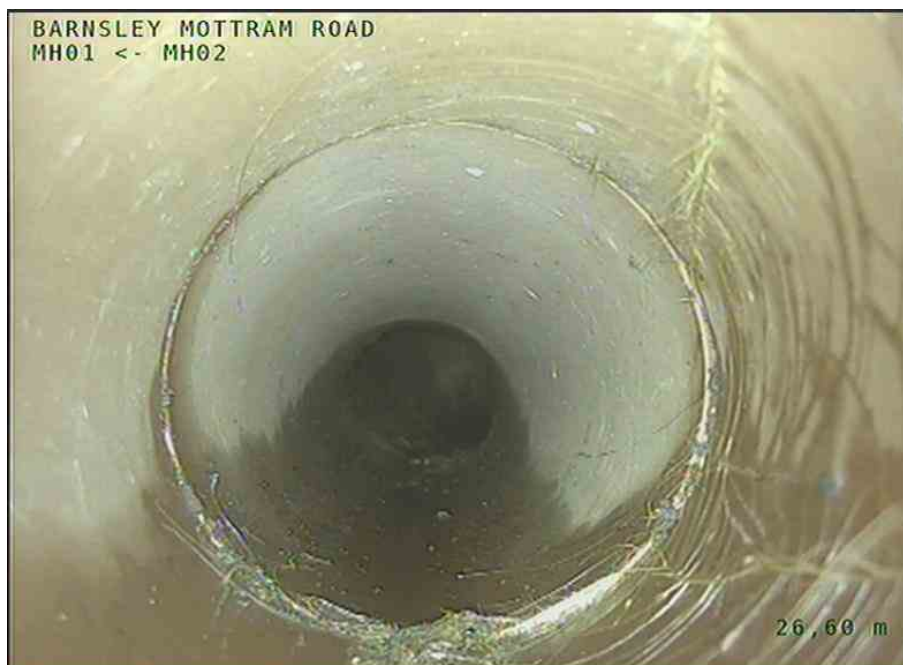
2, 00:03:01, 26.60 m  
Roots, fine at joint, CIP PATCH REQ

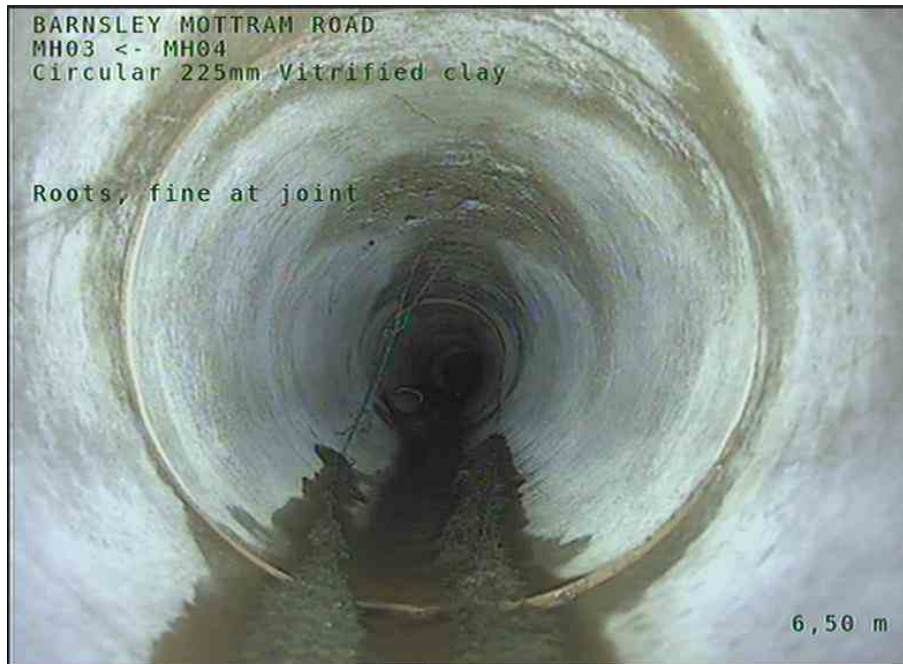
1, 00:00:40, 6.50 m  
 Roots, fine at joint, CIP PATCH REQ

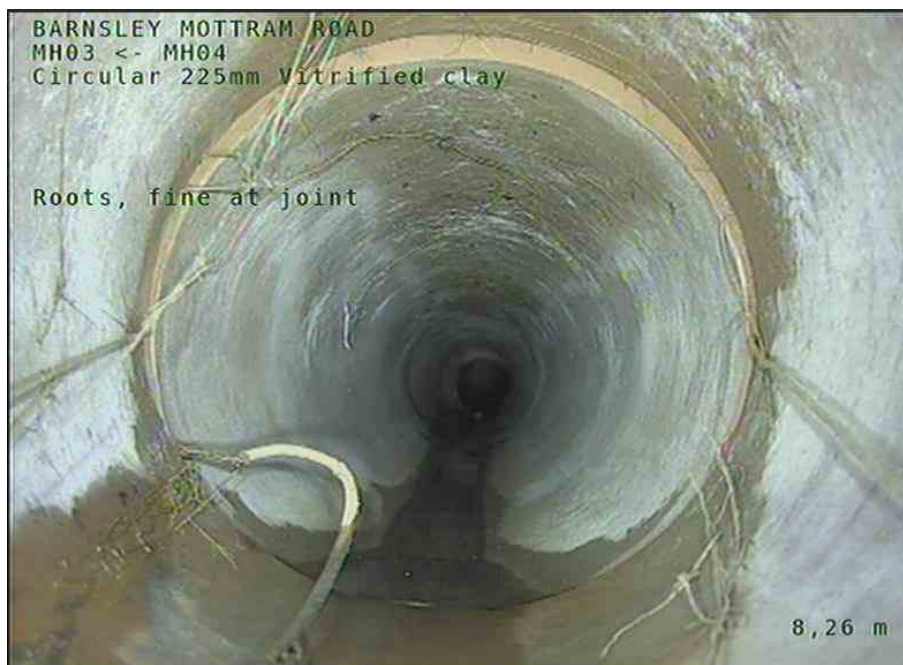
2, 00:00:50, 8.26 m  
 Roots, fine at joint, CIP PATCH REQ

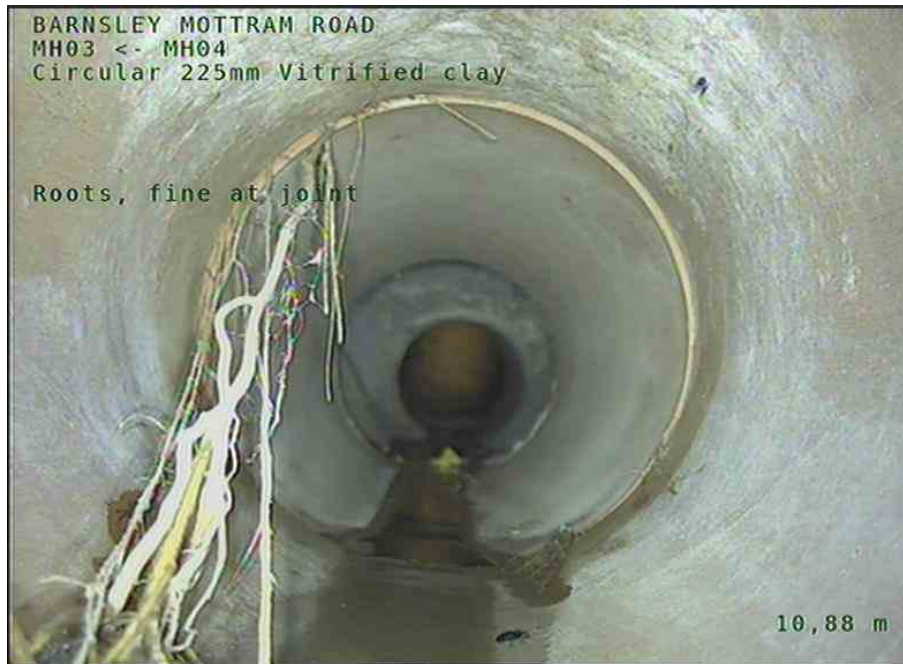
3, 00:01:05, 10.88 m  
 Roots, fine at joint, CIP PATCH REQ

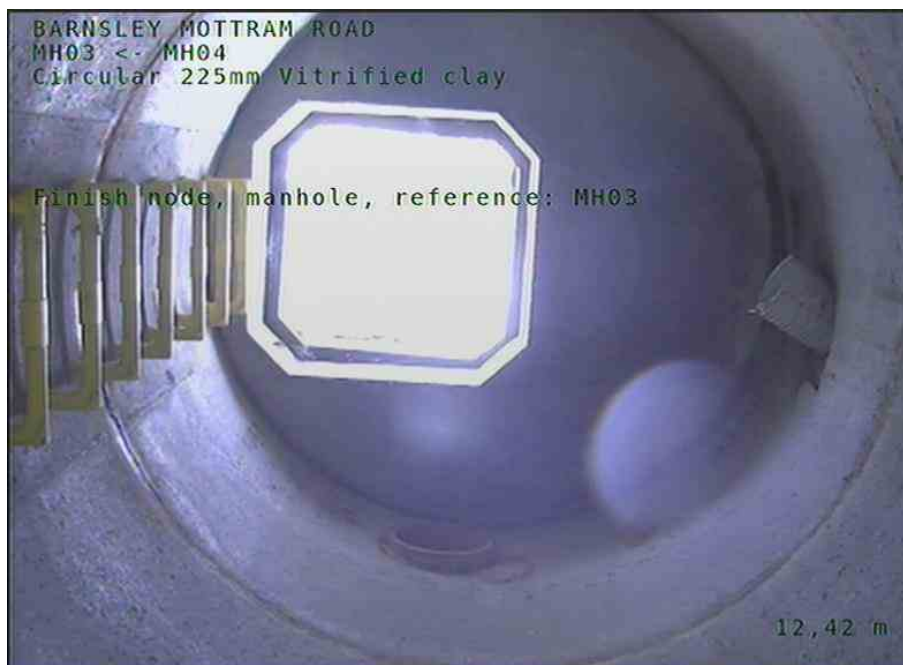
4, 00:01:29, 12.42 m  
 Finish node, manhole, reference: MH03, NO COVER ON MANHOLE

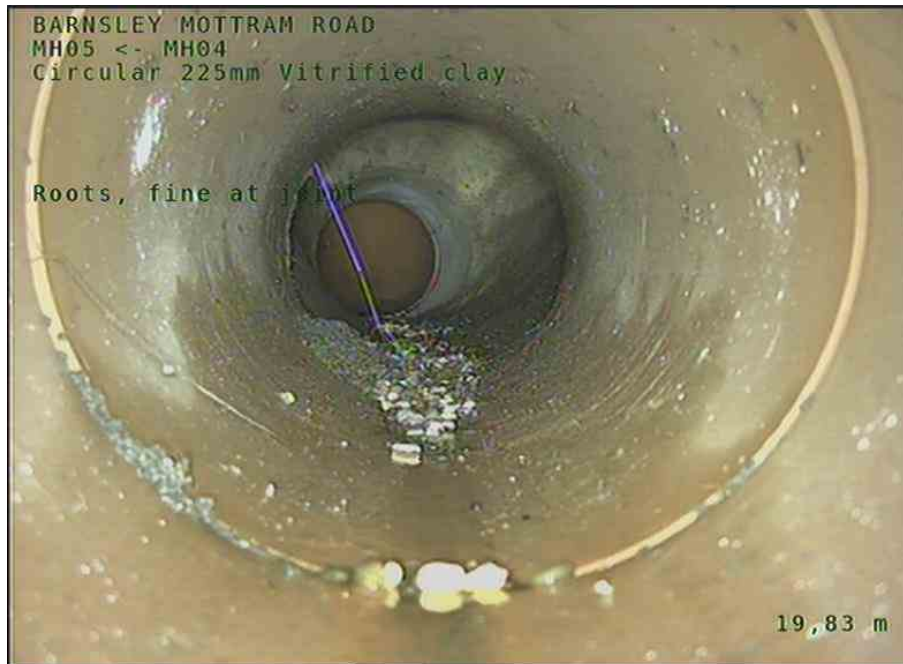
1, 00:01:31, 19.83 m  
Roots, fine at joint, CIP PATCH REQ

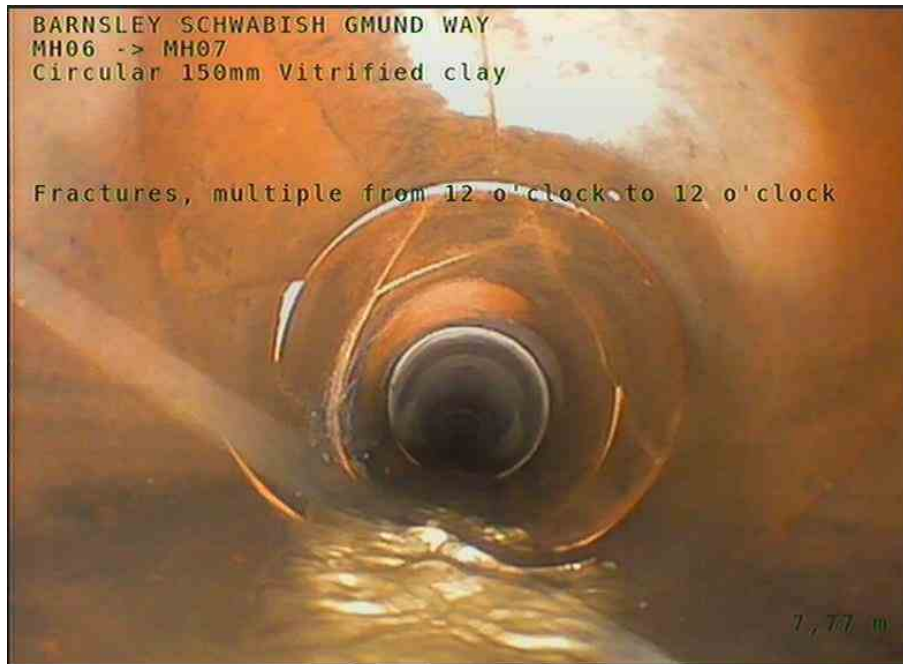
1, 00:02:15, 7.77 m

Fractures, multiple from 12 o'clock to 12 o'clock, CIP PATCH REQ

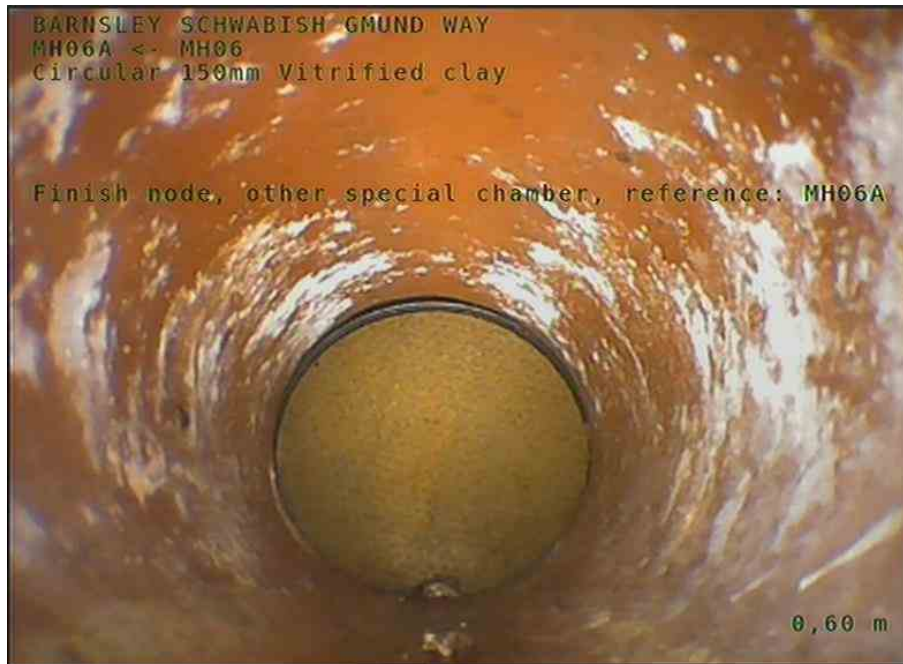
1, 00:00:07, 0.60 m

Finish node, other special chamber, reference: MH06A, CAPPED

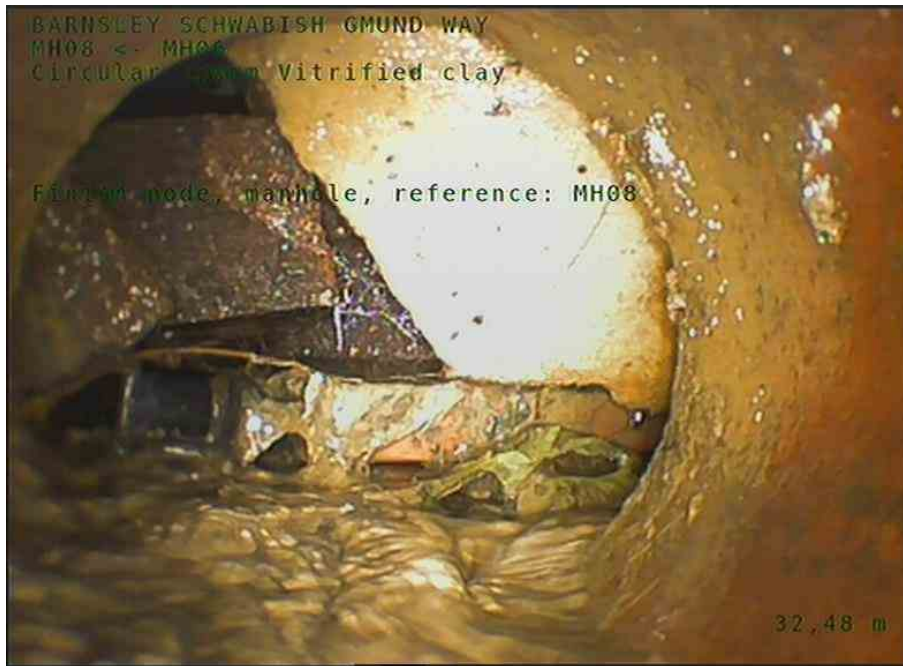
1, 00:04:45, 32.48 m

Finish node, manhole, reference: MH08, FILLED WITH DEBRIS

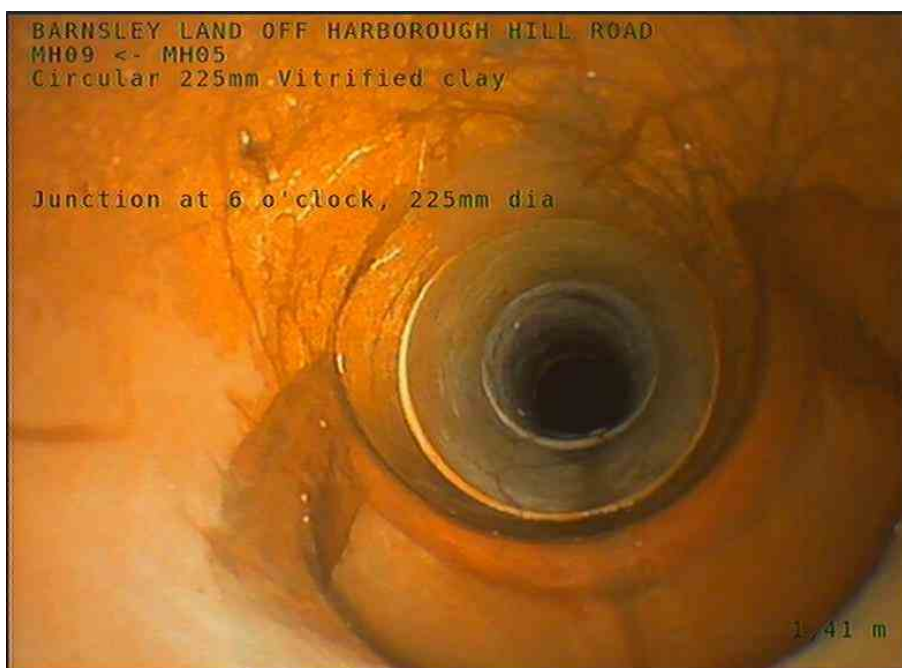
1, 00:00:23, 1.41 m  
Junction at 6 o'clock, 225mm dia, BACKDROP

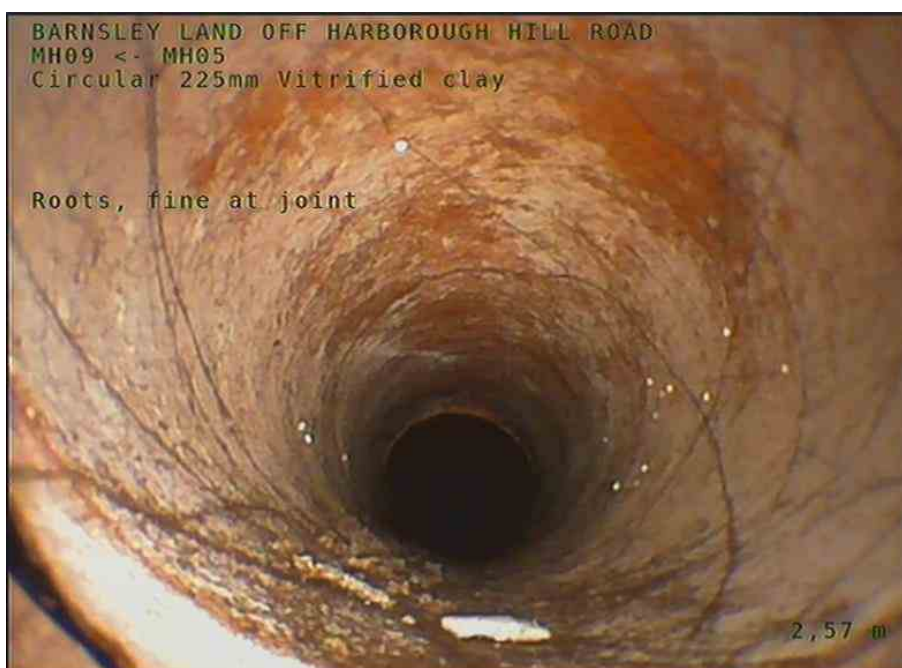
2, 00:00:40, 2.57 m  
Roots, fine at joint, CIP PATCH REQ

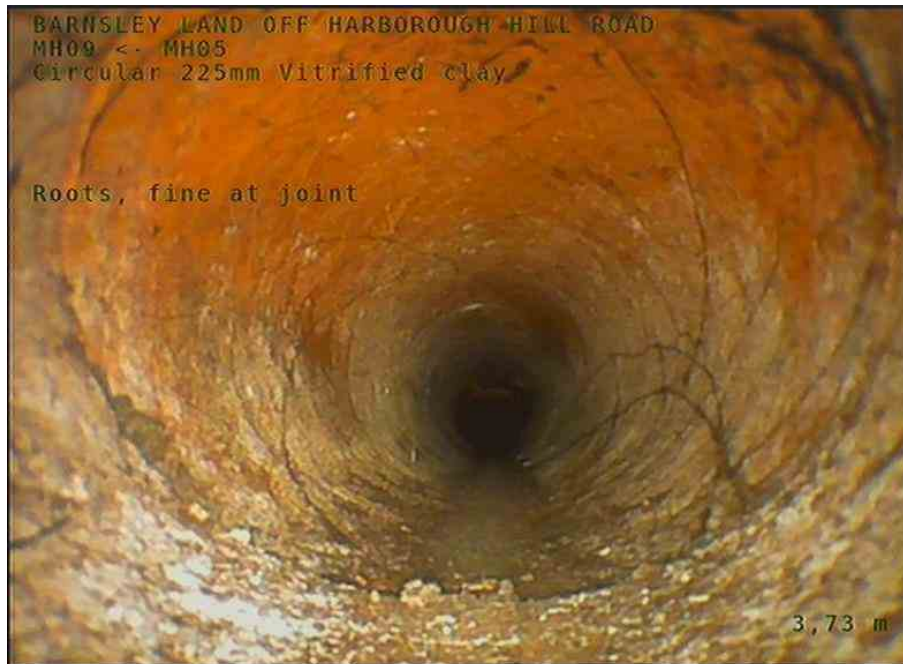
3, 00:00:57, 3.73 m  
 Roots, fine at joint, CIP PATCH REQ

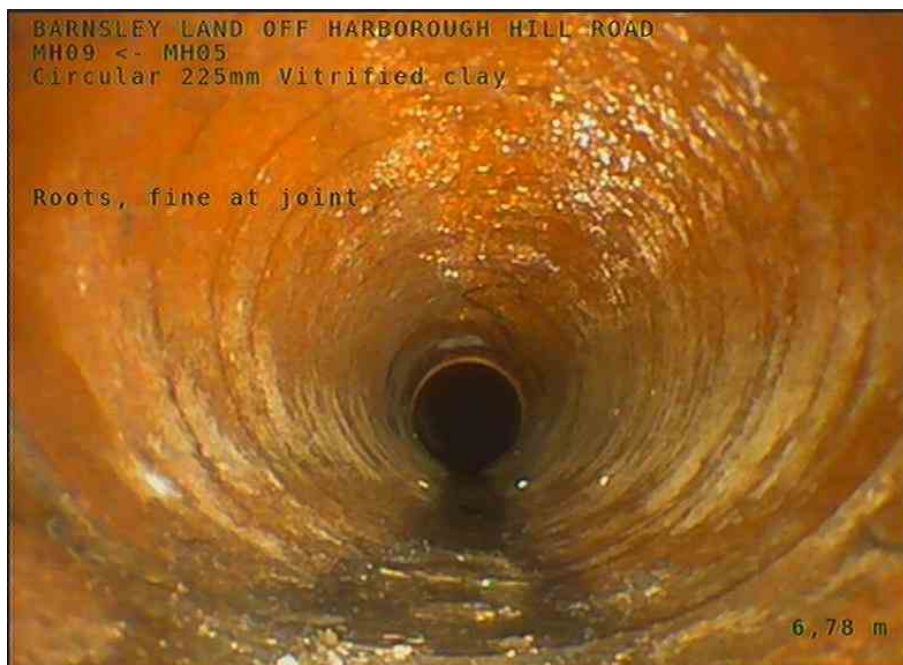
4, 00:01:21, 6.78 m  
 Roots, fine at joint, CIP PATCH REQ

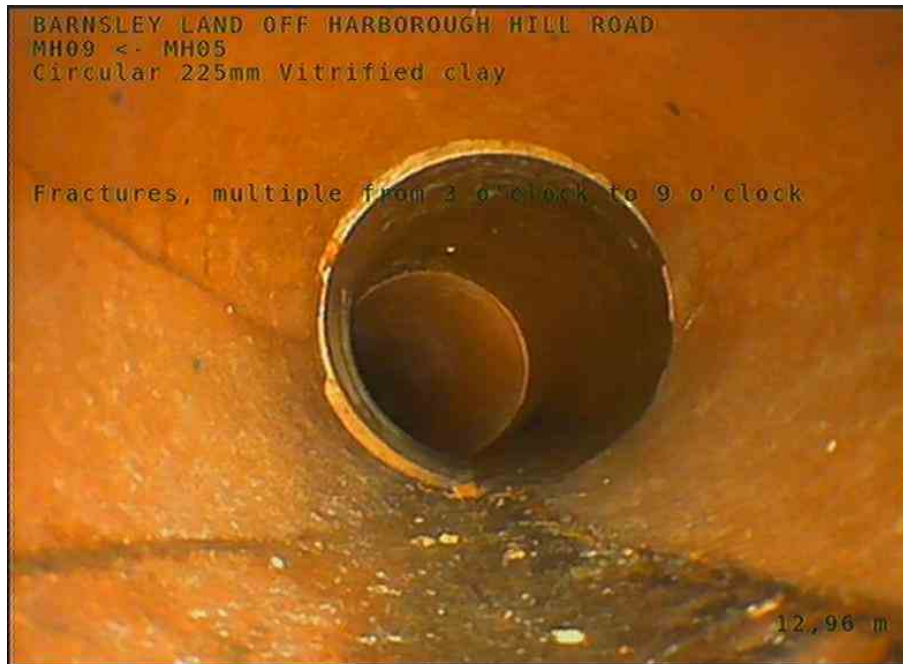
5, 00:02:01, 12.96 m  
 Fractures, multiple from 3 o'clock to 9 o'clock, CIP PATCH REQ

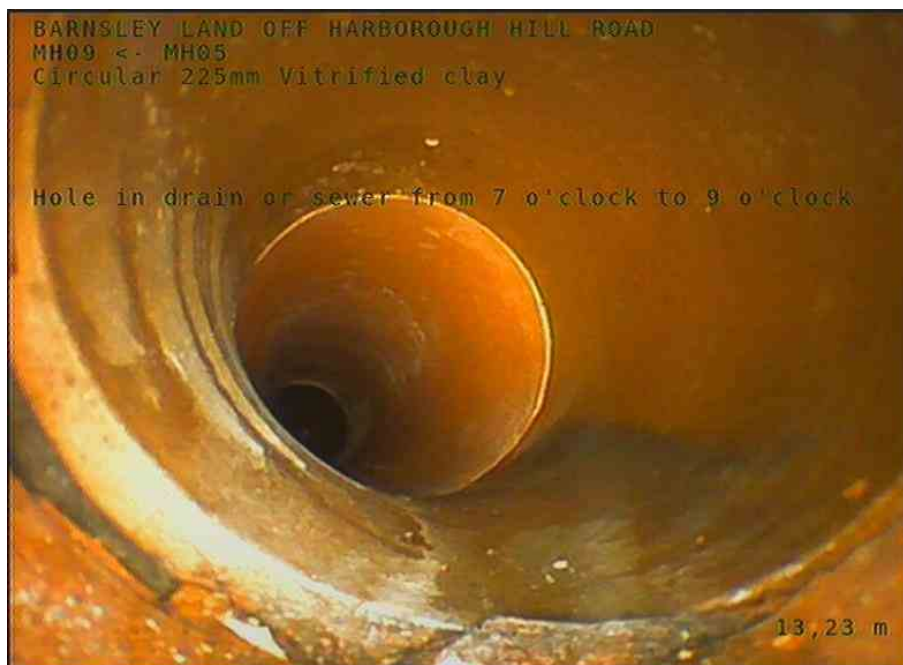
6, 00:02:19, 13.23 m  
 Hole in drain or sewer from 7 o'clock to 9 o'clock, CIP PATCH

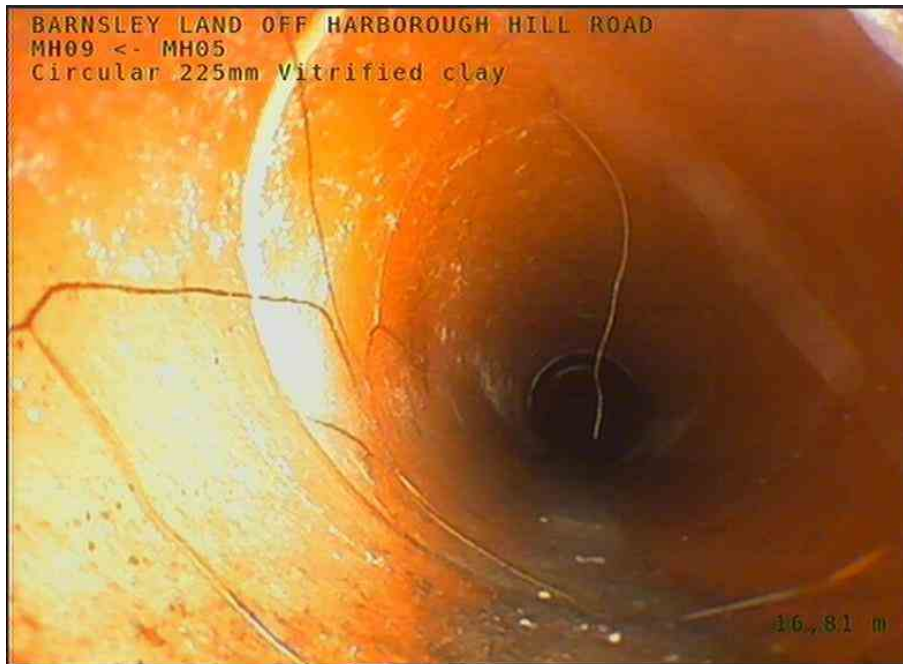
7, 00:02:43, 16.81 m  
 Roots, fine at joint, CIP PATCH

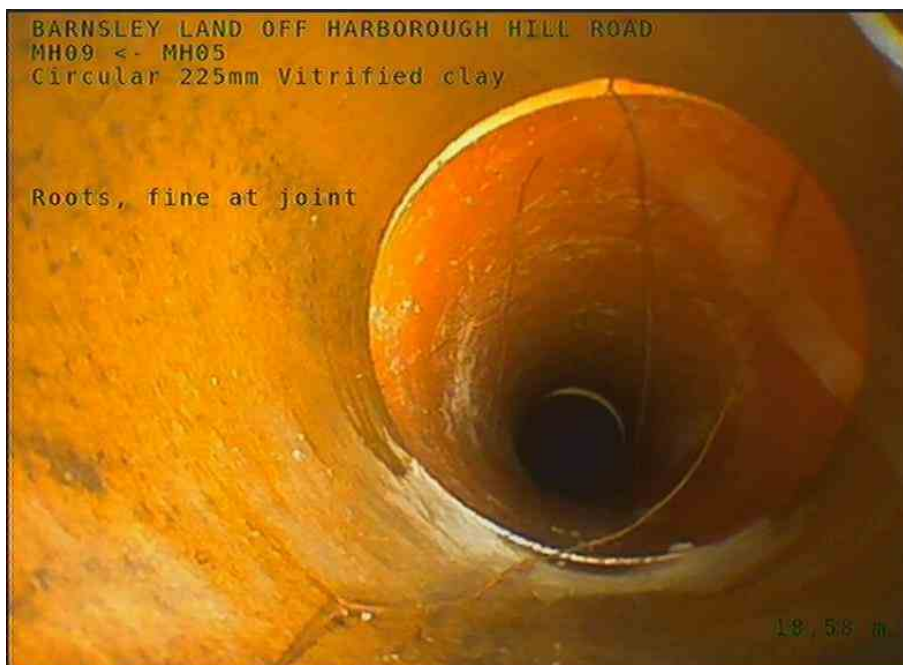
8, 00:02:58, 18.58 m  
 Roots, fine at joint, CIP PATCH REQ

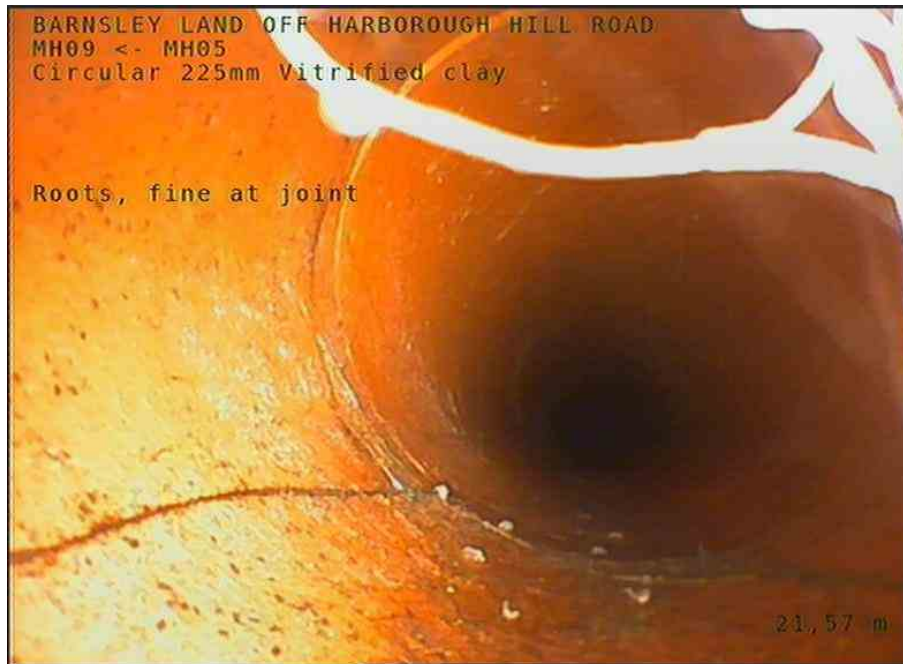
9, 00:03:19, 21.57 m  
Roots, fine at joint, CIP PATCH REQ

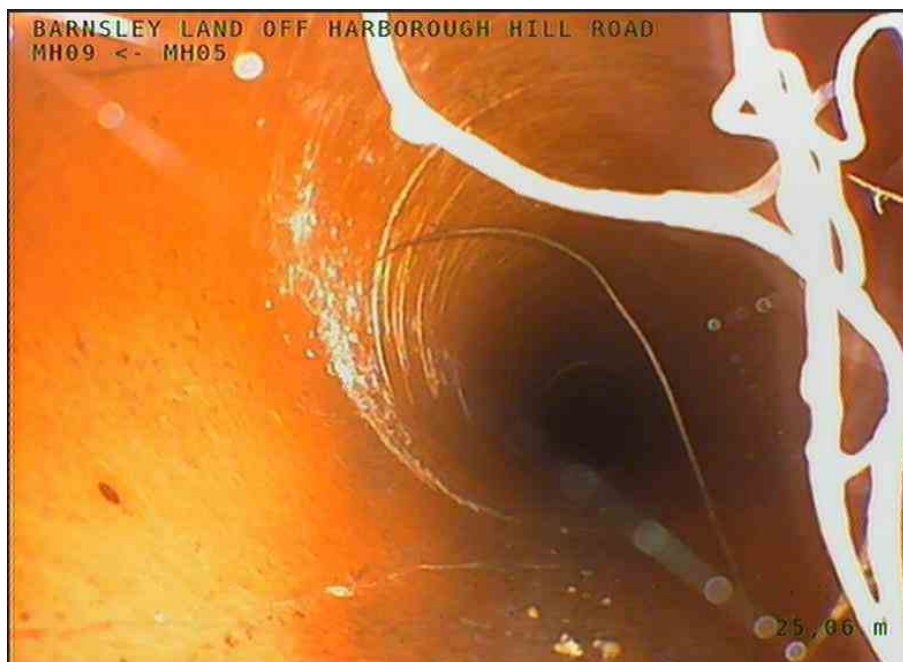
10, 00:04:15, 25.06 m  
Roots, fine at joint, CIP PATCH REQ

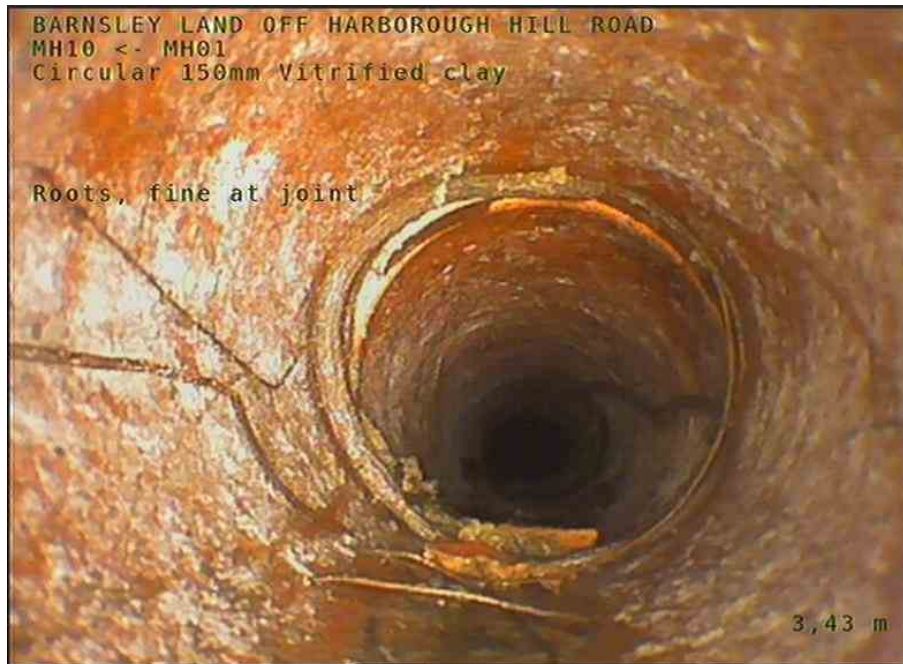
1, 00:01:09, 3.43 m  
Roots, fine at joint, CIP PATCH REQ

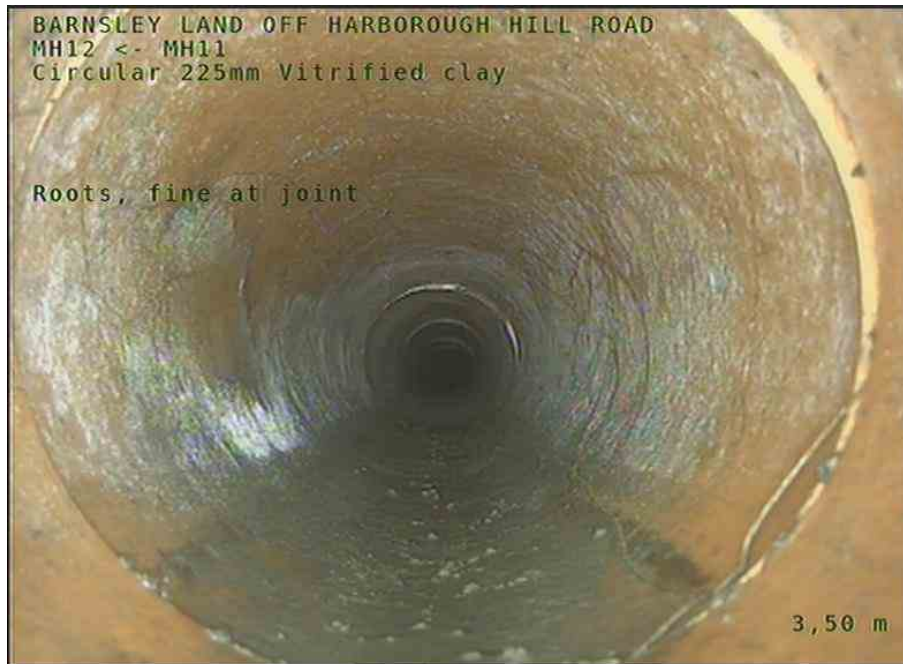
1, 00:00:26, 3.50 m  
Roots, fine at joint, CIP PATCH REQ

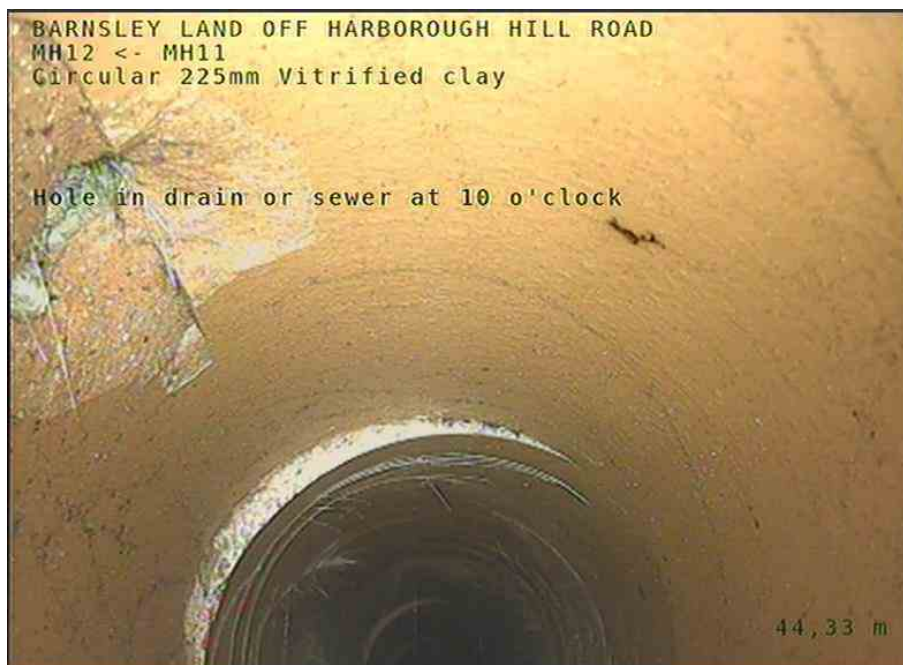
2, 00:02:57, 44.33 m  
Hole in drain or sewer at 10 o'clock

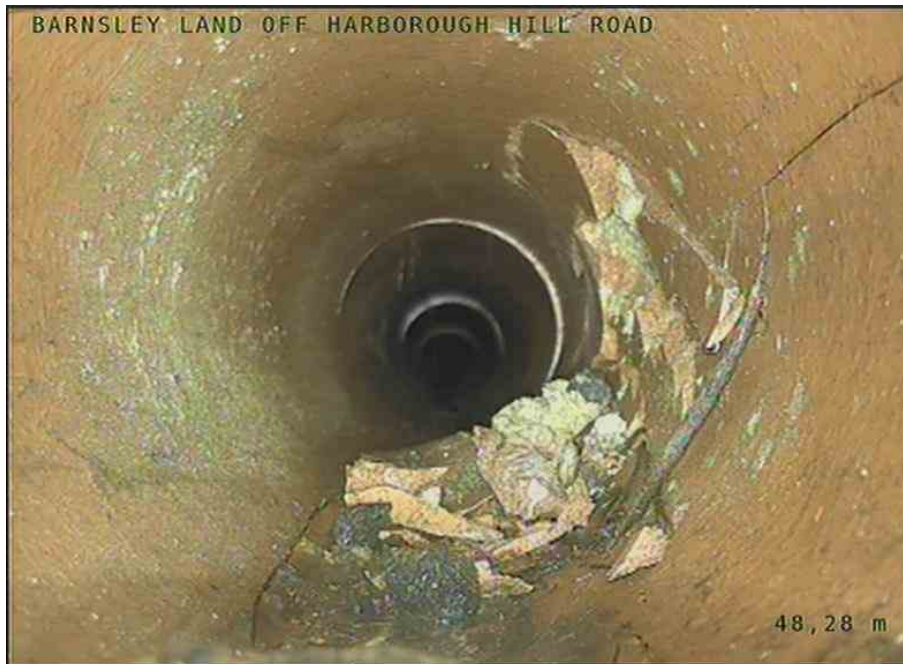
3, 00:04:43, 48.28 m  
Broken pipe from 1 o'clock to 6 o'clock

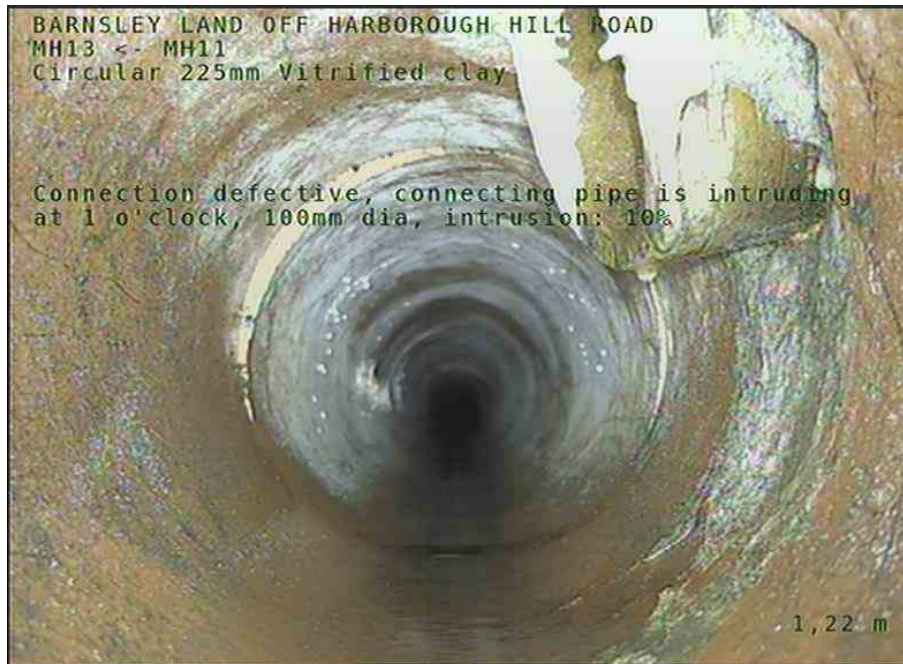
1, 00:00:21, 1.22 m  
 Connection defective, connecting pipe is intruding at 1 o'clock, 100mm dia, intrusion: 10%

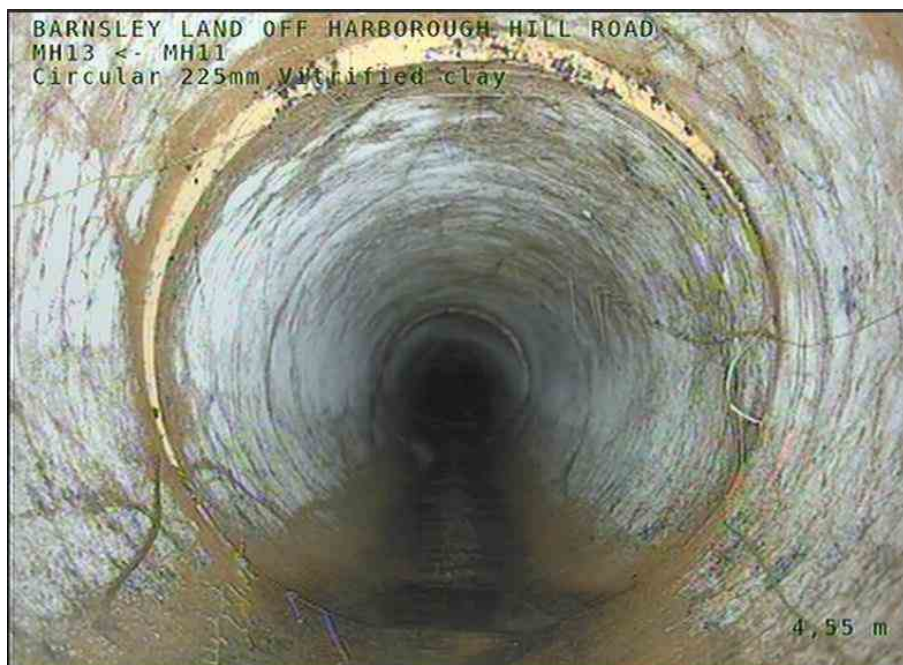
2, 00:00:36, 4.55 m  
 Roots, fine at joint, CIP PATCH REQ

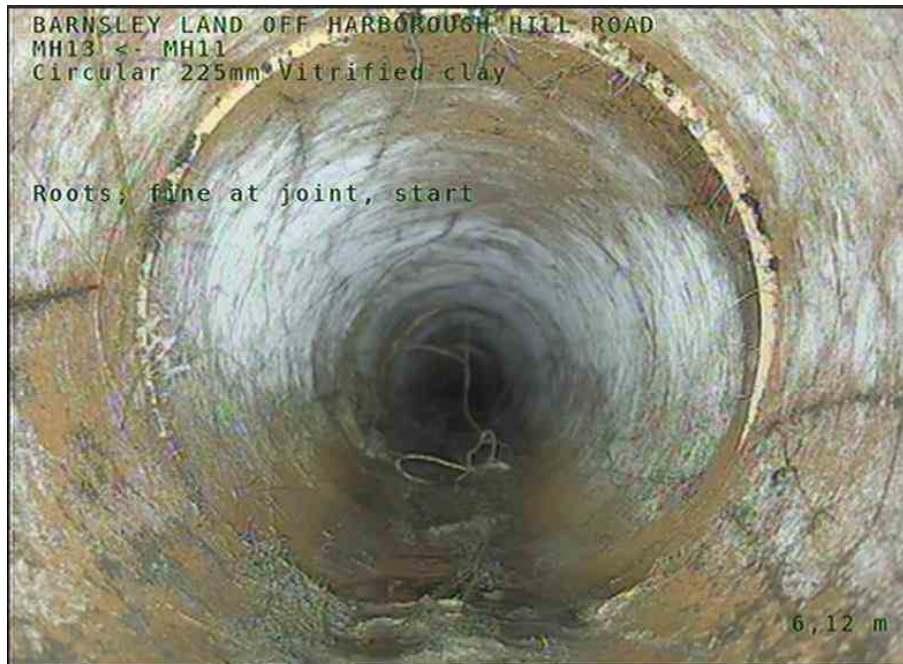
3, 00:00:44, 6.12 m  
Roots, fine at joint, start

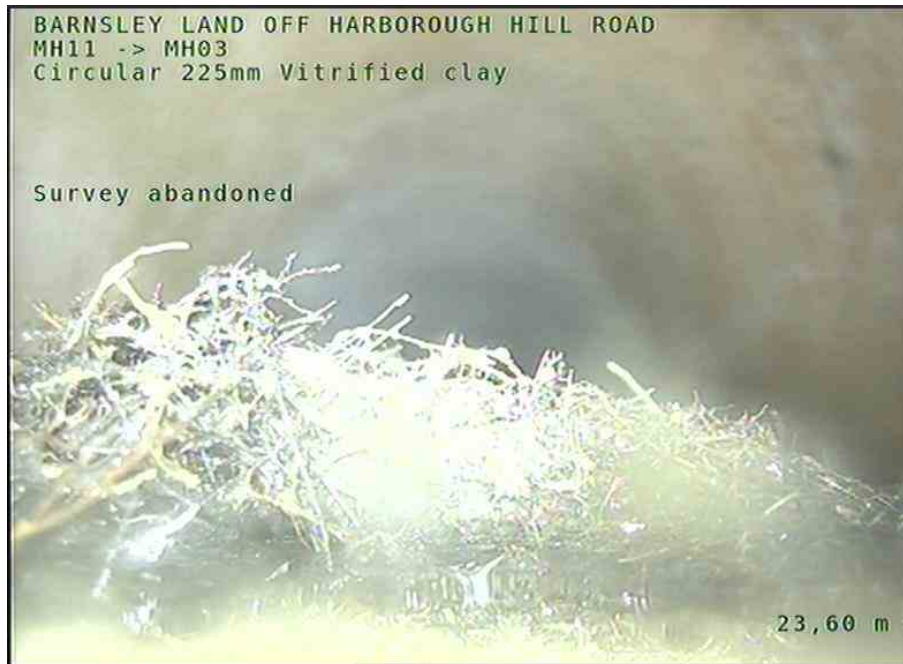
1, 00:01:32, 23.20 m  
Roots, mass at joint, 20% cross-sectional area loss
