Tree Survey; **Drummore/Mayfield,  
Barnsley Road, Dodworth.**

Client; **Matthew Stephens Esq.  
Quest Property, Barnsley, S35 3SP.**

Date of Survey; **May 9<sup>th</sup> 2011,  
and numerous occasions since 2006.**

File reference **Mayfield Court 01**

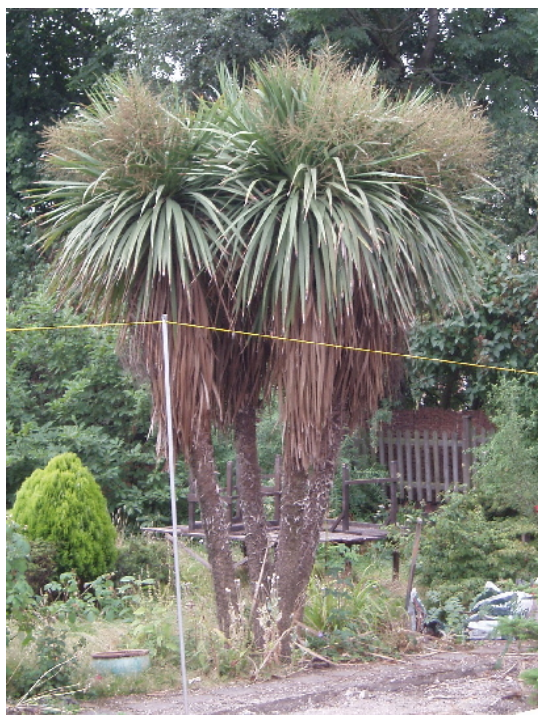
Photograph 1.

| Tree No. | Species. | Ht | TD | Age class | Cate-gory | Comments. | RPA |
|---|---|---|---|---|---|---|---|
| 12. | Cabbage Palm | 4 | 300 | OM | R | Dead. Killed by last winter's frost. (Almost certainly) | 0 |

Photograph 1 taken in 2006 shows tree 12 the Cabbage Palm, as does photo 2, but in 2011 it is overgrown by bramble and other shrubs and clearly dead; killed by frost, like every other Cabbage Palm in Yorkshire, that was not protected over winter.

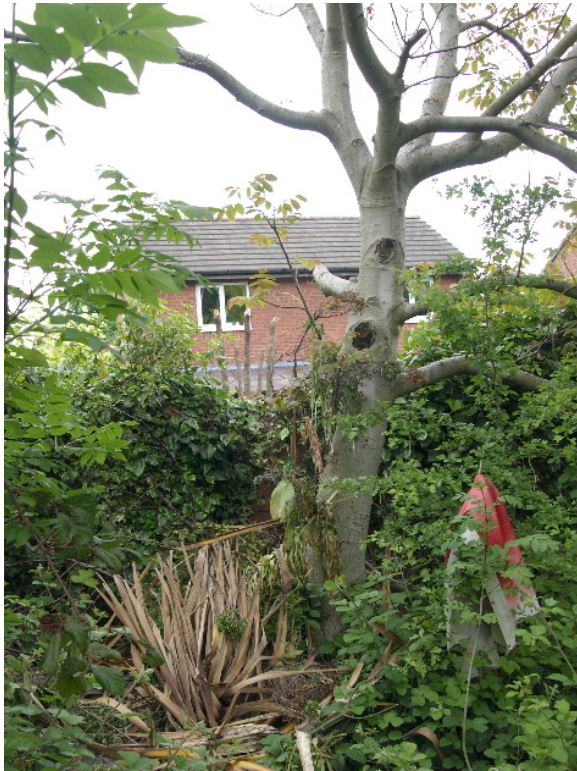
Photograph 3.

| Tree No. | Species. | Ht | TD | Age class | Cate-gory | Comments. | RPA |
|---|---|---|---|---|---|---|---|
| 15. | Walnut | 8 | 300 | M | C1 | Branches have been hacked off by a neighbour. Fly tipping at the base. Could be T3 in the TPO (see discussion below). | 41 |

Photograph 3 shows Walnut tree 15, branches have been cut off where they extend over the neighbouring garden. Coincidentally the debris at the base of the tree is the tops off the dead Cabbage Palm that can just be glimpsed over the wall. The neighbour obviously regards the site as some sort of dumping ground.

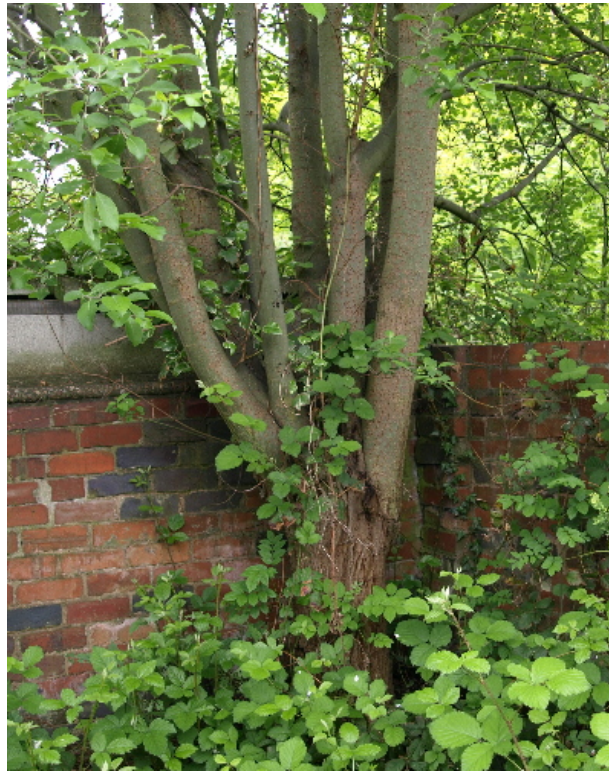
Photograph 4.

| Tree No. | Species. | Ht | TD | Age class | Cate-gory | Comments. | RPA |
|---|---|---|---|---|---|---|---|
| 9. | Pussy Willow | 7 | 300 | M | C1 | Previously pollarded, hard against the boundary wall. | 41 |

Photo 4 shows the Pussy Willow tree 9 adjacent to the boundary wall and photo 5 shows the False Acacia tree 16 now almost dead. There is an as yet unidentified, blight of some sort affecting the yellow leafed form of False Acacia, dying ones can be seen all over the country. In fact the reason for this was the third most frequent query of the Tree Advice Trust when they hosted a stand at the 2009 Chelsea Flower Show. (<http://www.treehelp.info/the-gardening-publics-concerns>)

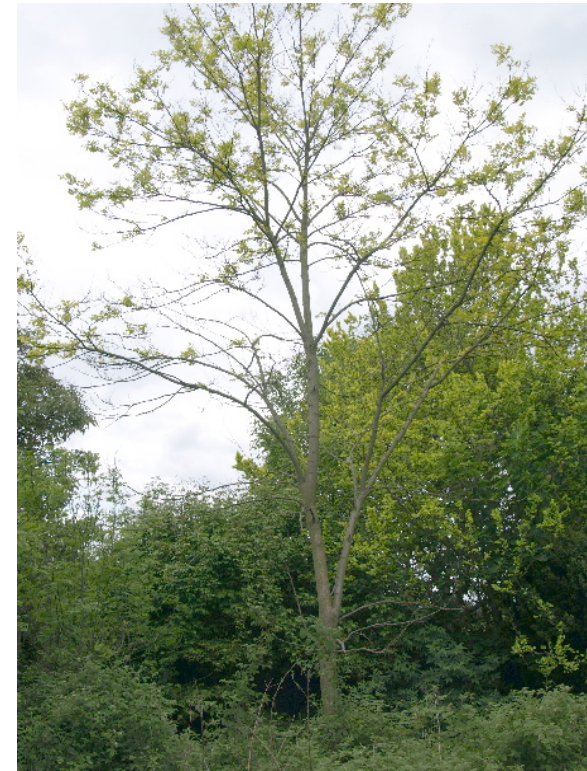
Photograph 5.

| Tree No. | Species. | Ht | TD | Age class | Category | Comments. | RPA |
|---|---|---|---|---|---|---|---|
| 16. | Golden False Acaia | 6 | 250 | M | R | Nearly dead. | 0 |

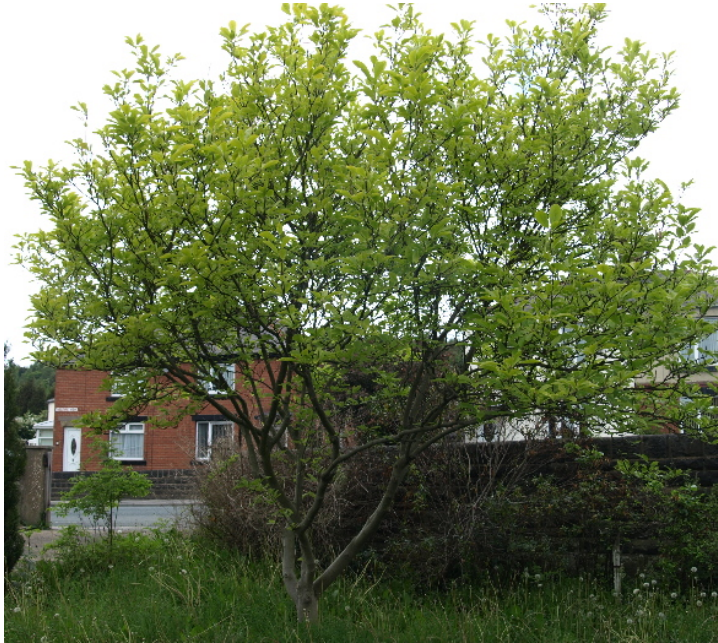
Photograph 6.

| Tree No. | Species. | Ht | TD | Age class | Cate-gory | Comments. | RPA |
|---|---|---|---|---|---|---|---|
| 2. | Magnolia | 4 | 170af | M | C1 | A shrub, only included by virtue of it being included in the TPO (T5). | 10 |

Photo 6 shows Magnolia tree 2 that is included in the TPO. In my opinion this is not a tree but a large shrub. I pointed this out in the original objection to the TPO although I have no idea whether the objection was ever considered. Photo 7 taken in January last year shows tree 17 which is T1 in the TPO. This is quite a handsome tree albeit irrelevant to anyone outside the garden. It is also worth noting that while of reasonable form it is rather small; it is not a tree that anyone would anticipate gaining significant stature.

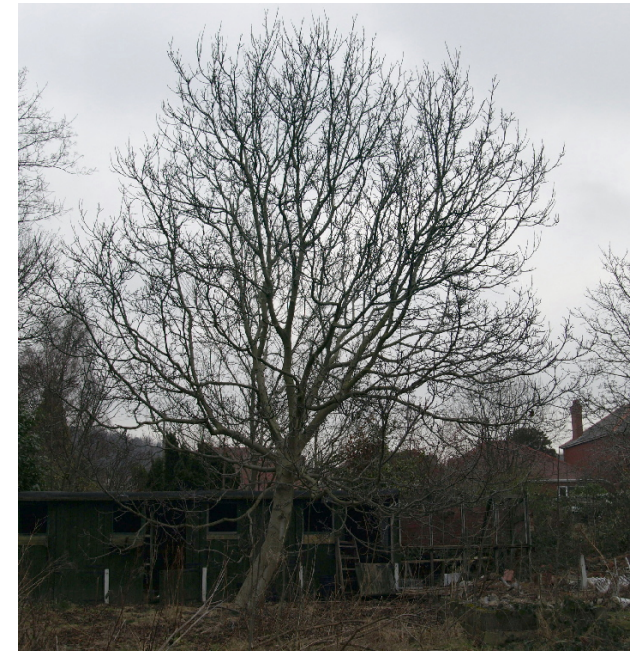
Photograph 7.

| Tree No. | Species. | Ht | TD | Age class | Category | Comments. | RPA |
|---|---|---|---|---|---|---|---|
| 17. | Walnut | 8 | 320 | M | C1 | T1 in the TPO. A reasonable specimen albeit small and overshadowed by trees outside the site. | 47 |

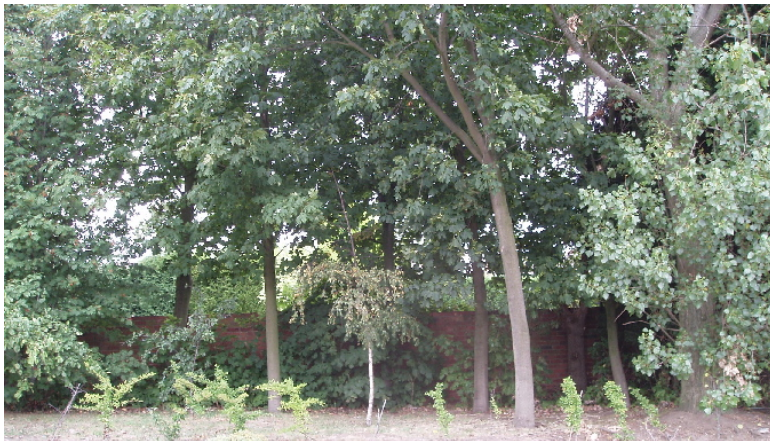
Photograph 8.

| Tree No. | Species. | Ht | TD | Age class | Category | Comments. | RPA |
|---|---|---|---|---|---|---|---|
| 19. | Group | 15 max | 490 max | M | C2 | Cherry, Norway Maple, Lime, Rowan, Hybrid Black Poplar, some Leyland Cypress. These trees are all poor specimens due to having been grown in close proximity to one another and never received any silvicultural maintenance work. Some have obviously suffered root damage, some Maples are (unusually) suffering from some sort of Bleeding Canker and all the Cherries are showing signs of Bacterial Canker. Also, there are numerous Cherry seedlings emerging within the group, these are actually suckers from roots of other trees. Area 1 in the TPO. One of the Poplars is severely decayed. Some trees are very close to the boundary wall. | 109 |

Photograph 8 shows the group of trees 19. This photograph is taken from the hotel car park. While it is plain that they provide a reasonable screen between the car park and the garden, the TPO has not led to any of the trees being maintained. This photograph was taken in 2006 although the group looks pretty much the same now albeit taller. It is undesirable to allow them to keep growing unchecked as they are continuing to develop poor form, some are too close to the boundary and the competition between them seems to be allowing diseases to develop: This is the only place where I've ever seen Bleeding Canker on Norway Maples. Some maintenance work should be undertaken.

The maintenance work that I would anticipate for this group would be the removal of some trees where they're too close to the wall or diseased, some pruning to encourage development of better crown form, and some work to improve soil conditions for the trees (mulching). I think it is reasonable to note that building in relatively close proximity to this group is likely to lead to pressure for this management, which is something the TPO has singly failed to achieve. As undertaking work on protected trees involves the completion of a fairly onerous application form it could even be reasoned that the TPO has discouraged prudent management work.
