Our Ref: B22639.L001/JAW/cl

Date: 26 July 2018

Re: Ranah Stones, Sheffield, S36 4HJ

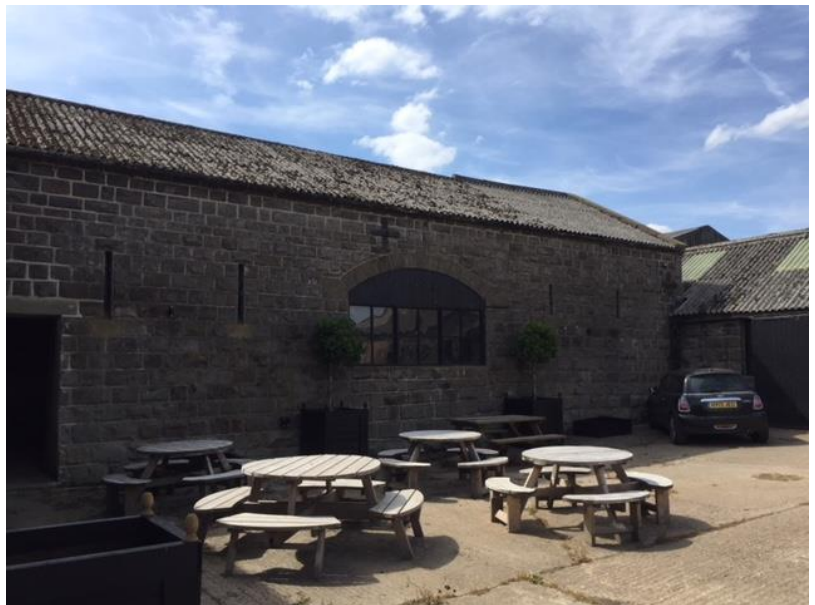
Photograph 4

Further to our joint visit to the above property yesterday, I write as promised with regards to the main barn at the above property. For the purpose of this report, the front of the barn, photograph 4, is deemed to be that facing the main farmhouse with all descriptions left and right are as if facing the front.

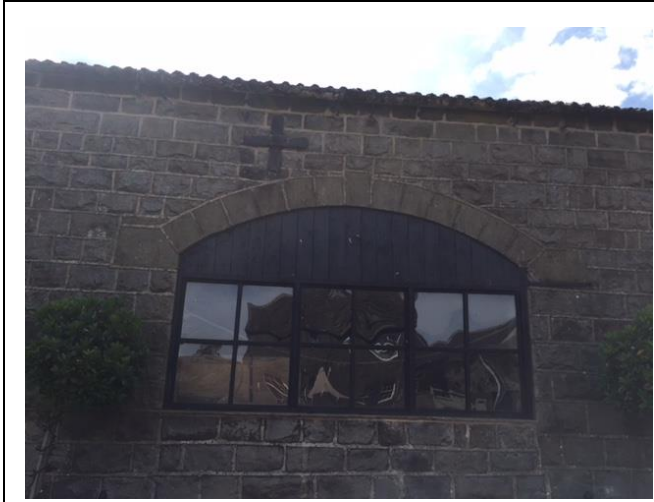
Photograph 5

underneath the truss. In an effort to prevent further movement, two tie bars have been inserted at the location shown on sketch SK1, see also photographs 5 and 6. The first tie bar is close to the right gable wall, whilst the second tie bar has been positioned over the arched window to the front elevation. This is a particular weak point to place a tie and localised movement of the masonry has occurred, directly over the arch but fortunately has not caused any damage to the arch. This damage would indicate that further pulling along the tie bar has occurred, due to further outward movement of the rear elevation.
