Arboricultural Consultancy for AXA Insurance

Insured		Address	Stonehurst, Green Road, Barnsley, South Yorkshire, S75 3RP		
Client	Subsidence Management Services	Contact	Mauro Loscalzo	Claim No.	IFS-AXA-SUB-22-0104873
ES Ref	SA-252208	Consultant	Keith Burgess	Contact No.	0330 380 1036
Report Date	21/02/2023 Revised: 05/09/2023

Scope of Report: To survey the property and determine significant vegetation contributing to subsidence damage, make recommendation for remedial action and assess initial mitigation and recovery prospects. The survey does not make an assessment for decay or hazard evaluation. This is a revised report, updating management advice based on the results of recent site investigations

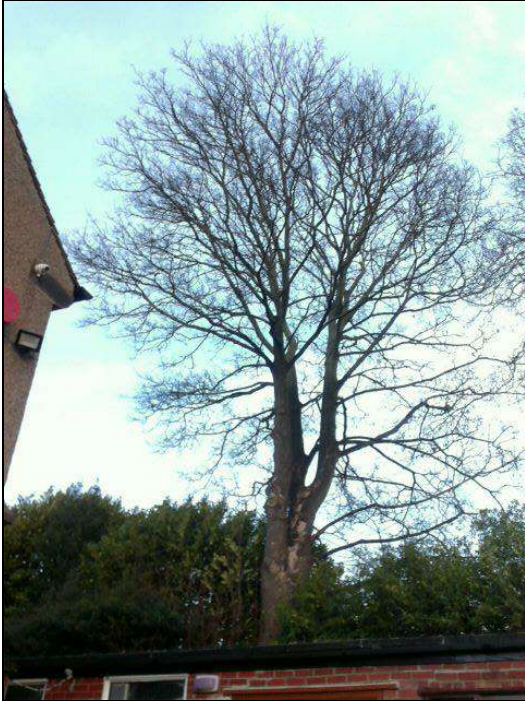
Our survey of the site identified T1 (Sycamore) and T2 (Oak) which, in our opinion, will be the source of the roots recovered and as such we have identified them as the primary cause of the current movement / damage.

Tree No.	Species	Age Cat	Approx. Height (m)	Distance to Building (m) *	Ownership	Action	Requirement
T1	Sycamore	1	19	7.0	B - Local Authority	Remove	Remove close to ground level and treat stump to inhibit regrowth. Distance stated relates to area of damage.
T2	Oak	1	16	2.0	B - Local Authority	Remove	Remove close to ground level and treat stump to inhibit regrowth. Distance relates to outbuilding.

T1 - Sycamore

Consequently, we have advocated the complete removal of T1 & T2 as it will offer the most certain arboricultural solution likely to restore long-term stability.

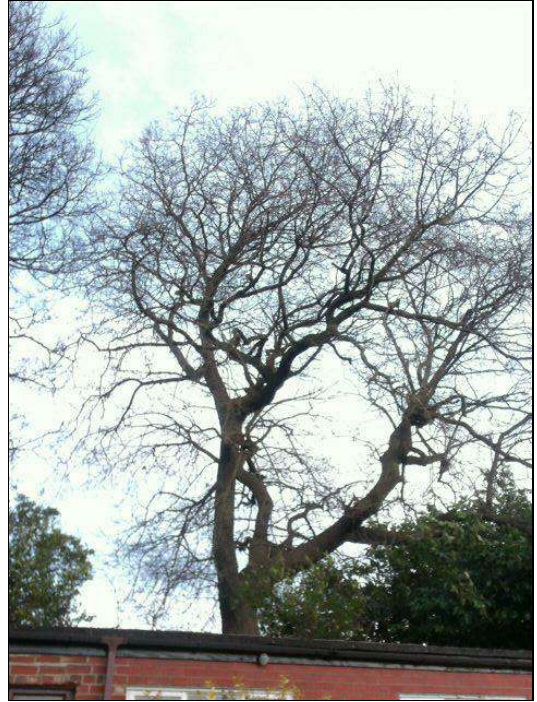
T2 - Oak

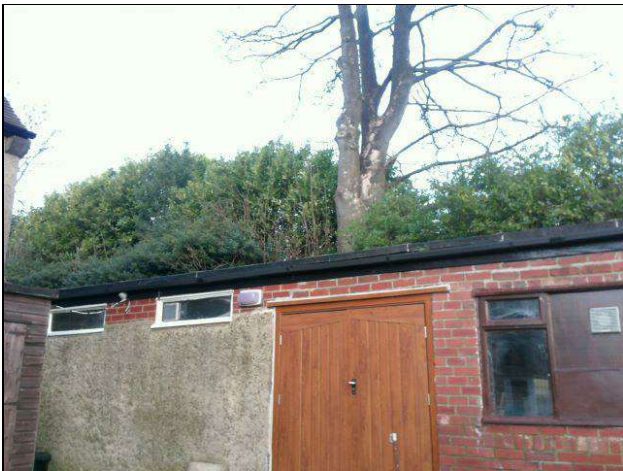
Tree No.	Species	Age Cat	Approx. Height (m)	Distance to Building (m) *	Ownership	Action	Requirement
H1	Mixed Species Hedge: including Holly & Cherry Laurel.	1	5	2.0	B - Local Authority	Action to avoid future risk	Maintain at, or below current dimensions by way of regular pruning.
H2	Cypress	1	5	3.0	C - Insured	Action to avoid future risk	Maintain at, or below current dimensions by way of regular pruning.
H3	Privet	1	2	1.6	C - Insured	Action to avoid future risk	Maintain at, or below current dimensions by way of regular pruning.
H4	Mixed Species Hedge: including Privet & Hawthorn.	1	5	2.5	C - Insured	Action to avoid future risk	Maintain at, or below current dimensions by way of regular pruning.
SG1	Mixed species shrubs: including Berberis & Pheasant Berry.	1	2	0.3	C - Insured	Action to avoid future risk	Maintain at broadly current dimensions by way of regular pruning.
TG1	Ash	1	12	2.0	B - Local Authority	Action to avoid future risk	Crown reduce overall canopy by 30% (minimum) to achieve a crown volume reduction in line with BRE IP7/06. Maintain at reduced dimensions by re-pruning back to points of previous reduction on a 3 year (max) cycle. Distance relates to outbuilding.

H1 - Mixed species hedge

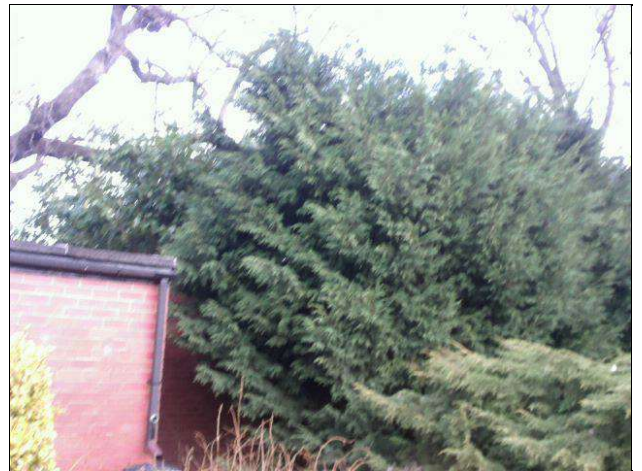
H2 - Cypress
