# ARBORICULTURAL REPORT

# & Impact Assessment to BS5837:2012 at:

Land at
Bismarck Street,
Worsbrough,
Barnsley,
South Yorkshire
570 4NA

Reference: AWA2575

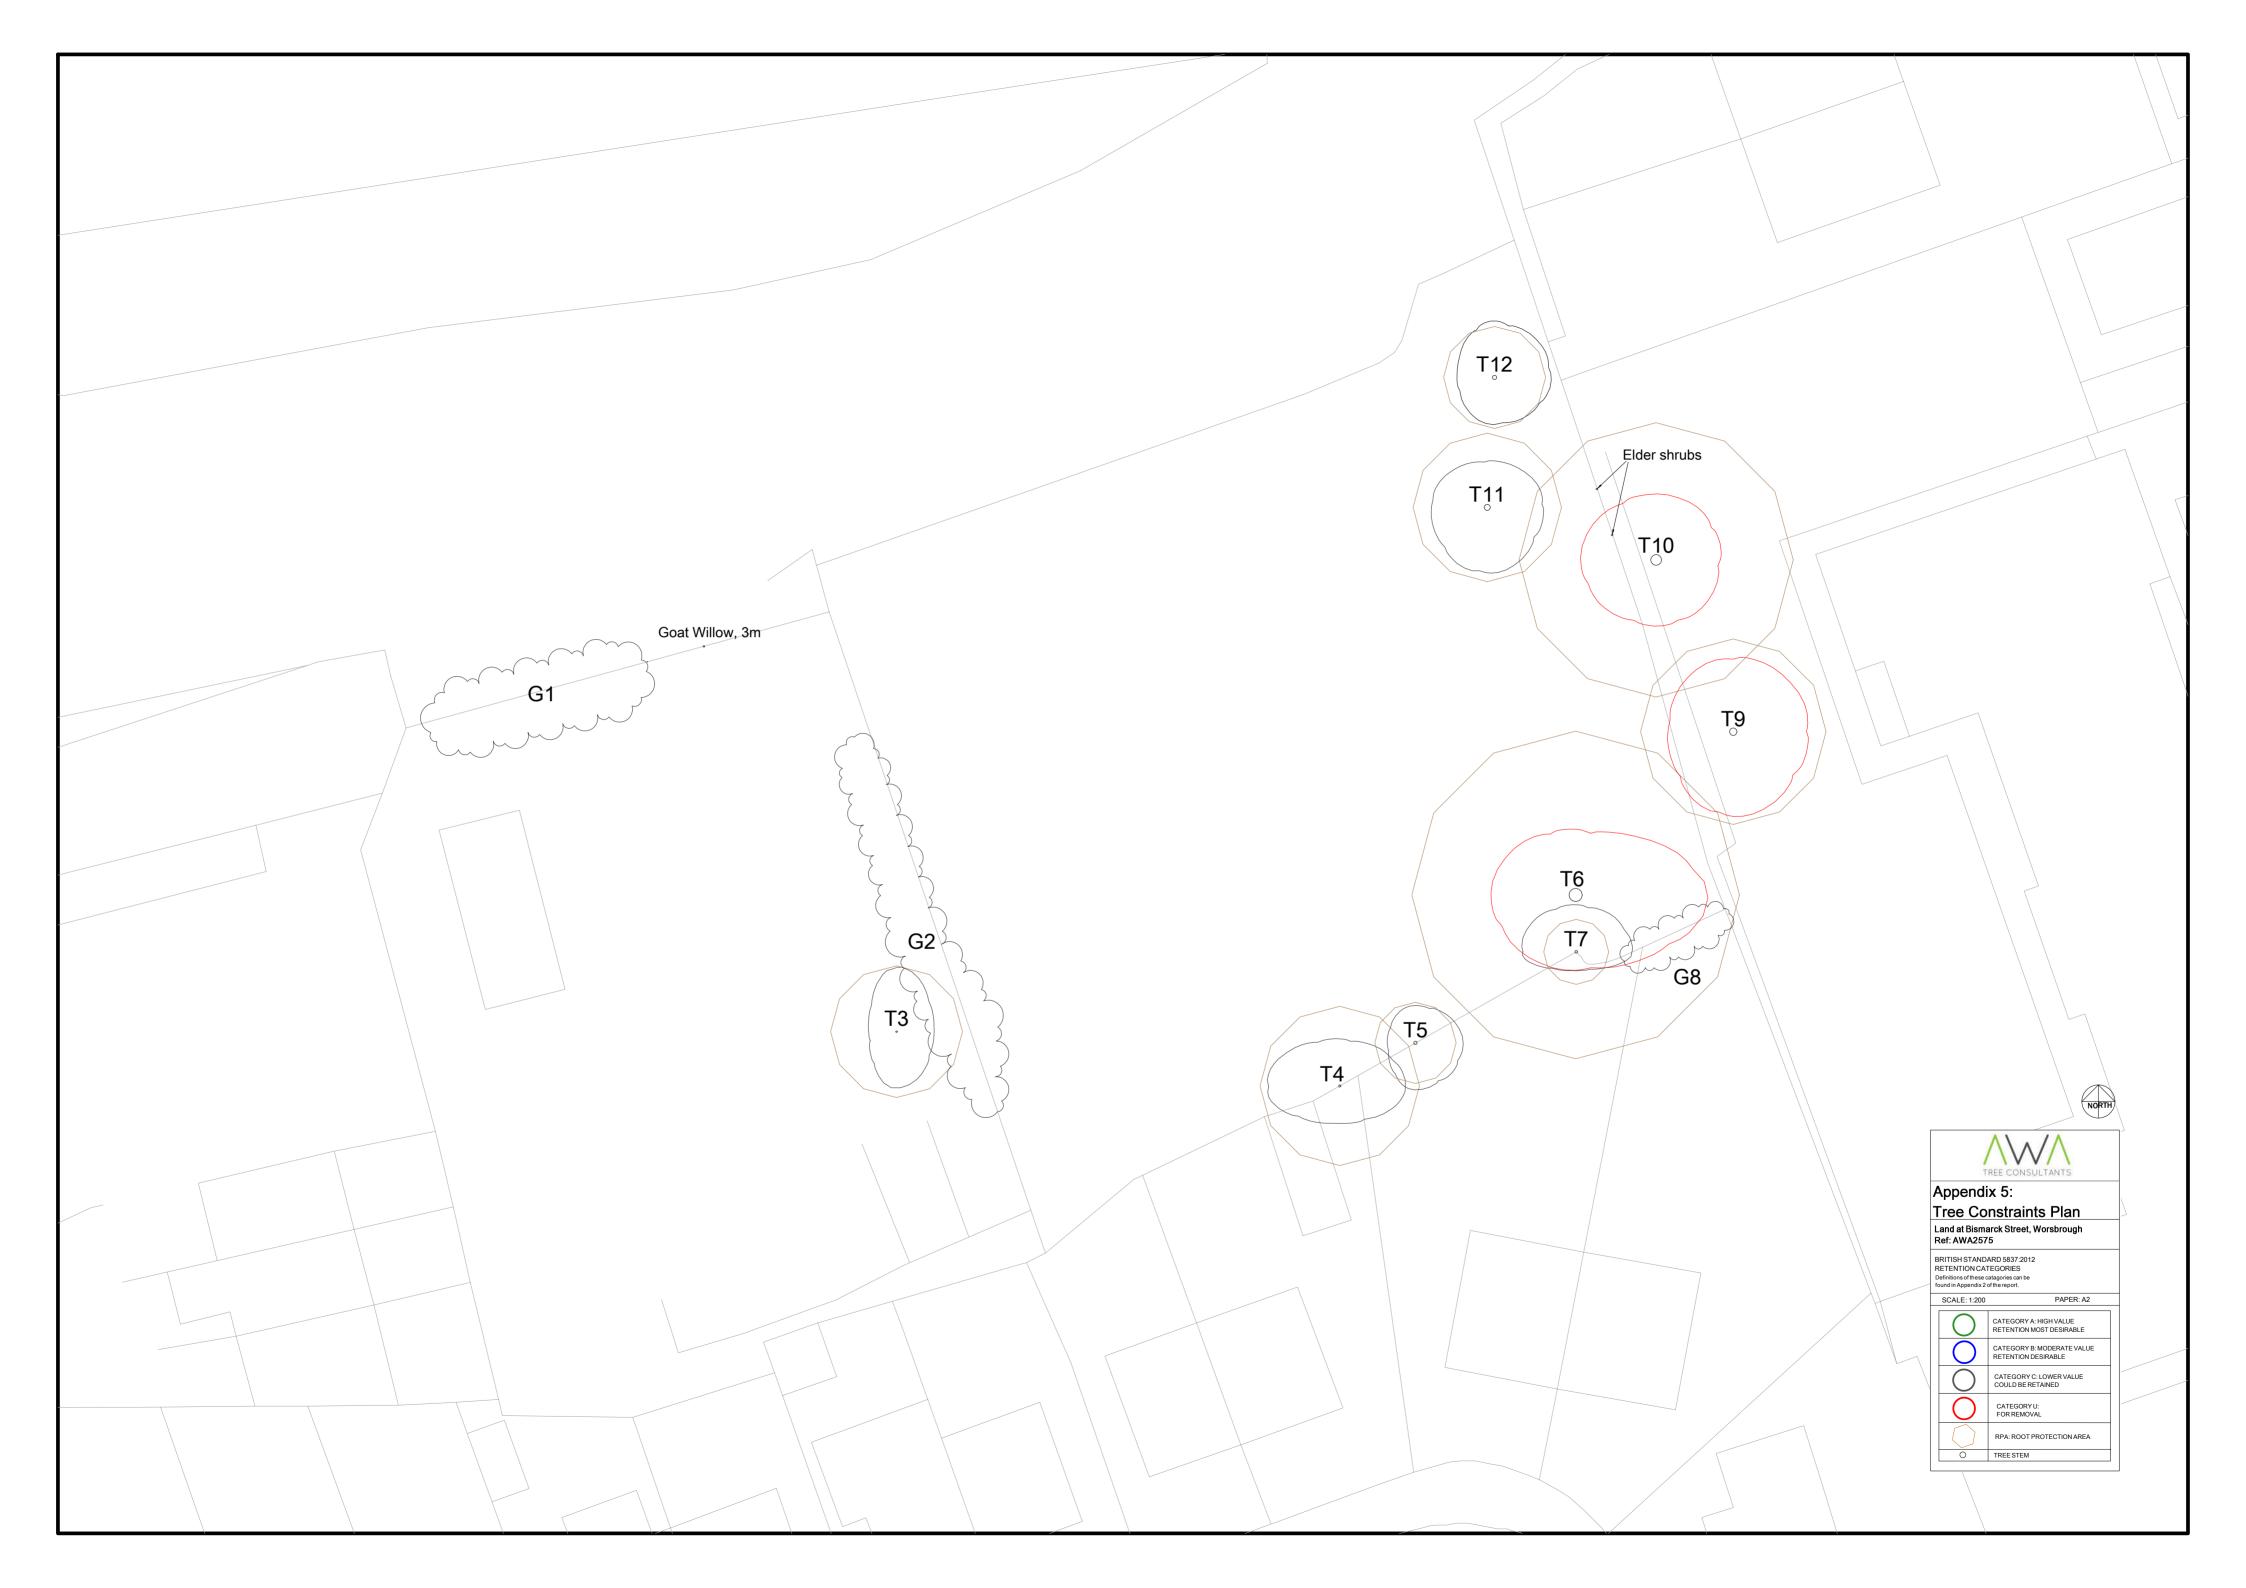
- 3.2.13 The tree Root Protection Area (RPA) detailed on the Tree Constraints Plan at Appendix 5, has been used as a layout design tool, to inform on the area around a tree where the protection of the roots and soil structure is treated as a priority.

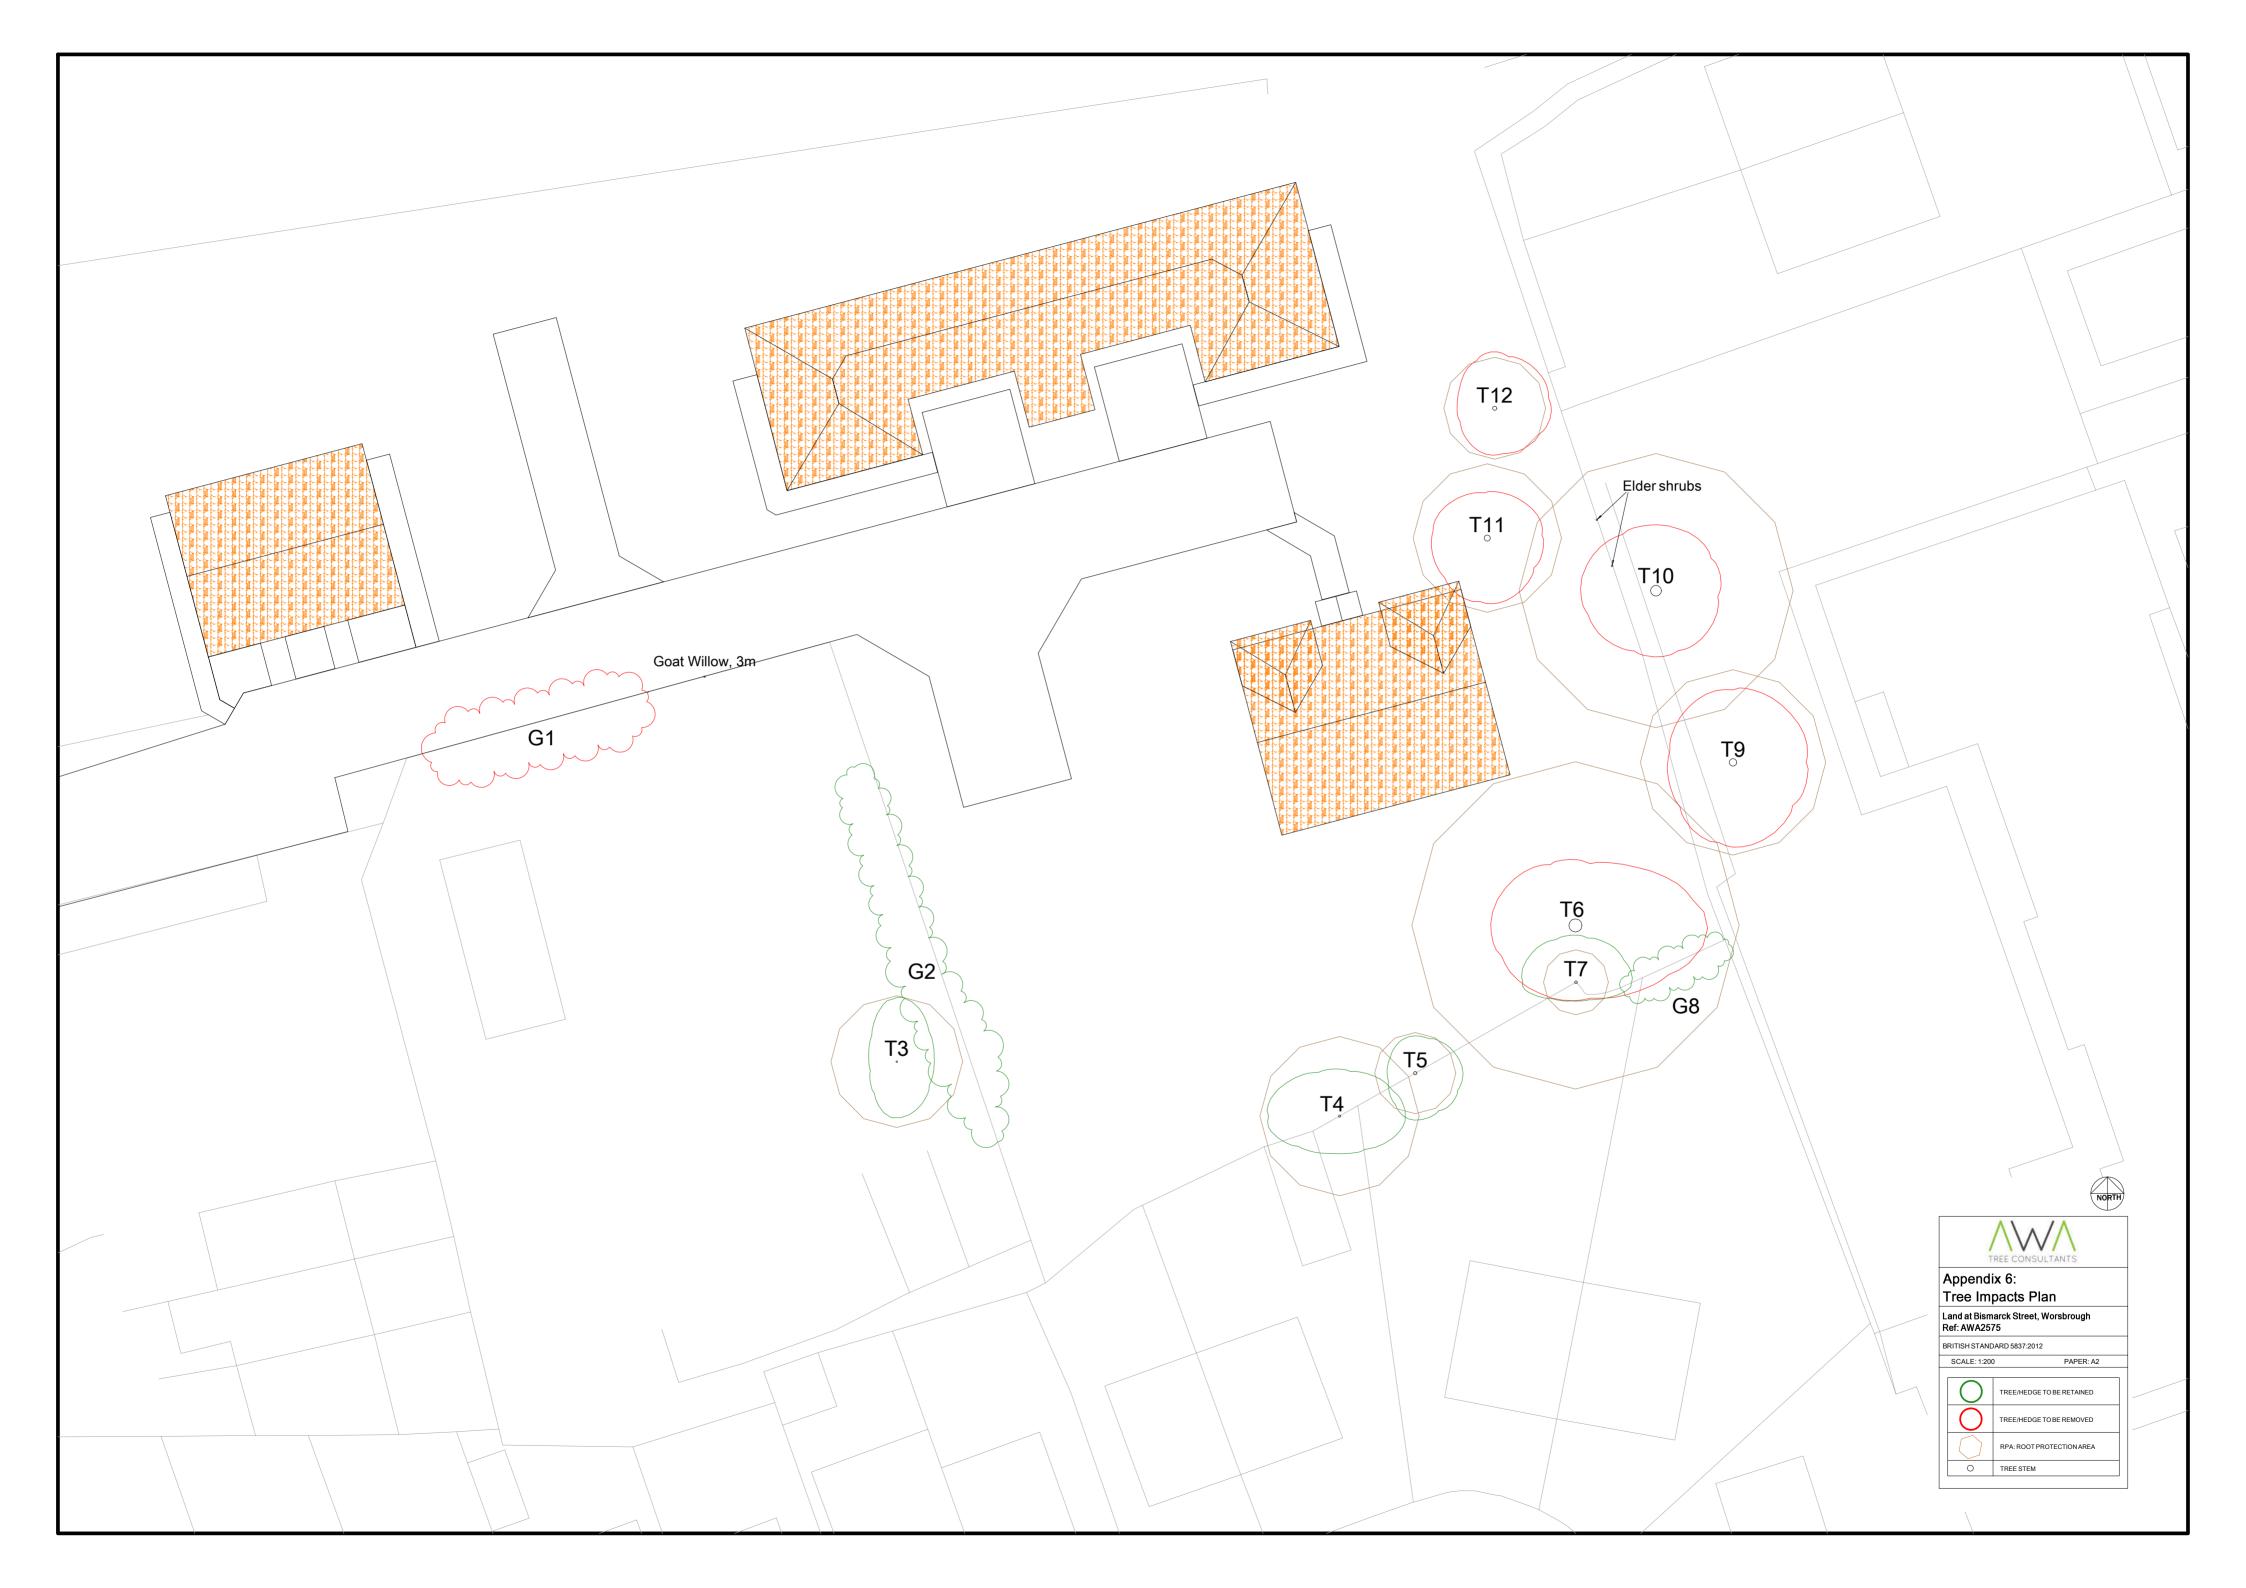
- 4.2.1 From assessing the new development proposals, 2 trees and 1 group will require removal as they are situated in the footprint of the structure or their retention and protection throughout the development is not suitable.

- 4.2.2 The trees that require removal are G1, T11 and T12.
- 4.2.3 The trees that require removal are all lower value, retention categories 'C'. The long-term prospects of low value self-set tree group G1 are limited due to their location, growing against and through the boundary fence. The trees T11 and T12 have significant defects that limit their long-term prospects and make their retention unsuitable close to the proposed development.

- 4.5.1 The retained trees may require protection by fencing in accordance with BS 5837: 2012, during the development phase. The protective fencing for this site should be located to protect the RPAs of the retained trees as detailed on the attached Tree Impacts Plan at Appendix 6.
