# **ARBORICULTURAL REPORT & Impact Assessment to BS5837:2012 at:**

*Land at*  
**19 Hill Street**  
**Elsecar**  
**Barnsley**  
**S74 8EL**

*Date: February 2021*

Reference: AWA3596

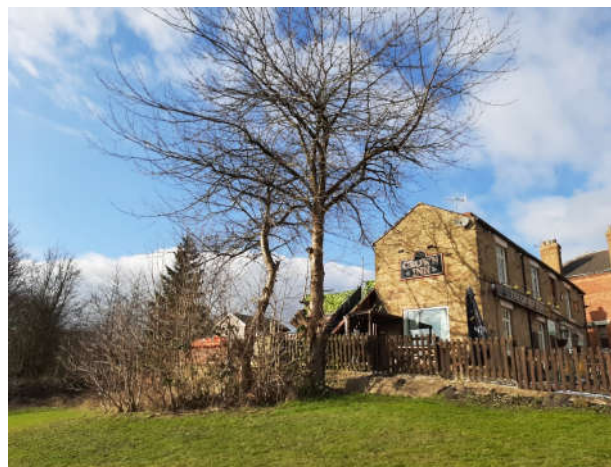
- 3.2.7 At the northern boundary of the site are Cherry trees T1 and T2. As the trees are situated close to the road they are somewhat prominent in the wider area, with T1 providing a moderate level of amenity. Both trees are in fair condition, but historic, low quality pruning has resulted in large stubs with early signs of decay. The crowns of both trees overhang into the neighbouring pub, with the potential to cause nuisance issues.

Photo 2: T1 and T2, at the northern boundary

- 4.2.3 The trees to be removed are all lower value, retention category 'C'.
- 4.2.4 T1 and T2 are somewhat prominent on site so there will be some negative impact from the removal of these trees. However, the trees will likely have more limited long-term value due to decay resulting from previous poor pruning.

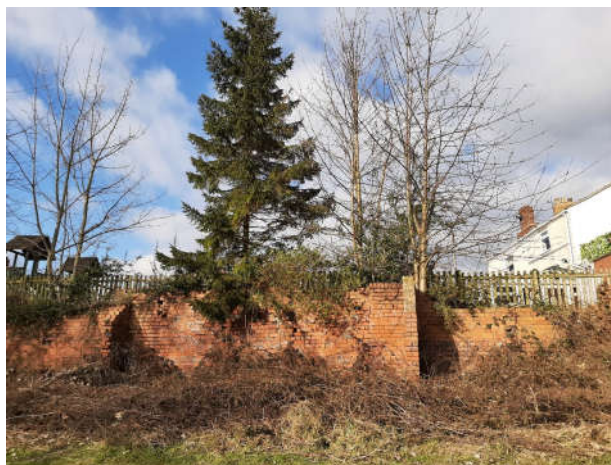
- 3.2.8 Along the northern boundary of the site are trees T3 to T11. Of these trees, T3 to T6 are young, self-set trees situated within the boundary of the site, while T7 to T11 are semi-mature trees that are situated on top of the retaining wall of the pub garden. The trees on the retaining wall have some value as a screen. However, there are notable cracks and bulges in the retaining wall, immediately beneath the trees, and while this may not necessarily have been caused by tree growth it is reasonable to assume that continued tree growth will exacerbate this damage. While these trees do not require removing immediately, they are likely to be unsuitable for long-term retention.

Photo 3: Trees situated in the retaining wall at the northern boundary

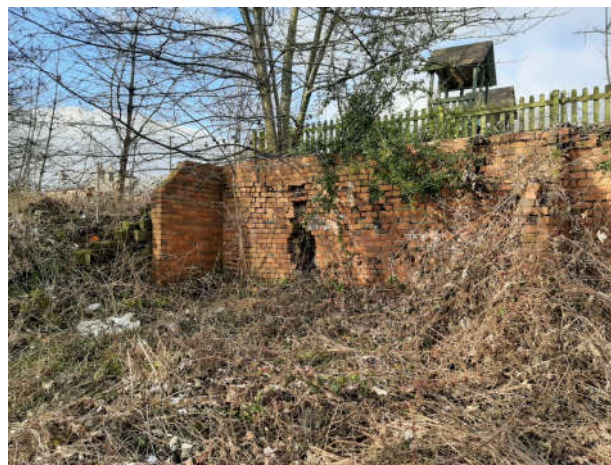
Photo 4: Damage to the retaining wall, which may be exacerbated by further tree growth

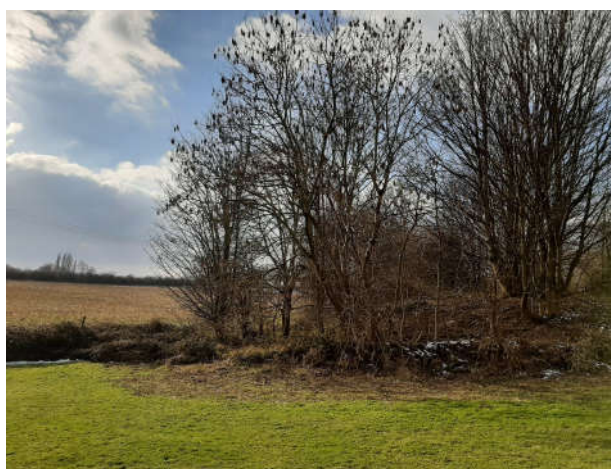
- 3.2.9 To the west, just beyond a somewhat dilapidated boundary wall, is a woodland, with edge trees T12 to T16. T12, T13 and T16 are early-mature, multi-stemmed Sycamore trees, T14 is a semi-mature Cherry, and T15 is an early-mature Ash, with a leaning stem that significantly overhangs into the site. While these trees, collectively, form a woodland that has moderate arboricultural value, individually they have more limited value, and their removal or pruning as part of development would have a negligible impact on the collective value of the woodland.

Photo 5: The woodland to the west, with edge trees T14 to T16

- 4.2.9 A stem in T15 will be removed to facilitate development. The eastern, leaning stem would require such a heavy reduction to clear the footprint of the proposed dwelling that reducing and retaining the stem would not be suitable.

- 4.2.10 The remaining crown of T15 will be crown reduced, at the eastern aspect, to facilitate a 1m clearance from the proposed dwelling. This will require pruning of smaller, third order branches which will be readily tolerated.
- 4.2.11 The pruning work to trees at the western boundary should be readily tolerated by the trees, and will not significantly impact their collective value as part of the woodland.
- 4.2.12 All tree work should be carried out according to British Standard 3998:2010 *Tree Work - Recommendations*.

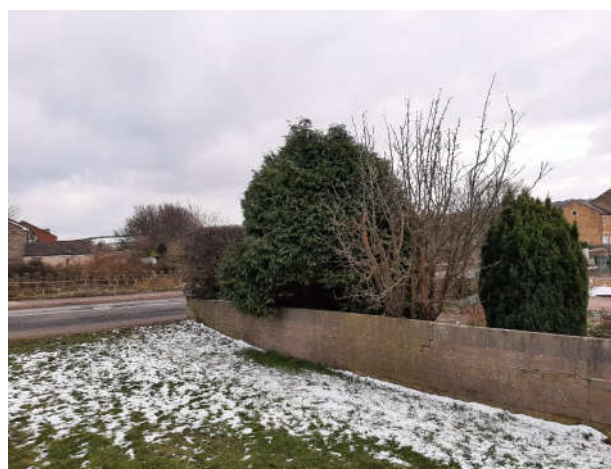
- 3.2.10 In the adjacent garden, at the south-east boundary of the site, are trees T17 to T20, and hedge G21. T17, T19 and T20 are small, managed Cypress trees that occasionally overhang into the site. T18 is a Laburnum, which also overhangs into the site, which has some dead wood and has previously been topped. G21 is a managed Hawthorn hedge. The trees and hedge in the neighbouring garden all have little arboricultural value, but do collectively provide reasonable screening value between the front garden and the site.

Photo 6: T17, T18 and T19 in the neighbouring garden
