## Feasibility Check Soil Stabilisation

Mr Rob Bramley - 23 Oakfield Walk, Barnsley, S75 2LW

### Brief history of the Claim

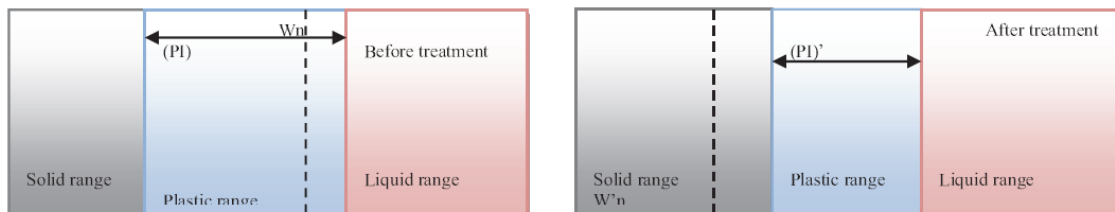
Effect of liming on the consistency of soil

Soil pH directly affects the life and growth of vegetation because it directly affects the availability of *all* plant nutrients. A nutrient is in its most available state between pH 6.0 and pH 6.5. A nutrient must be soluble long enough and remain soluble long enough to successfully travel through the solution into the roots. Nitrogen for example has its greatest solubility between soil pH 4 and soil pH 8. Outside of that range its solubility is seriously restricted. The usual recommendation in order to raise the pH of soils is the application of lime. Clay soils are typically neutral displaying a pH of 7; as mentioned previously the pH value of a soil has a huge influence on what plants will grow. The addition of lime and consequent raising of the pH value will moreover limit the extent to which vegetation develop in the zone of soil stabilisation.

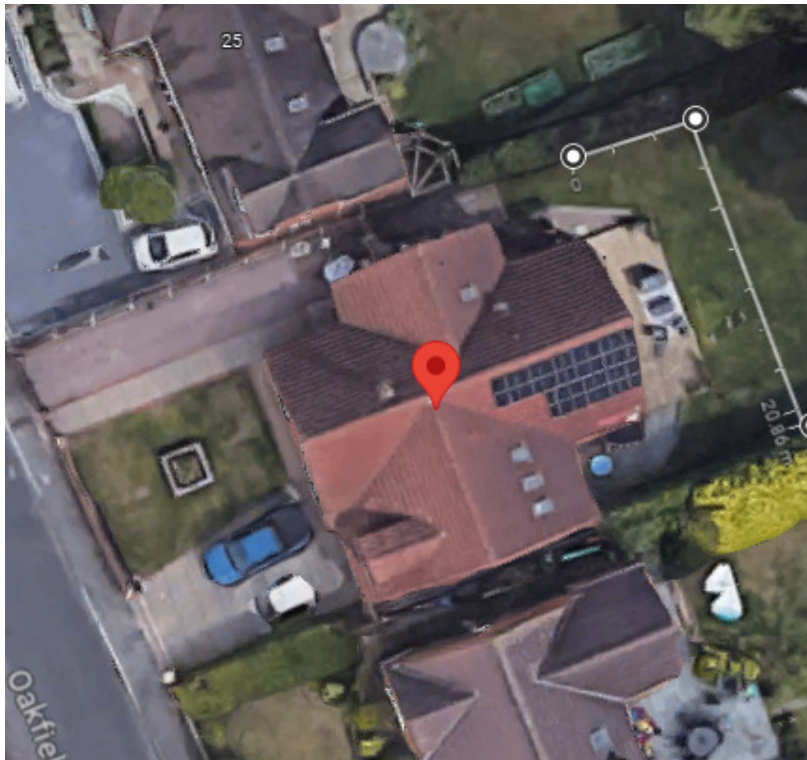
### General Schematic

Lime soil improvement channel to be installed as shown opposite in order to intervene successfully between the tree and area of damage.

Barrier length approx. 17m (See later opposite)

1. Line searches to be carried out to establish any services in the area for the proposed barrier however cat and jenny scans are still required.
2. Root severance application to be made to Barnsley City Council and approval to be agreed before barrier can be installed in respect of T2 Willow. T1 is being removed as part of a separate agreement.
