Arboricultural Consultancy for Lloyds Bank

Insured	Mr Rob Bramley	Address	23 Oakfield Walk, Barnsley, S75 2LW		
Client	Subsidence Management Services	Contact	Warja Warner	Claim No.	IFS-LBG-SUB-18-0078492
ES Ref	SA-246912	Consultant	Will Rickerby	Contact No.	0330 380 1036
Report Date	23/11/2020 Revised: 16/03/2022

Scope of Report: To survey the property and determine significant vegetation contributing to subsidence damage, make recommendation for remedial action and assess initial mitigation and recovery prospects. The survey does not make an assessment for decay or hazard evaluation. This is a revised report, amended to include the results of level monitoring.

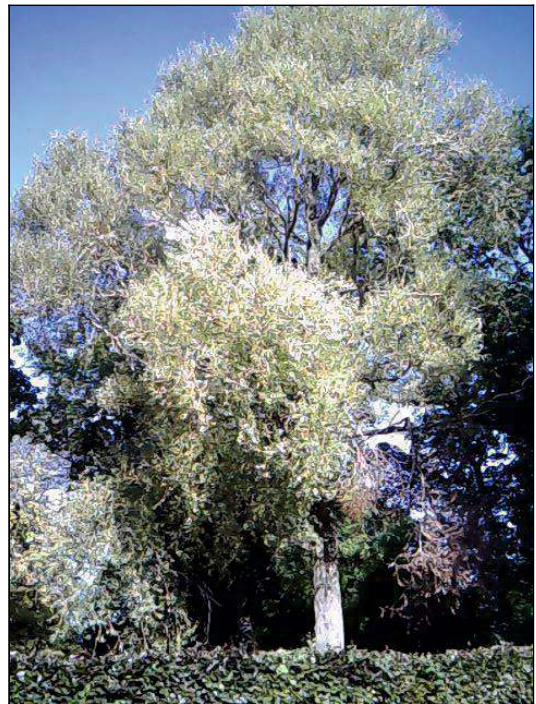
T2 - Willow

However, whilst not positively implicated by root analysis, the Willow (T2) cannot be discounted as contributing to the overall level of soil drying proximate to the area of damage and is therefore also considered to retain a significant, albeit secondary, contributory influence.

The size and proximity of T2 is consistent with the location of damage and advised mechanism of movement; it is our opinion on balance of probability that roots from T2 will also be in proximity to the footings of the insured property.

Consequently, complete removal of T1 & T2 will offer the most certain arboricultural solution likely to restore long-term stability.

Tree No.	Species	Age Cat	Approx. Height (m)	Distance to Building (m) *	Ownership	Action	Requirement
T1	Oak	3	15.2	18.2	A - Third Party	Remove	Remove close to ground level and treat stump to inhibit regrowth.
T2	Willow	3	15.2	15.7	A - Third Party	Remove	Remove close to ground level and treat stump to inhibit regrowth.
Age Cat: 1 = Younger than property; 2 = Similar age to the property; 3 = Significantly older than property

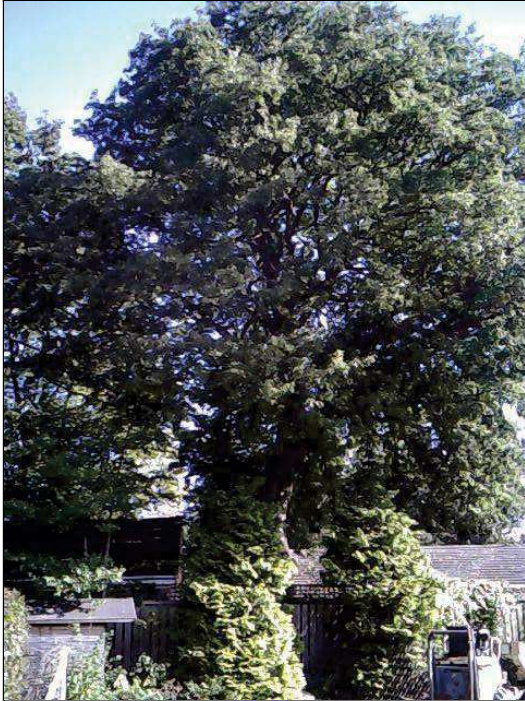
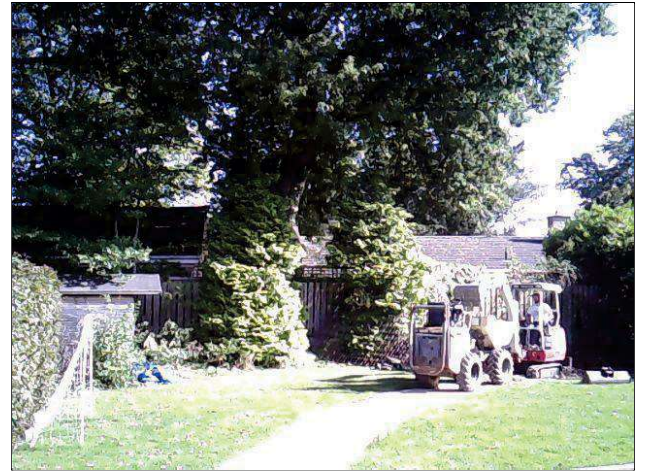
T1 - Oak

Samples of these roots were recovered from underside of foundations and throughout the borehole, these roots were identified (using anatomical analysis) as having emanated from the genus *Quercus* spp. (Oak).

Our survey of the site identified the Oak (T1), given its position relative to the damage it is our opinion that the *Quercus* spp. roots identified in TP/BH2 will emanate from this tree.
