**Home Farm, Worsbrough Road, Worsbrough Village**  
**Application Ref 2012/0626**

**Home Farm, Worsbrough,  
Barnsley**

**Structural Conditional Report  
on Cow House & Hayloft**

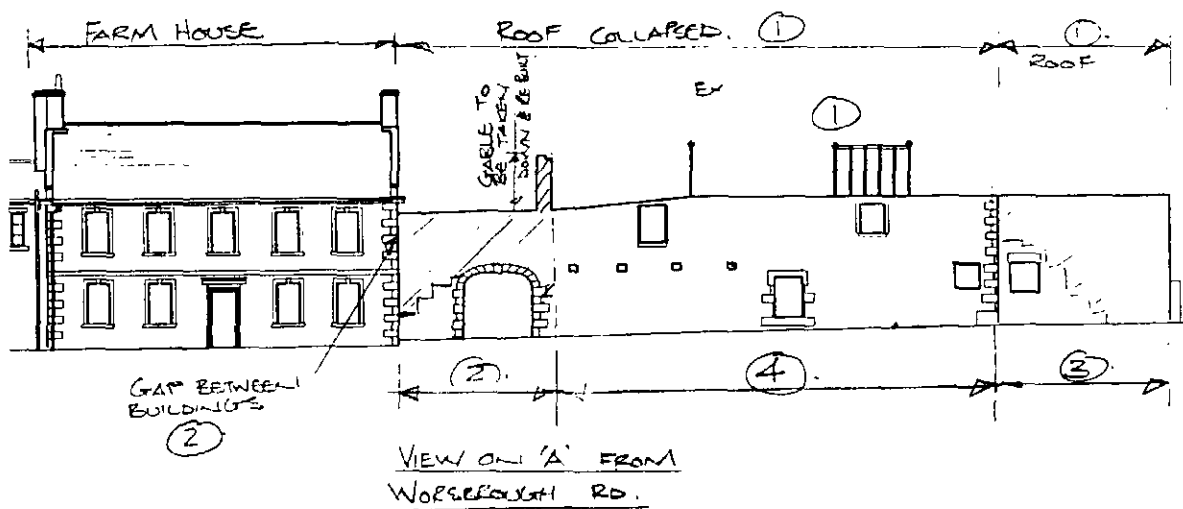
**View on A – From Worsbrough Rd**

| Element | Repair | Approx % of Elevation |
|---|---|---|
| 1 | Remaining Roof structure to be removed.<br>(Top of walls to consolidated and repaired to make level) | 15% |
| 2 | Wall to be taken down and reinstated / realigned. Feature stone replaced / rebuilt | 14% |
| 3 | Sections of stone to be replaced repointing required | 16% |
| 4 | Minor patch repairs + repointing. Generally sound structure | 5% |

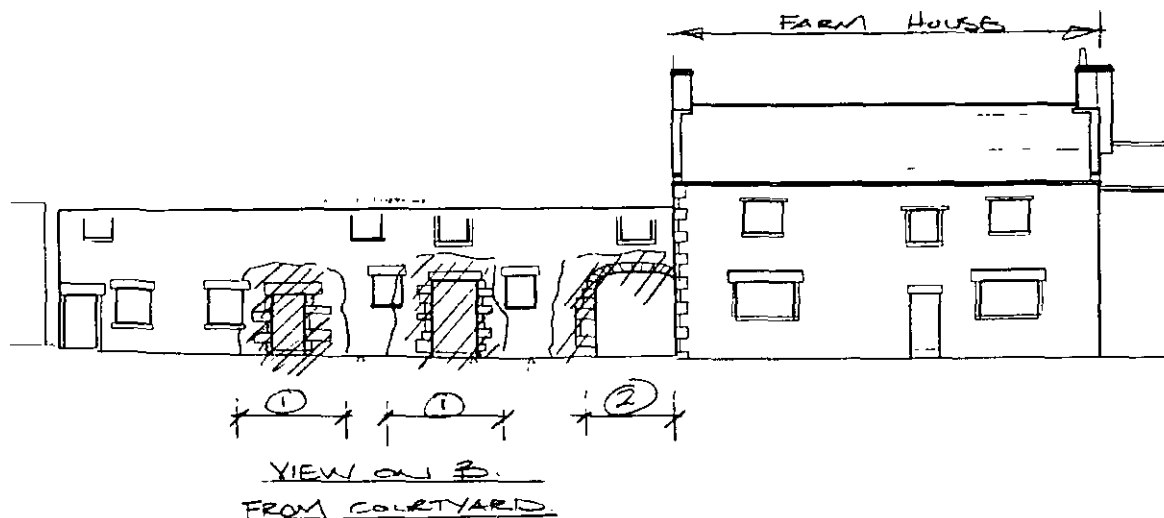
View on B – From the courtyard

| Element | Repair | Approx % of Elevation |
|---|---|---|
| 1 | Badly weathered stone work around doors to be taken down and replaced | 14% |
| 2 | Voussiers to door are unstable. Take stones down and reinstate | 8% |
| 3 | General patch repairs and repointing | 5% |

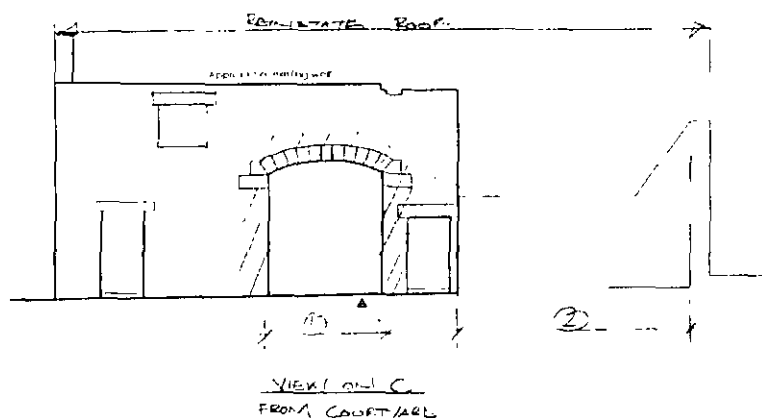
View on C – From the courtyard

| Element | Repair | Approx % of Elevation |
|---|---|---|
| 1 | Voussiers to door are unstable. Take stones down and reinstate | 20% |
| 2 | Collapsed area of wall to opposite elevation to be reinstated. Sections to be taken down to stabilise and allow reinstatement | 25% |
| 3 | General patch repairs and repointing | 3% |
