Further to our recent discussion, I have inspected the woodland plantings on the North Gawber Colliery Site and have the following comments to make.

**Woodland on Former Colliery Site – North Gawber Colliery**

**Len Carr Consultancy**

29/09/2011

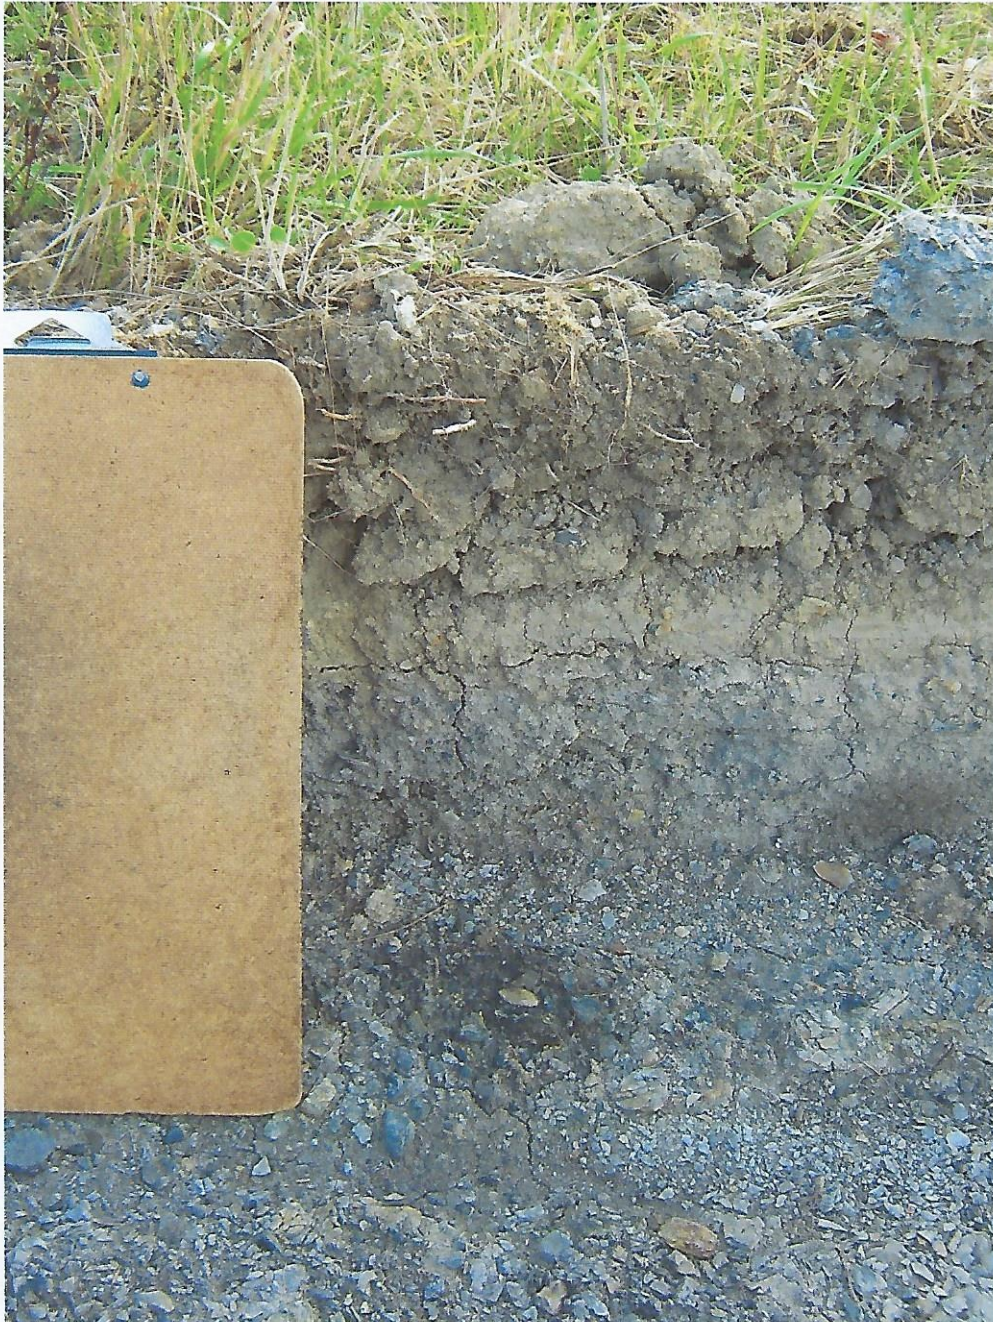
I understand the trees were established on the site approximately twenty years ago (the colliery closed at the end of 1987). Very little amelioration of the site appears to have been undertaken prior to the planting of the trees. About 150 mm (6 inches) of soil has been spread directly onto the colliery waste (see photograph 1). The colliery waste is very compressed and compacted and therefore resistant to root penetration. Such soils are prone to summer drought and winter water logging. Both of these conditions restrict tree growth.

Photograph 1 – Showing depth of soil overlying the colliery waste.

- The ripping of the compacted colliery spoil down to at least half a metre in depth, deeper if possible. This improves drainage and rooting depth.
- The loose tipping of a variety of soil forming materials, topsoil or subsoil on top of the ripped colliery soils to a depth of between one and two metres. Once tipped, this material should not be driven over or compacted in any way but spread by an excavator bucket. There are a number of industrial by-products, such as paper crumb and

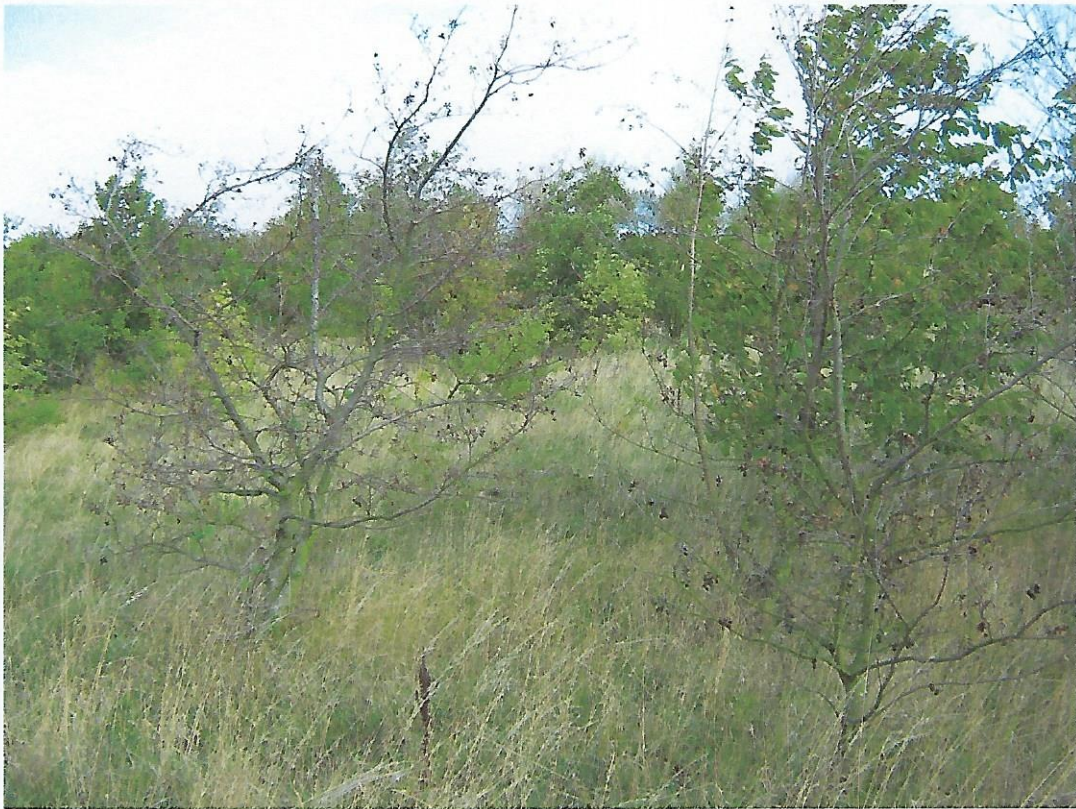
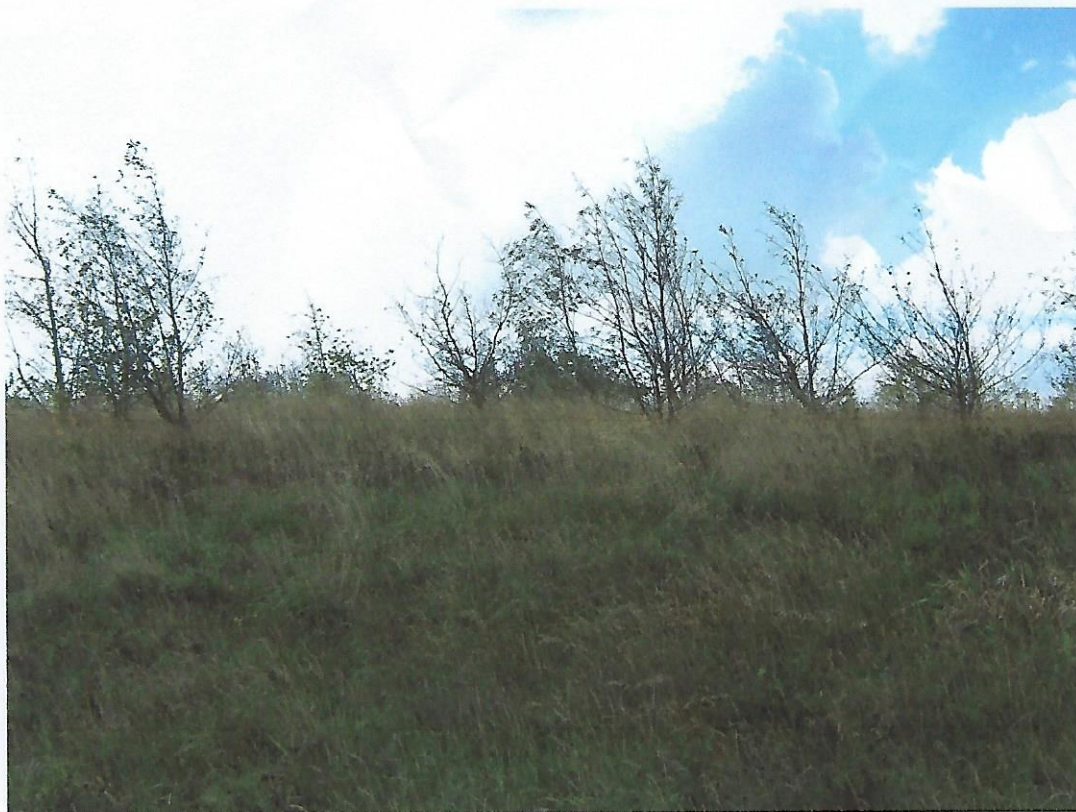
A wide variety of broadleaved trees were planted, including oak, birch, cherry, alder, hazel, rowan, hawthorn and willow. Planting failures have been high and, consequently, large areas are now understocked. Of those trees left on the site, many are struggling to grow or are dying back. Many of the alders are dying. Alders were at one time commonly planted on restoration sites as they are leguminous and add nitrogen to the soil. However, alder is a water demanding tree, being native to wet ground and land adjacent water courses. Over the years it has been found on many restoration sites that alder trees get to a certain size and then start to die back due to insufficient soil moisture. This appears to be the case at North Gawber Colliery.

are widely spaced and growing very slowly compared to trees of the same species planted on colliery sites restored using more modern techniques. Photographs 2 to 8 illustrate the low stocking and die back characteristic of the majority of the North Gawber Colliery site. For comparison, two photographs (numbers 9 and 10) of Edlington Pit Wood, established on the former Yorkshire Main Colliery site, are shown. This wood was established using modern amelioration techniques in 2002. At nine years old, the trees on this site have already outgrown those ten years older at North Gawber Colliery and have a much higher survival rate.

Photographs 2 and 3 – Low stocking and alder die back

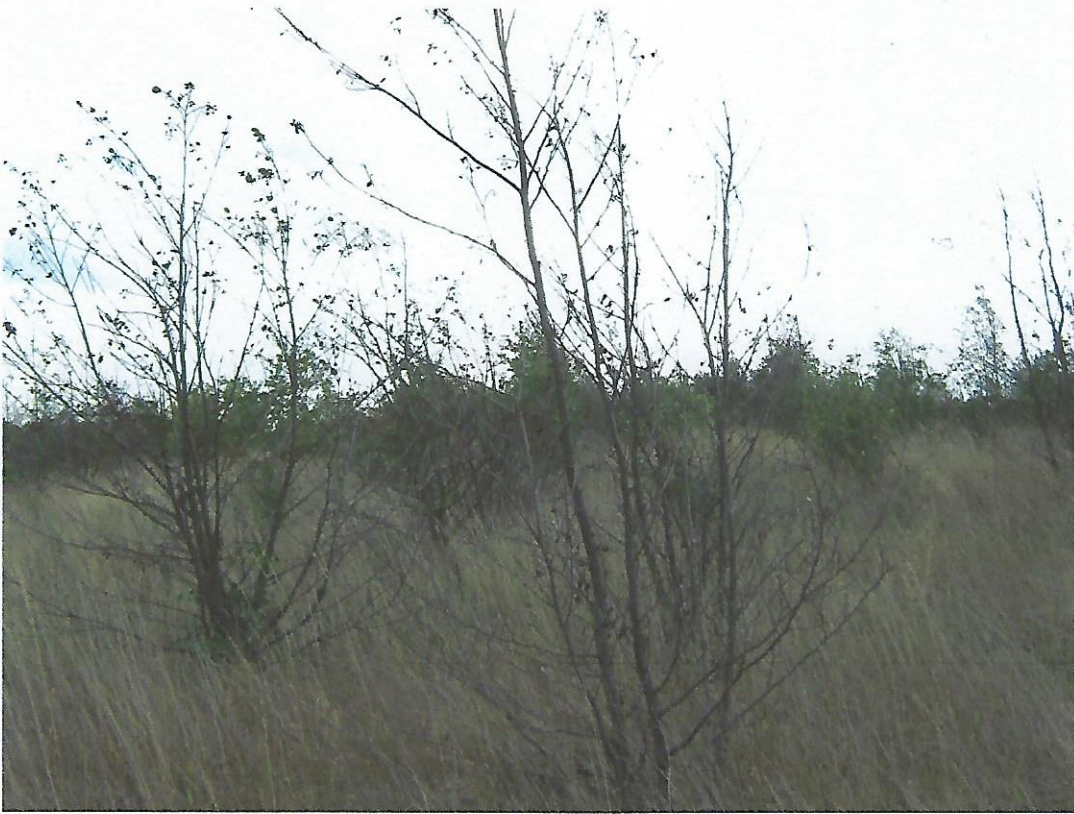
Photograph 4 – Low stocking and alder die back

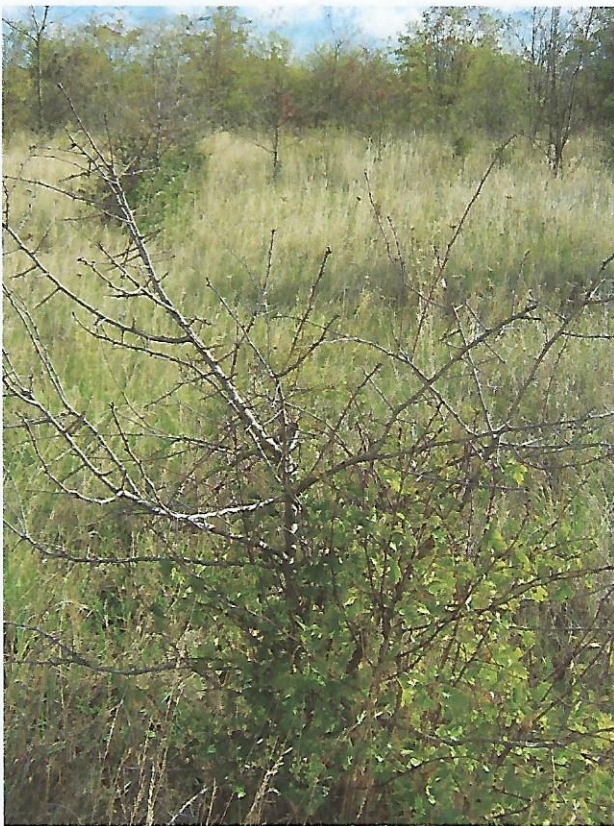
Many of the other tree species also appear to be dying back in places, including rowan, hazel and hawthorn. Even birch, a pioneer species able to grow in a wide variety of conditions, is dying back in patches. Only the oak, cherry, and in most places, the birch, appear to be surviving. However, they

Photograph 5 – Low stocking and hawthorn die back

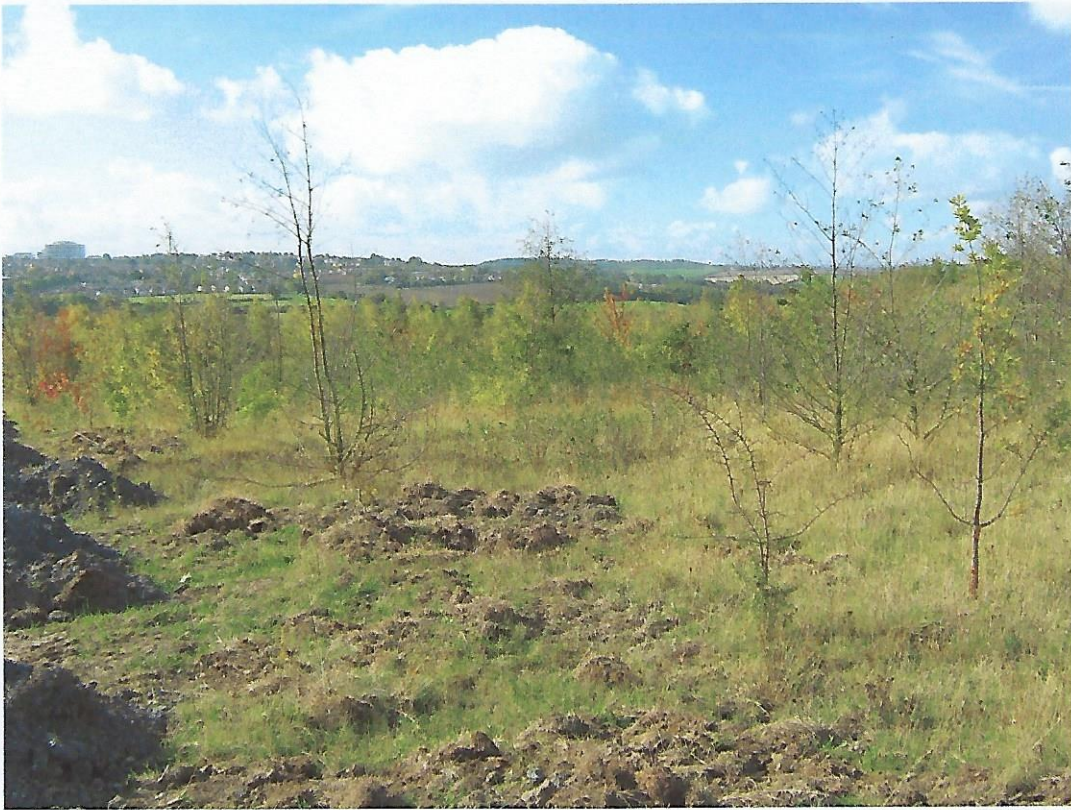
Photograph 6 – Low stocking and alder die back

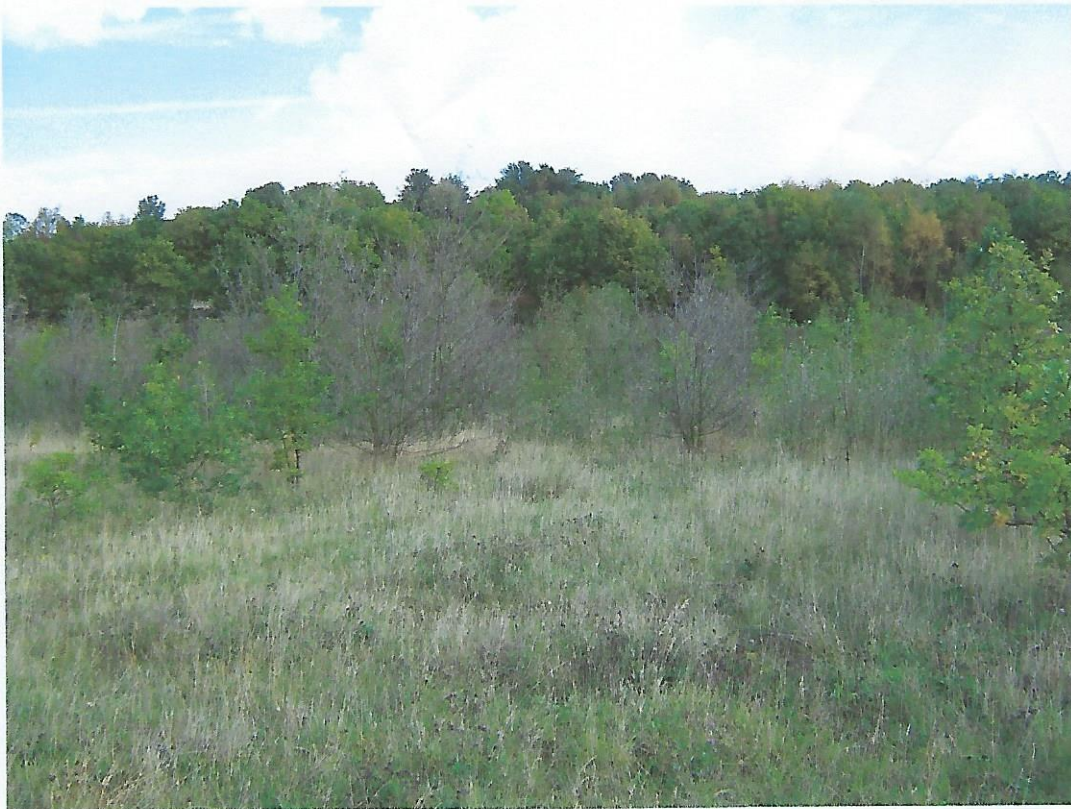
Photograph 7 – Alder die back

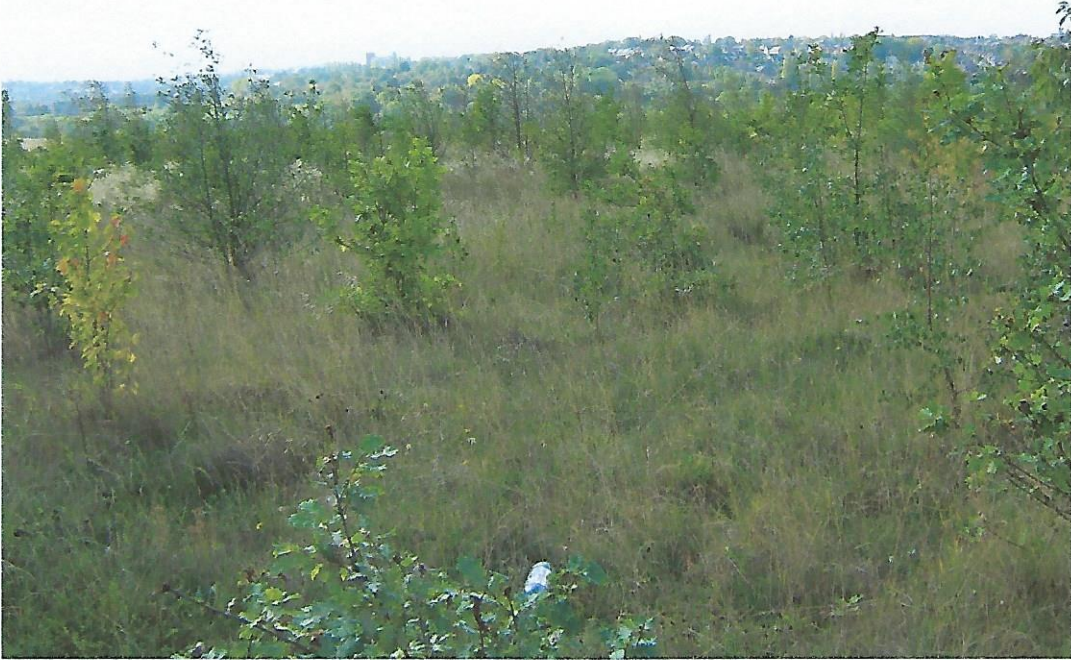
Photograph 8 – Low stocking due to planting failures. Very slow growth.

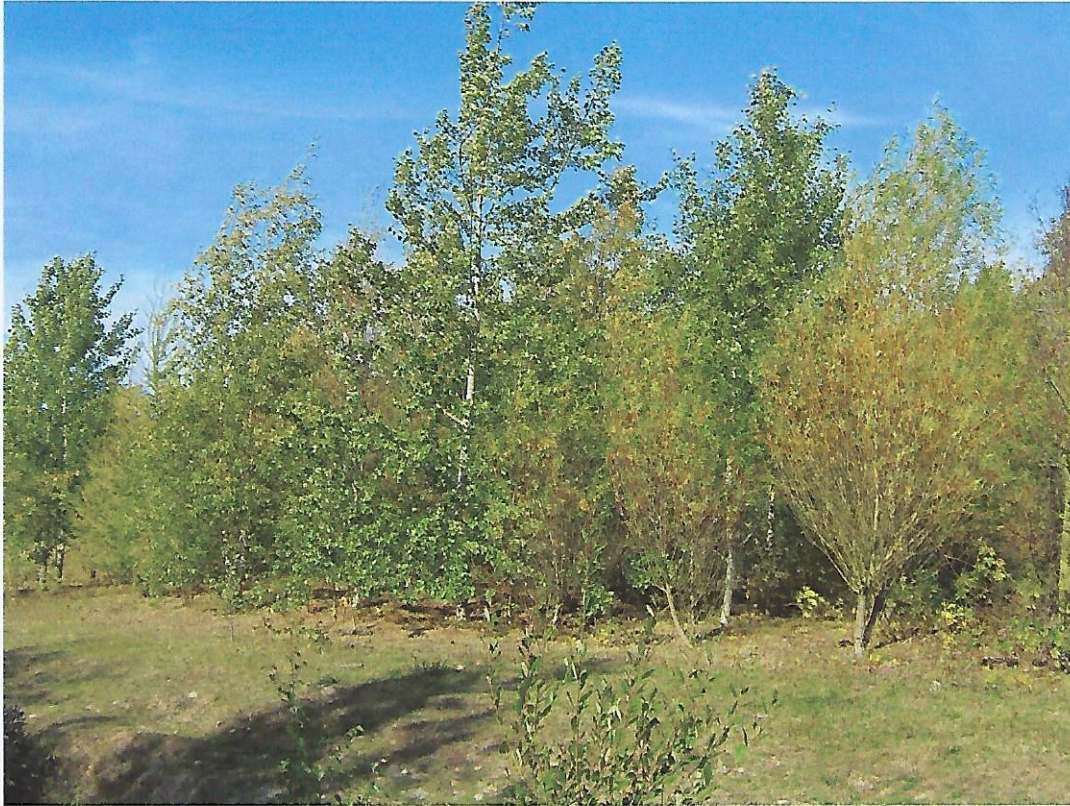
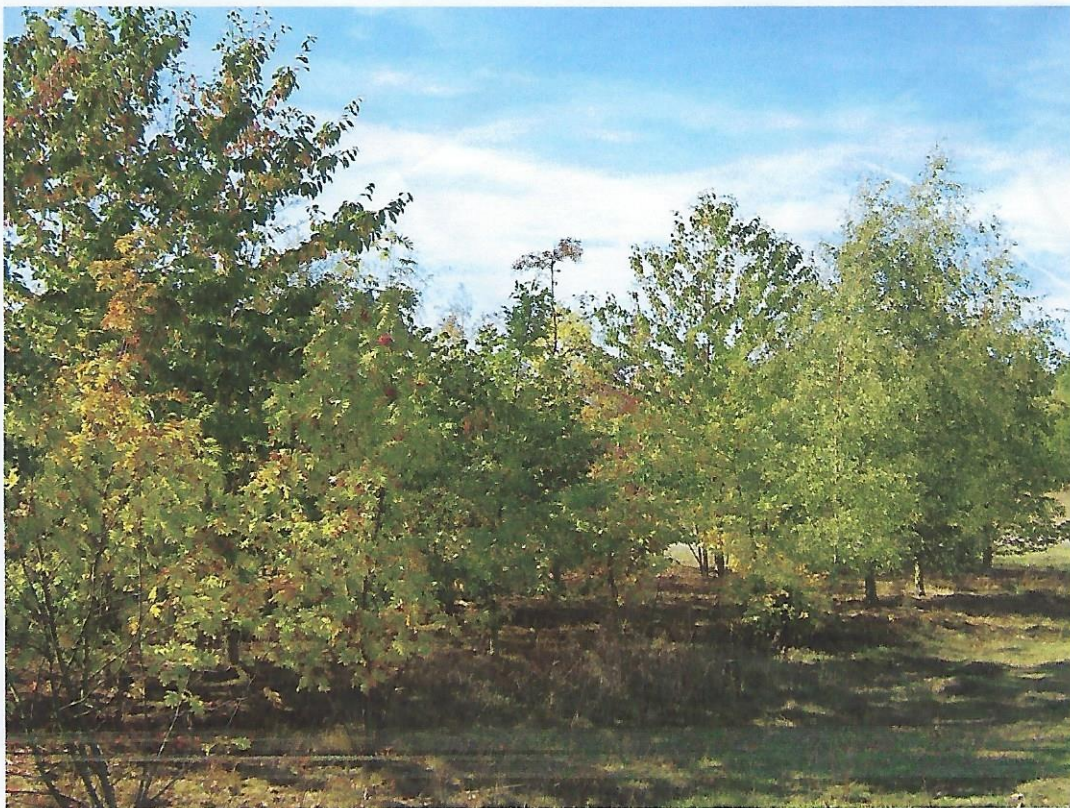
Photographs 9 and 10 – Successful establishment at Edlington Pit Wood using appropriate restoration techniques. Planted 2002.
