## ***Hill End Farm, Mapplewell***

### ***Structural survey of existing farm building***

MP Consulting Engineers (UK) Ltd

Job Number: MP8312

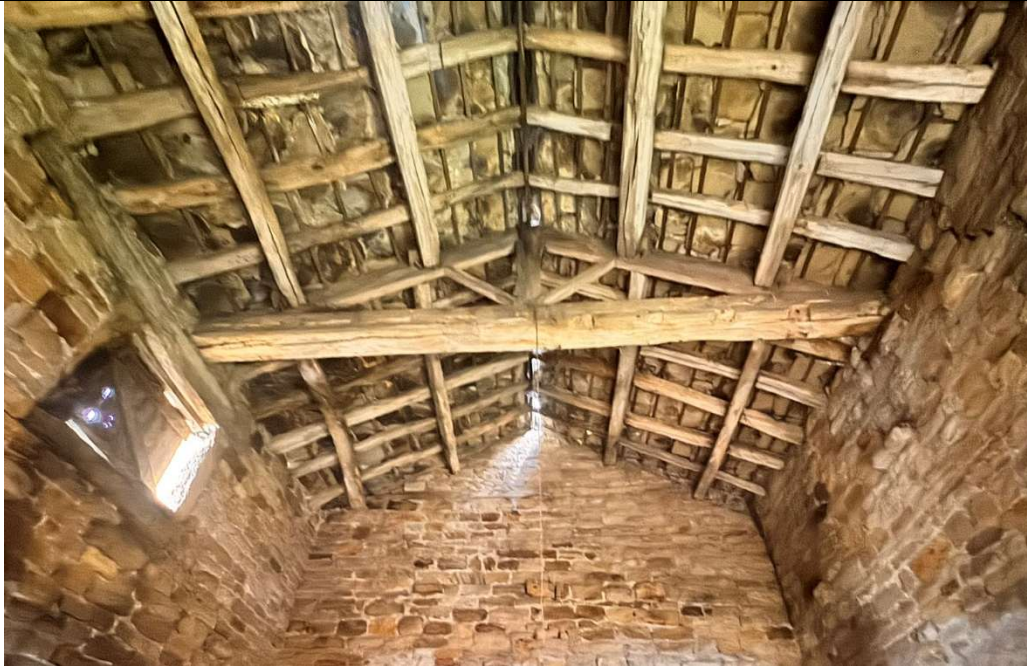
- Roof finish of original barn is a traditional yorkstone tile, supported by timber battens, rafters and purlins sat onto kingpost trusses spanning clear between masonry walls. Evidence of historical deflection of the roof timbers with ridge line dipping between points of support, to be expected for a heavy stone tiles roof of this age. Timbers appear in good condition with no significant signs of moisture ingress or infestation, sizes in the expected range for a building of this type. Clearly some repairs and maintenance would be needed as part of any refurbishment, but the roof structure is generally suitable for reuse.
- Roofs to both lean-to elements consist of corrugated steel sheeting supported by a light gauge steel arrangement. Although currently in use, these would likely be replaced to ensure a suitably insulated and visually acceptable structure is provided.

**Photo 1:** Typical view on underside of roof structure

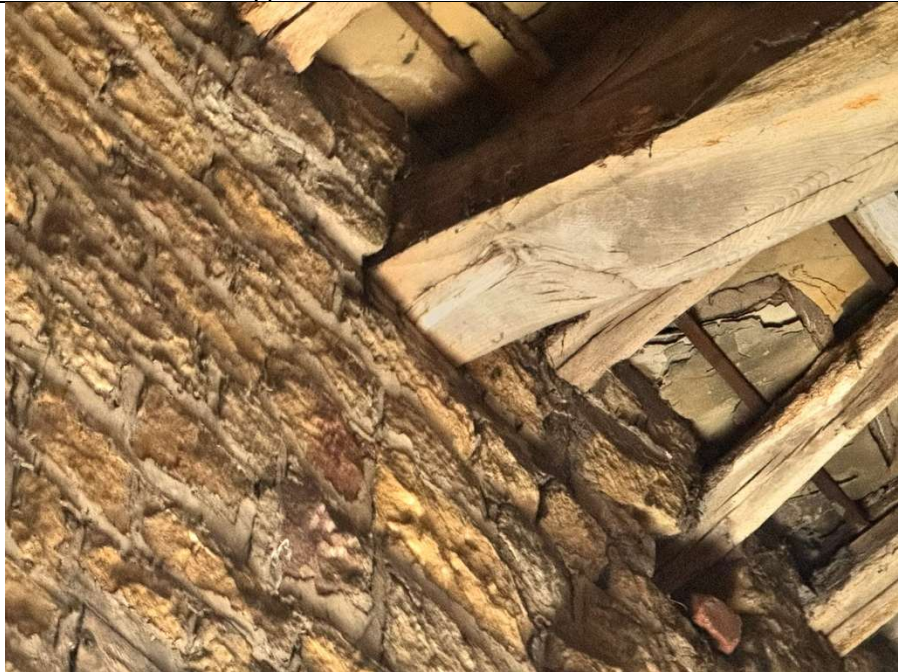
**Photo 2:** Truss bearing onto external stone wall

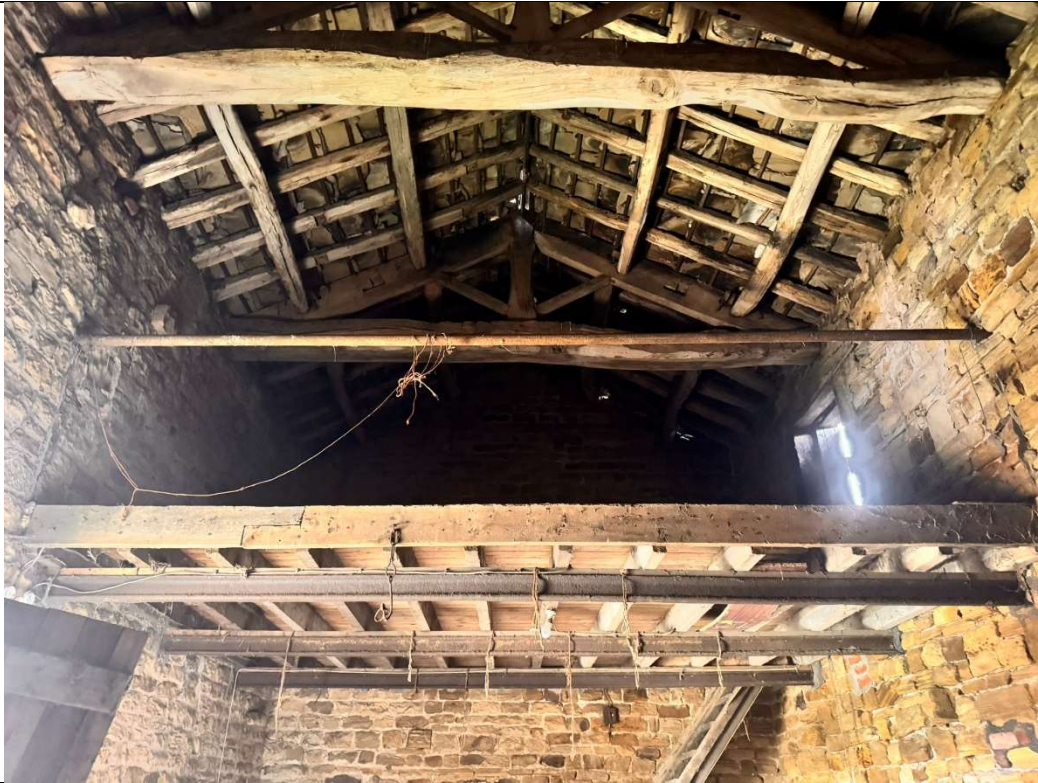
- Verges are pointed with tiles extending over walls, no gable copings/kneelers exist.
- Part first floor structure formed from timber boards and joists sitting onto steel beams spanning wall to wall. Levels may dictate the flooring being replaced to suit the proposed refurbishment however the building is capable of supporting a new timber first floor throughout. Indeed, a new floor diaphragm would serve to further enhance the structural stability of the building in the long term.

**Photo 3:** view on part first floor

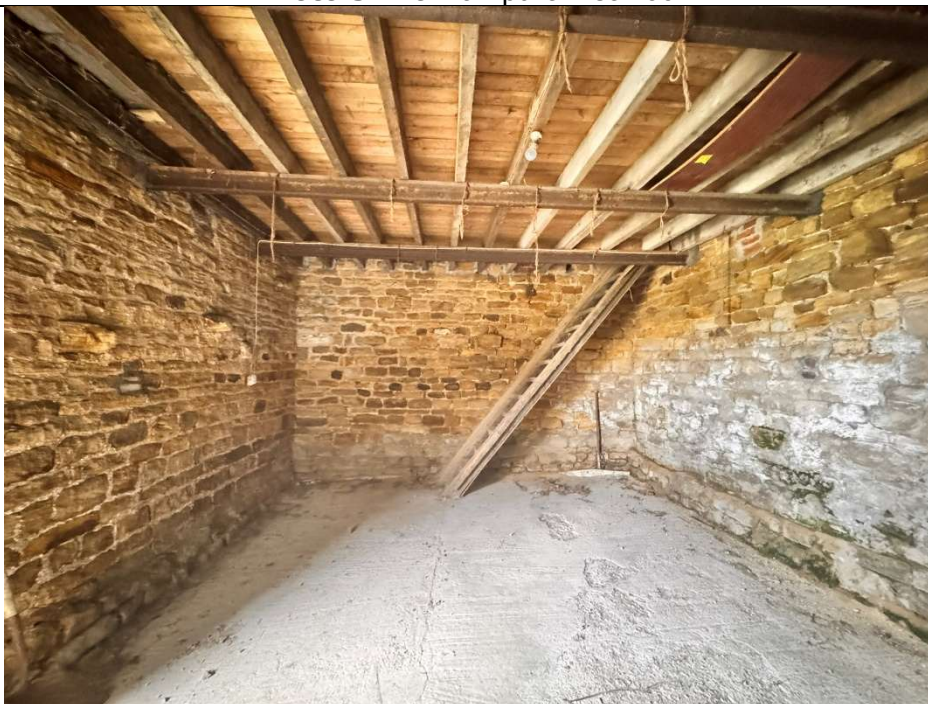
- Part yorkstone and part concrete ground bearing floor slab, no sign of any settlement or movement to the floor. Replacement of the floor with a modern insulated build up could be undertaken without detriment to the structure.

**Photo 4:** Underside of first floor and concrete ground floor structure

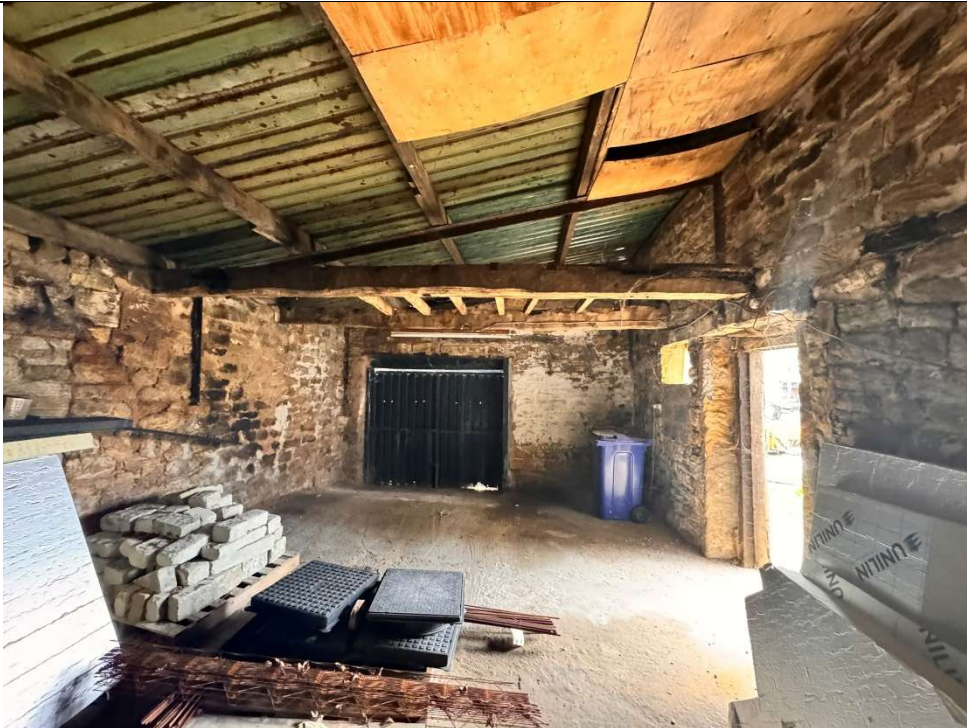
**Photo 5:** View on internal section of lean to

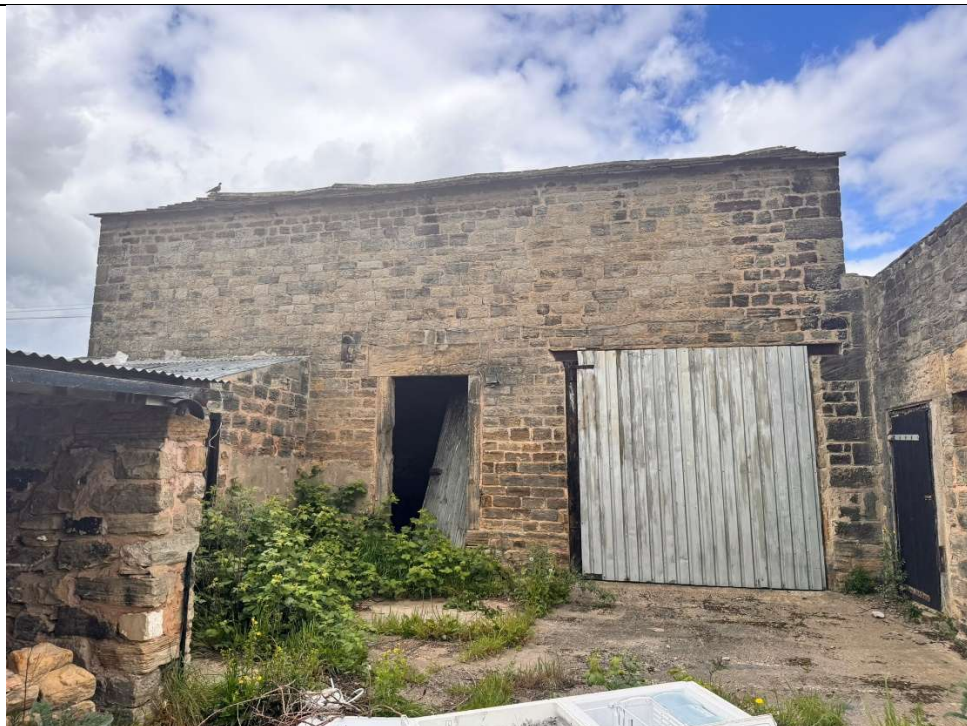
- Walls typically plumb with no significant signs of bowing or settlement. Stone lintels provided to external leaf (with some having steel replacements) with timber members supporting inner leaf. Lintel over main barn door has been replaced, a crack adjacent suggests the original may have failed over time.

**Photo 6:** View on main barn elevation, purlin over main door replaced with steel

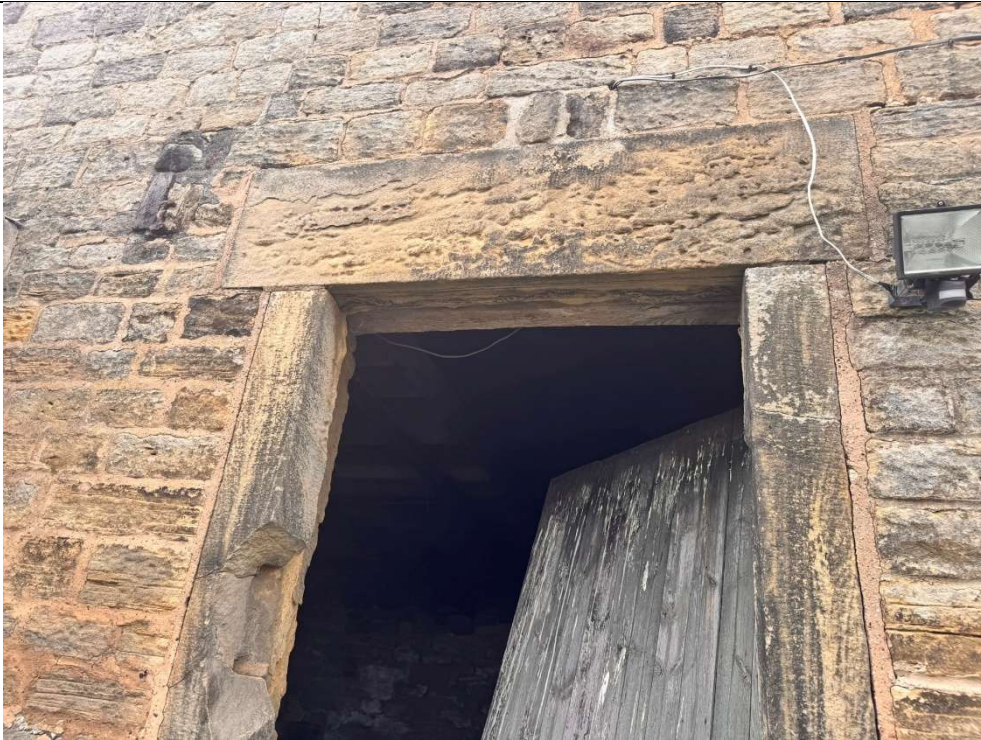
**Photo 7:** Typical support arrangement around doors/windows

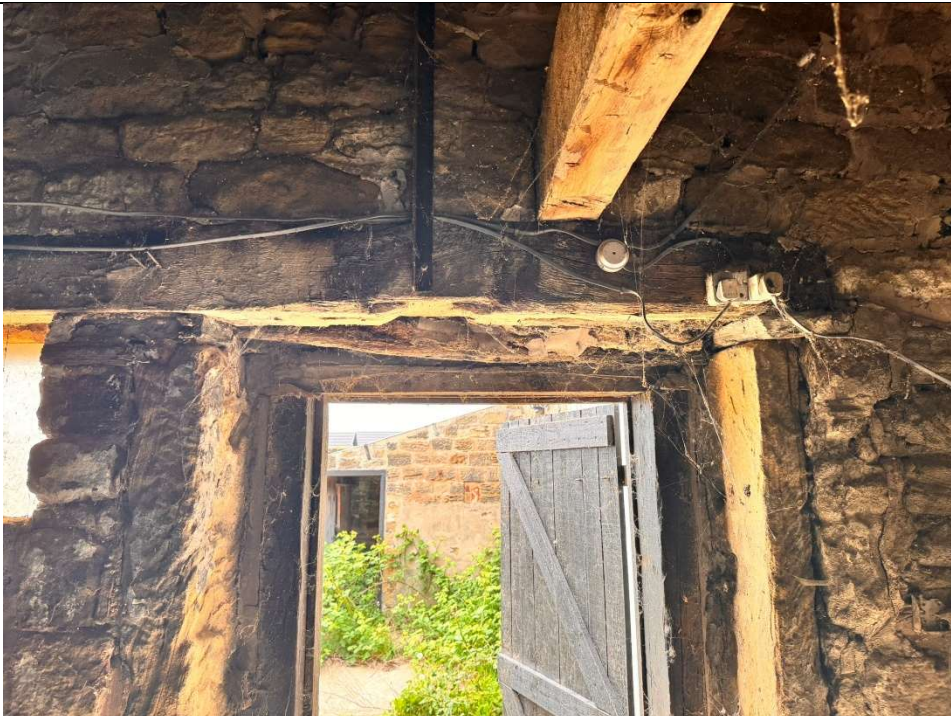
**Photo 8:** Internal timber lintel
